REPORT NUMBER: 201UI-CAL-09-03

**SAFETY COMPLIANCE TESTING FOR FMVSS 201  
OCCUPANT PROTECTION IN INTERIOR IMPACT  
UPPER INTERIOR HEAD IMPACT PROTECTION**

**GENERAL MOTORS CORP.  
2009 CHEVROLET TRAILBLAZER**

FINAL REPORT

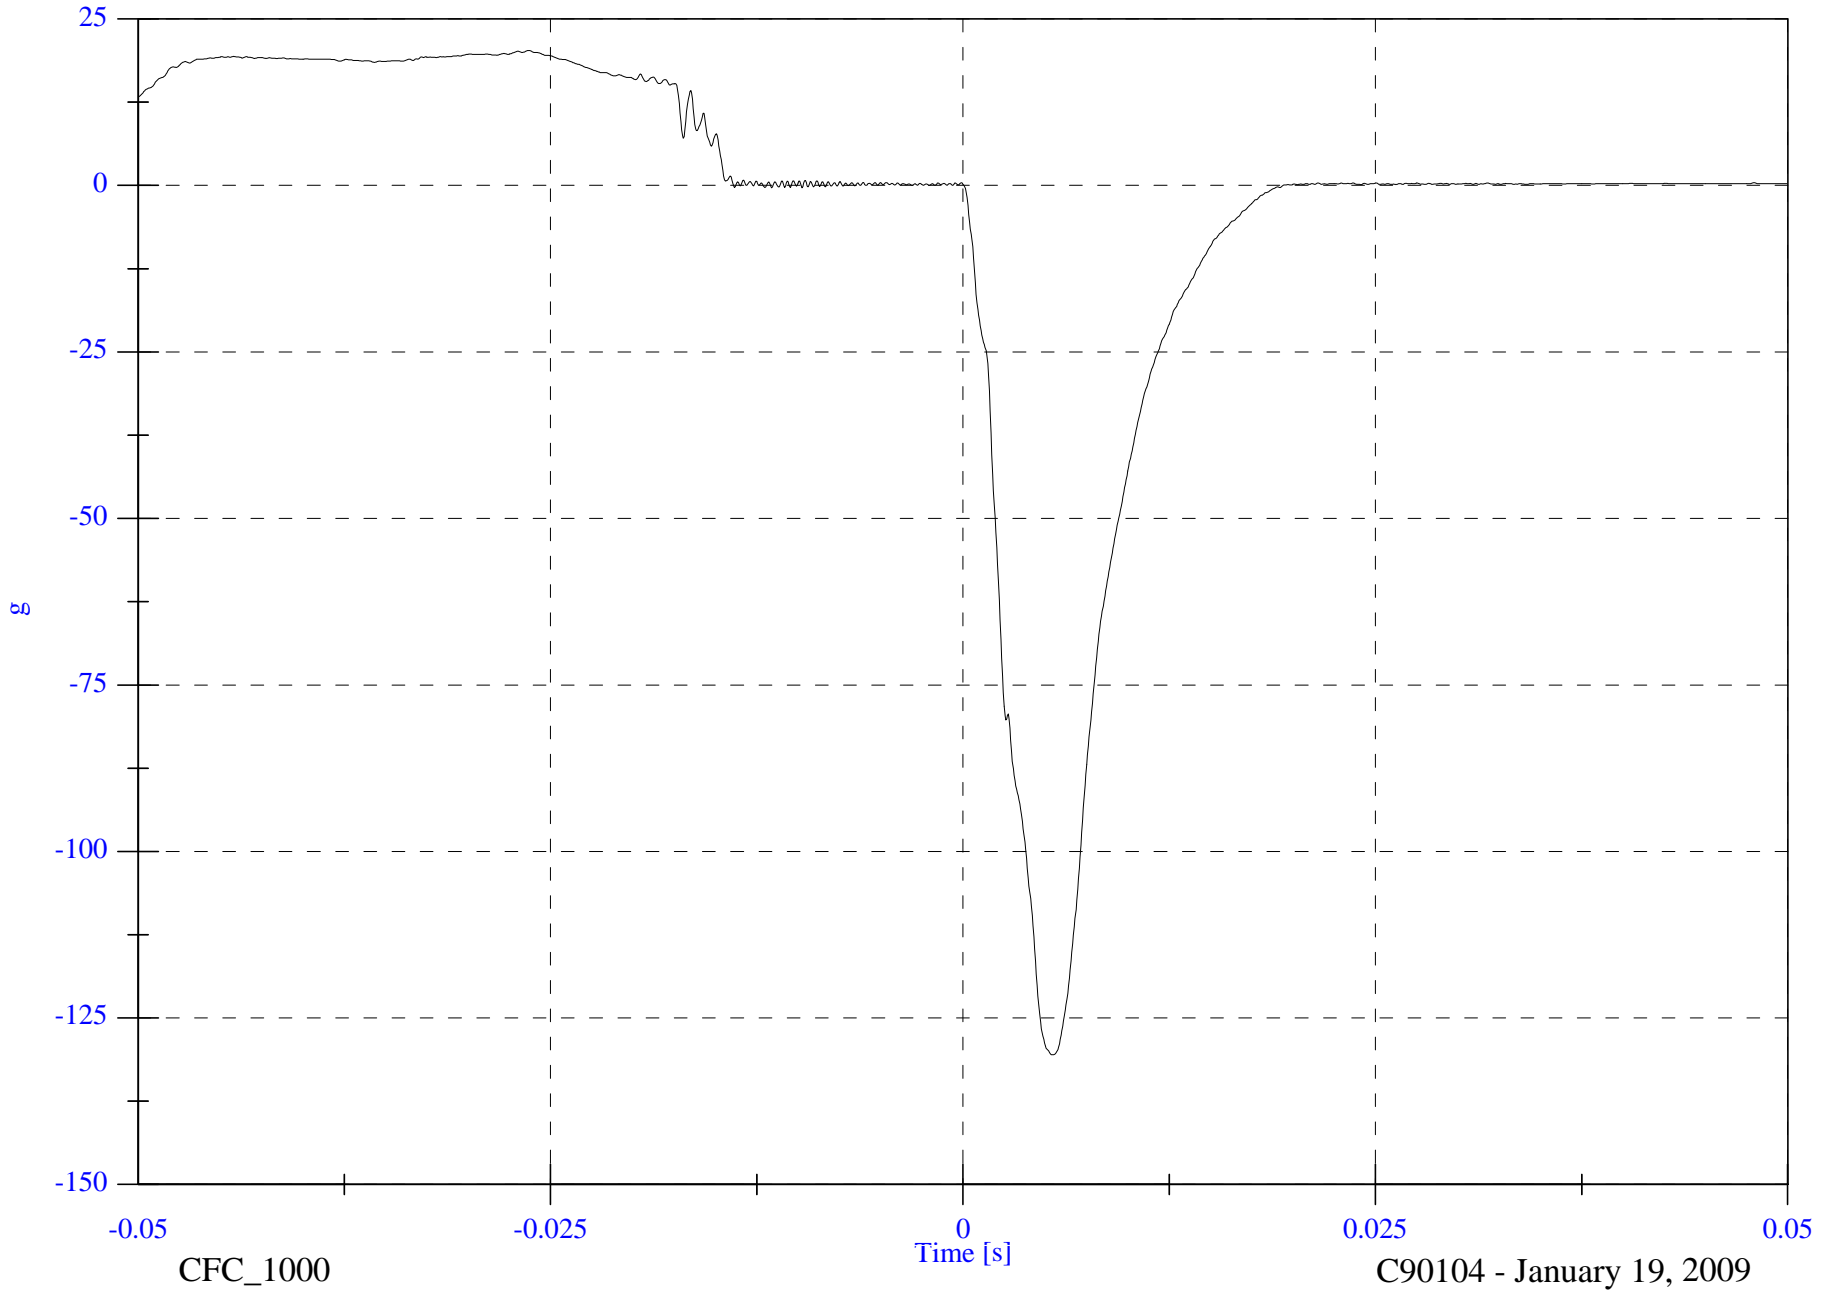
C90104 PASSENGER SIDE BP4 IMPACT PLOT #1

Min: -130.5 [g] at 0.005 [s]

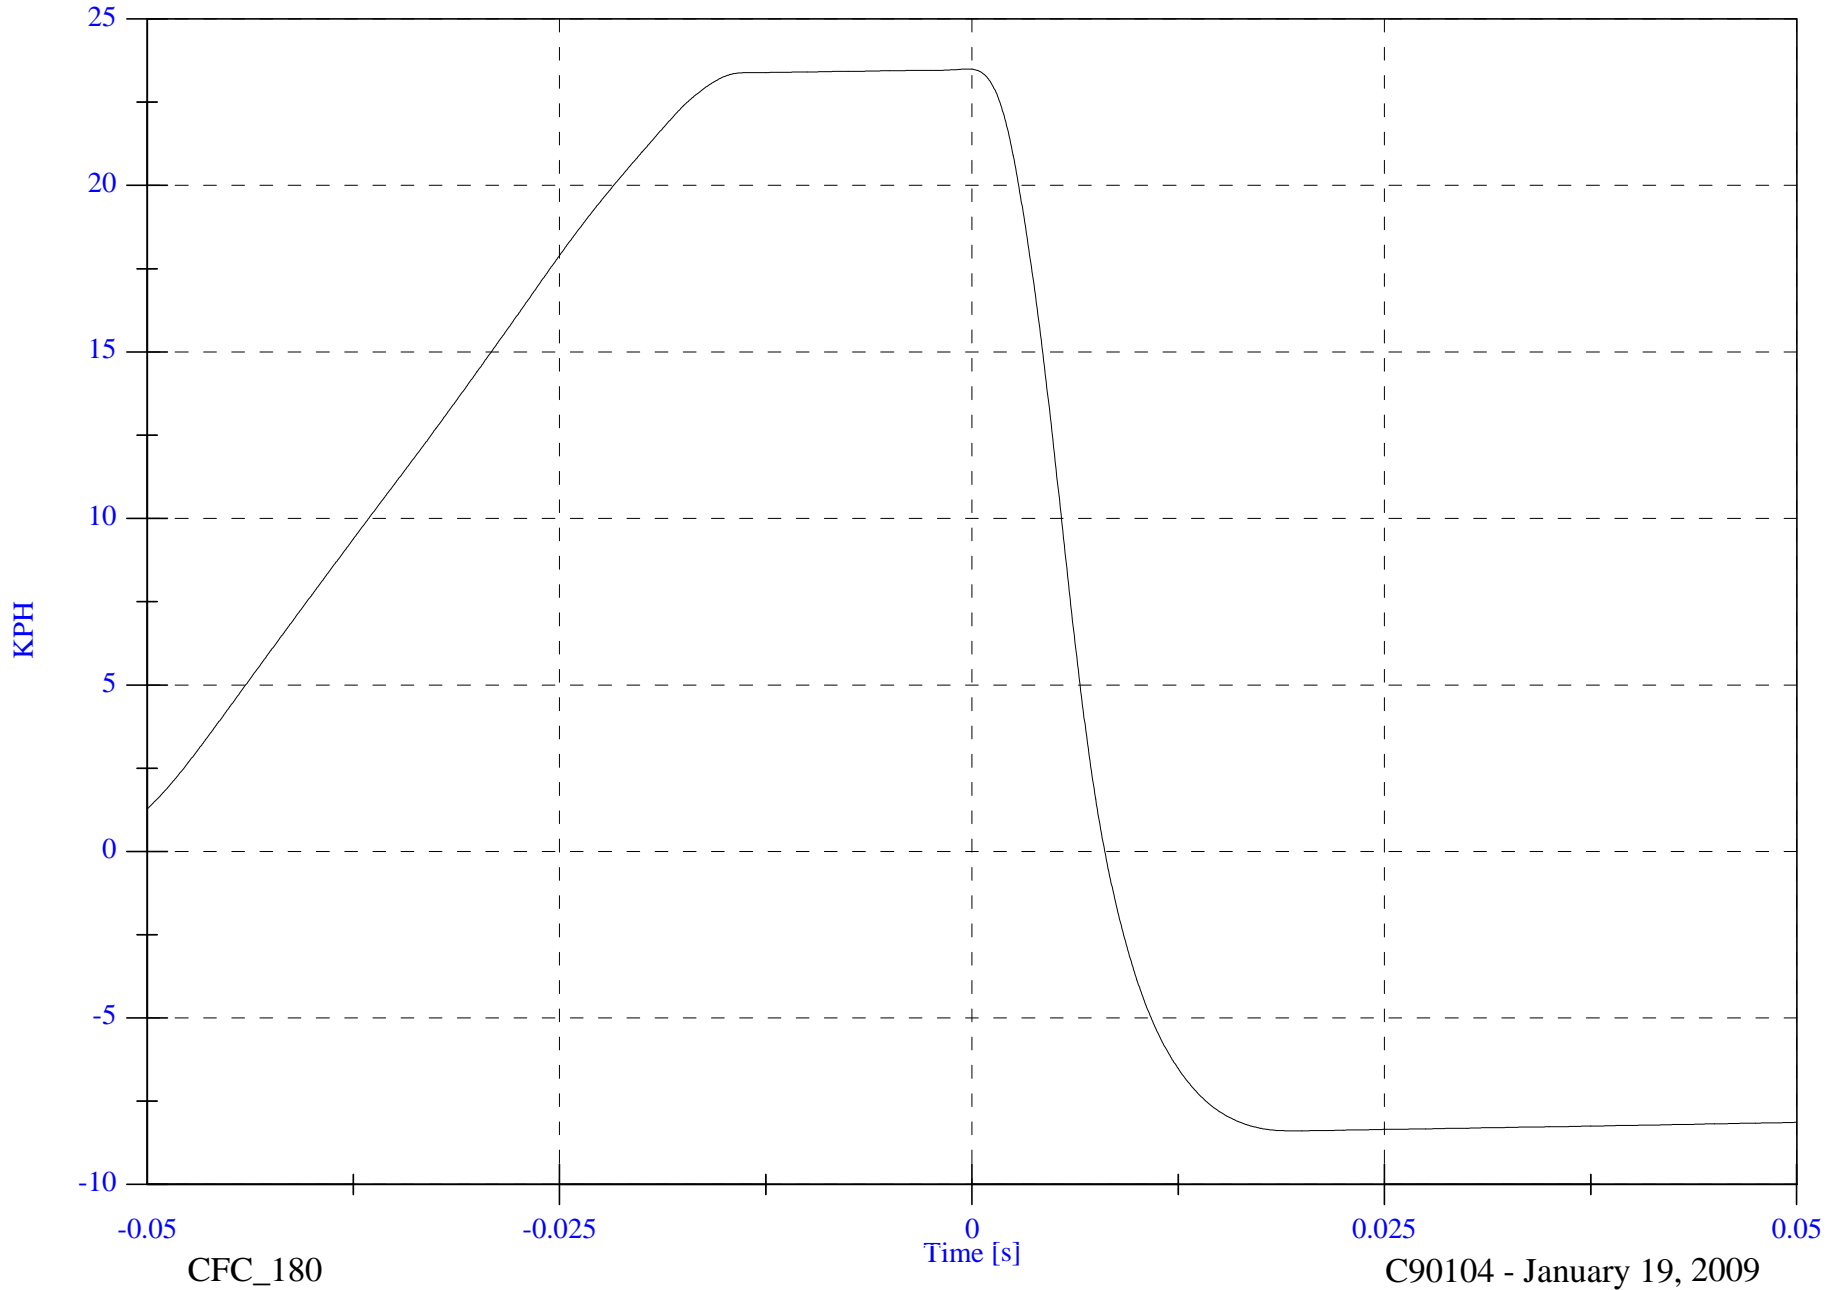
C90104 PASSENGER SIDE BP4 IMPACT PLOT #5

Max: 23.5 [KPH] at -0.000 [s]

Headform Velocity

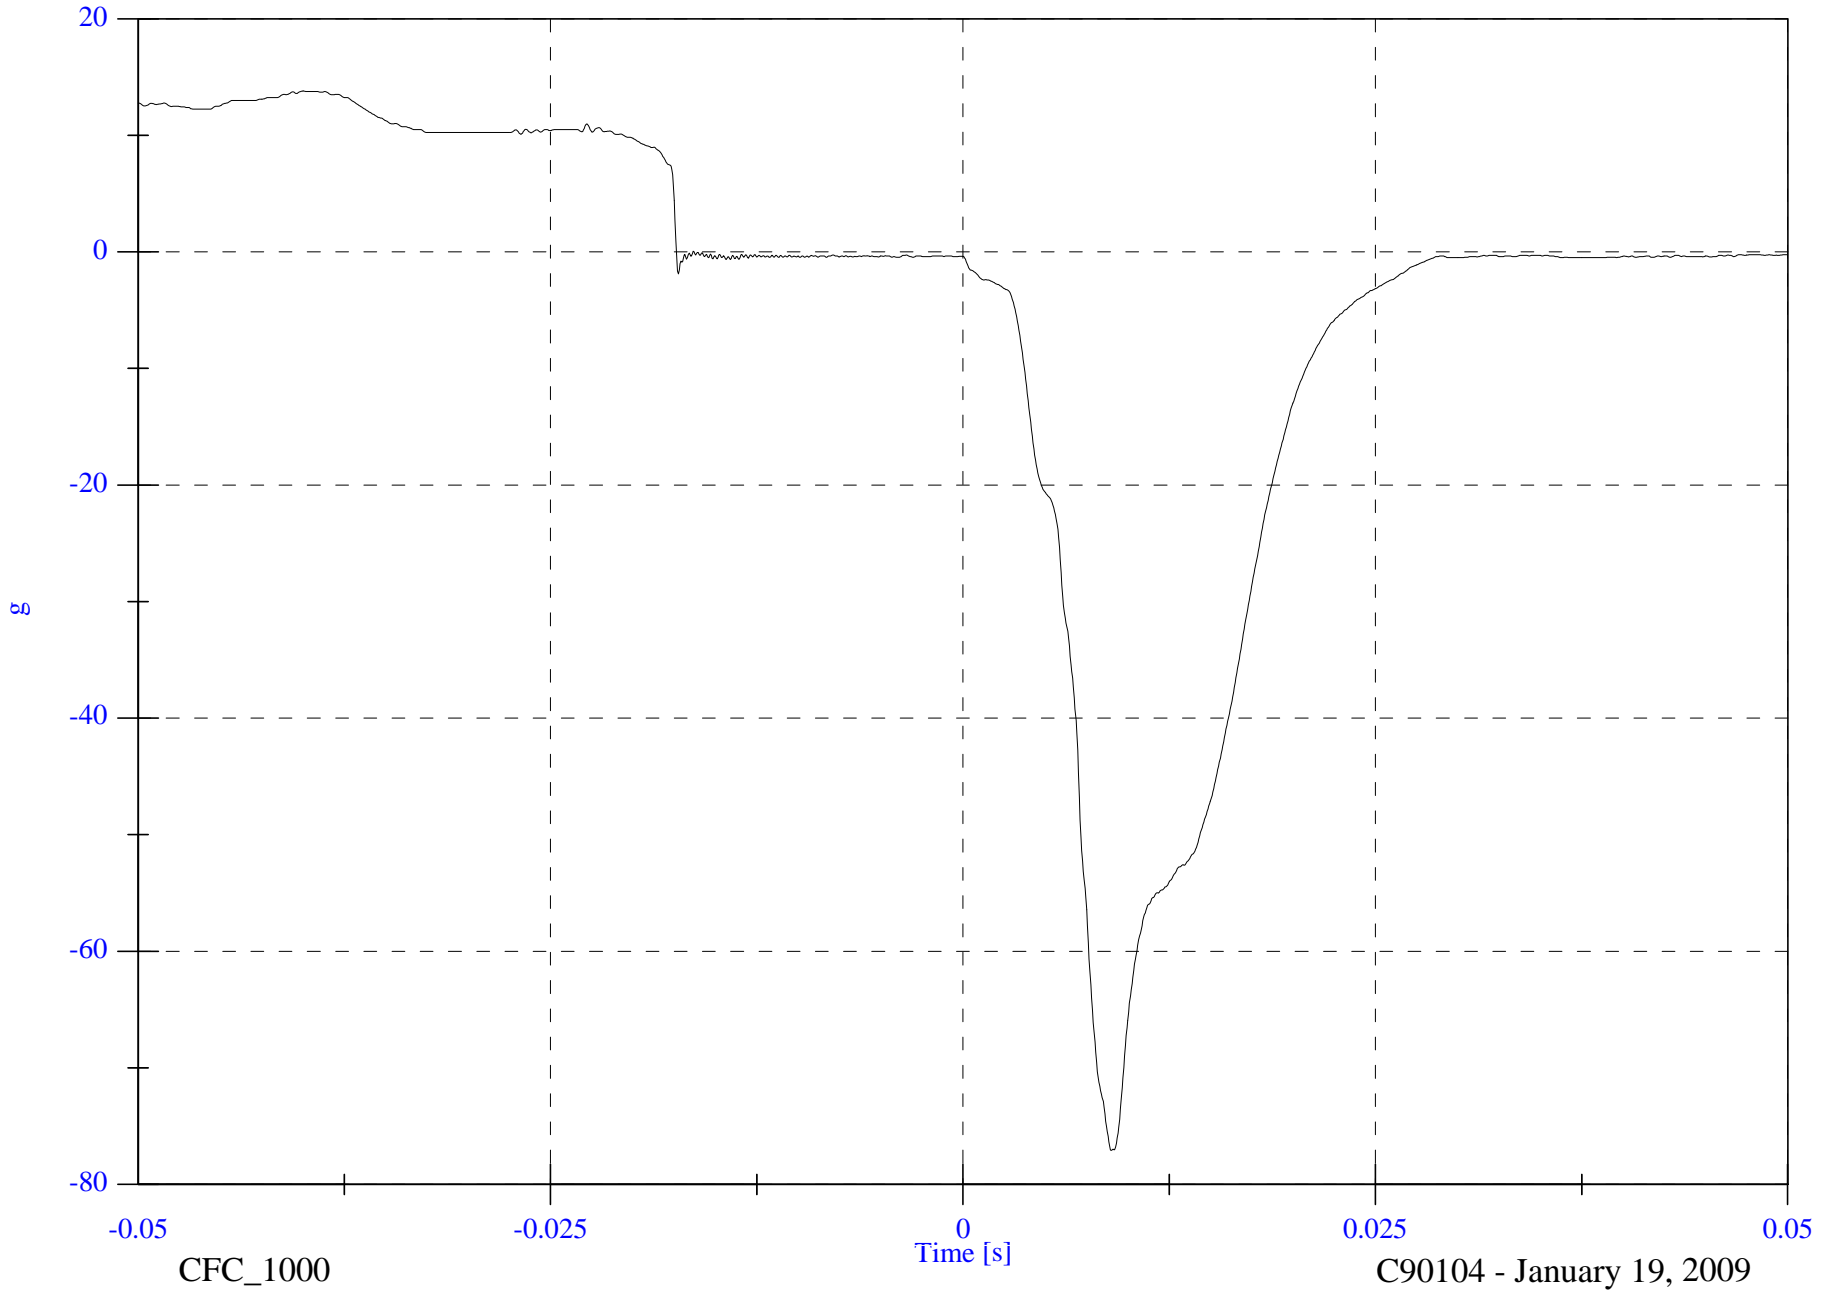
C90104 PASSENGER SIDE BP1 IMPACT PLOT #1

Min: -77.1 [g] at 0.009 [s]

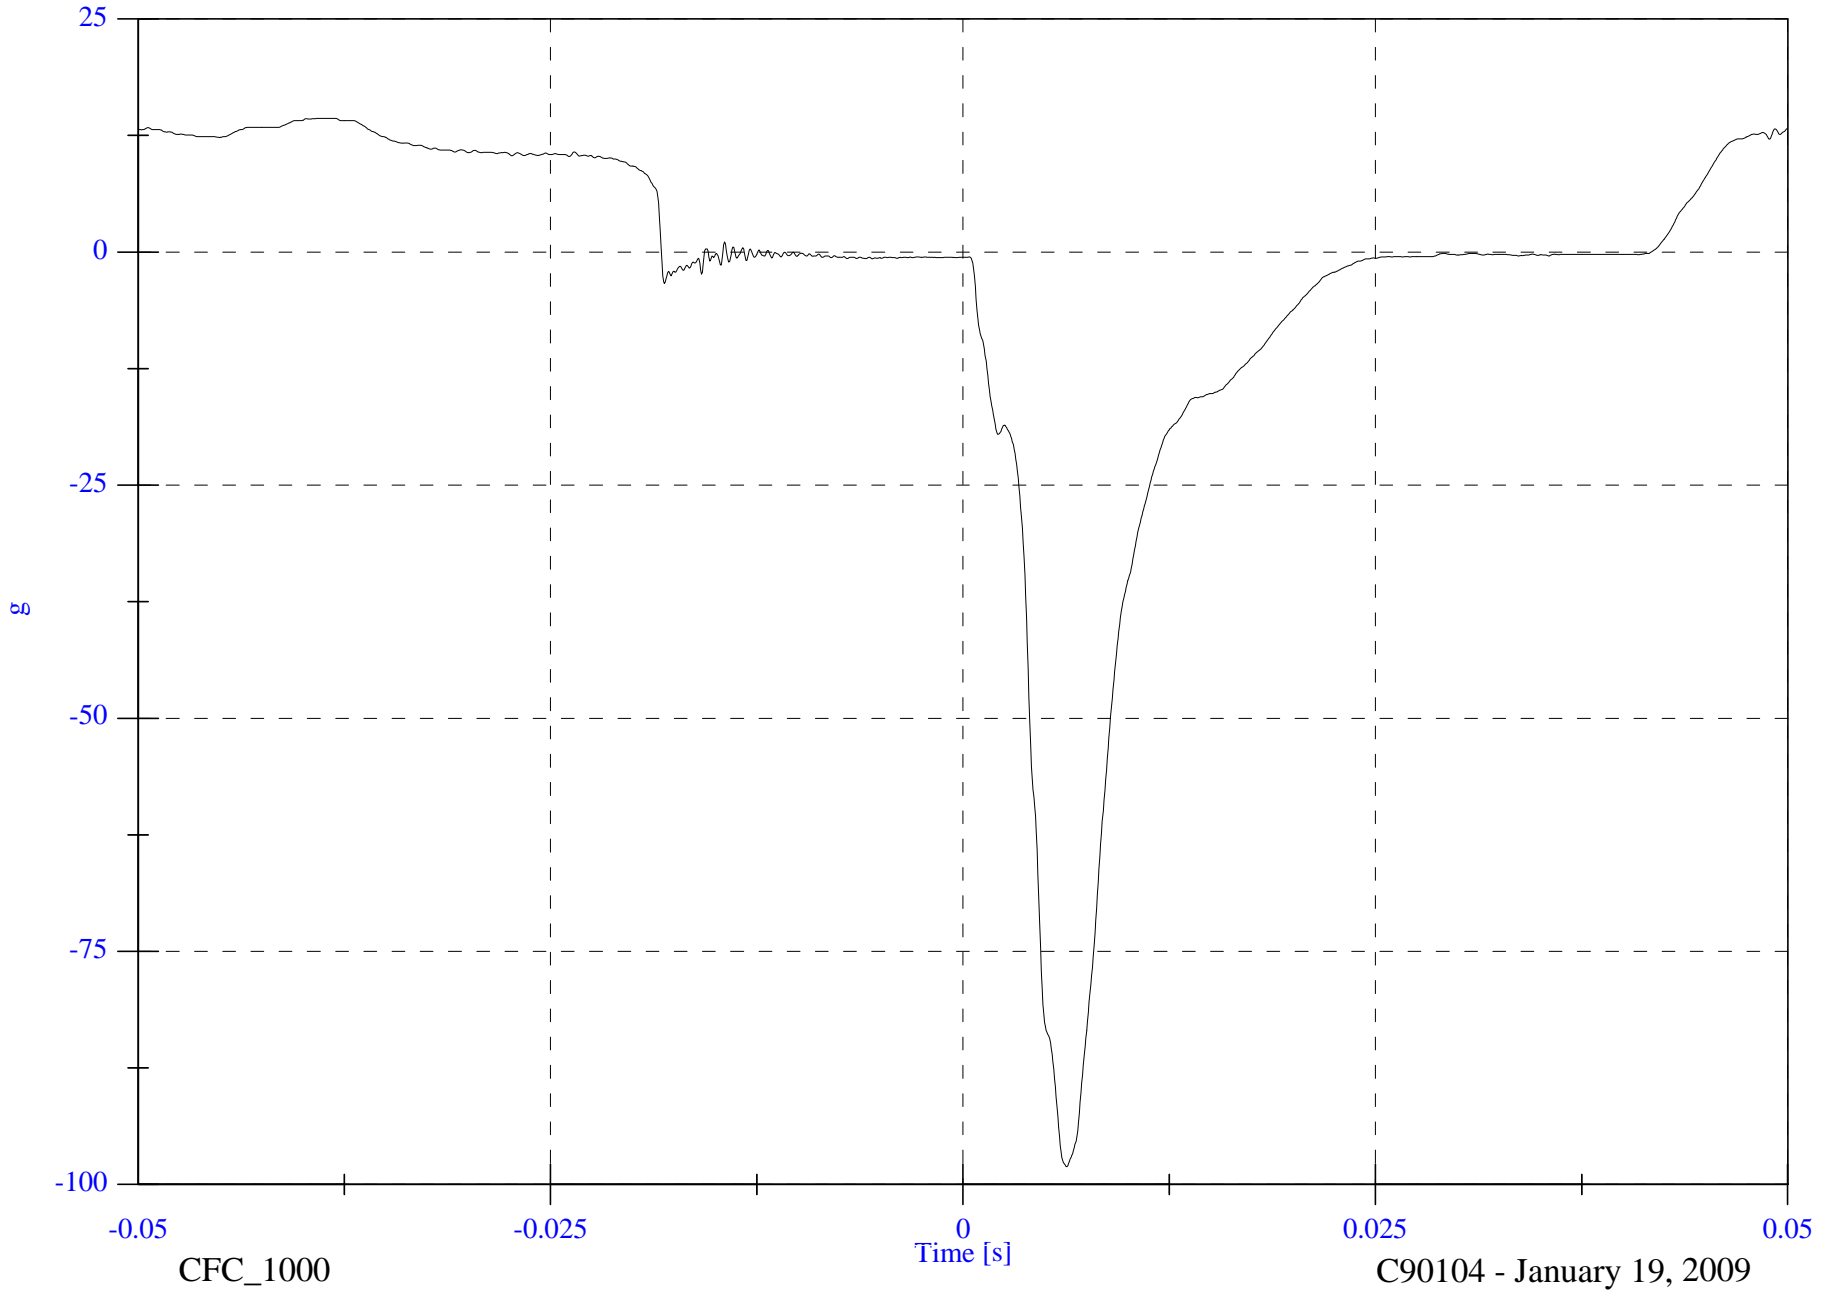
C90104 PASSENGER SIDE AP3 IMPACT PLOT #1

Min: -98.1 [g] at 0.006 [s]

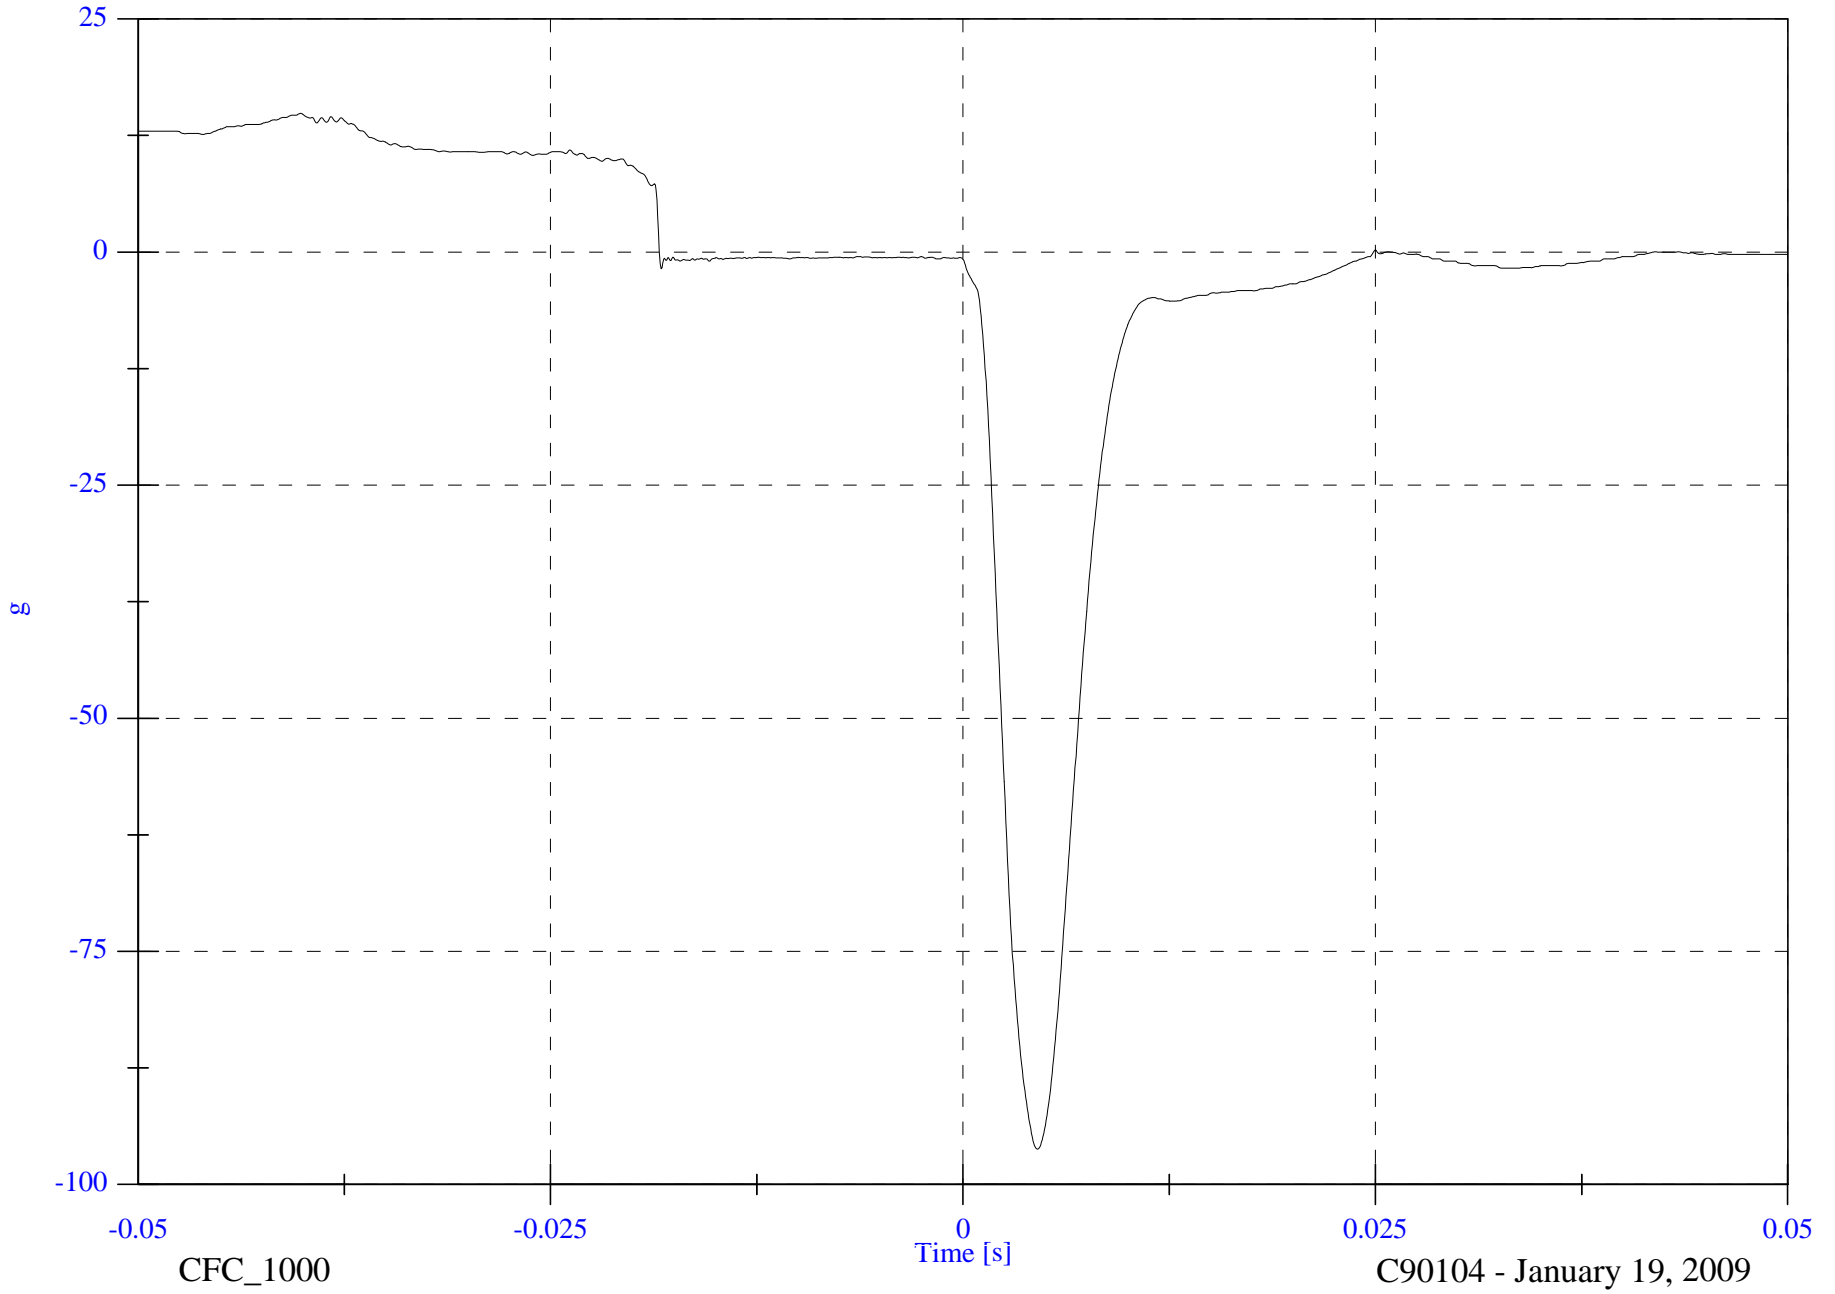
C90104 PASSENGER SIDE AP1 IMPACT PLOT #1

Min: -96.2 [g] at 0.005 [s]

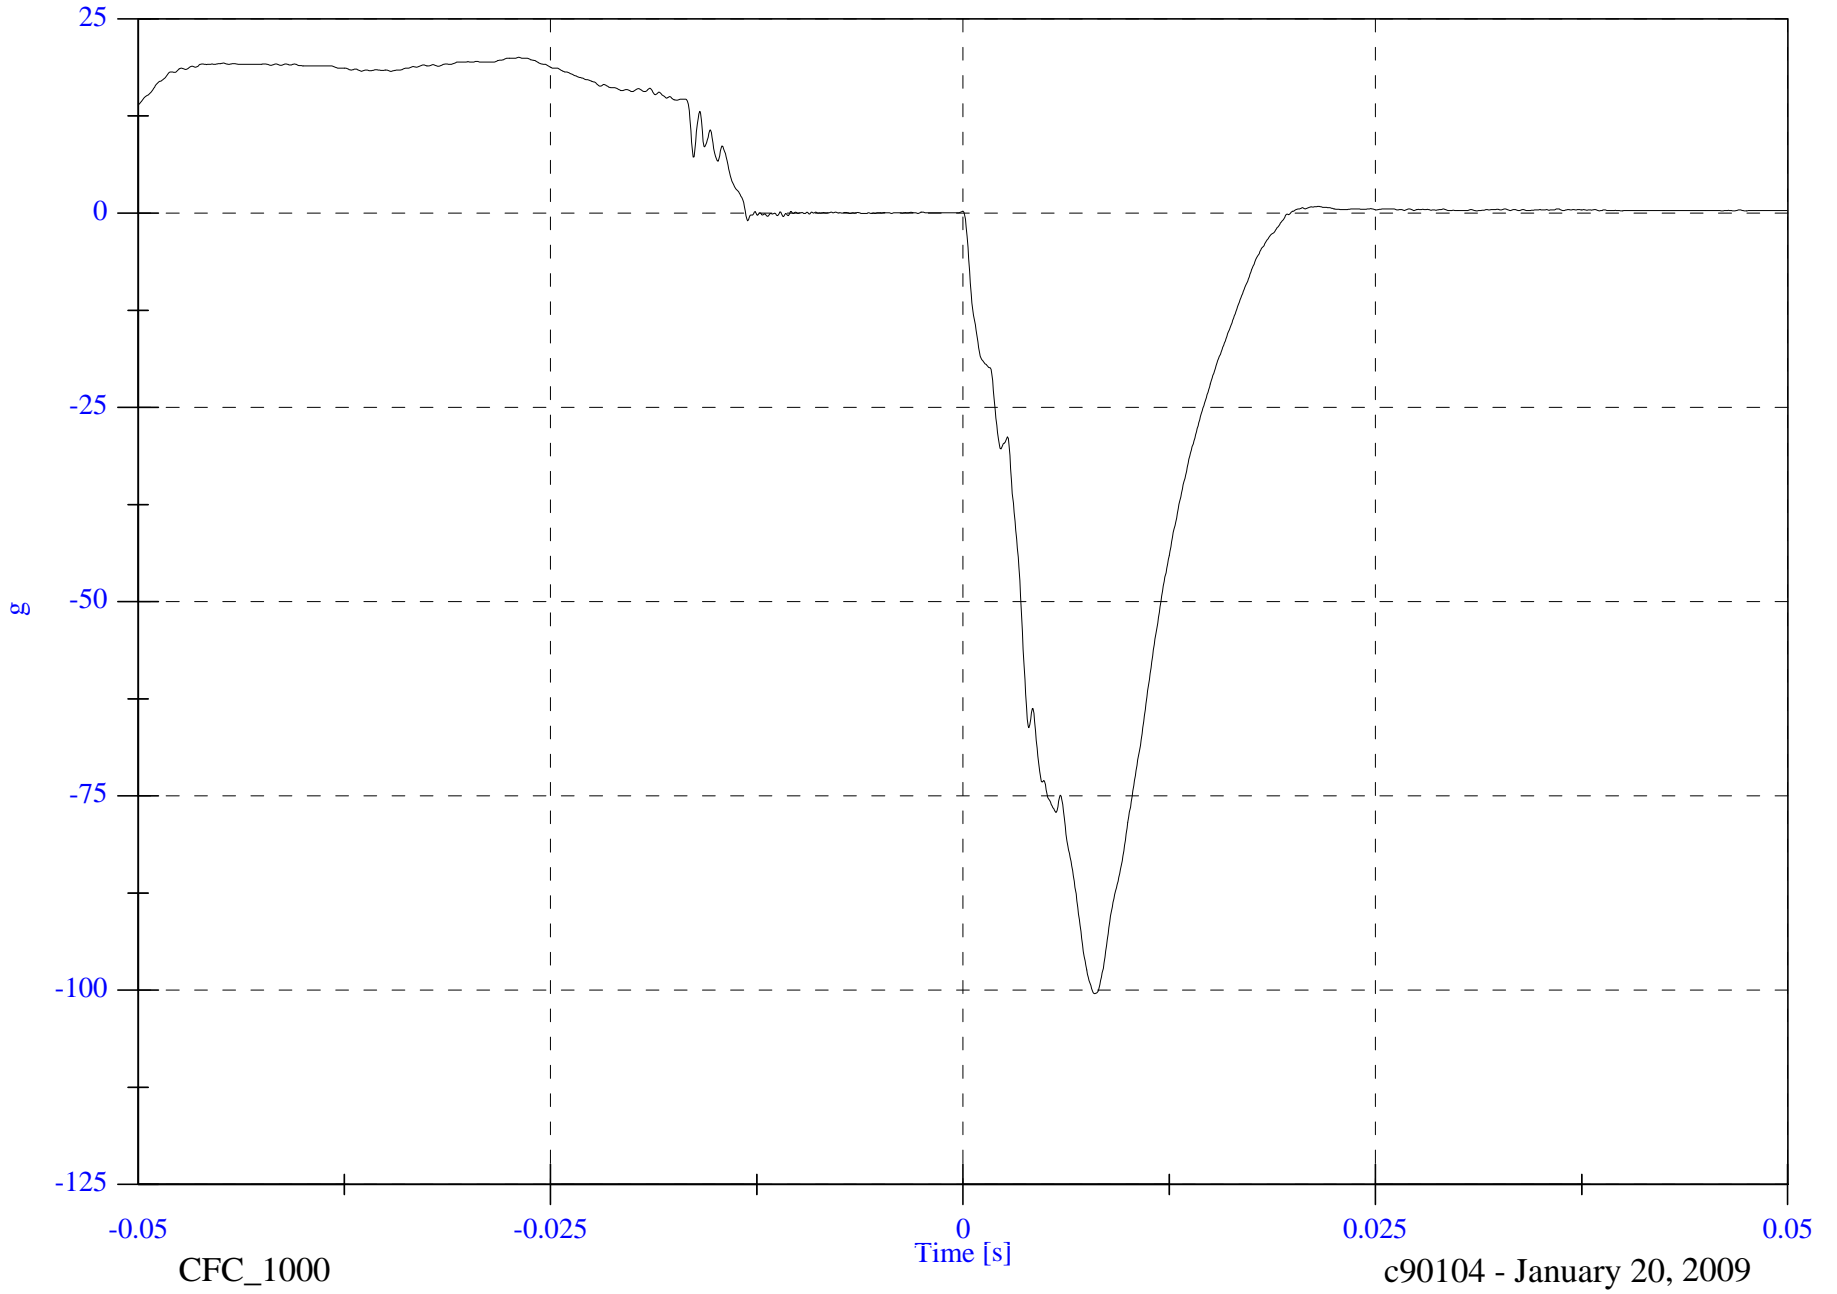
C90104 DRIVER SIDE BP3 IMPACT PLOT #1

Min: -100.4 [g] at 0.008 [s]

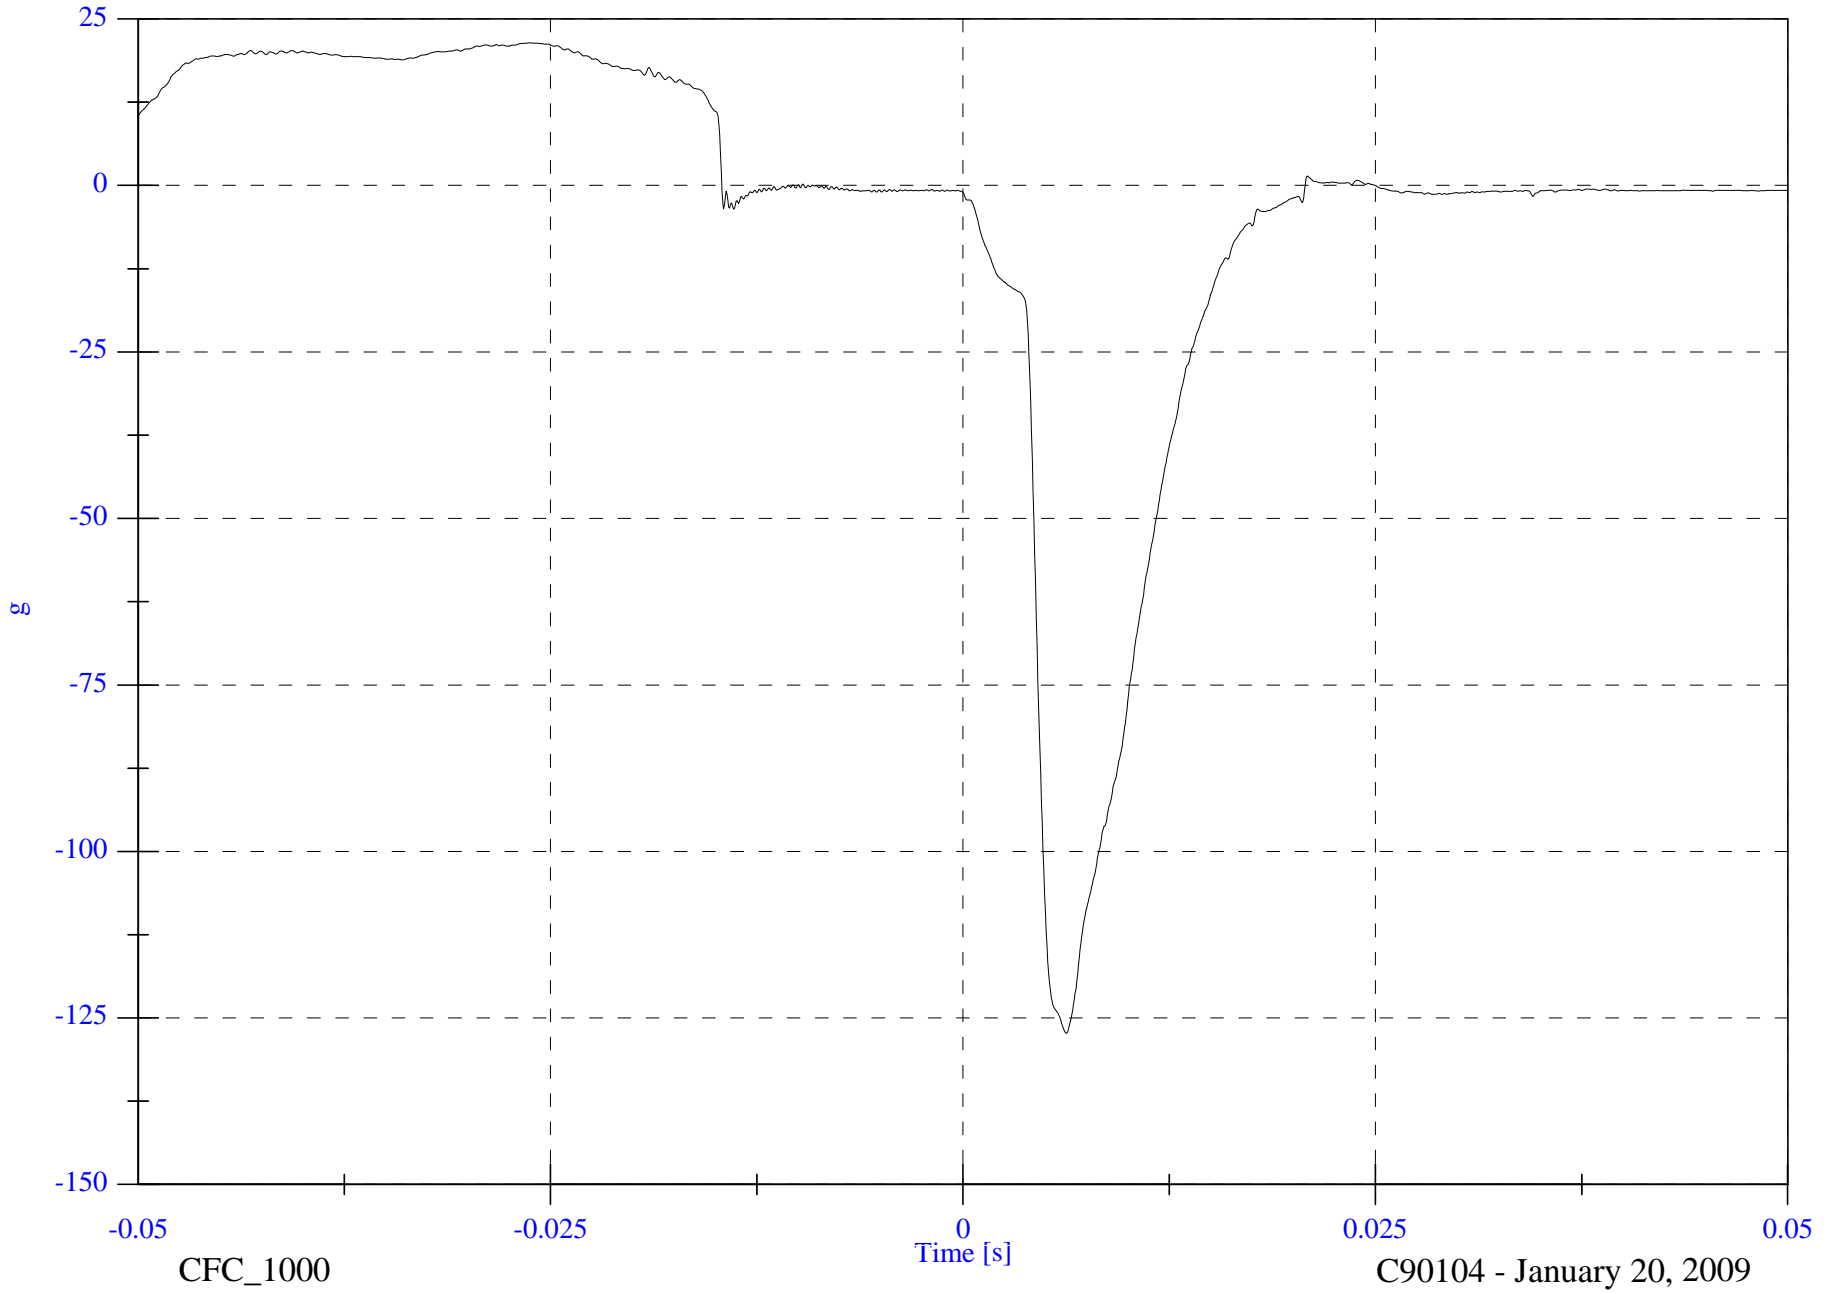
C90104 DRIVER SIDE URBP IMPACT PLOT #1

Min: -127.3 [g] at 0.006 [s]

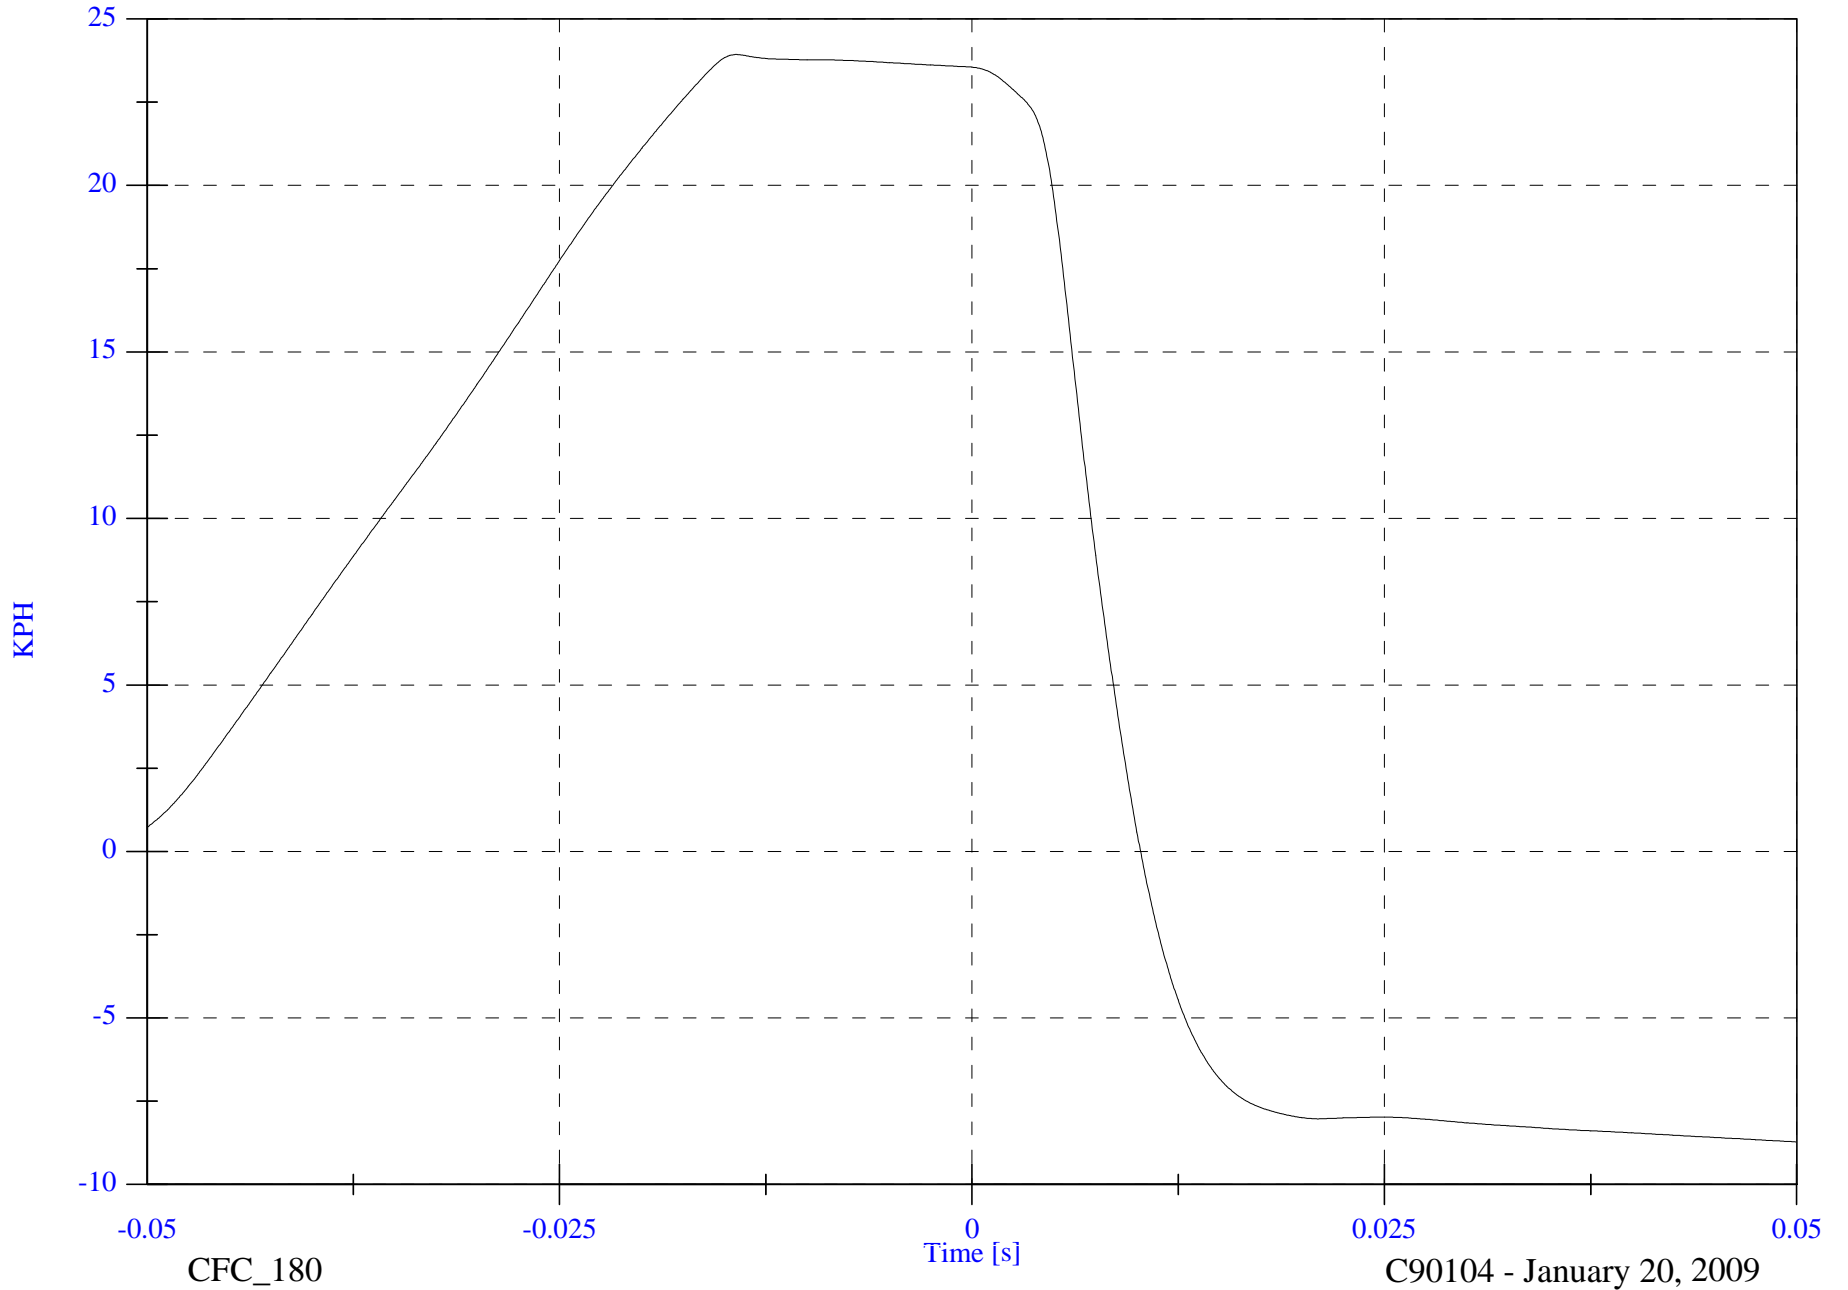
C90104 DRIVER SIDE URBP IMPACT PLOT #5

Max: 23.9 [KPH] at -0.014 [s]

Headform Velocity

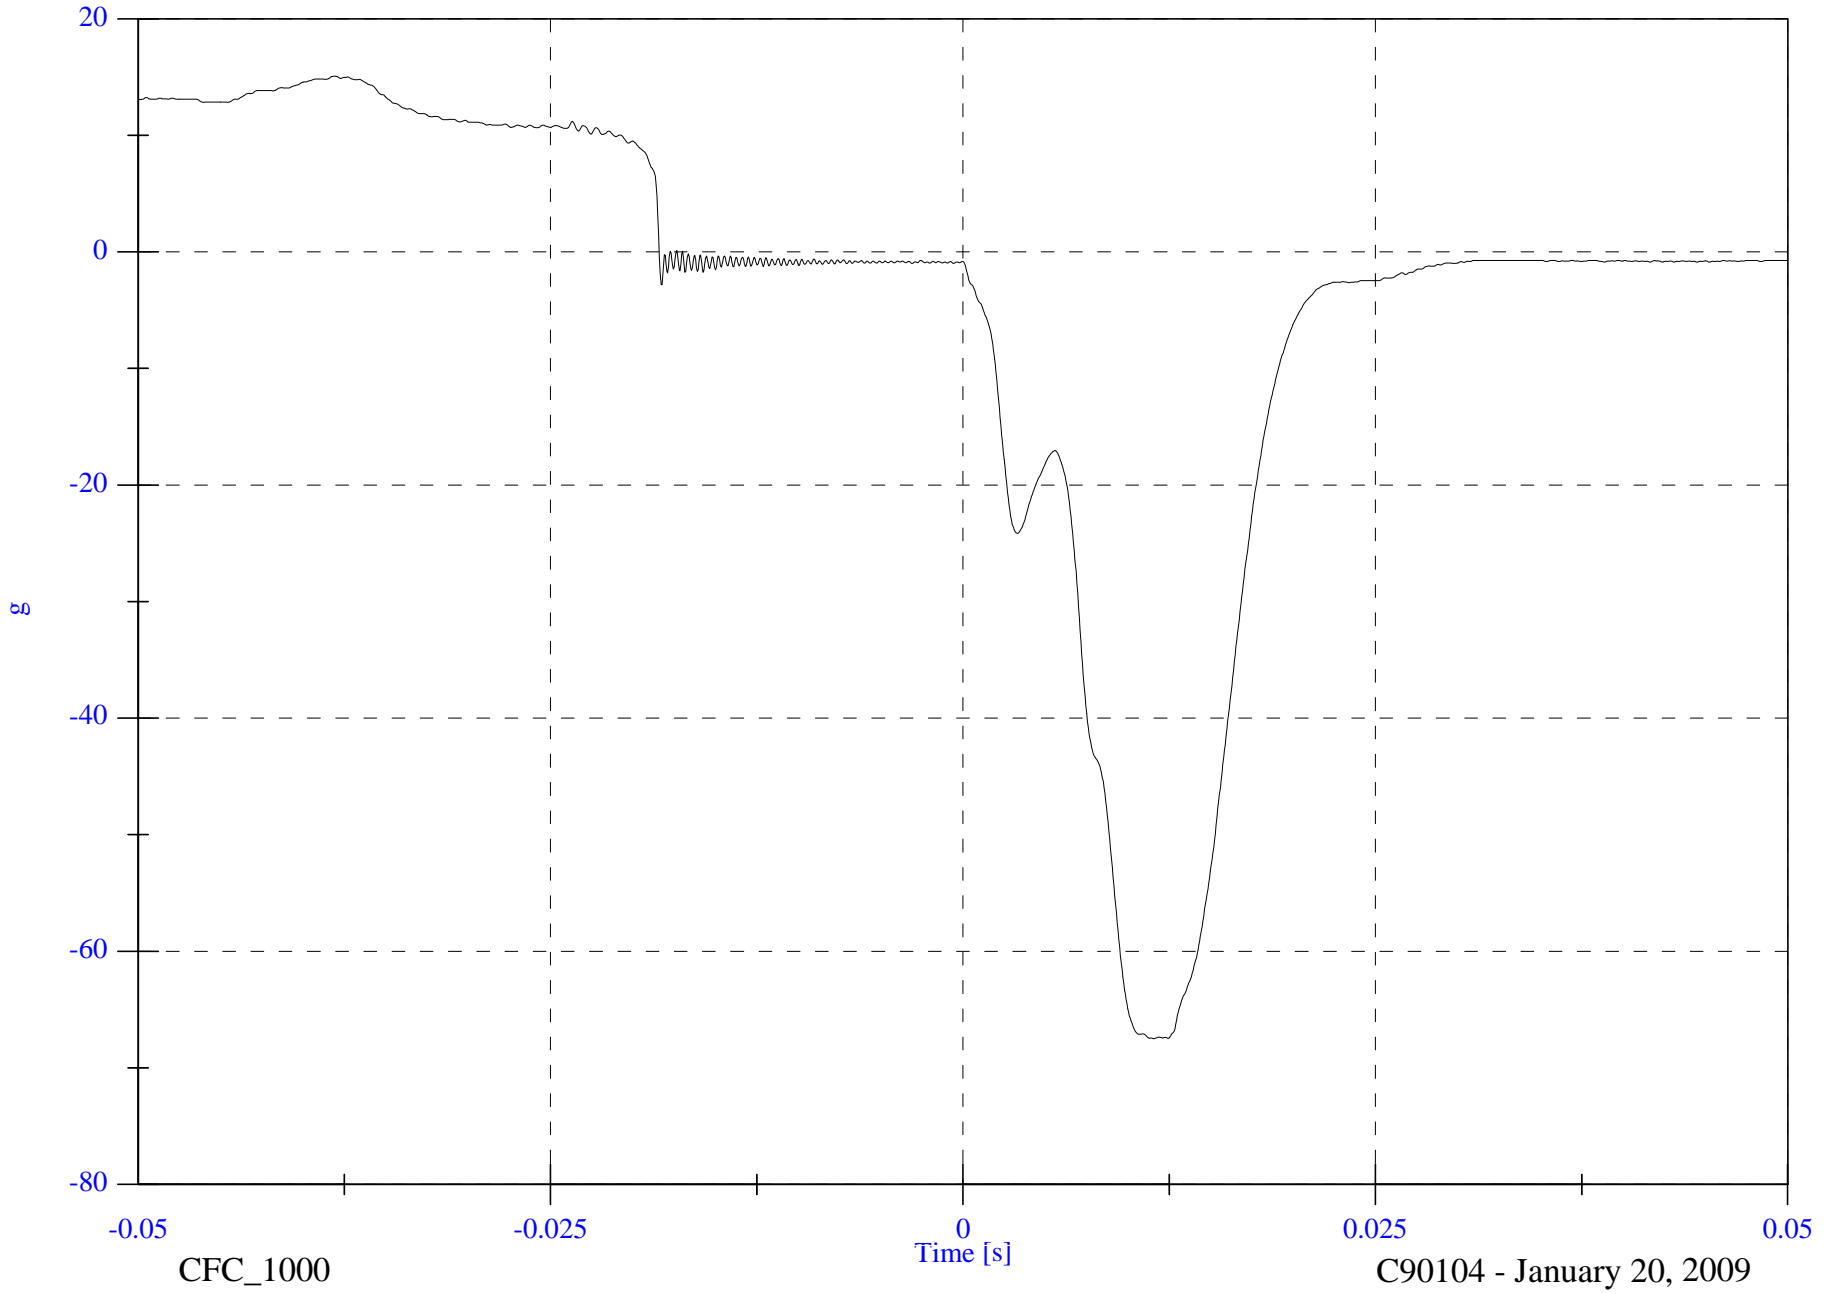
C90104 DRIVER SIDE SR2A IMPACT PLOT #1

Min: -67.5 [g] at 0.012 [s]
