REPORT NUMBER: 201UI-CAL-09-03

**SAFETY COMPLIANCE TESTING FOR FMVSS 201  
OCCUPANT PROTECTION IN INTERIOR IMPACT  
UPPER INTERIOR HEAD IMPACT PROTECTION**

**GENERAL MOTORS CORP.  
2009 CHEVROLET TRAILBLAZER**

FINAL REPORT

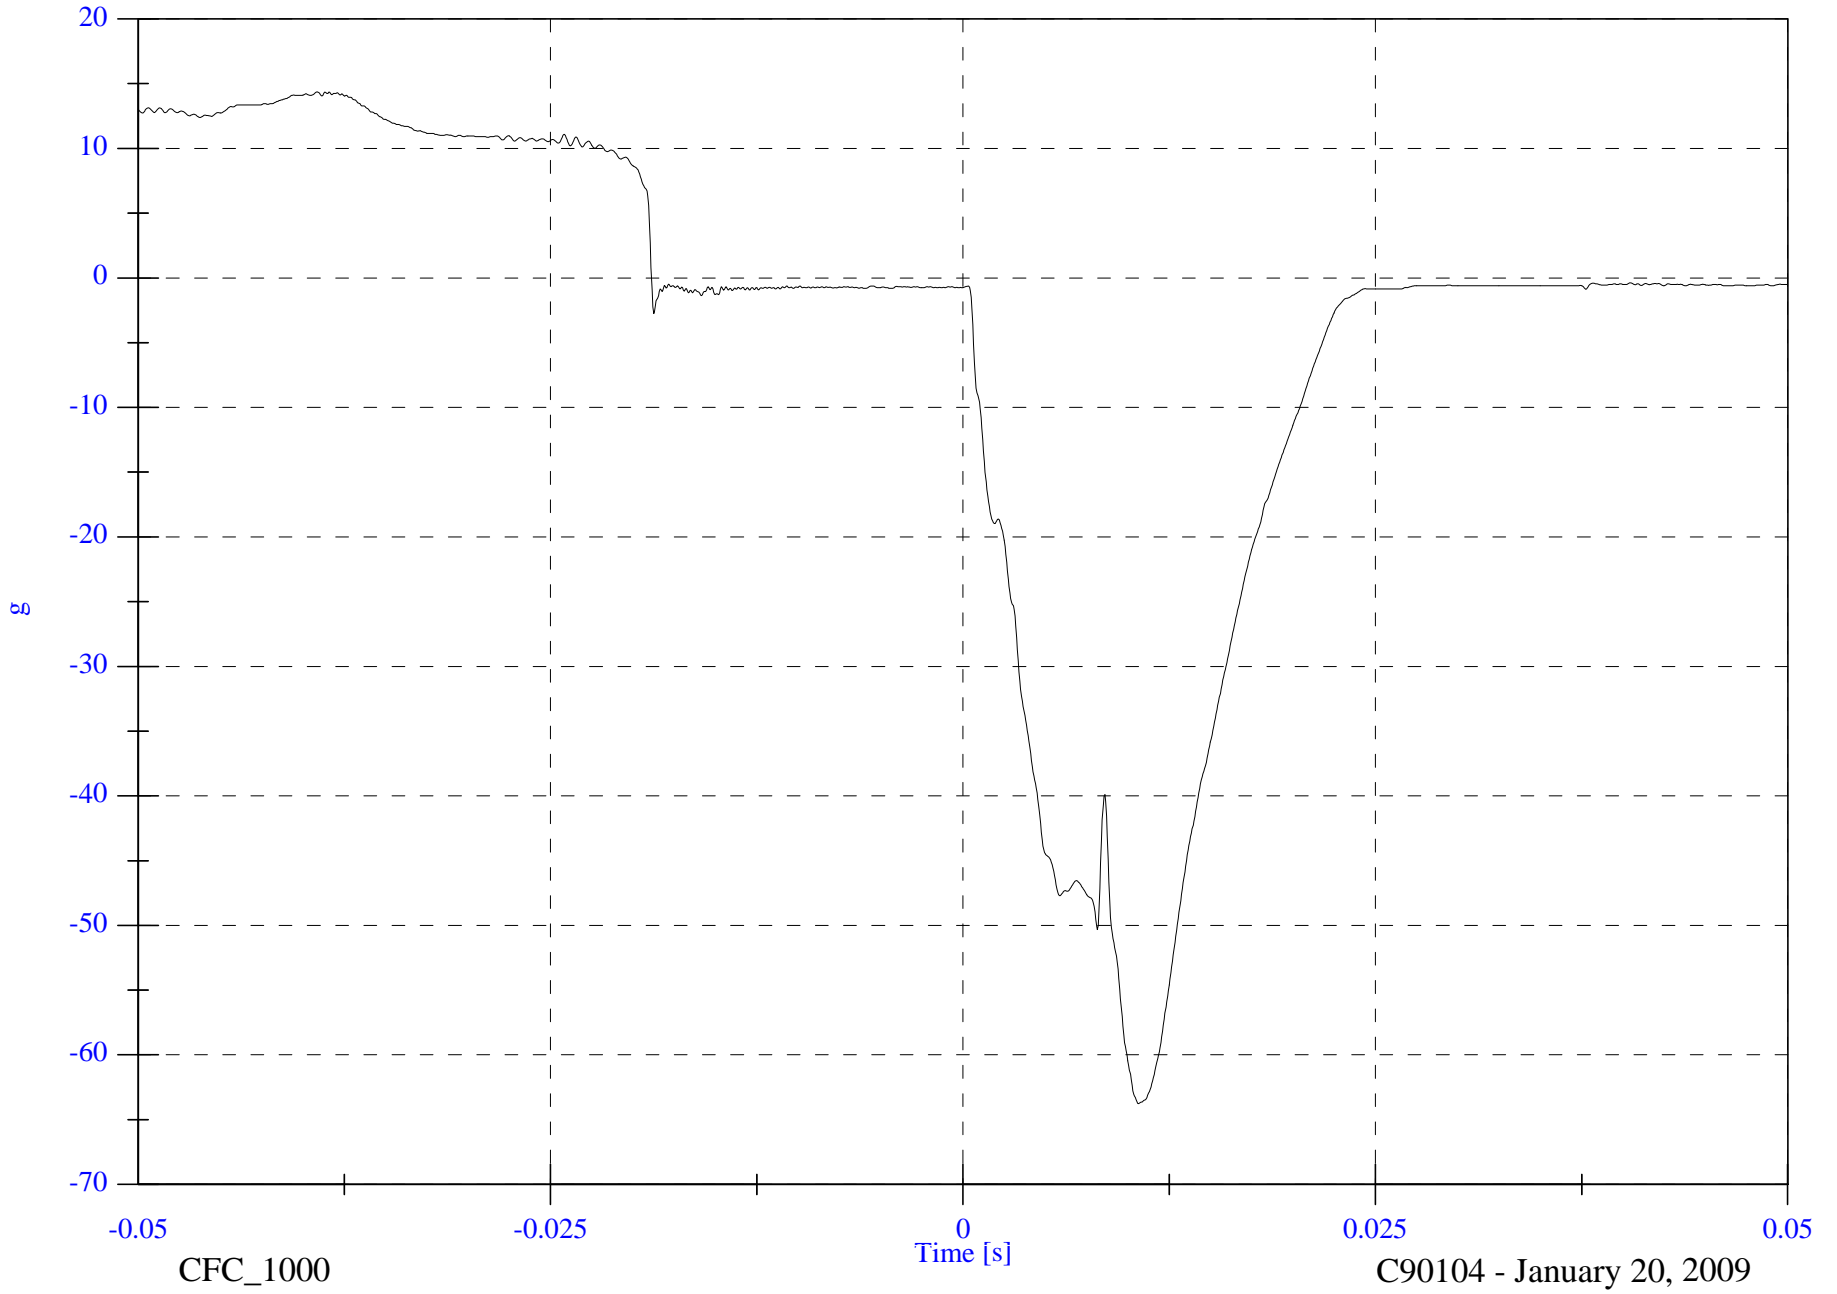
C90104 DRIVER SIDE AP2 IMPACT PLOT #1

Min: -63.8 [g] at 0.011 [s]
