REPORT NUMBER 401-STF-09-002

# SAFETY COMPLIANCE TESTING FOR FMVSS NO. 401 INTERIOR TRUNK RELEASE

HYUNDAI MOTOR COMPANY  
2009 HYUNDAI GENESIS  
FOUR-DOOR PASSENGER CAR  
NHTSA NO. C90501

FINAL REPORT

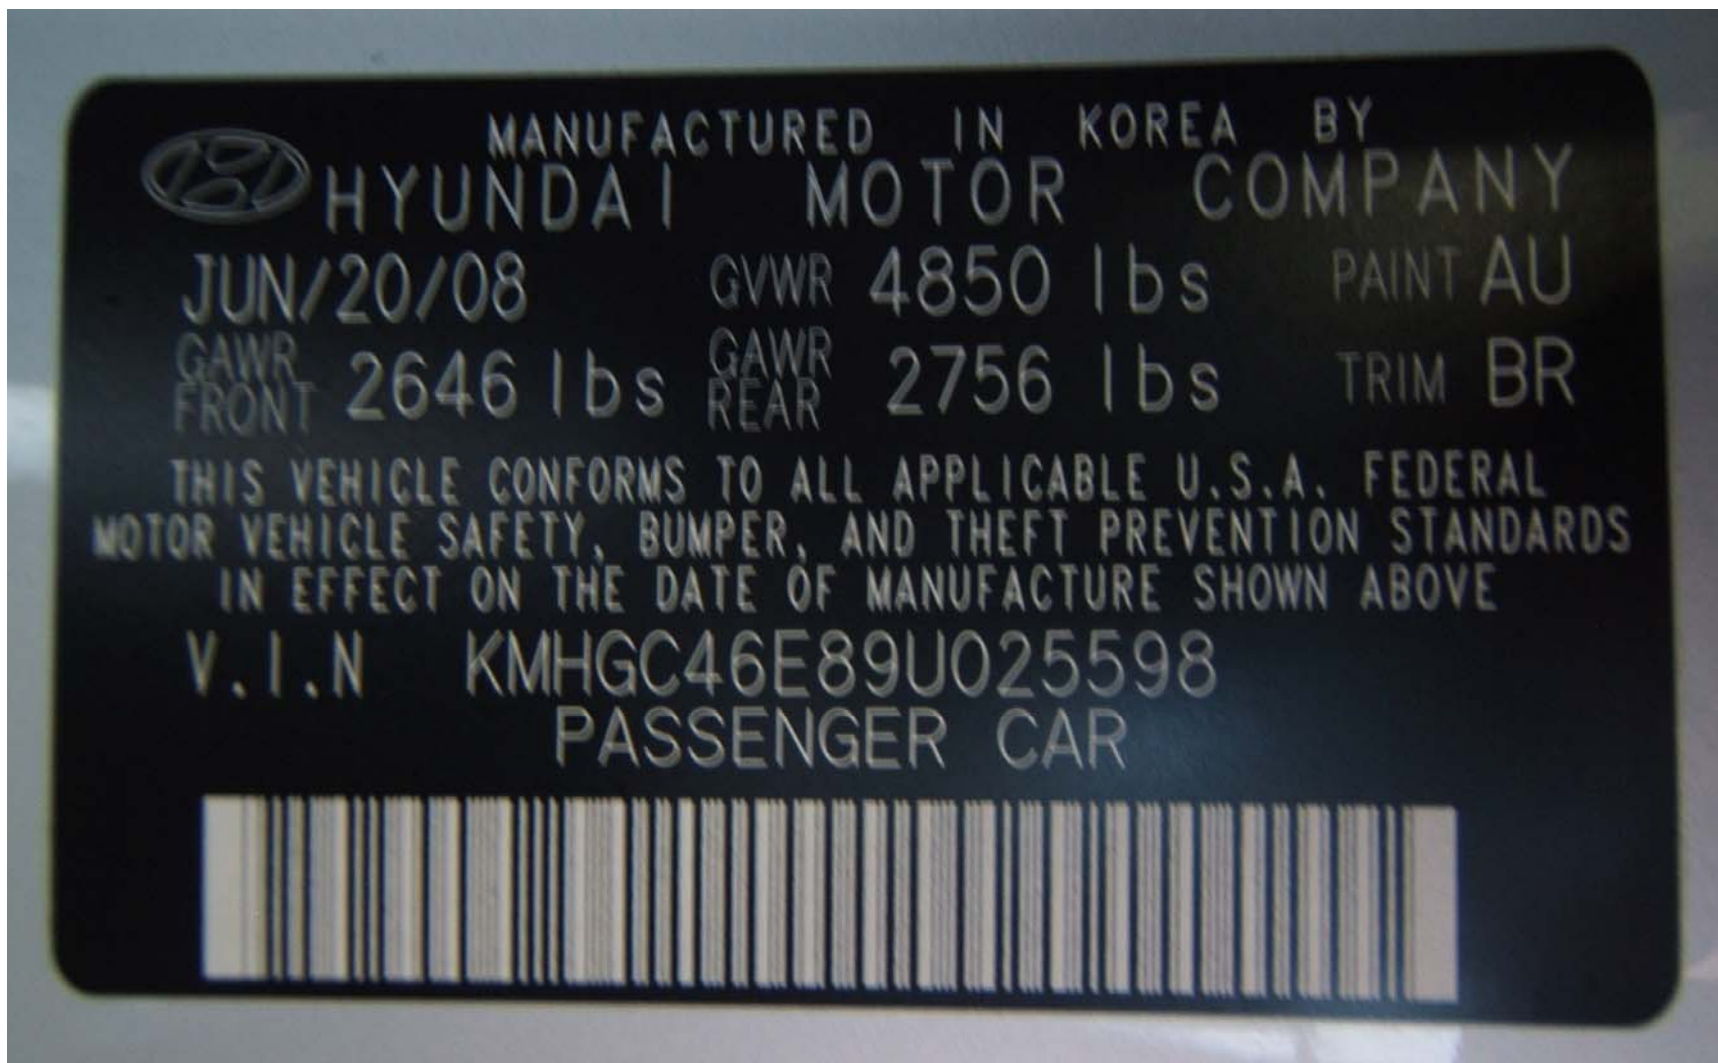
FIGURE 5.6  
VEHICLE CERTIFICATION LABEL

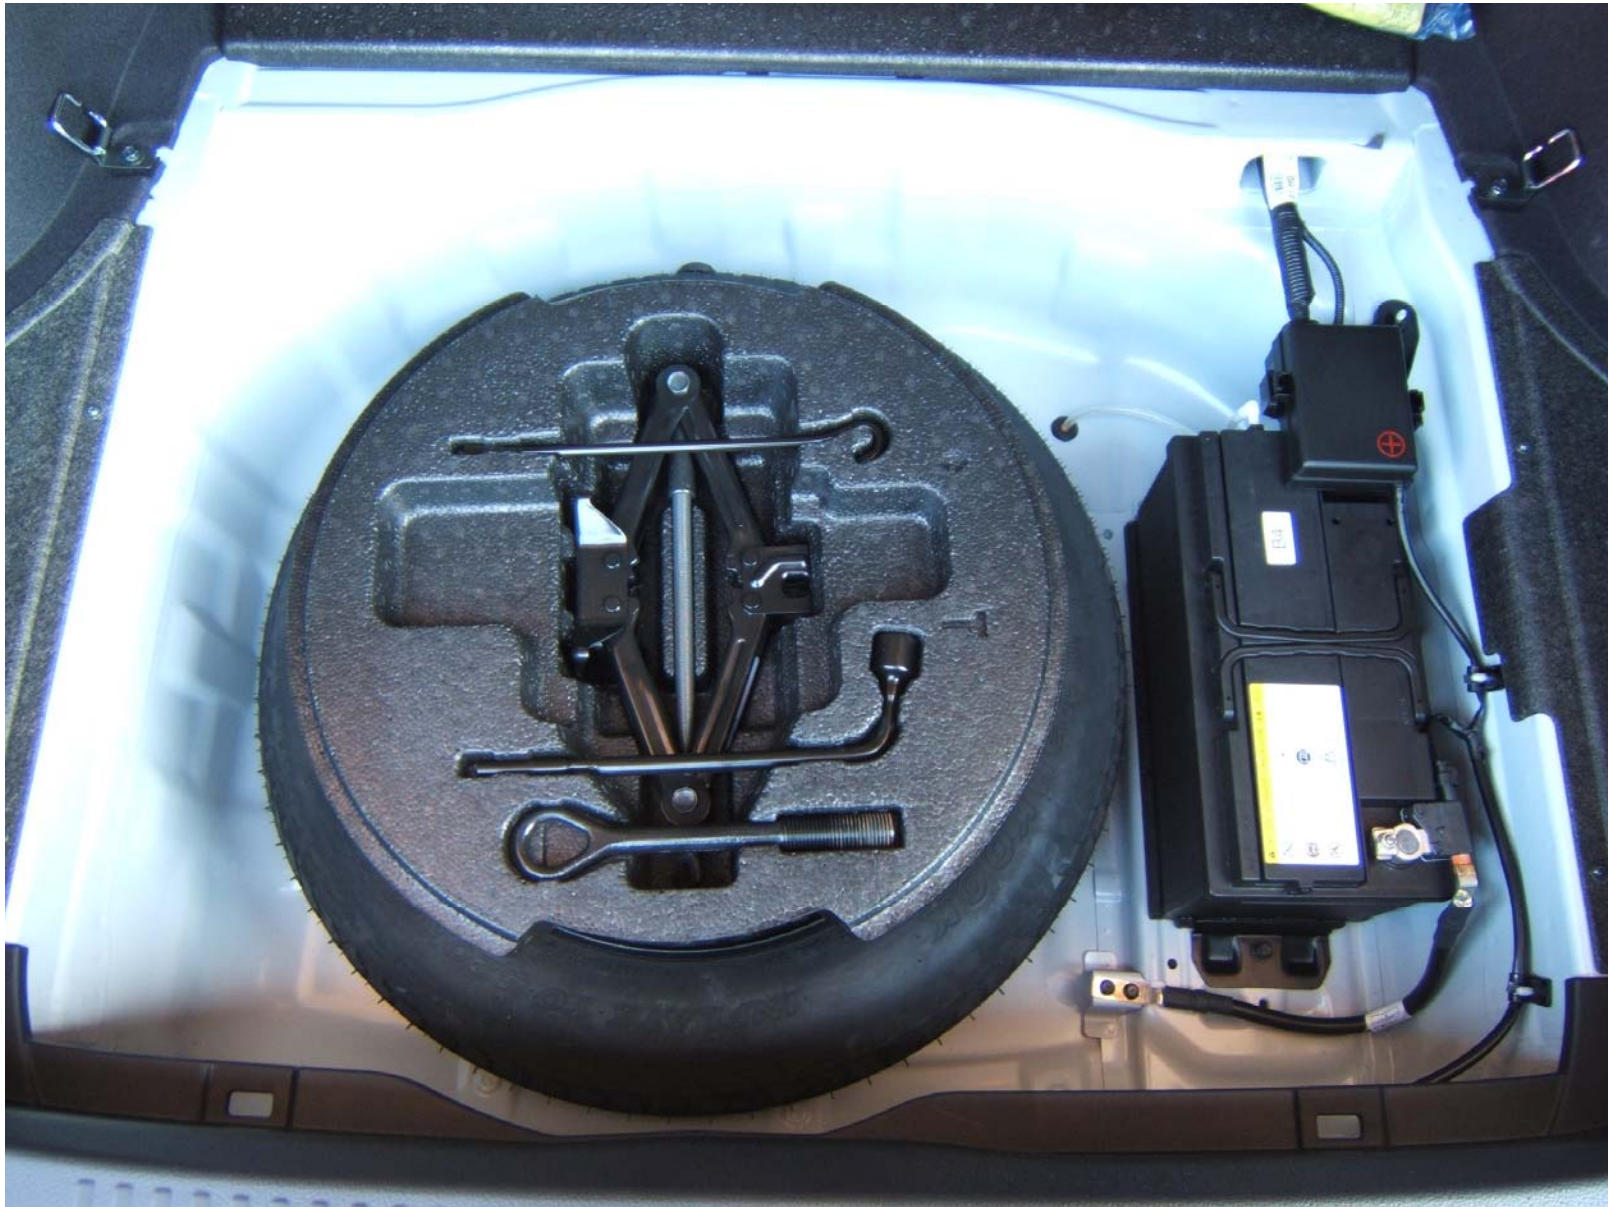
FIGURE 5.7  
VEHICLE TRUNK COMPARTMENT INTERIOR  
SHOWING ORIGINAL EQUIPMENT INSTALLED

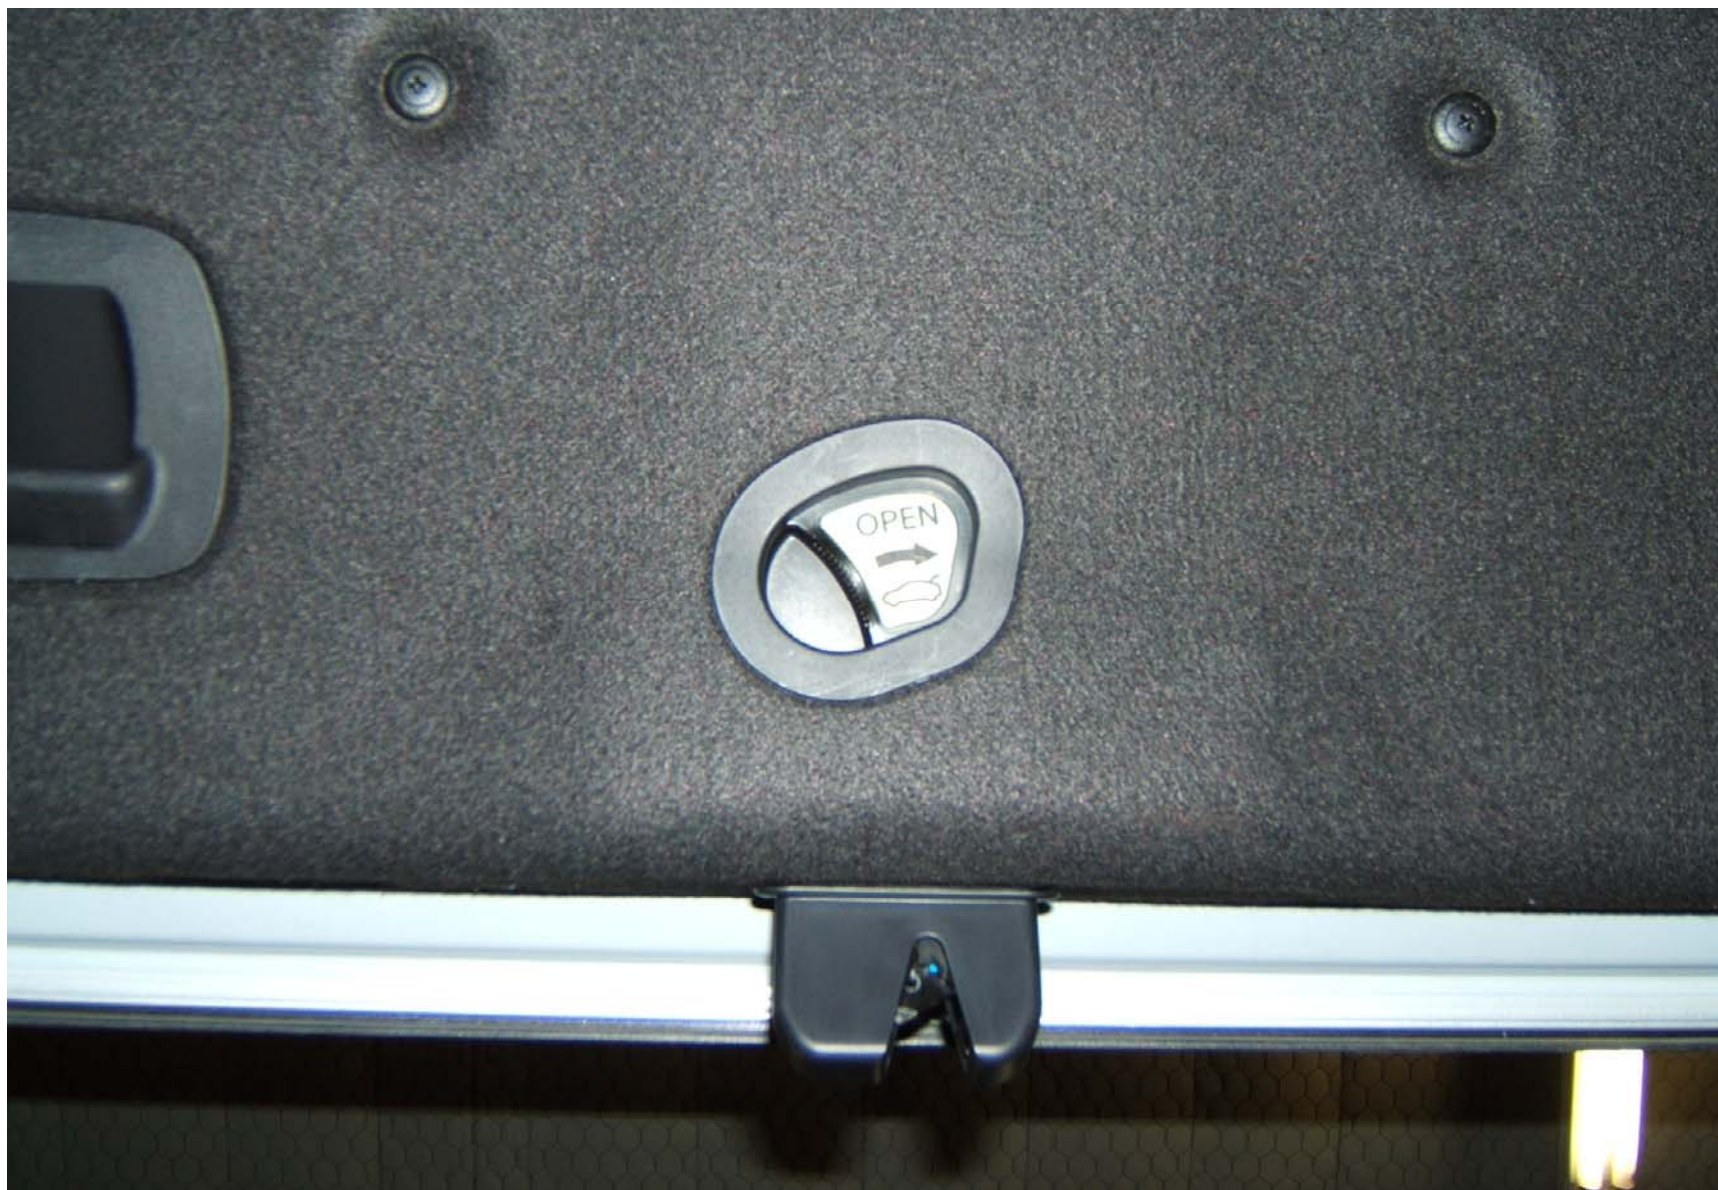
FIGURE 5.8  
VEHICLE TRUNK COMPARTMENT MANUAL RELEASE MECHANISM

Method used to actuate interior trunk release: Rotating cable lever

Method used by vehicle manufacturer to ensure that  
release mechanism is visible in the closed trunk compartment: Phosphorescence

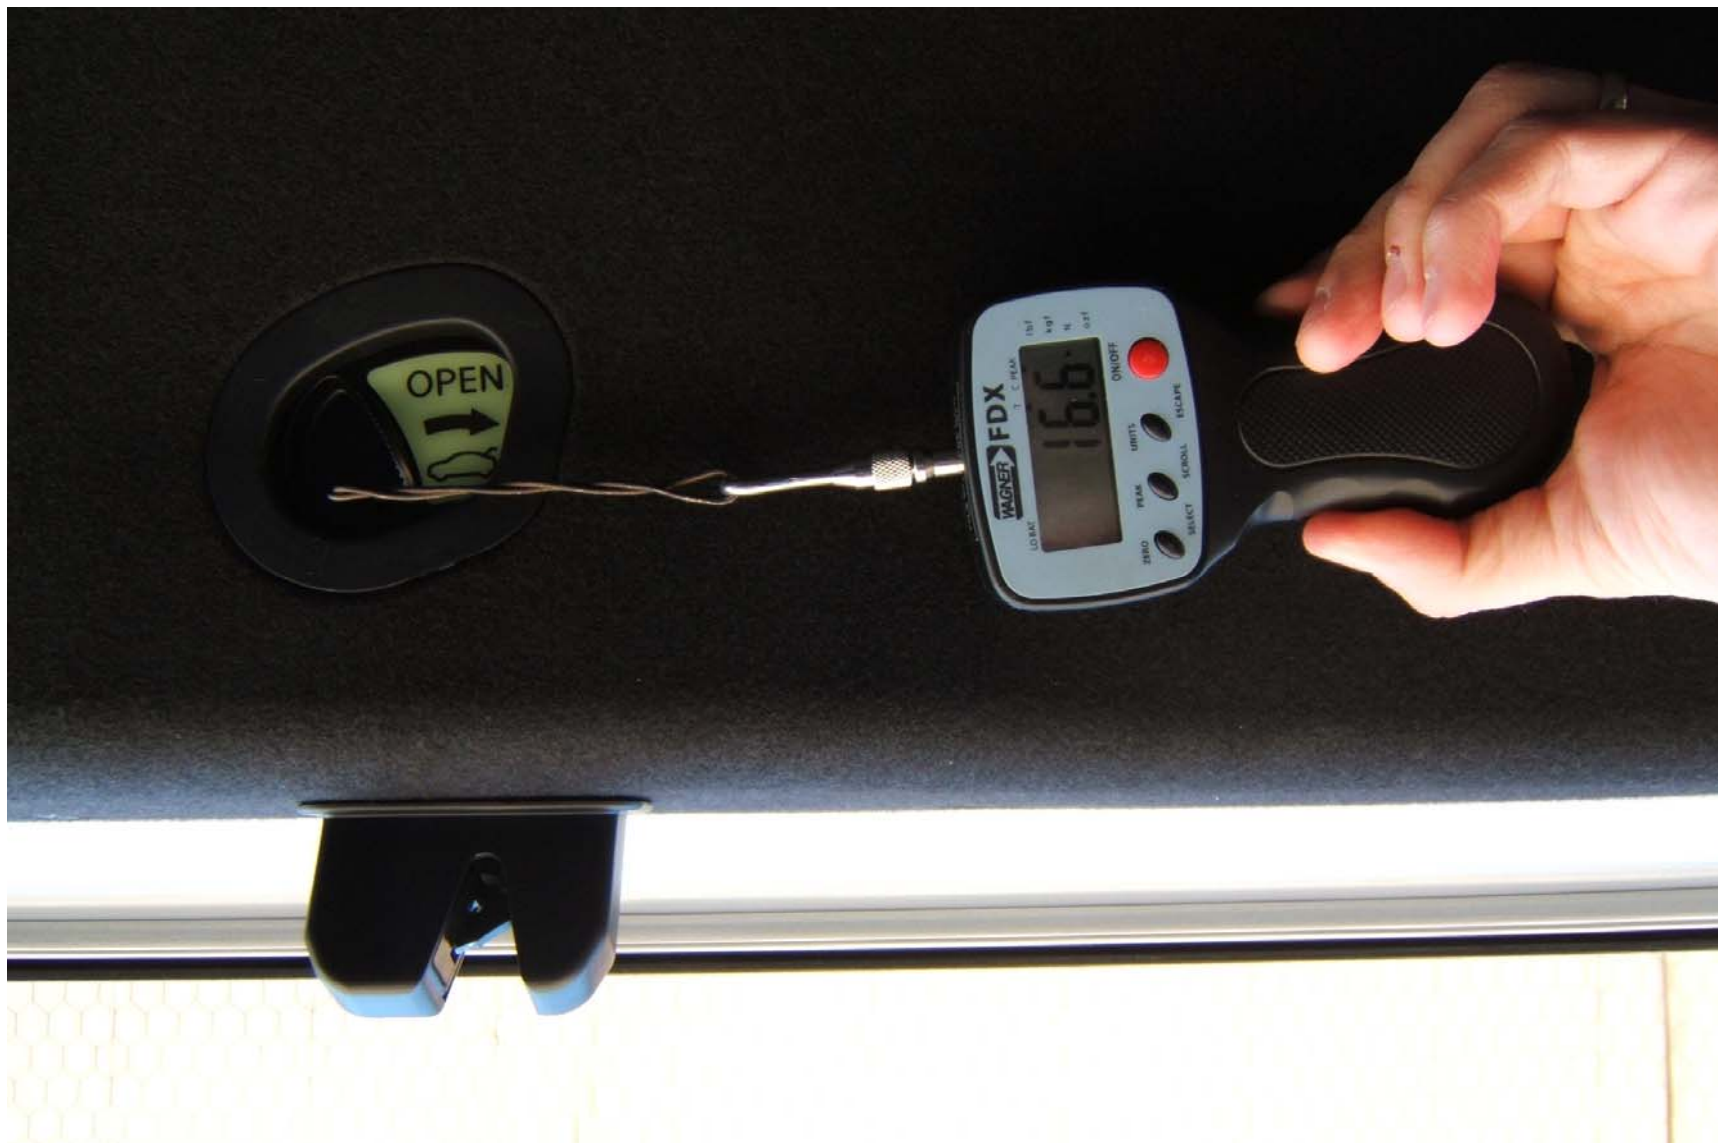
FIGURE 5.9  
RELEASE MECHANISM WITH TEST EQUIPMENT ATTACHED

Vehicle Stationary (0 km/h)	Force in Newtons Required to Release Trunk Lid (no requirement)	Trunk Released from <b>All</b> Latching Positions	Pass/Fail
<b>NO KEY IN IGNITION</b>			
Attempt 1	16.6	Yes	Pass
Attempt 2	16.4	Yes	Pass
Attempt 3	17.4	Yes	Pass
Average	16.8		
<b>ENGINE IDLING</b>			
Attempt 1	17.0	Yes	Pass
Attempt 2	16.0	Yes	Pass
Attempt 3	16.7	Yes	Pass
Average	16.6

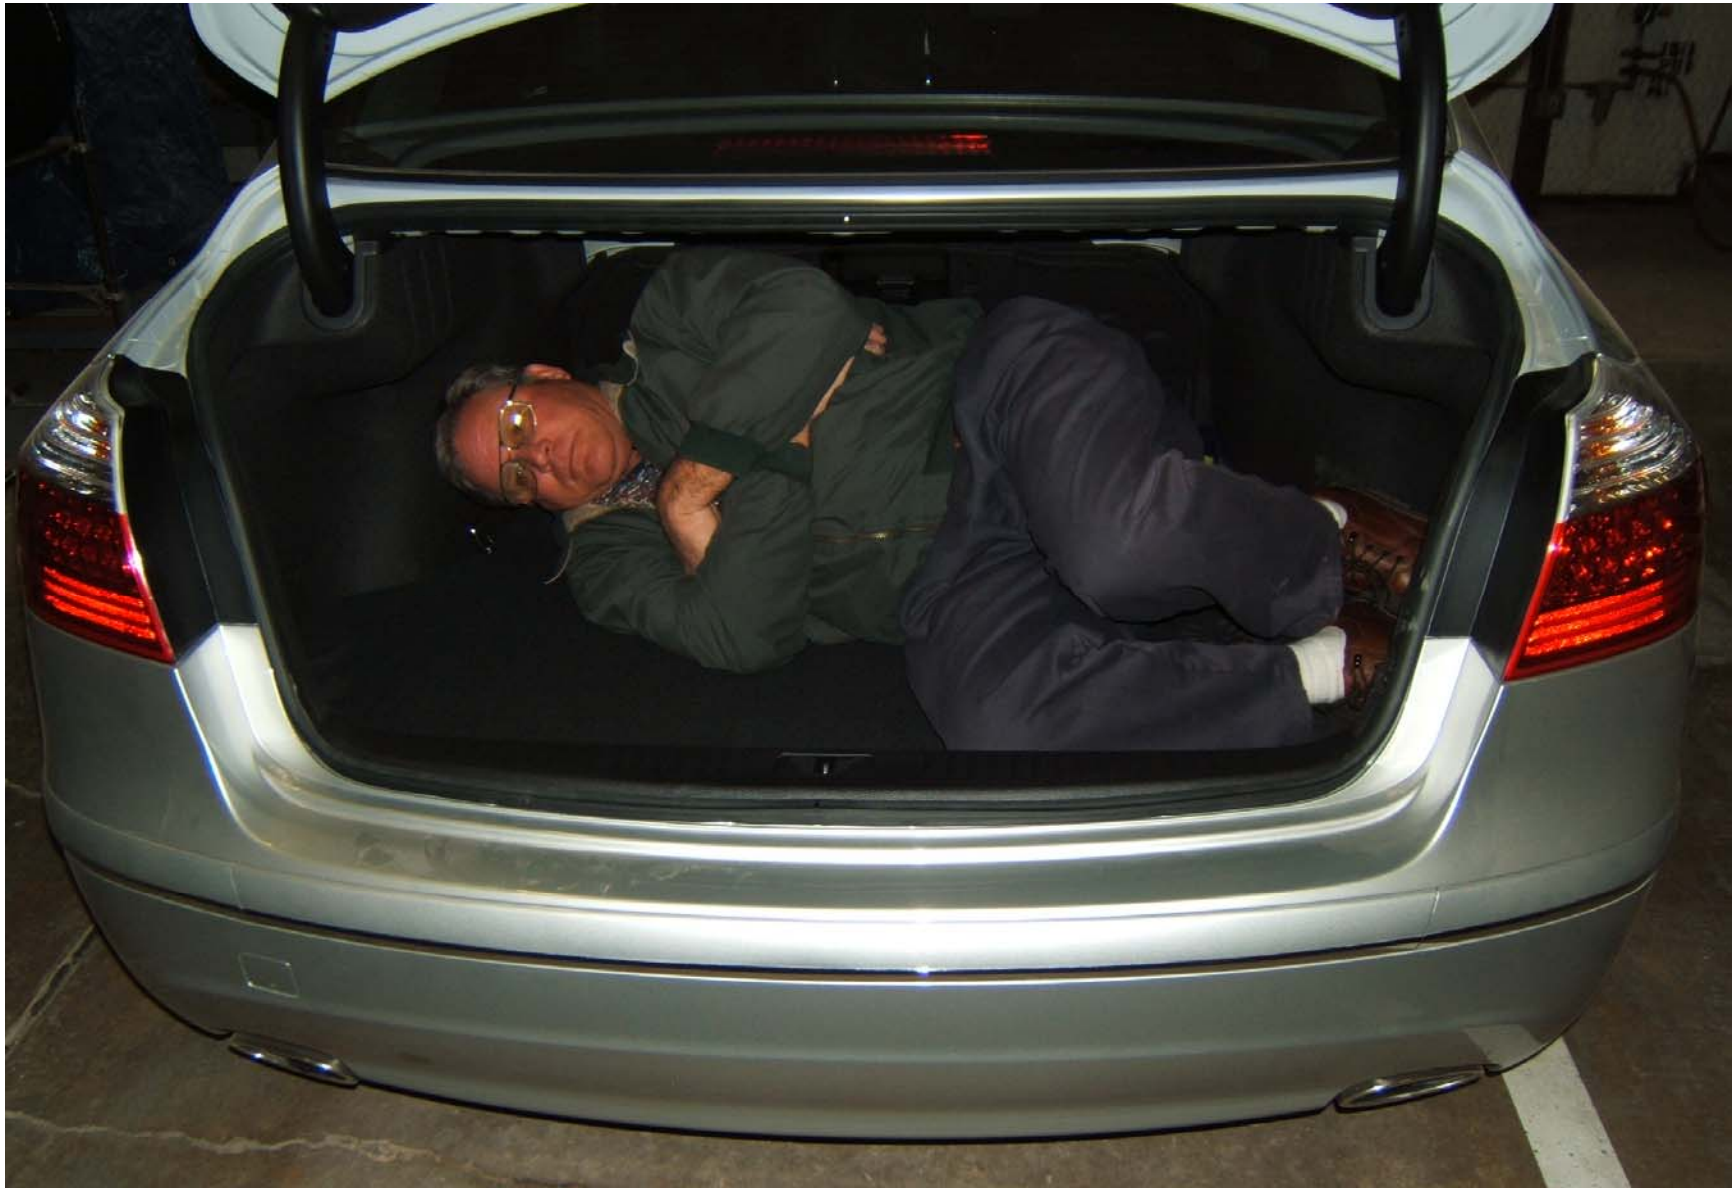
FIGURE 5.10  
TEST OBSERVER IN TRUNK COMPARTMENT

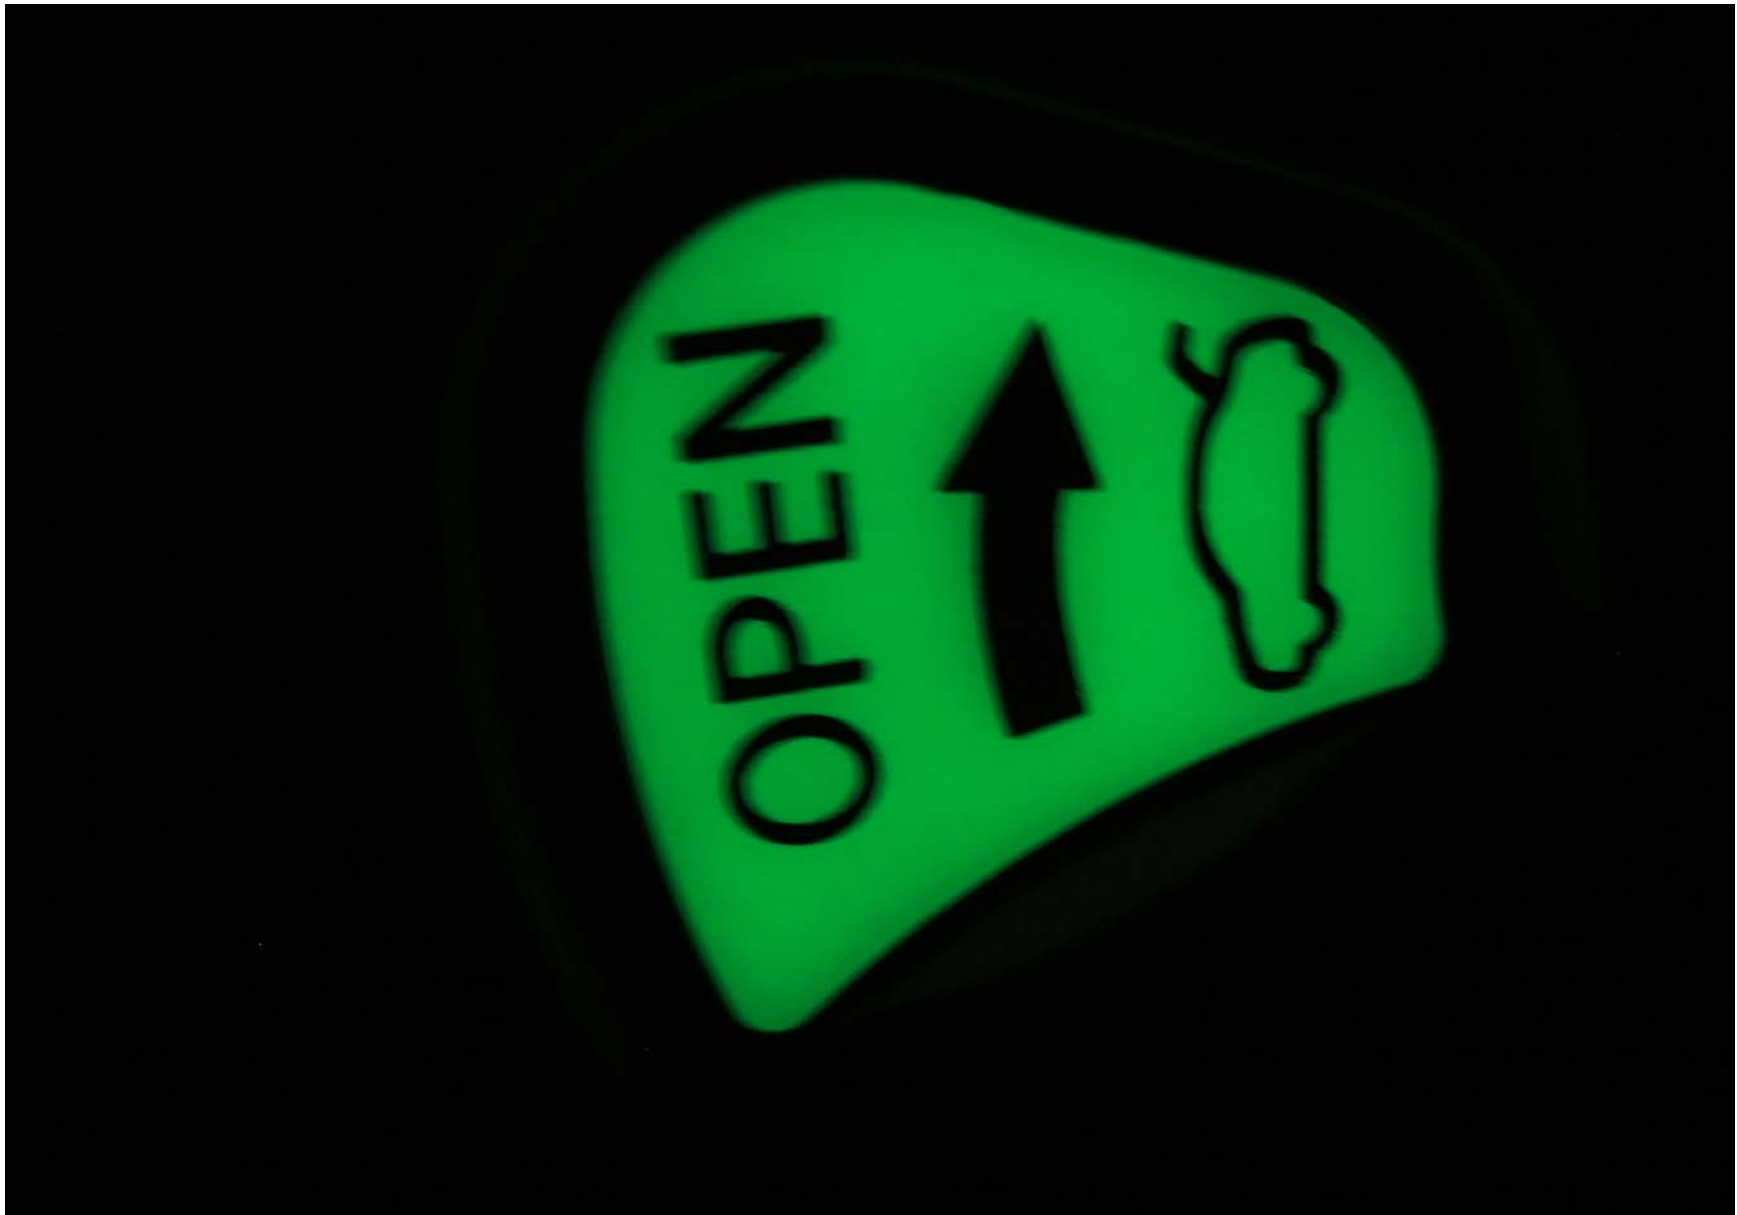
FIGURE 5.12  
RELEASE MECHANISM INSIDE CLOSED TRUNK

Can release mechanism be easily seen inside the closed trunk? Yes

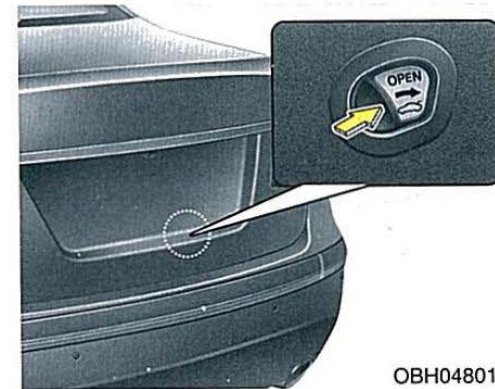
OBH048014

Your vehicle is equipped with an emergency trunk release cable located inside the trunk. The lever glows in the dark when the trunk lid is closed. If someone is inadvertently locked in the trunk, pulling this handle will release the trunk latch mechanism and open the trunk.

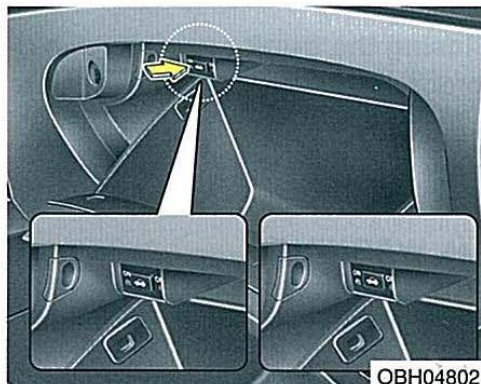
The trunk lid control button located in the vehicle glove box is used to prevent unauthorized access to the trunk.

- When the trunk lid control button is ON (depressed), the trunk can be unlocked with the trunk lid release lever and the transmitter (or smart key).
- When the trunk lid control button is OFF (not depressed), the trunk can be unlocked with the master key (or the mechanical key of the smart key) only.
