REPORT NUMBER 110-STF-11-008

# SAFETY COMPLIANCE TESTING FOR FMVSS NO. 110 TIRE SELECTION AND RIMS

CHRYSLER GROUP LLC  
2012 FIAT 500  
TWO-DOOR PASSENGER CAR  
NHTSA NO. CC0500

**FINAL REPORT**

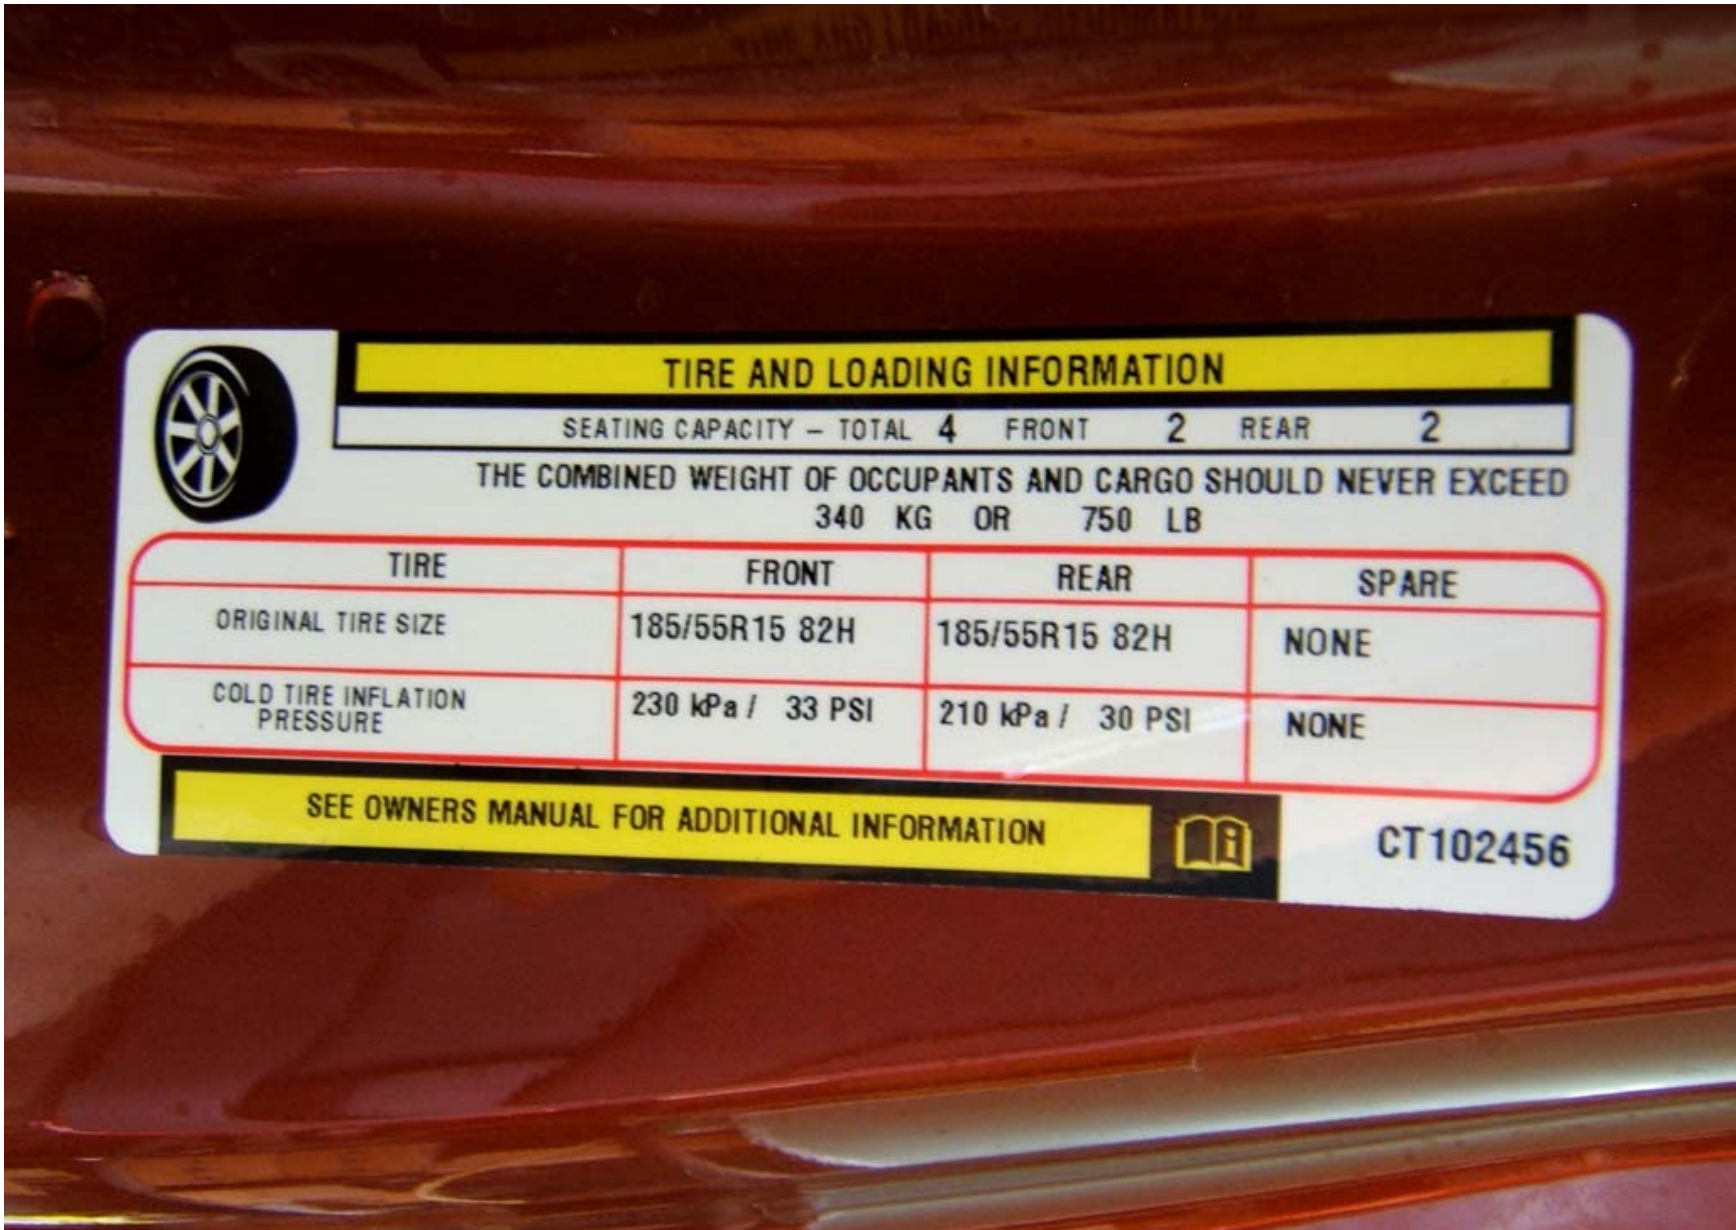
FIGURE 5.4  
VEHICLE PLACARD

**Vehicle Placard** has the exact color and format as specified in Figure 1 and text is in English language. ( ) YES ( X ) NO

Note: Axes on table for 'Front/Rear/Spare' and 'Original Tire Size and Cold Tire Inflation Pressure' are reversed, but all required information is present.

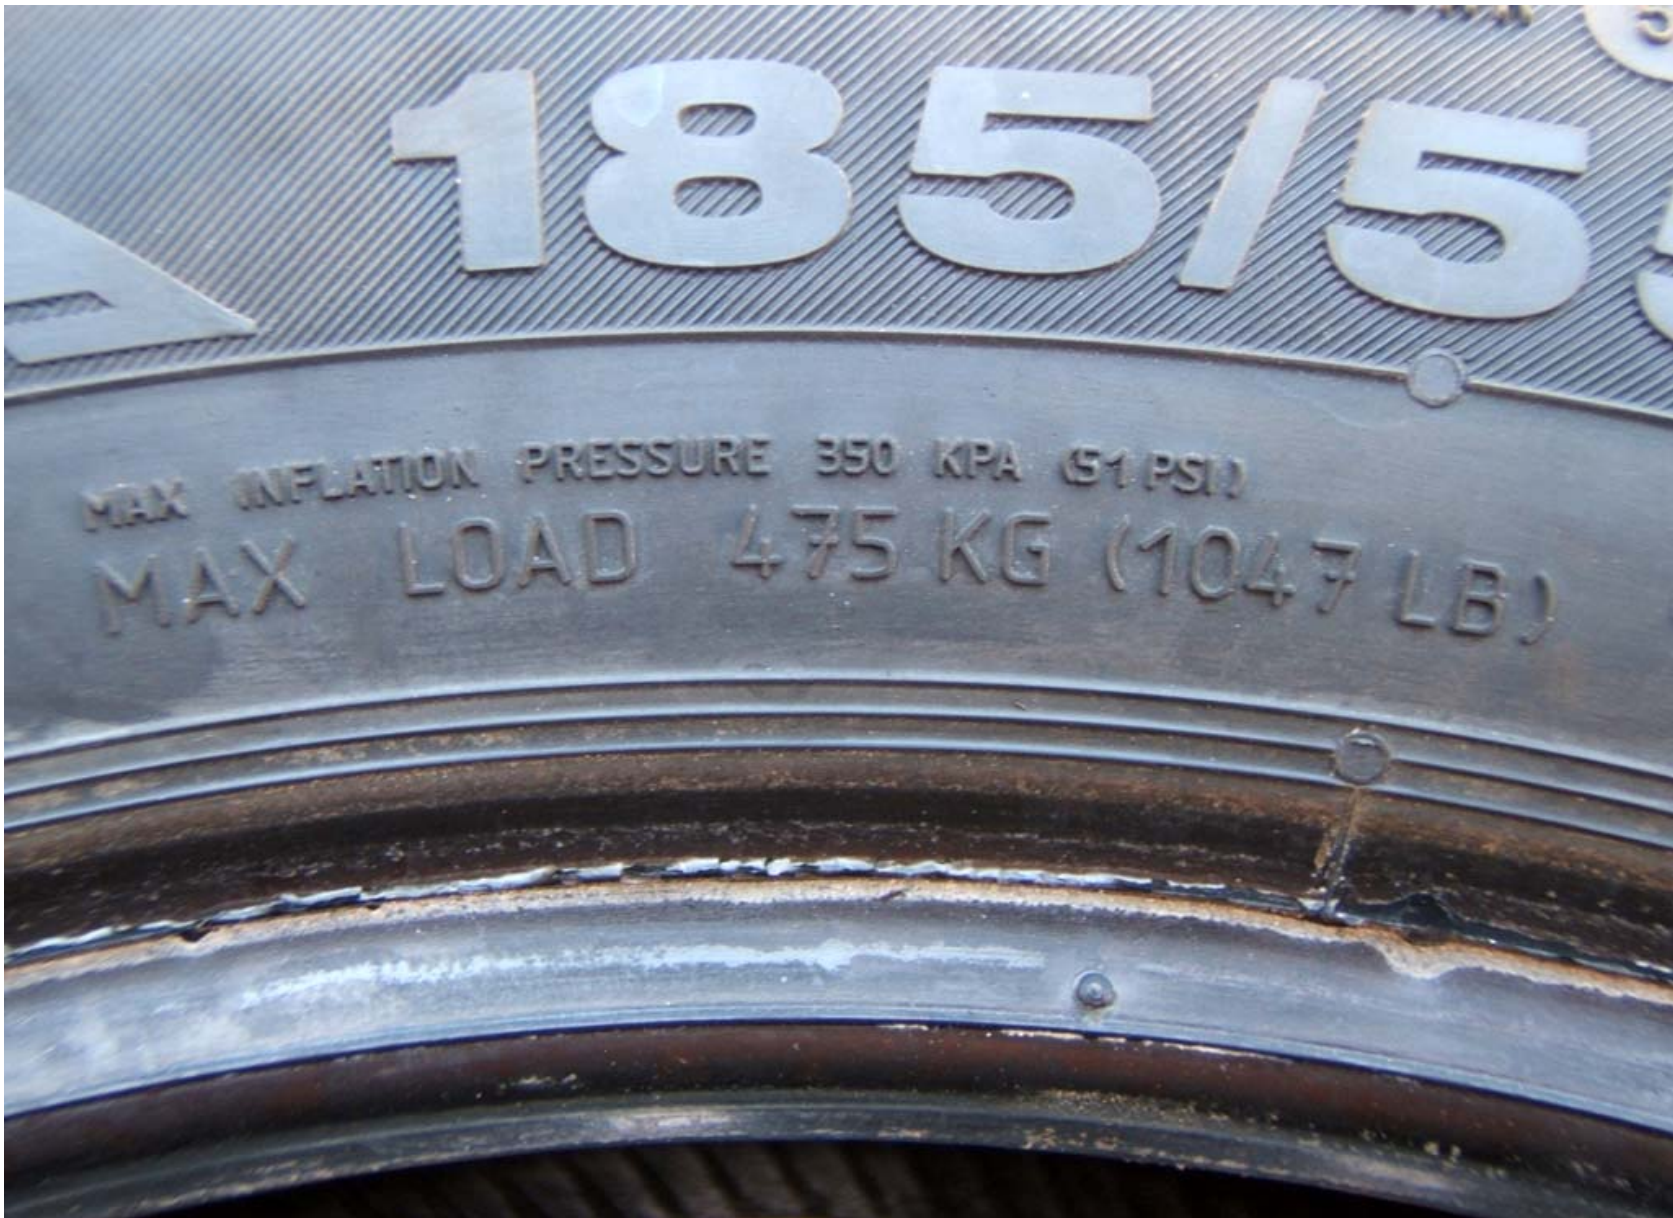
FIGURE 5.8  
TIRE SHOWING MAX LOAD RATING AND MAX INFLATION PRESSURE

Front	Rear
Installed Tire Size	<u>185/55R15</u>	<u>185/55R15</u>
Max. Load Rating on Sidewall	<u>475 kg (1,047 lb)</u>	<u>475 kg (1,047lb)</u>

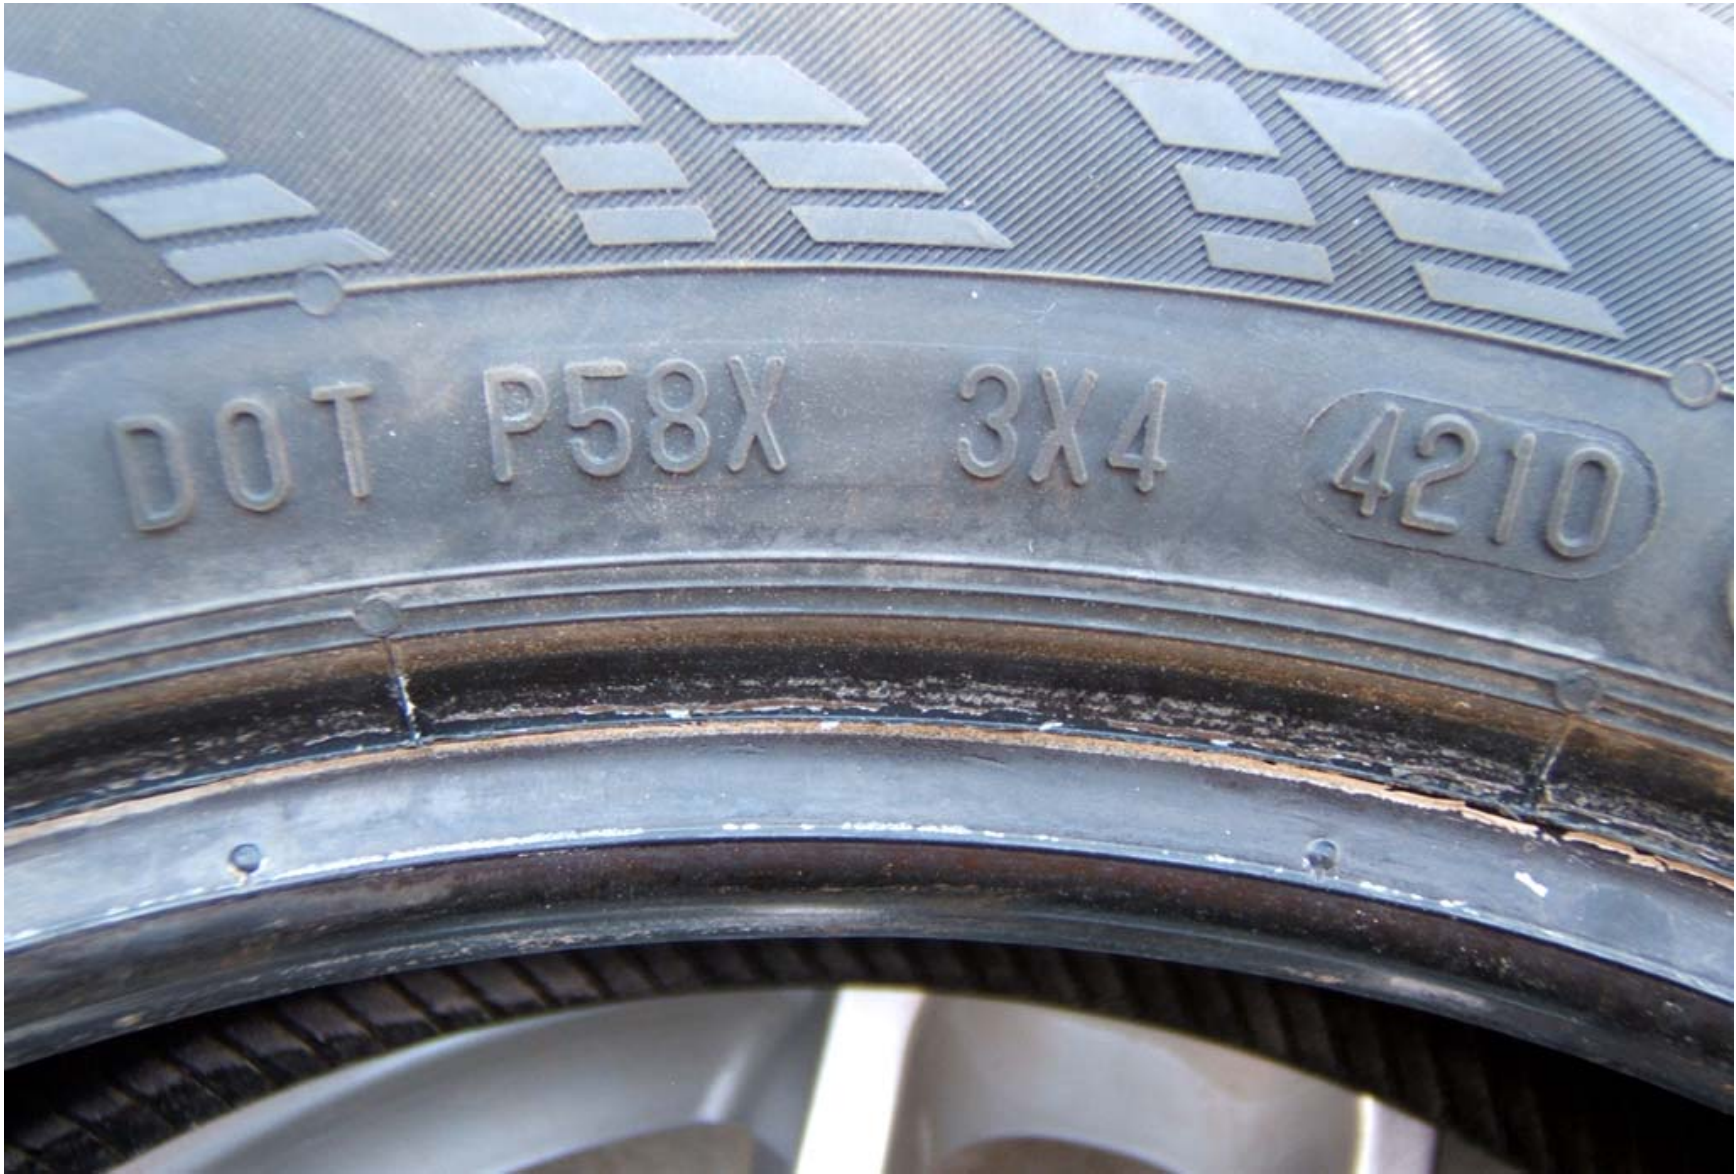
FIGURE 5.9  
TIRE SHOWING SERIAL NUMBER

Serial Number: Right Front P58X3X44210 Left Front P58X3X44110  
 Right Rear P58X3X44210 Left Rear P58X3X44110  
 Spare None

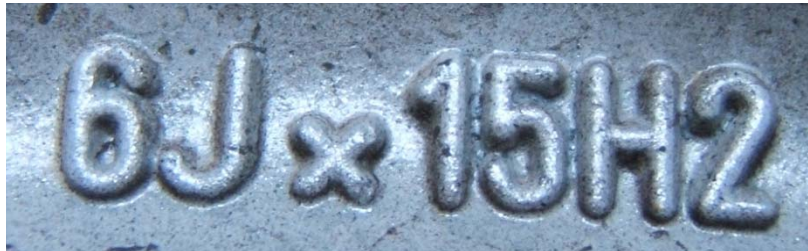
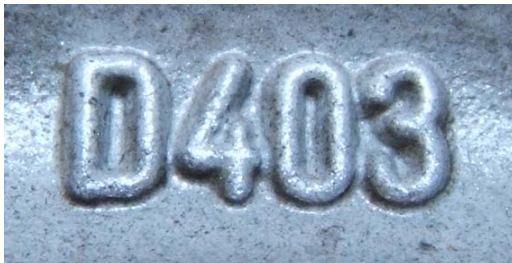
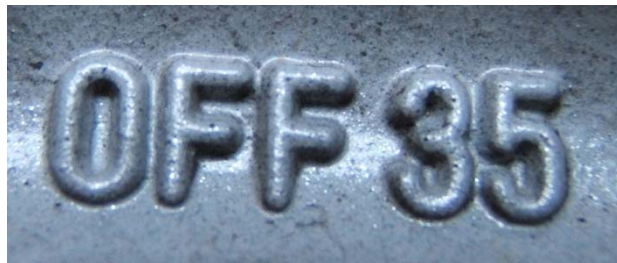
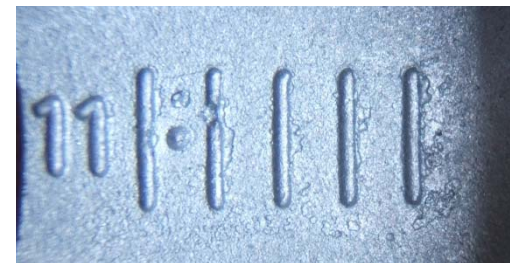
FIGURE 5.11  
RIGHT FRONT RIM SHOWING MANUFACTURER, DATE OF MANUFACTURE, SIZE,  
DESIGNATION FOR SOURCE OF PUBLISHED DIMENSIONS, DOT SYMBOL, AND OTHER RIM MARKINGS

Manufacturer's Name, Symbol or Trademark	<u>Ronal</u>	<u></u>
Rim Size	<u>15x6</u>	<u></u>
Date of Manufacture

<u></u>
Does Rim contain 'DOT' symbol? (YES/NO)	<u>Yes</u>	<u></u>
Other Rim Markings	<u>See Figures 5.11 &amp; 5.12</u>	<u></u>
Rim Inspection Comments:	<u></u>

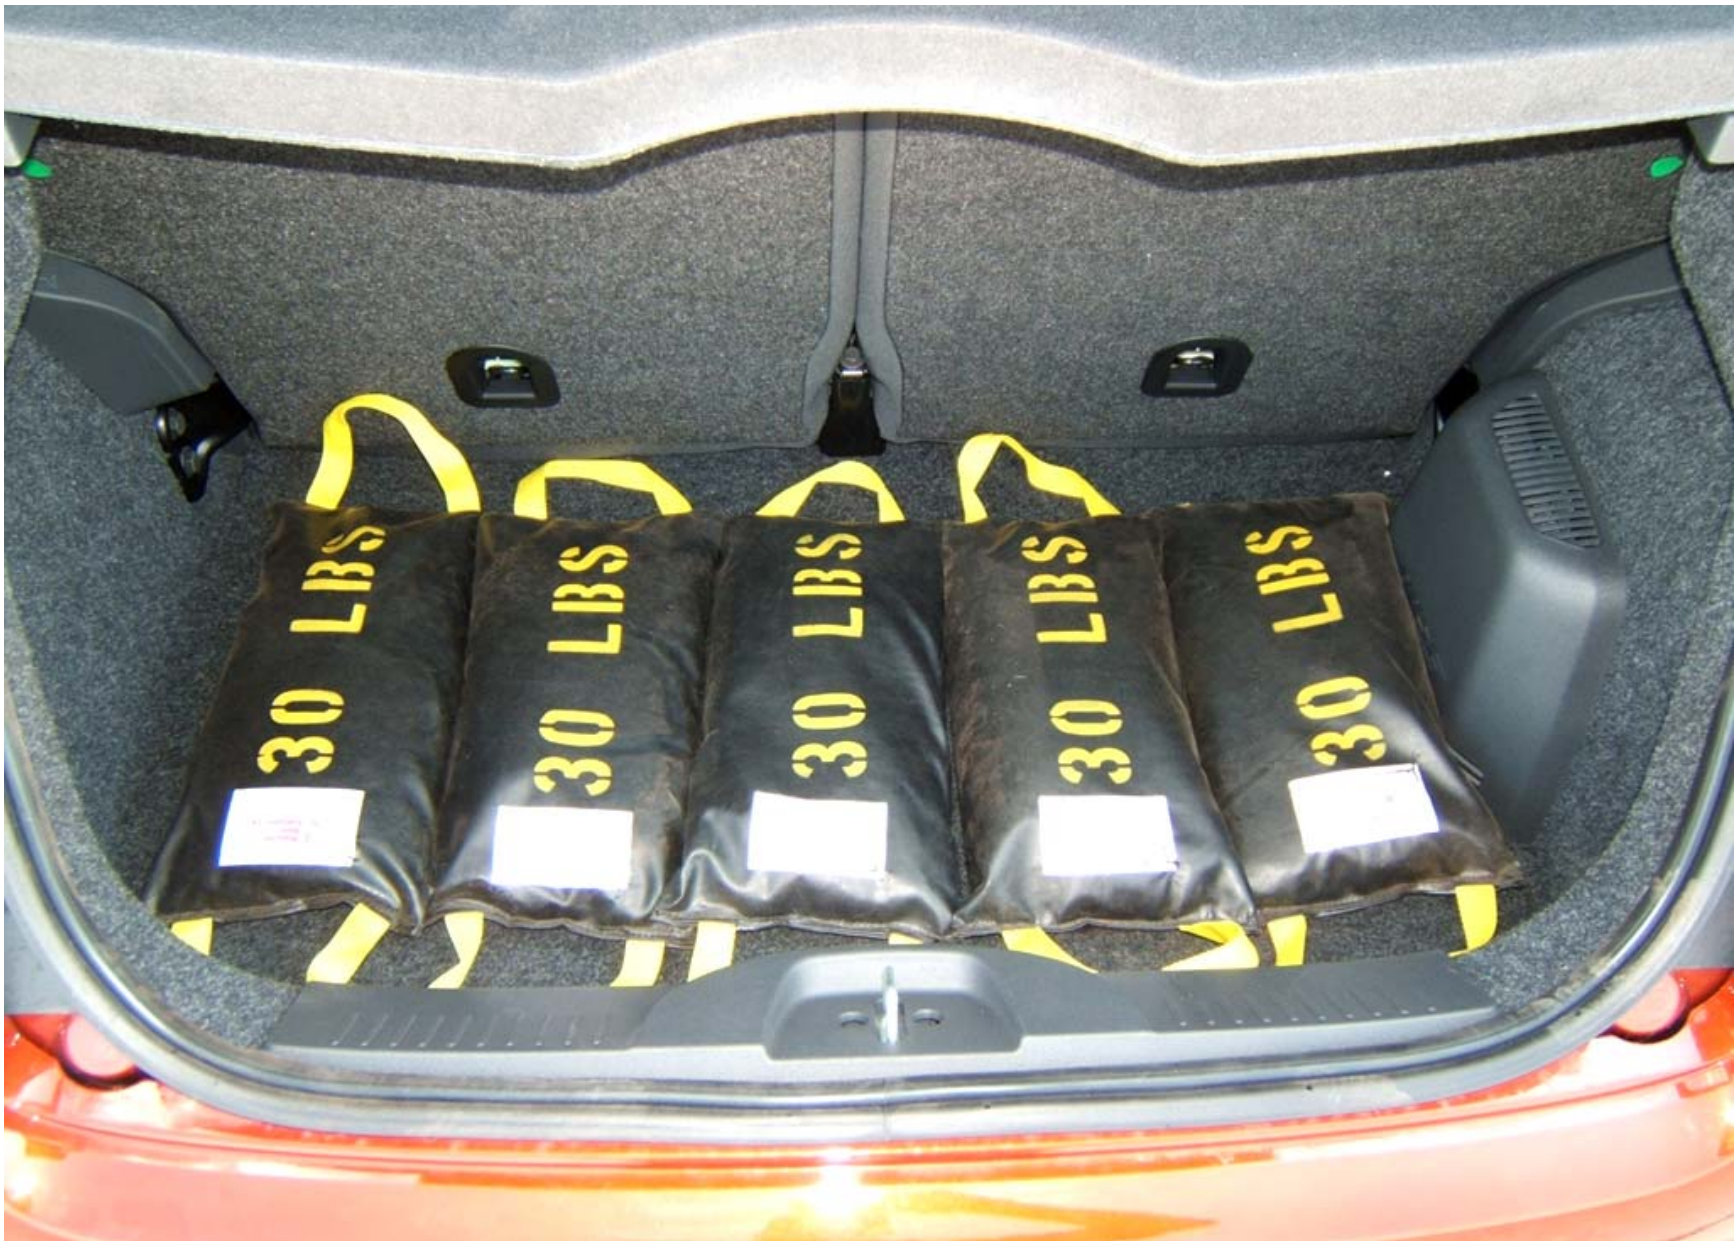
FIGURE 5.15  
VEHICLE TRUNK  
BALLASTED FOR MAXIMUM LOAD

(3) Luggage/Cargo Load (subtract (2) from (1)): 68 kg (150 lb)

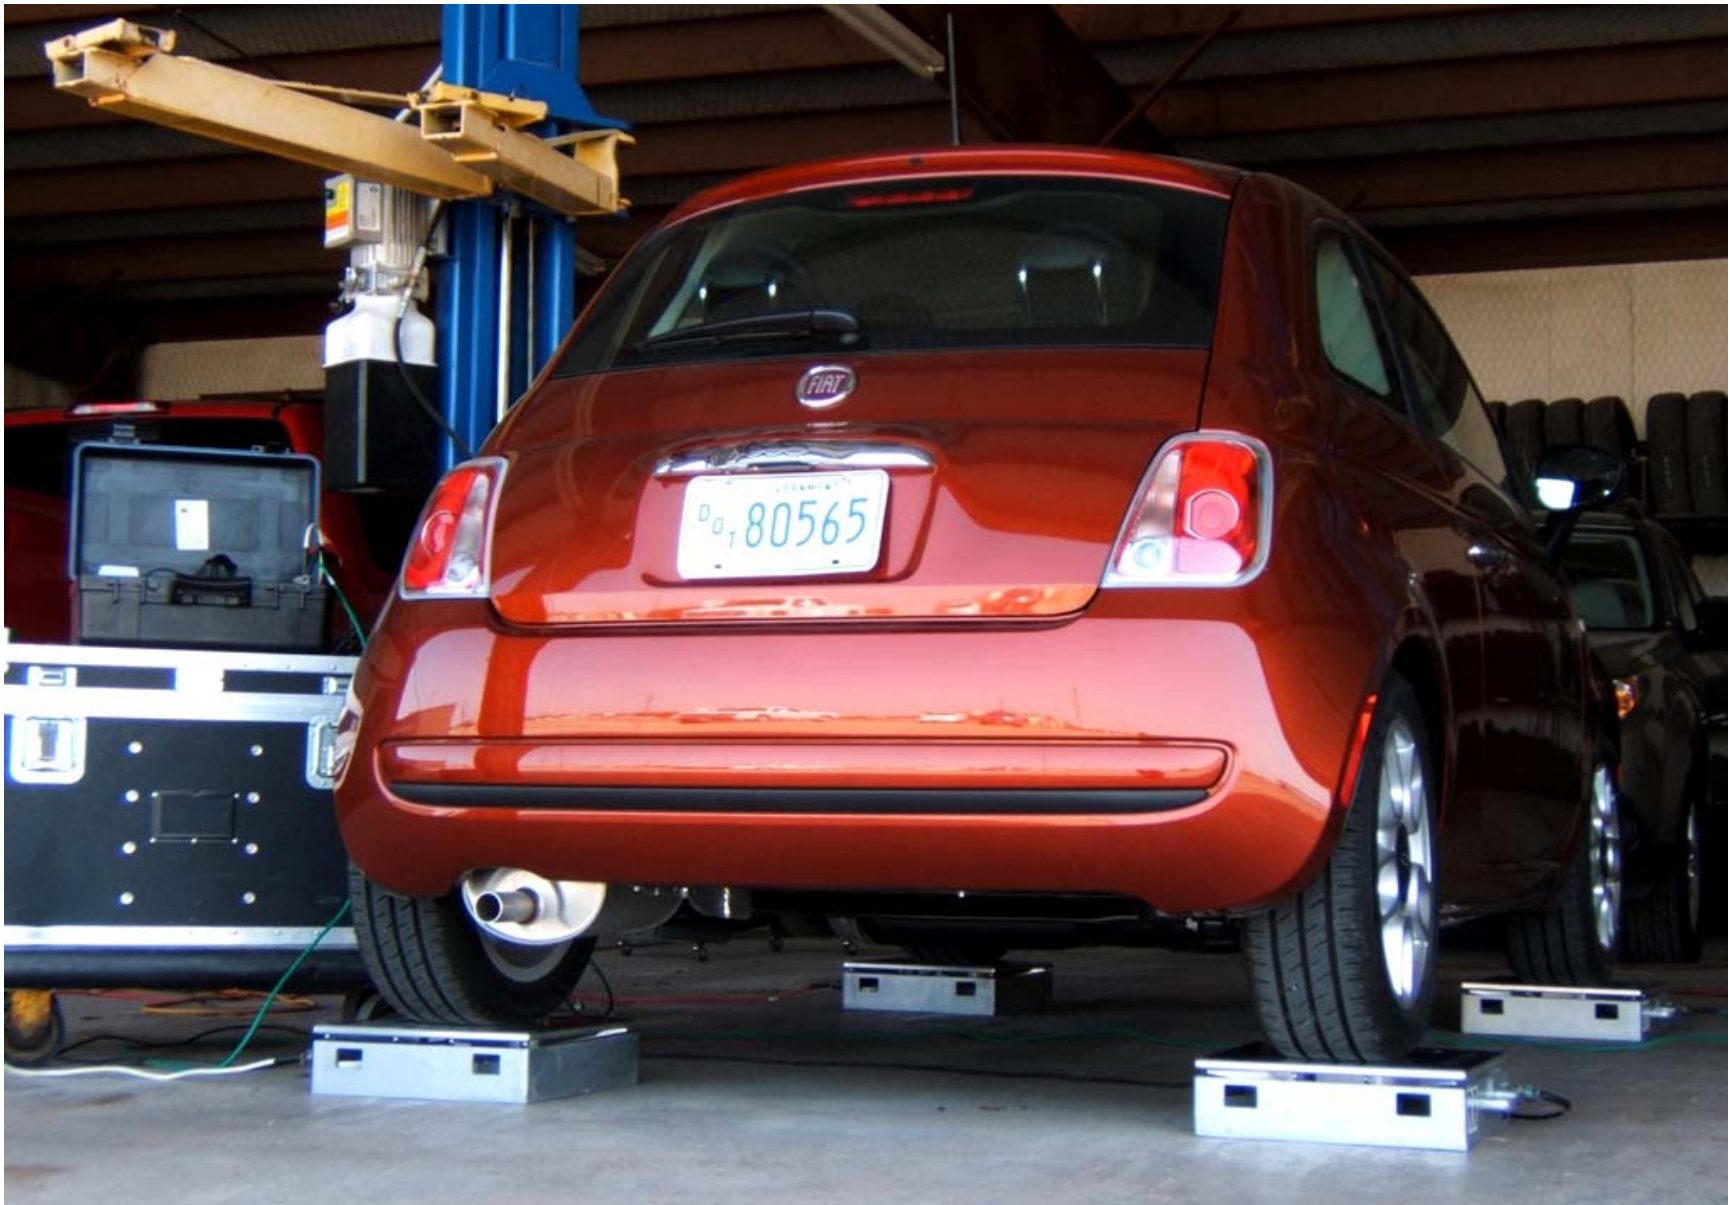
FIGURE 5.16  
VEHICLE ON WEIGHT SCALES

LF <u>390 kg (859 lb)</u>	LR <u>323 kg (712 lb)</u>
RF <u>378 kg (834 lb)</u>	RR <u>327 kg (720 lb)</u>
Front Axle <u>768 kg (1,693 lb)</u>	Rear Axle <u>650 kg (1,432 lb)</u>
Total Vehicle <u>1,418 kg (3,125 lb)</u>
