**REPORT NUMBER: 214P-CAL-10-5**

**SAFETY COMPLIANCE TESTING FOR FMVSS 214  
DYNAMIC SIDE IMPACT PROTECTION  
RIGID POLE SIDE IMPACT**

**HONDA OF CANADA, MFG  
2010 ACURA MDX  
4-DOOR SUV**

**NHTSA NUMBER: CA5304**

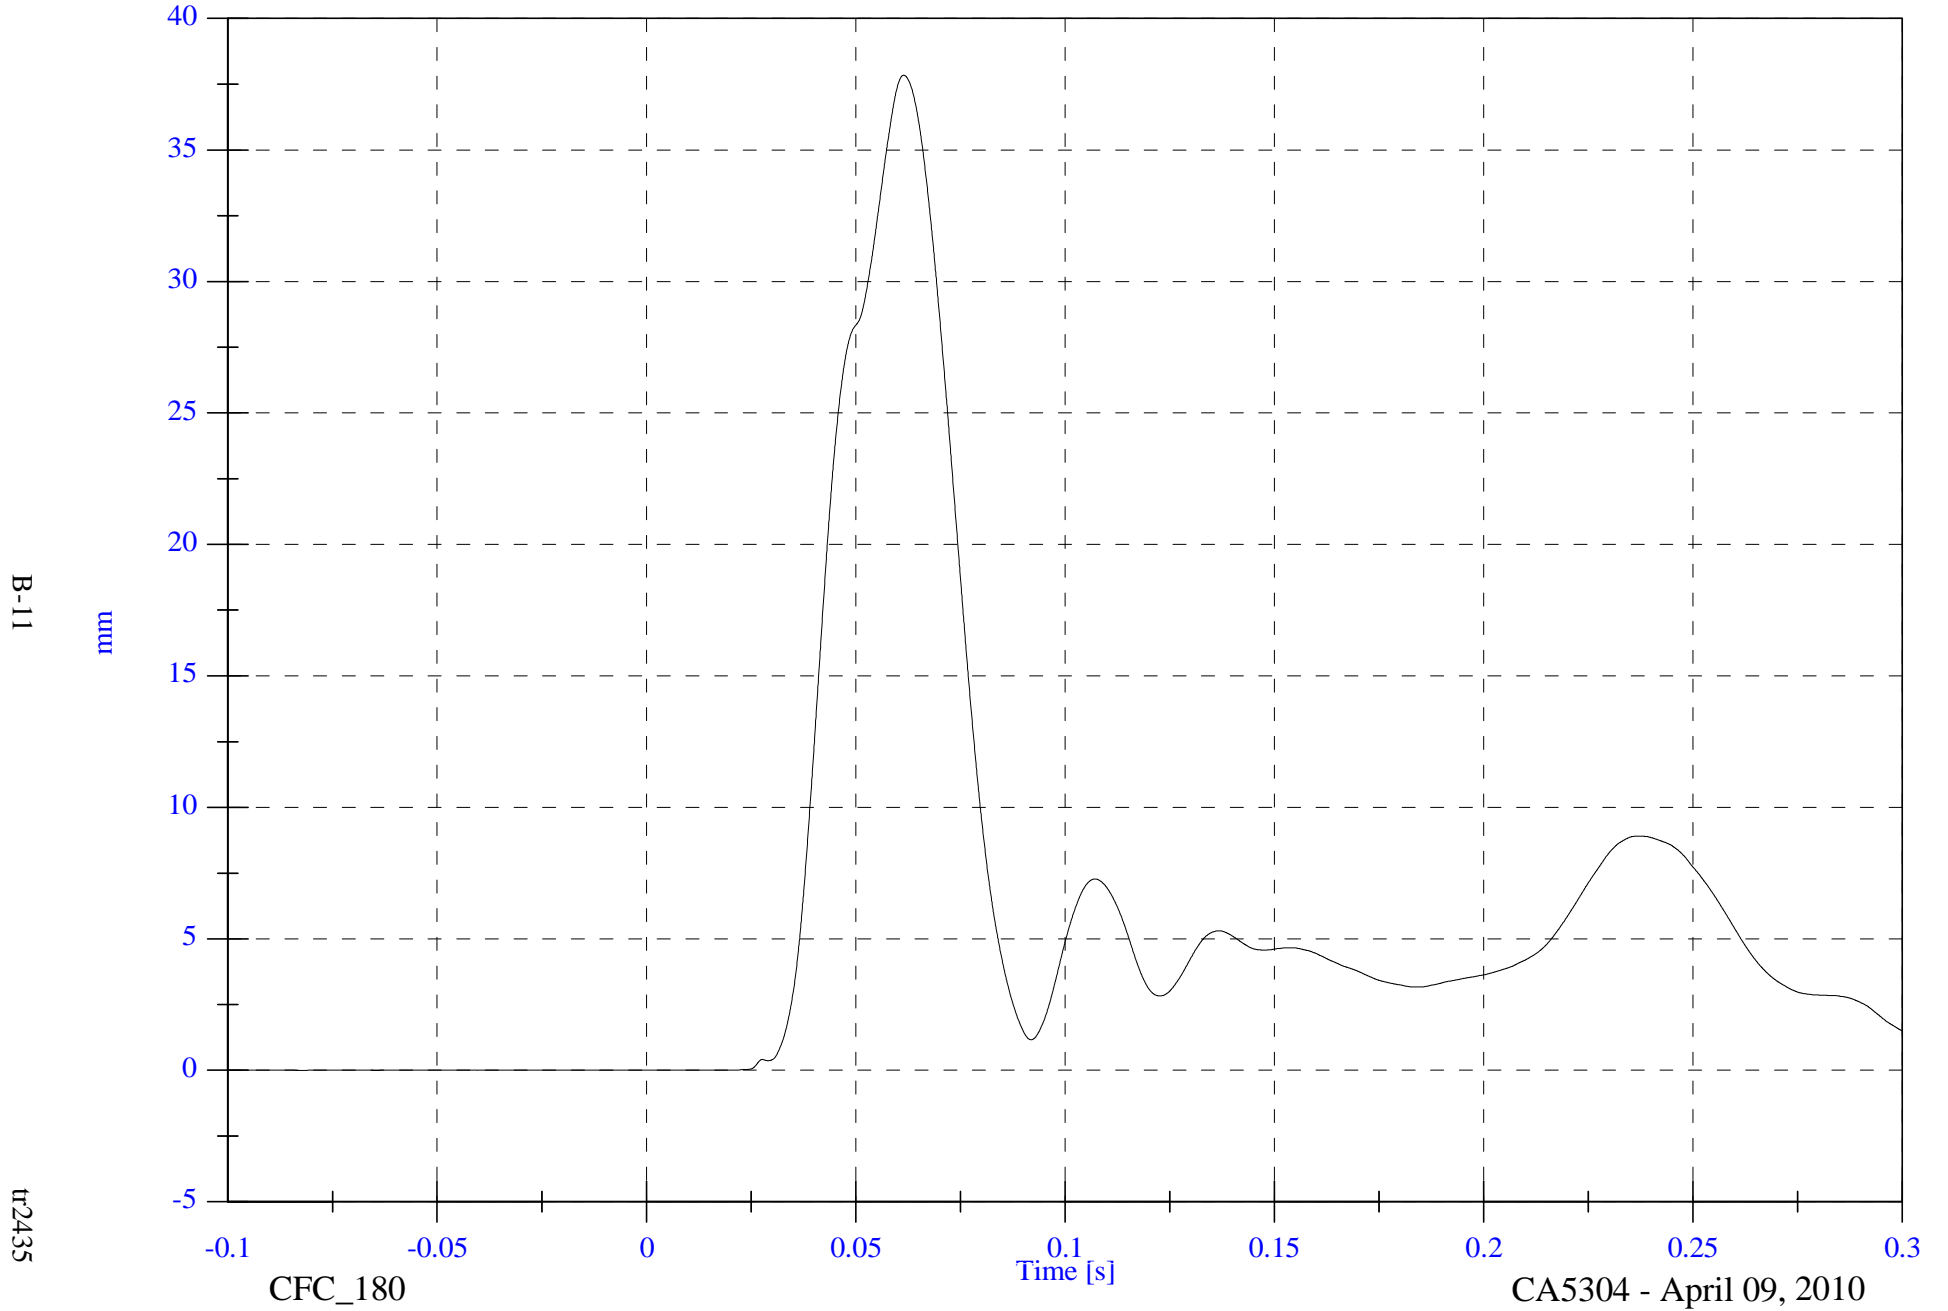
B-11

Max: 37.8 [mm] at 0.061 [s]

Driver ES-2re Male Dummy		
HIC	526.9	
UPPER RIB DEFLECTION	37.8	mm
MIDDLE RIB DEFLECTION	35.8	mm
LOWER RIB DEFLECTION	36.9	mm
ABDOMEN (FRONT)	**	N
ABDOMEN (MID)	392.0	N
ABDOMEN (REAR)	625.2	N
SUM OF ABDOMEN FORCES	**	N
PUBIC SYMPHYSIS	1613.6	N

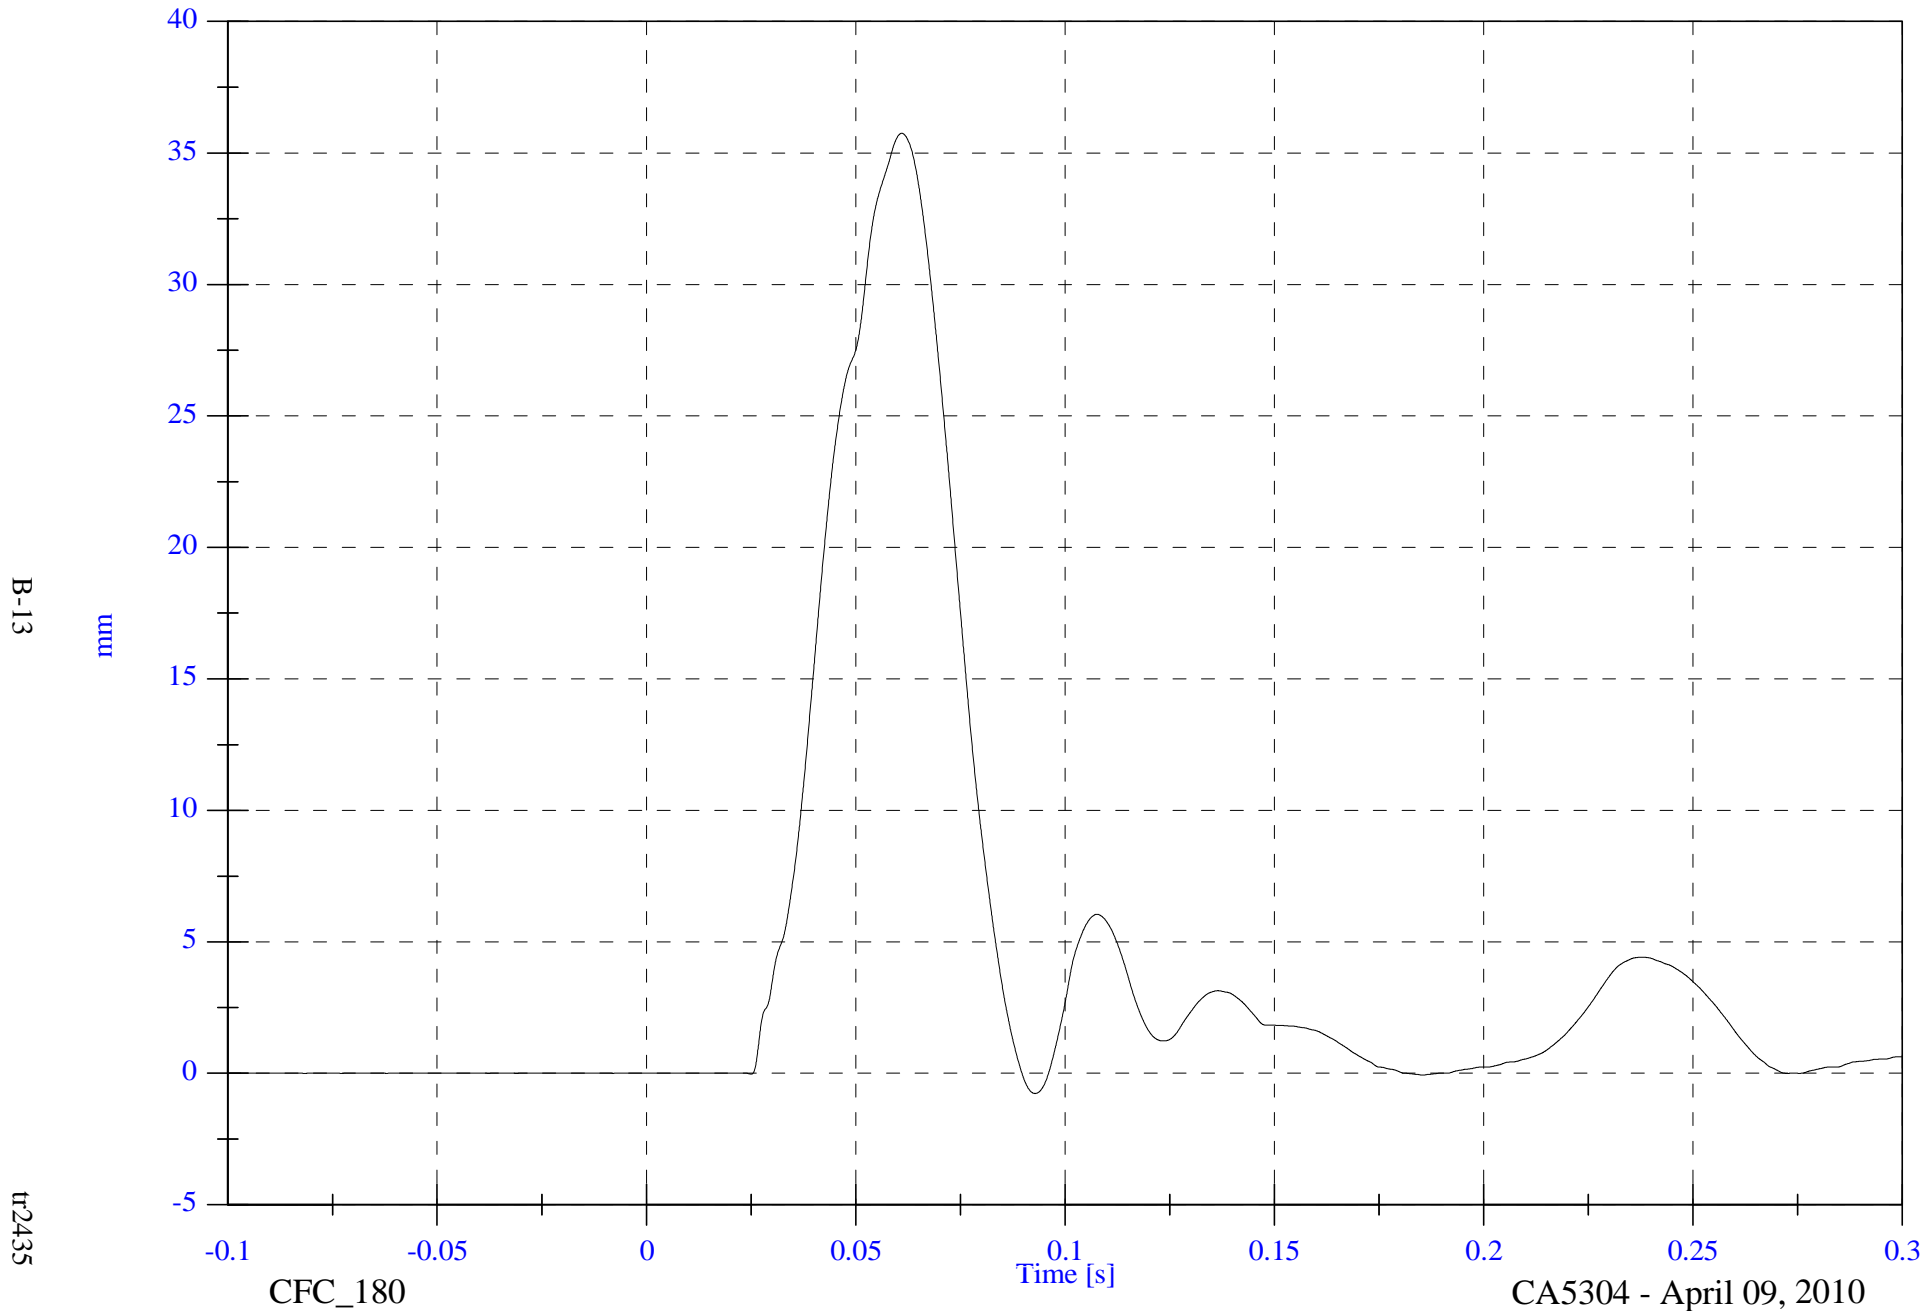
B-13

Max: 35.8 [mm] at 0.061 [s]

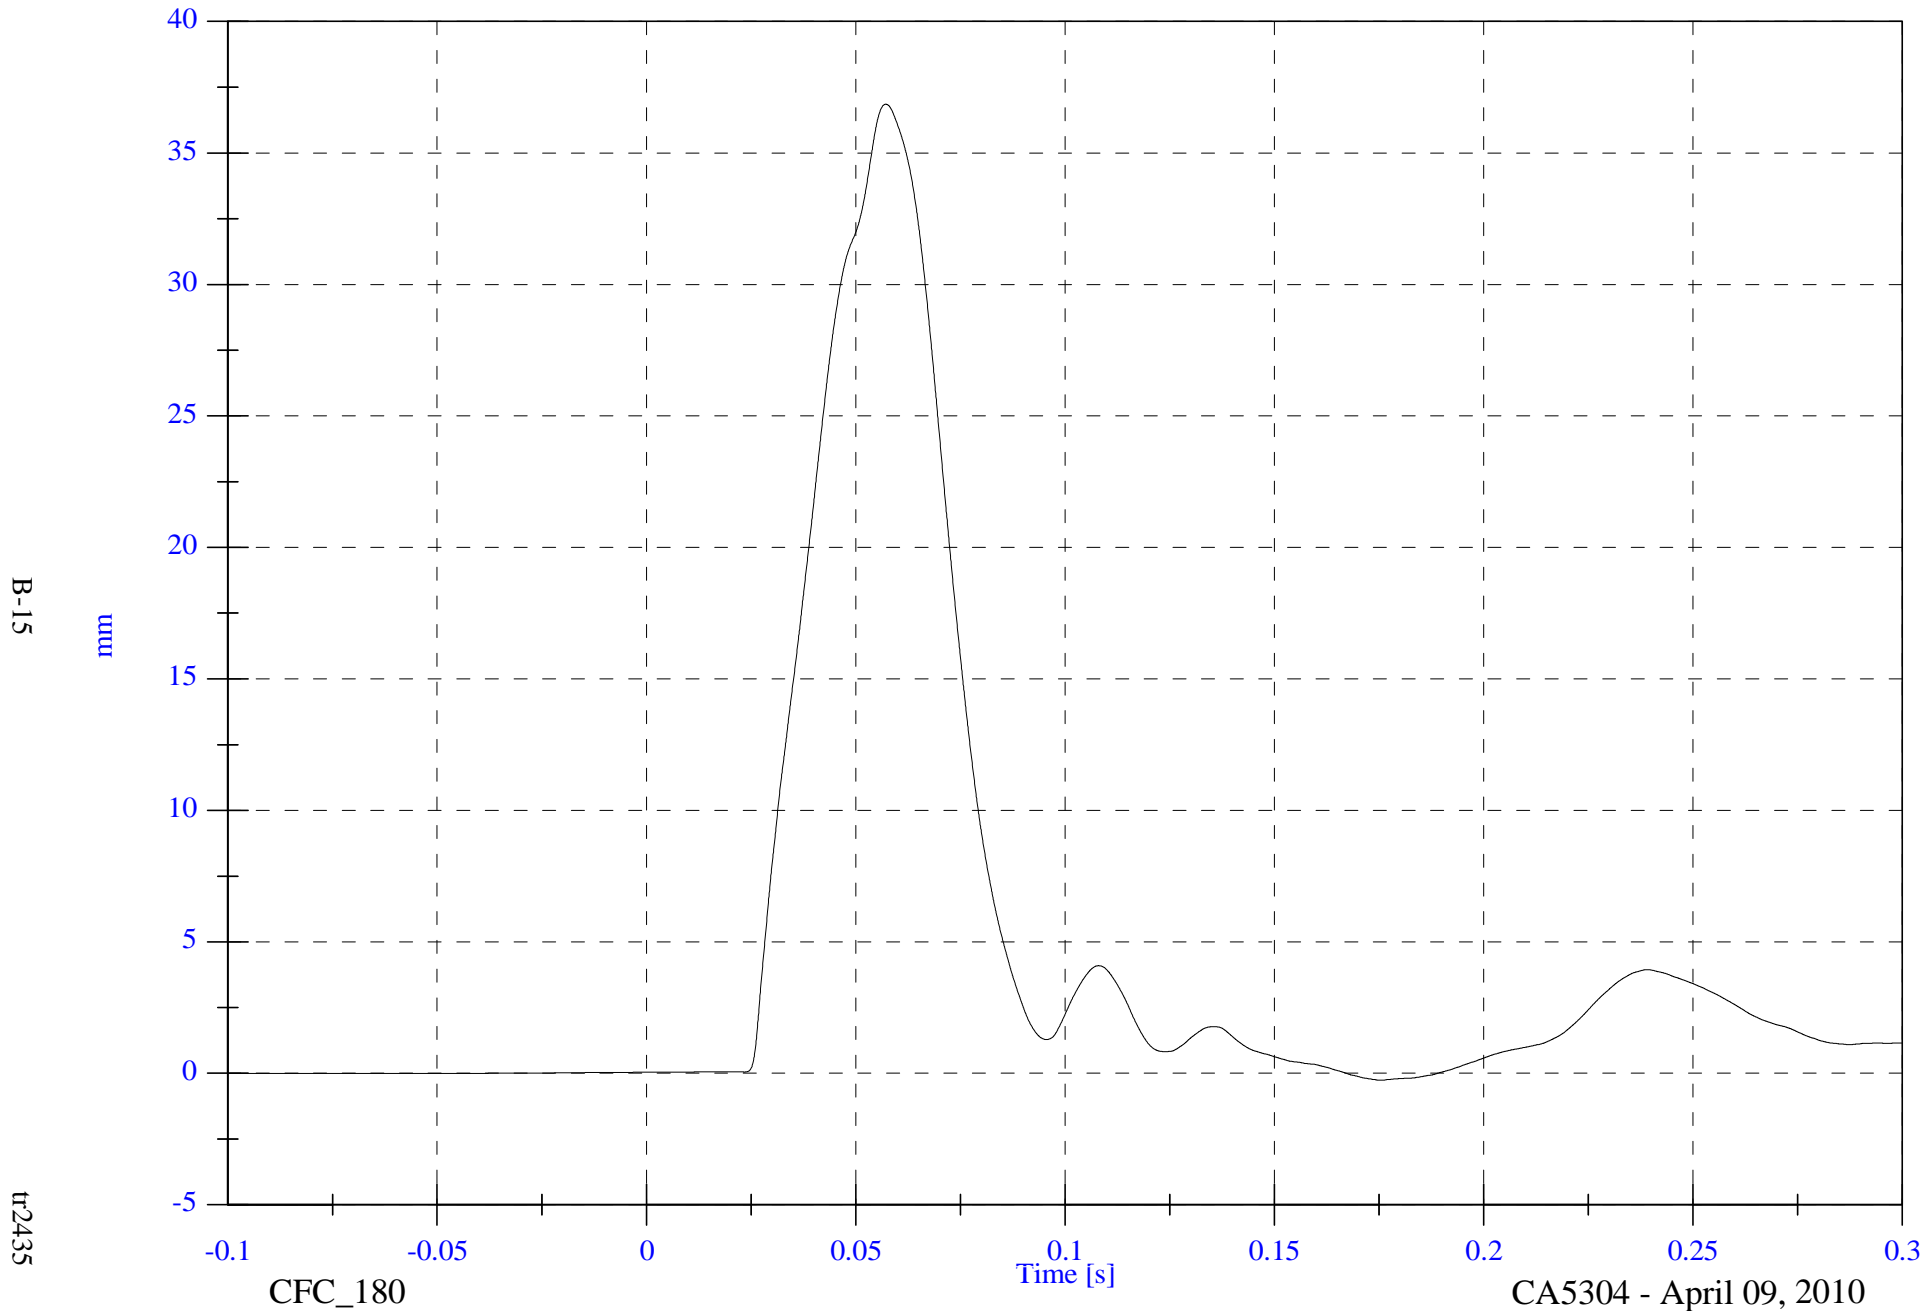
B-15

Max: 36.9 [mm] at 0.057 [s]

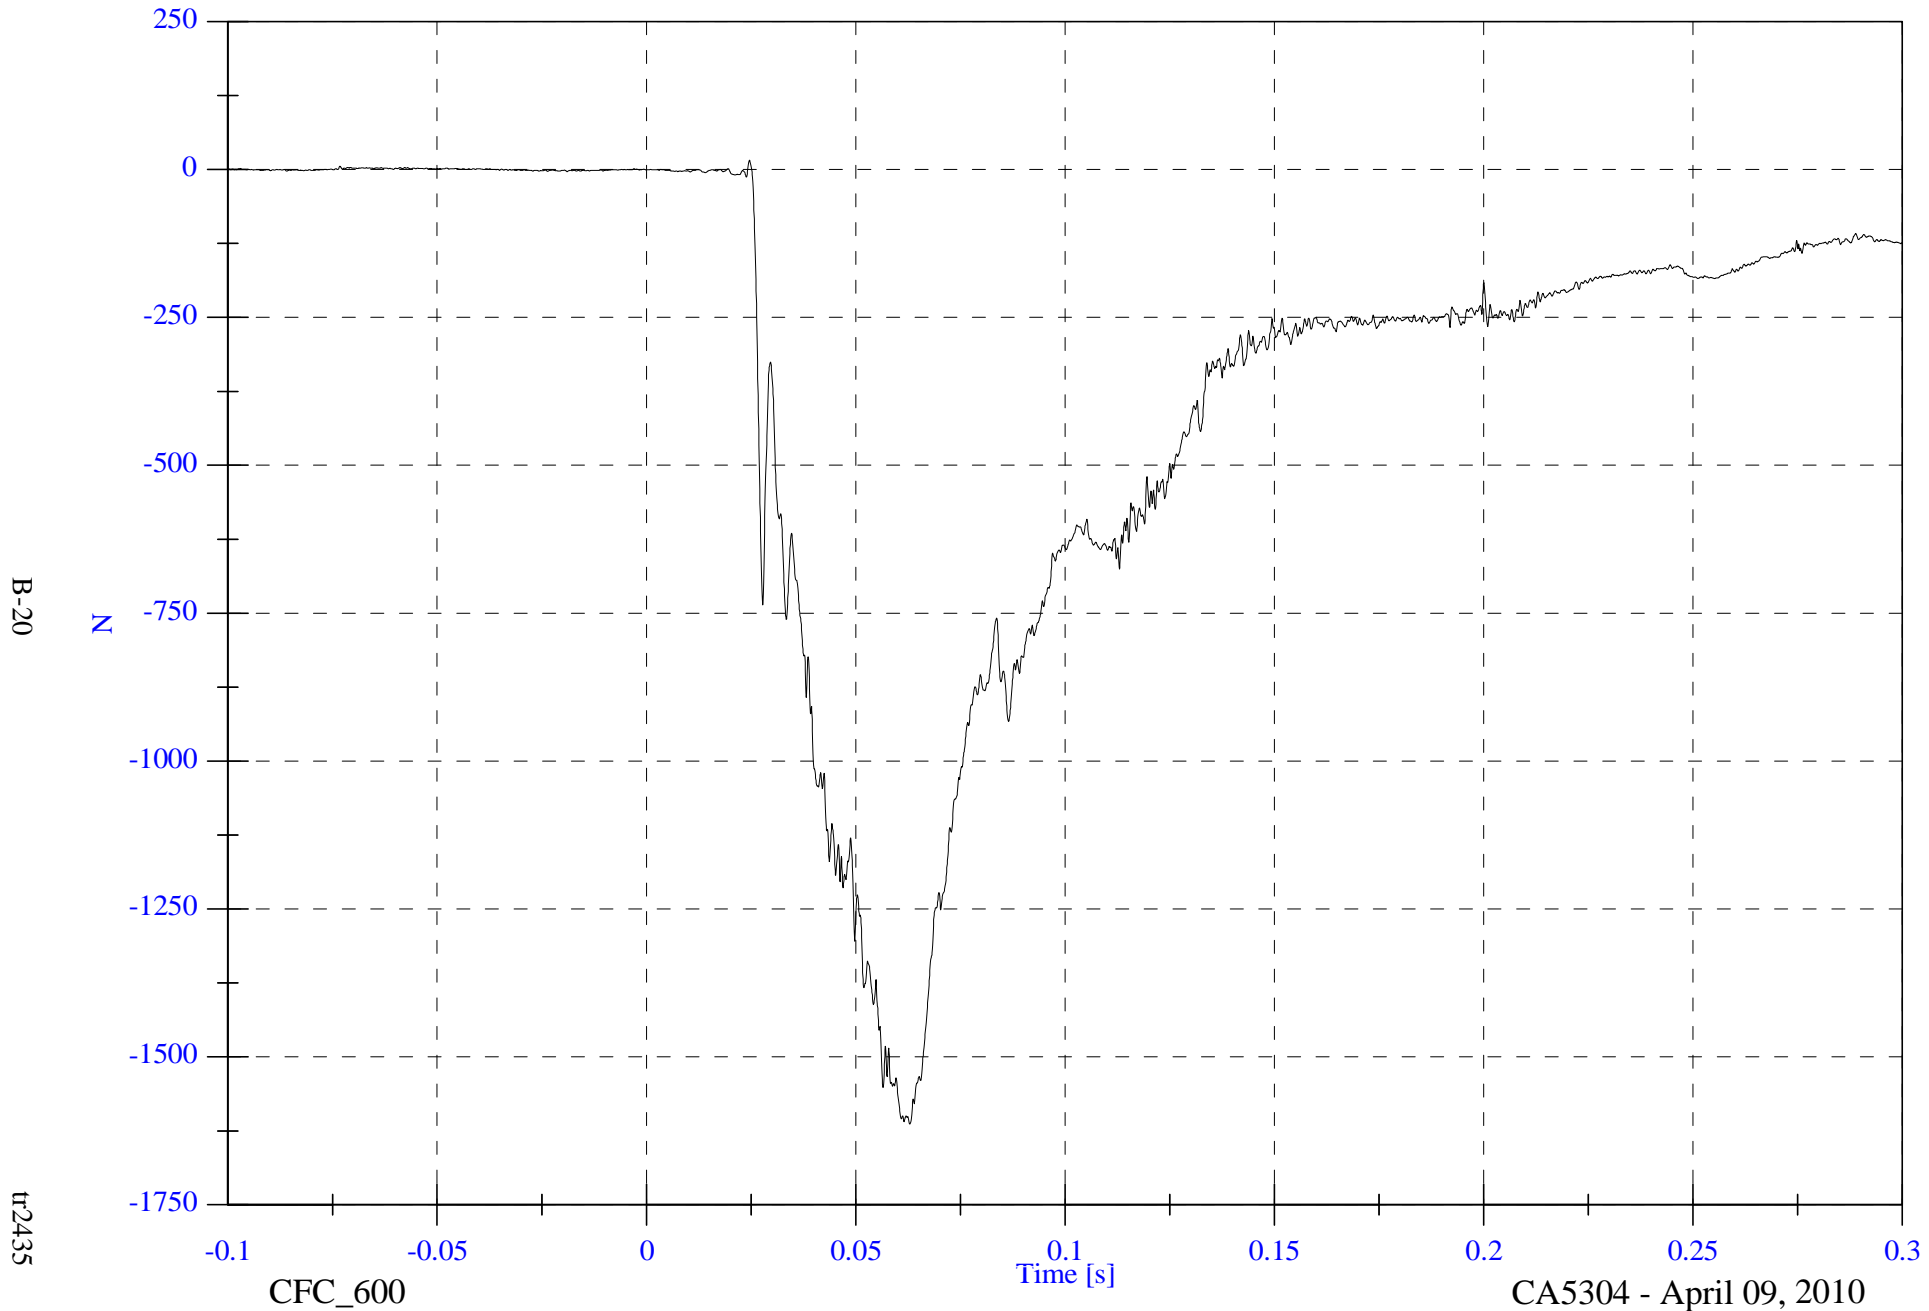
B-20

V1P1 Pubic Symphysis Fy

Min: -1613.6 [N] at 0.063 [s]
