REPORT NUMBER 138-STF-10-003

SAFETY COMPLIANCE TESTING FOR FMVSS NO. 138 TIRE PRESSURE MONITORING SYSTEMS

TOYOTA MOTOR MANUFACTURING
2010 TOYOTA VENZA
FOUR-DOOR MPV
NHTSA NO. CA5105

FINAL REPORT

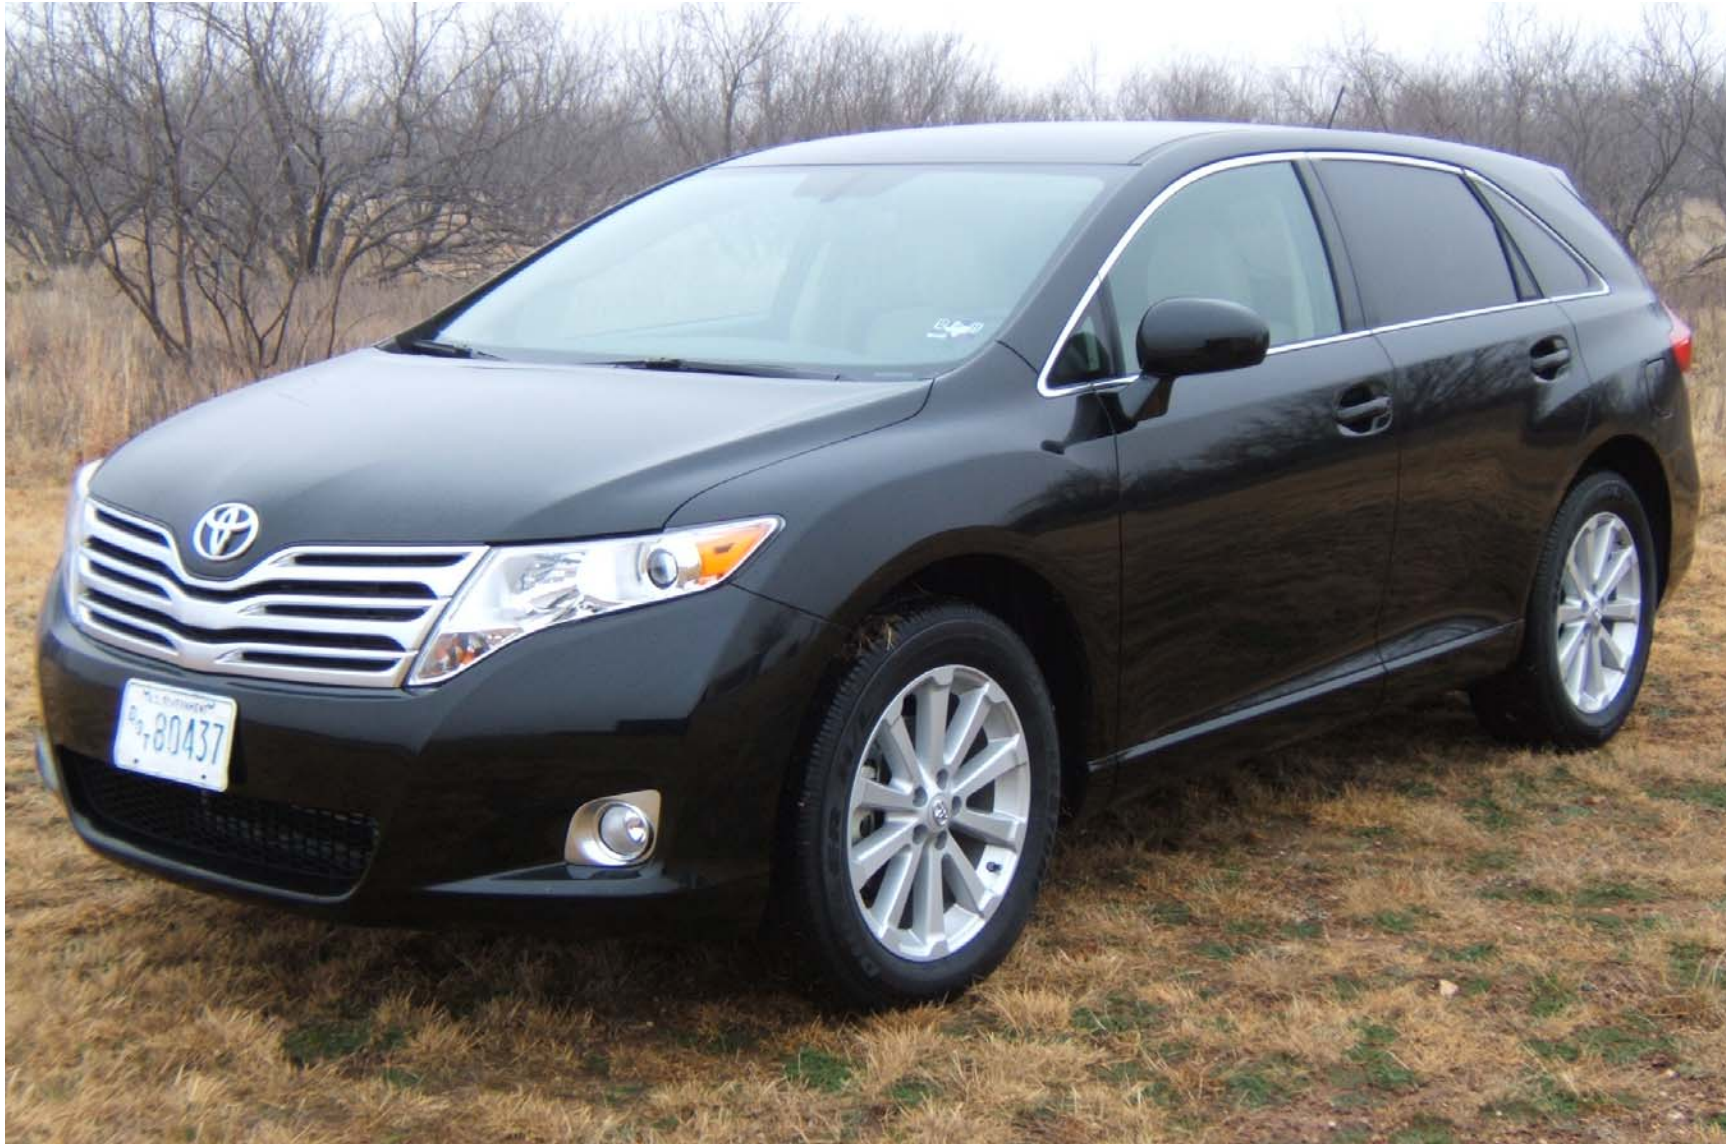
FIGURE 5.1
¾ FRONT VIEW FROM LEFT SIDE OF VEHICLE

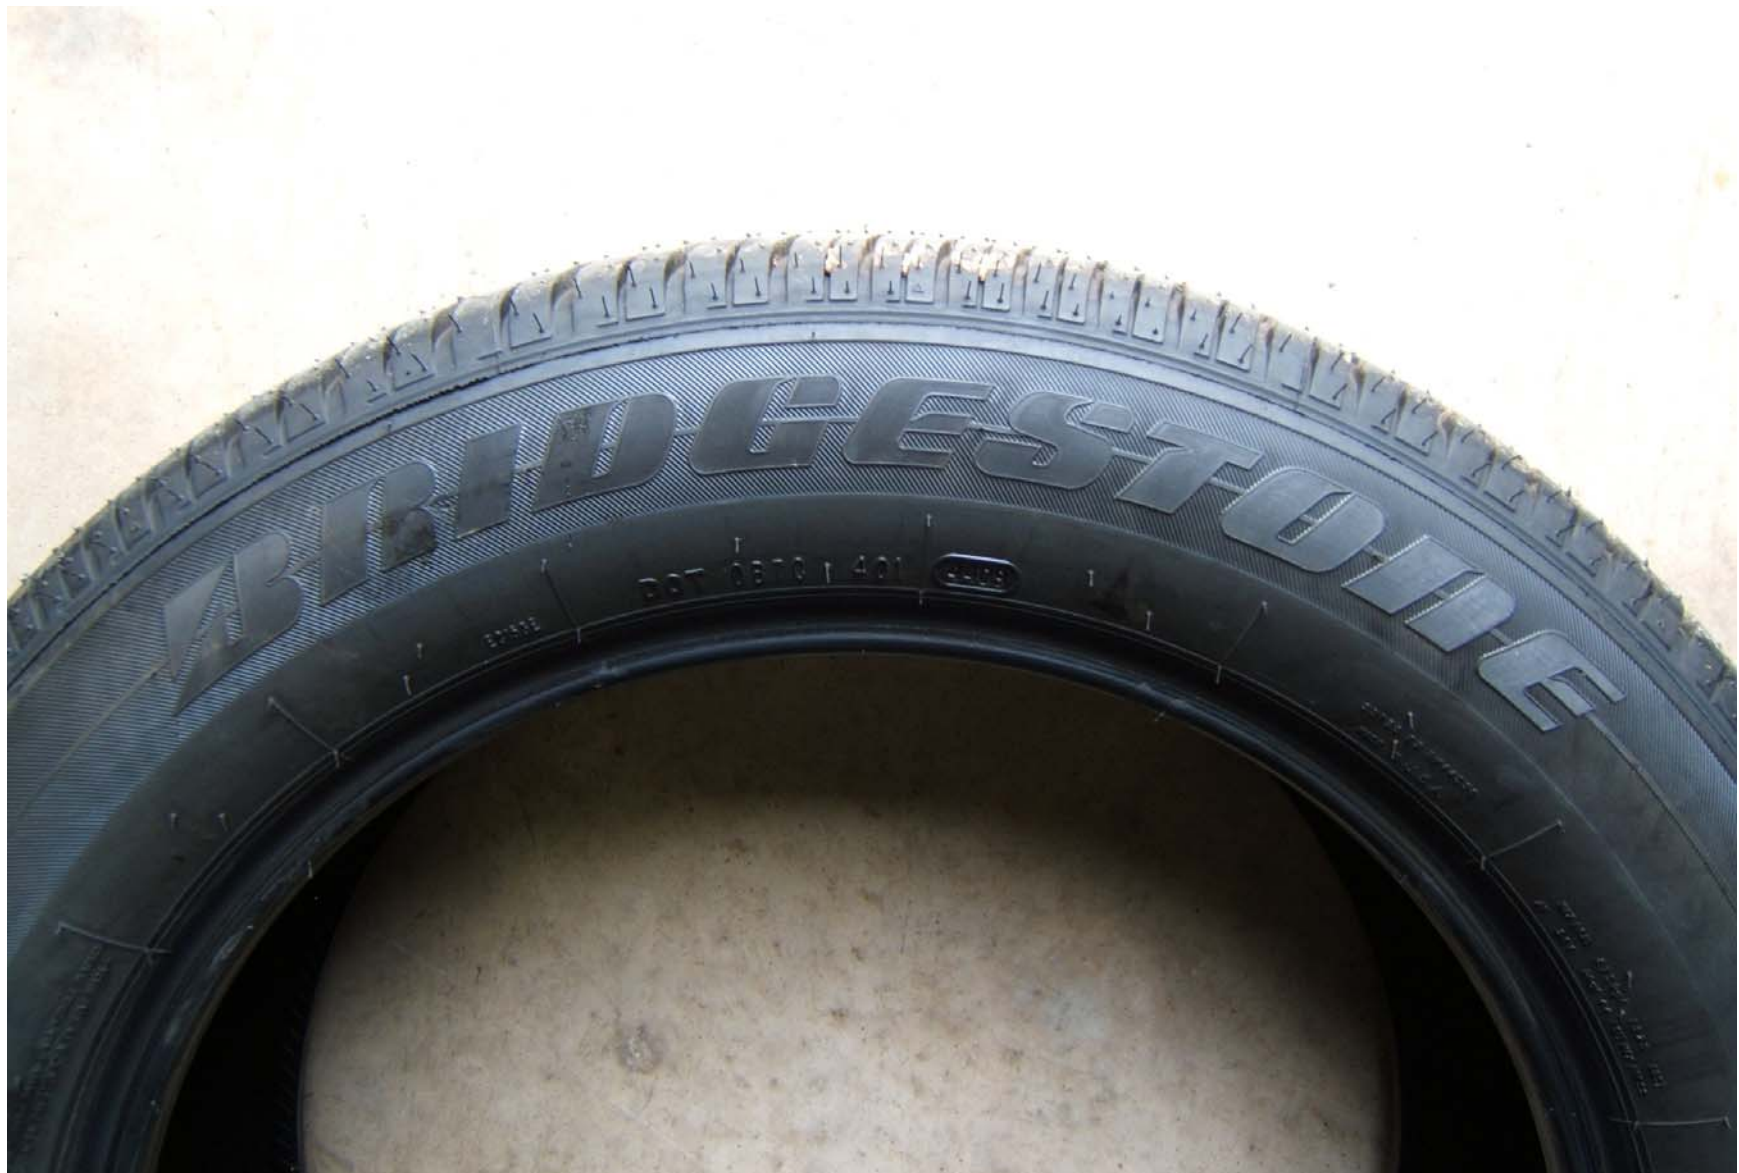
FIGURE 5.4
TIRE SHOWING BRAND

Manufacturer/Tire Name: Bridgestone Dueler H/L 400

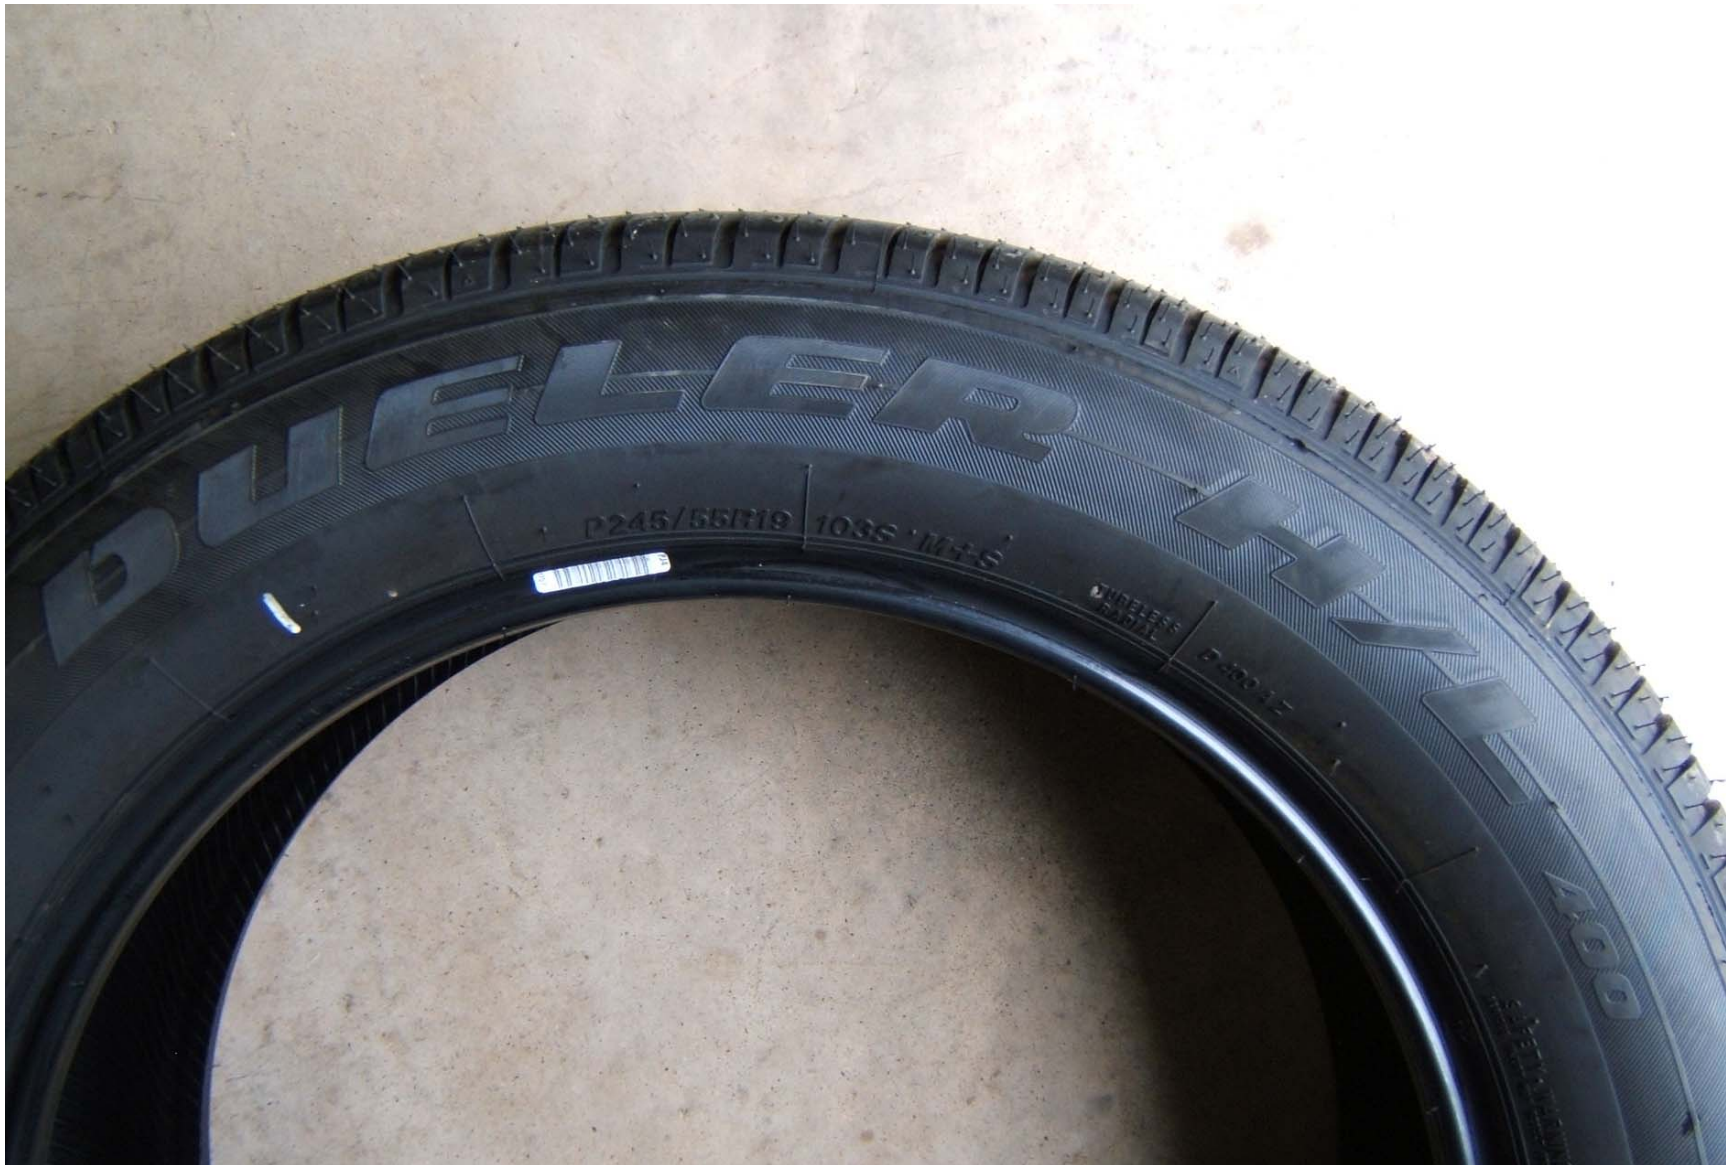
FIGURE 5.5
TIRE SHOWING MODEL

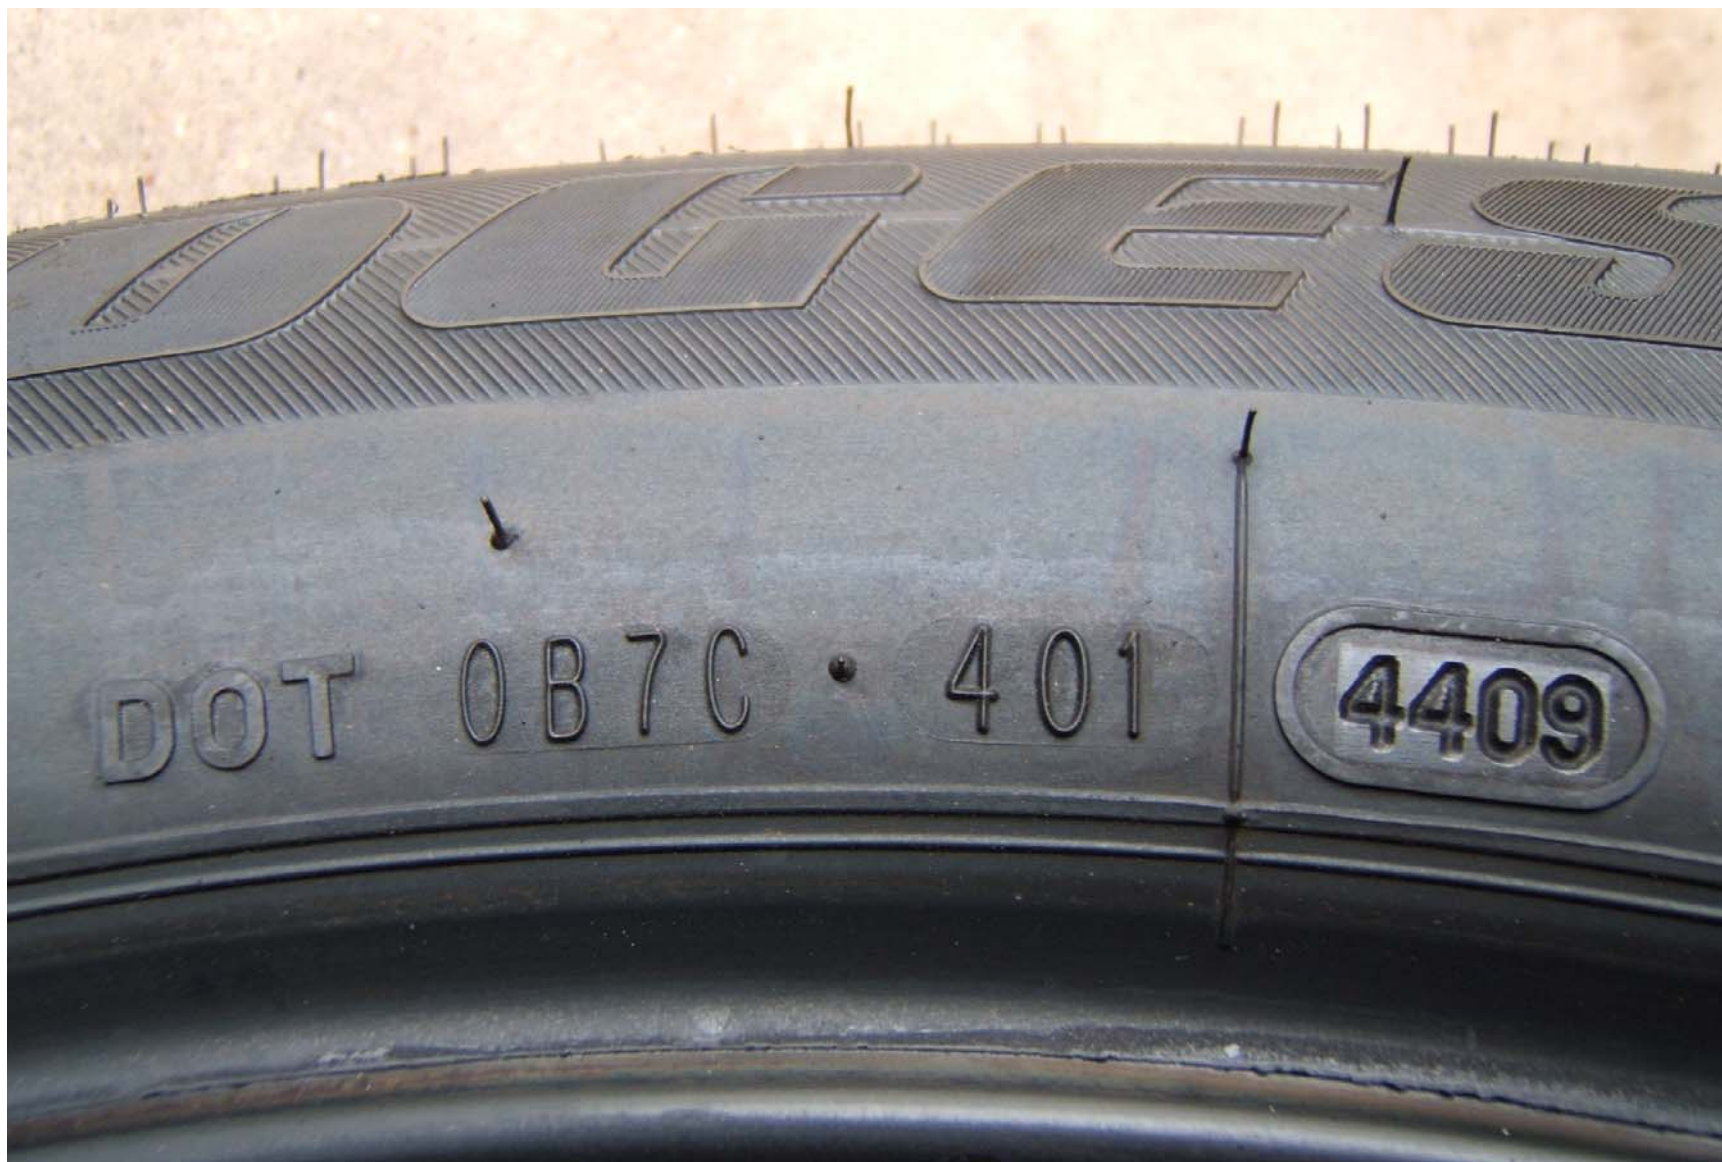
FIGURE 5.7
TIRE SHOWING DOT SERIAL NUMBER

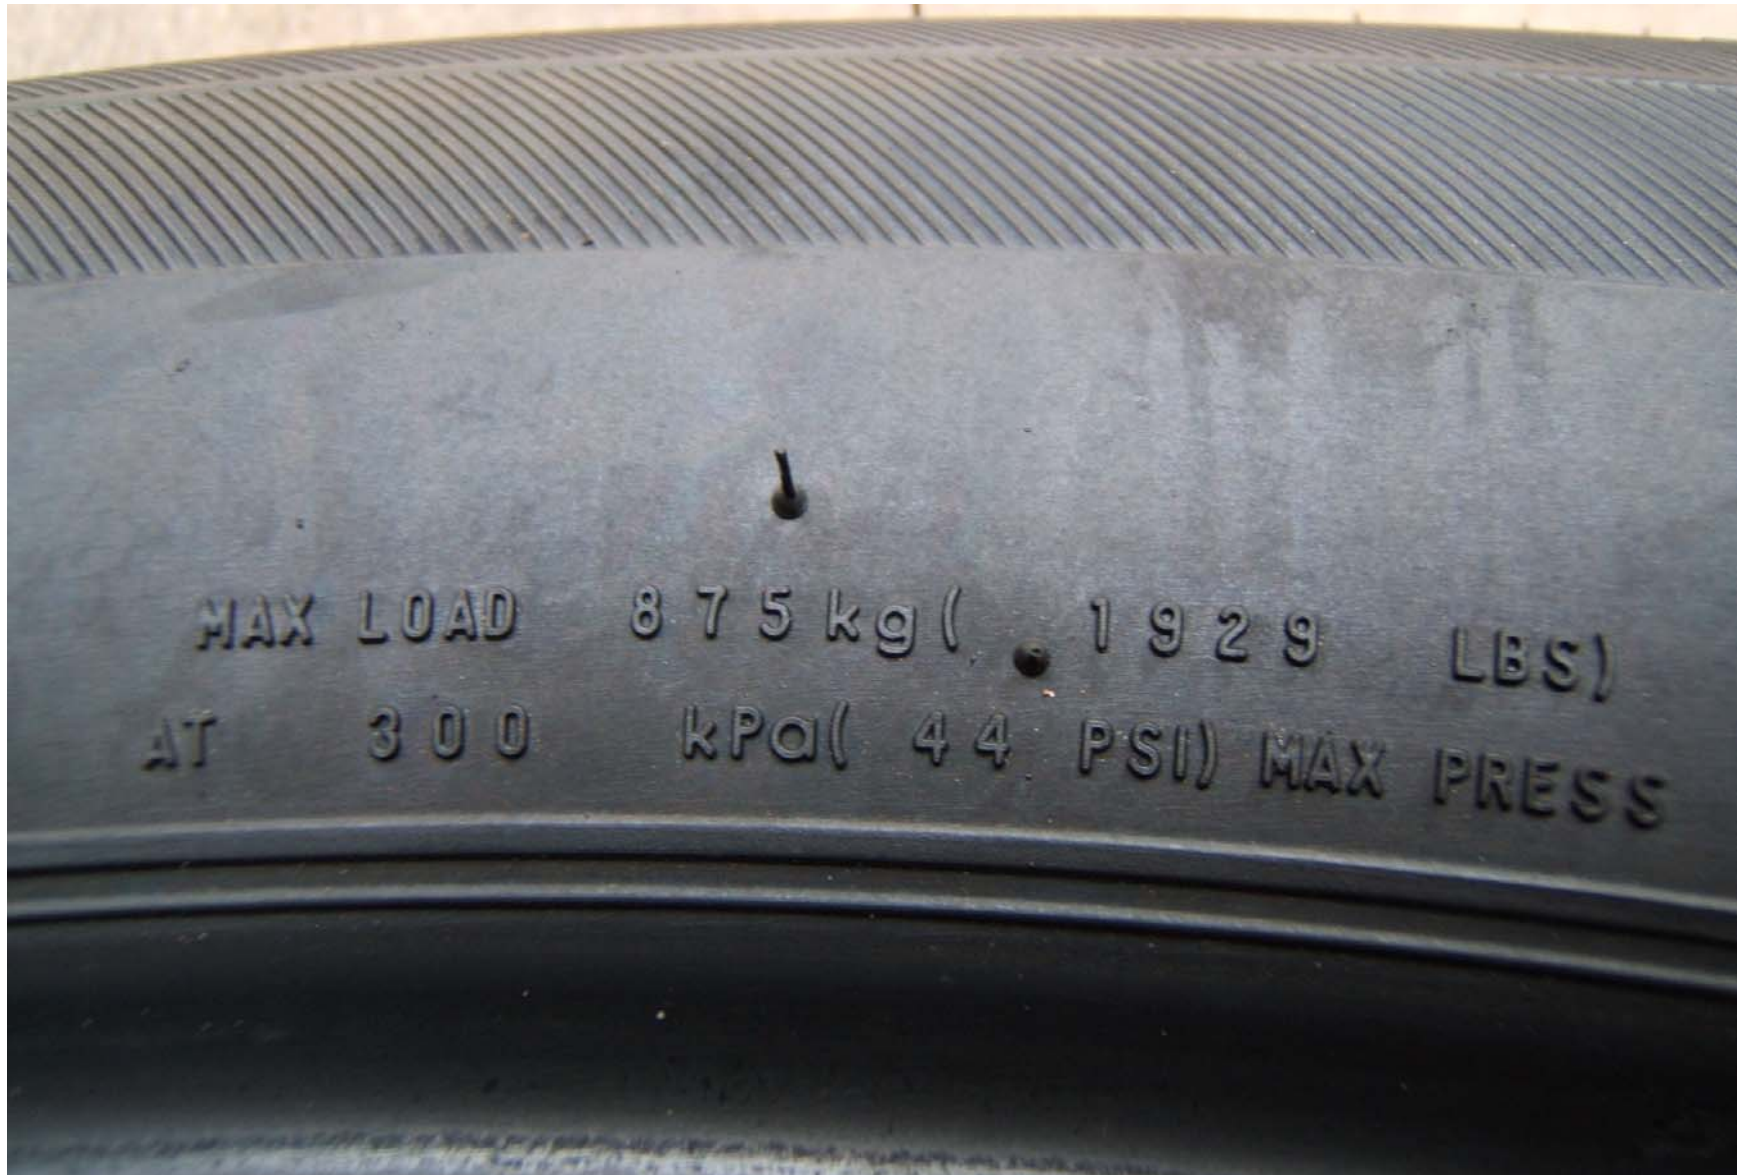
FIGURE 5.8
TIRE SHOWING MAX LOAD RATING
AND MAX COLD INFLATION PRESSURE

Sidewall Max Load Rating: 875 kg (1,929 lbs)

Max Inflation Pressure: 300 kPa (44 psi)

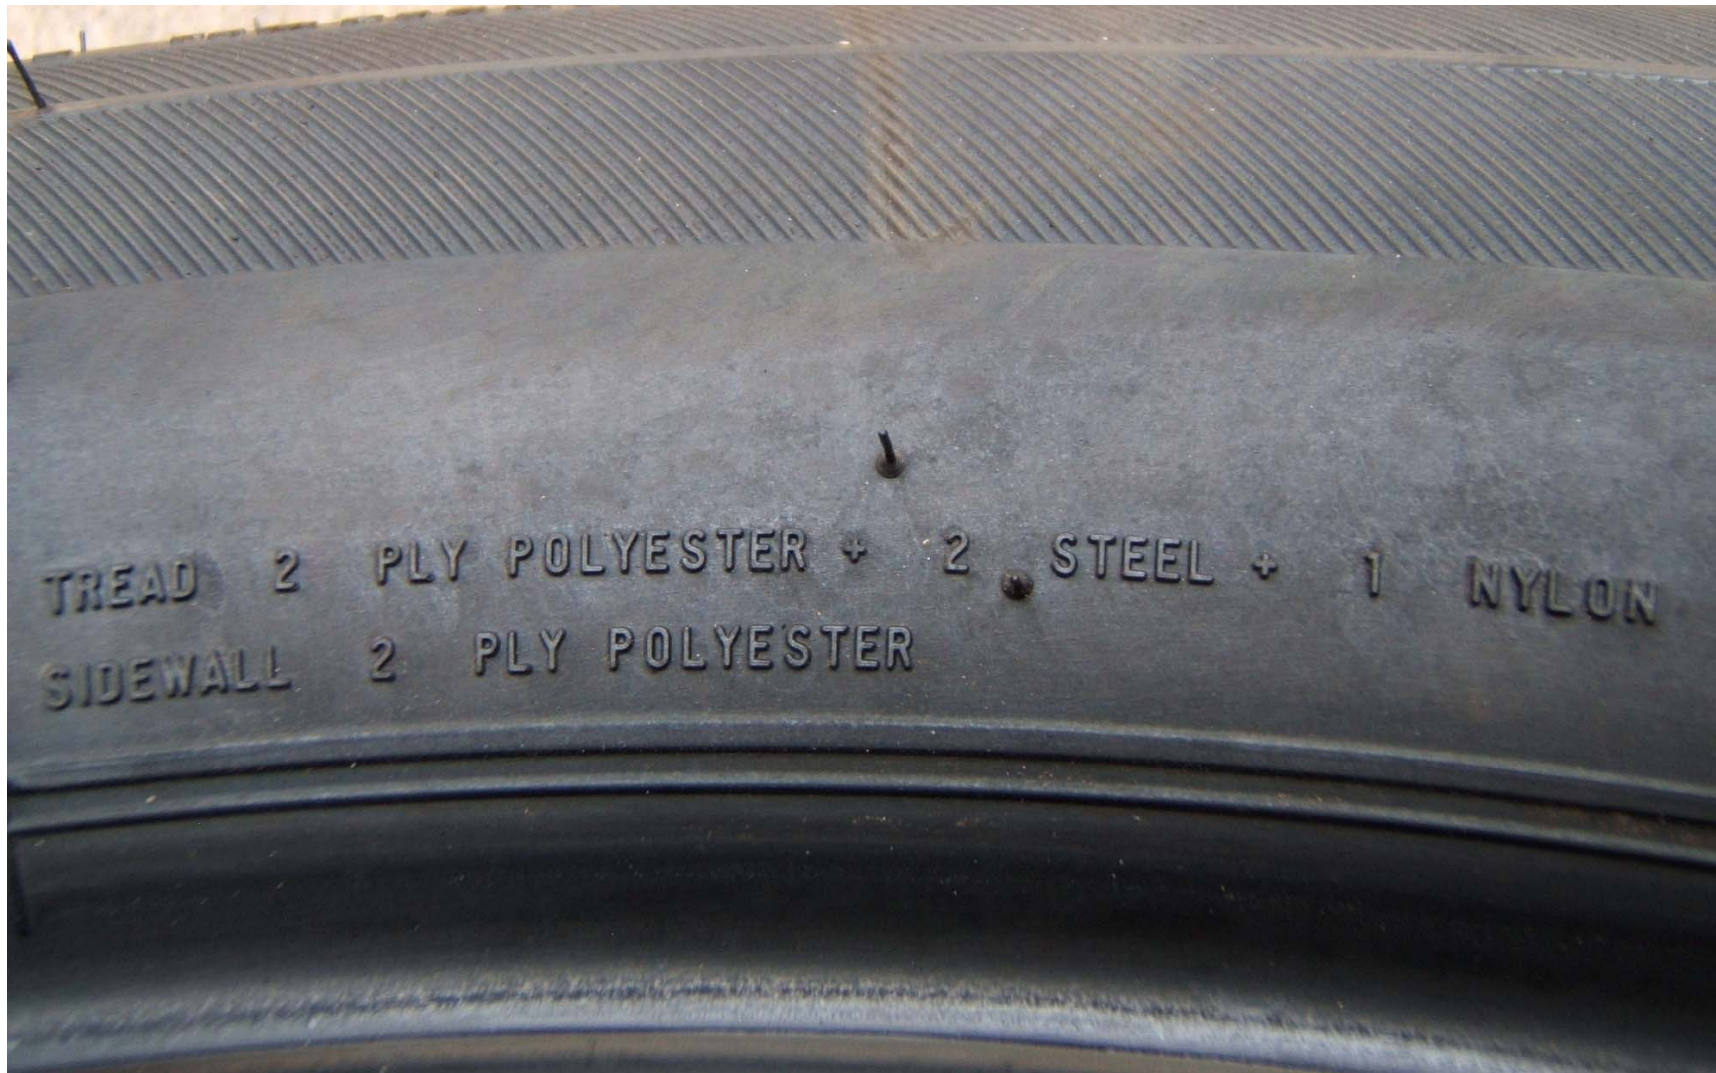
FIGURE 5.9
TIRE SHOWING SIDEWALL / TREAD CONSTRUCTION

Sidewall Construction (number of plies and ply material): 2 polyester

Tread Construction (number of plies and ply material): 2 polyester, 2 steel, 1 nylon

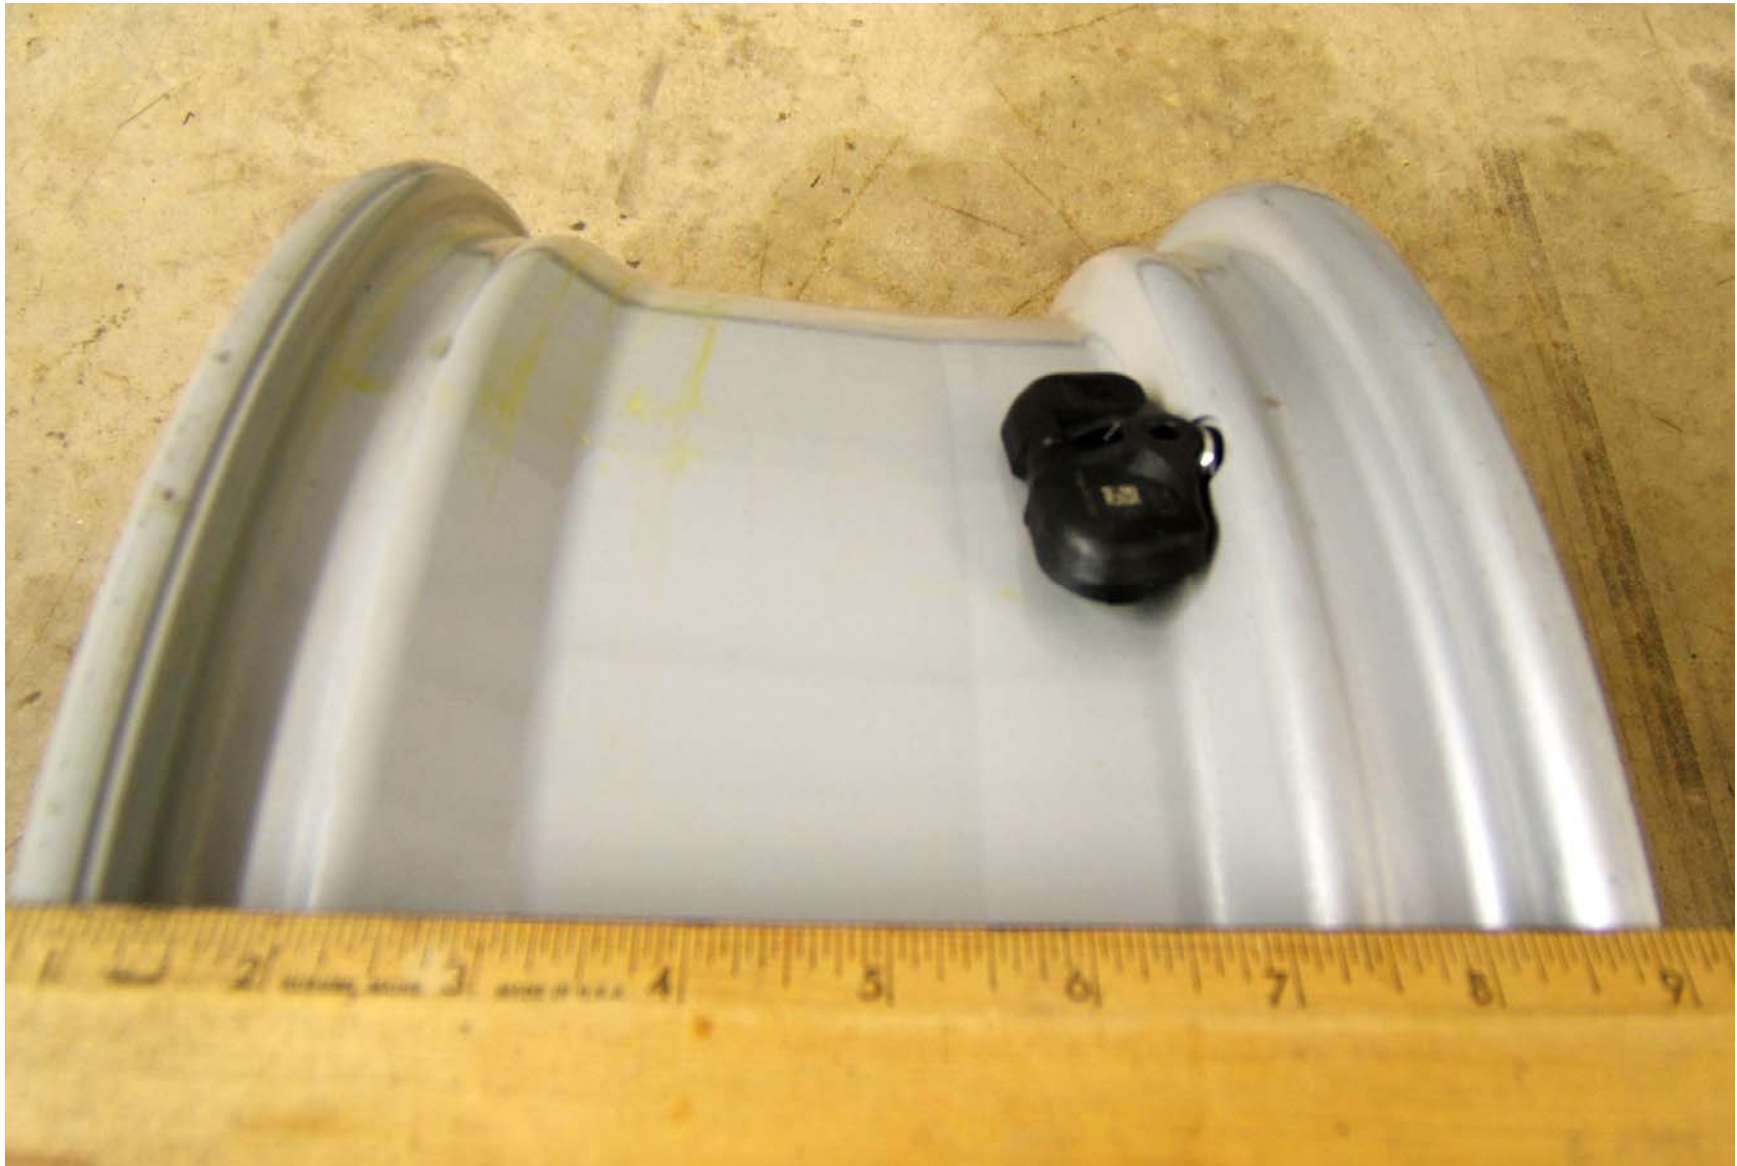
FIGURE 5.10
RIM SHOWING TPMS SENSOR AND RIM
CONTOUR FOR FULL WIDTH OF CROSS SECTION

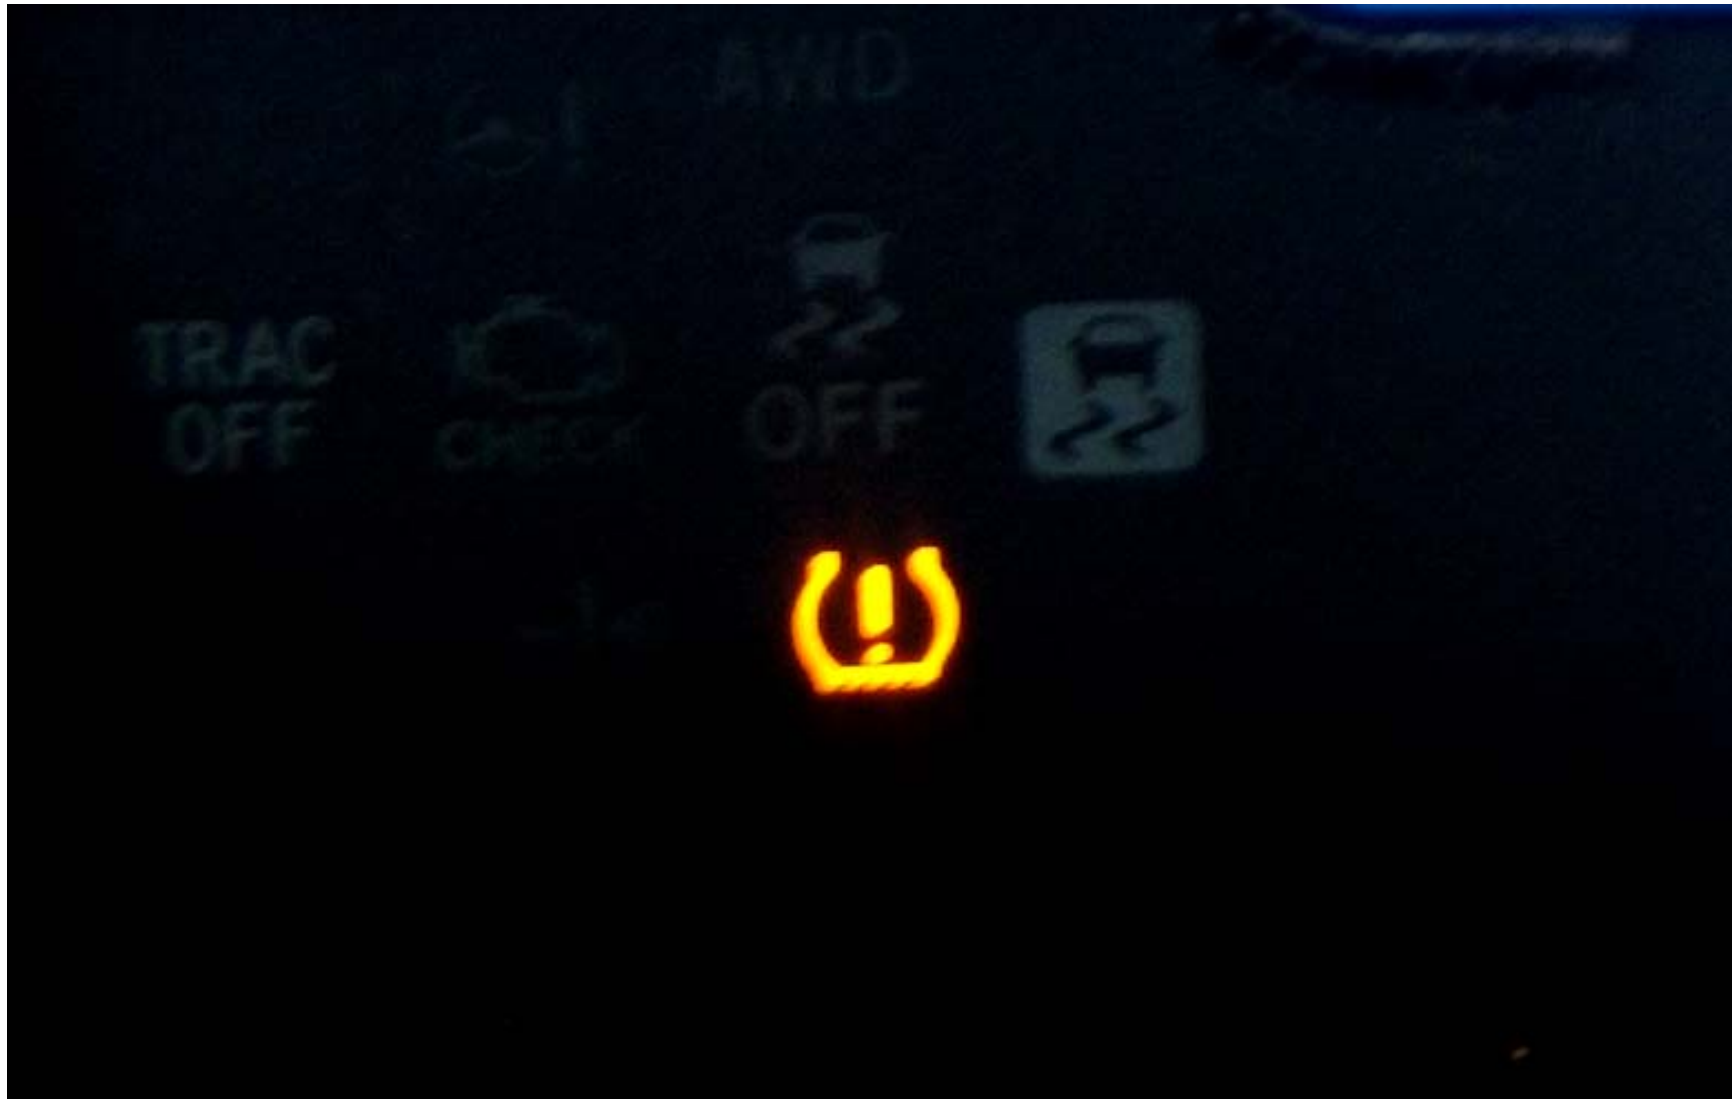
FIGURE 5.11
DISPLAY SHOWING COMBINATION LOW TIRE
PRESSURE / TPMS MALFUNCTION WARNING TELLTALE

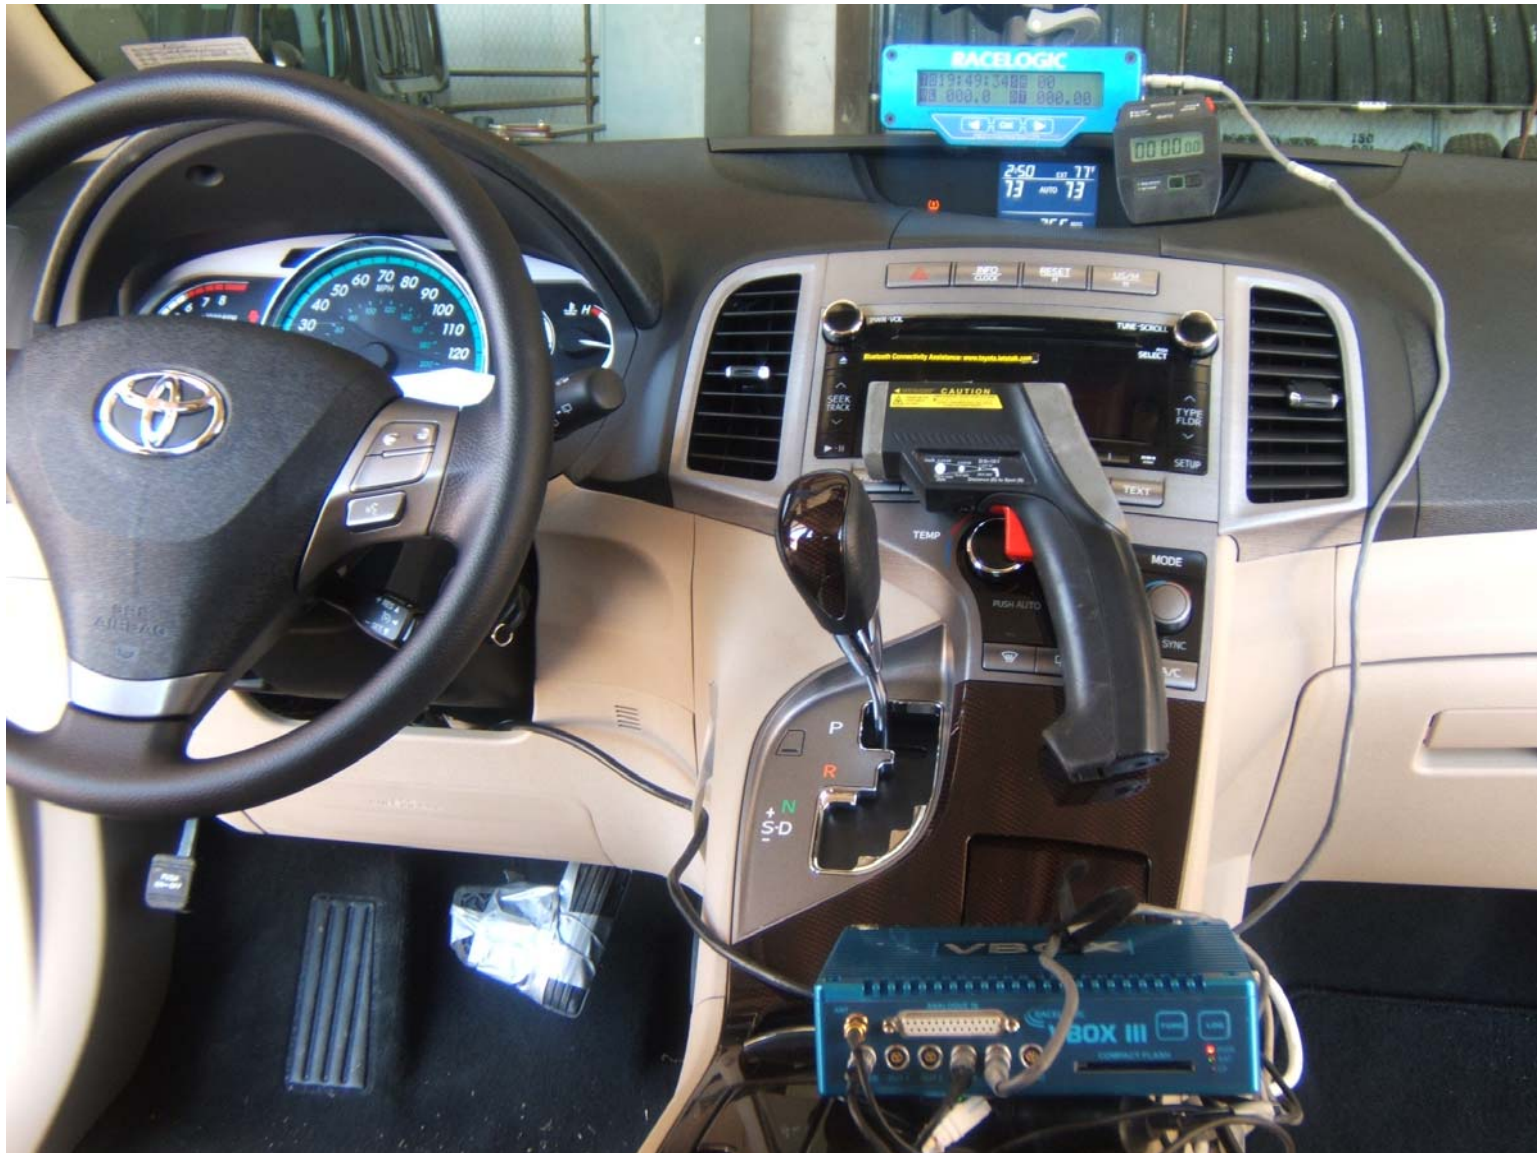
FIGURE 5.12
TEST INSTRUMENTATION INSTALLED IN VEHICLE

The vehicle was instrumented with a Racelogic VBOX III 100 Hz GPS Data Logger and brake pedal trigger. The VBOX uses GPS to measure vehicle speed, time, and distance. Test data were recorded to a compact flash card. During the test, a stopwatch was used to determine the approximate "cumulative driving time" during each test phase. Cumulative driving time does not include time during the brake application or when the vehicle speed was below 50 km/h or above 100 km/h. Upon completion of a tire deflation scenario, graphs were generated by VBOX software showing vehicle speed versus time during the test procedures. The graphs furnish a second by second analysis of each calibration and low inflation pressure detection phase (as appropriate). The cumulative driving time was calculated by post-processing the VBOX graph data, and is reported in Section 3 (Test Data) as 'Total Driving Time'.

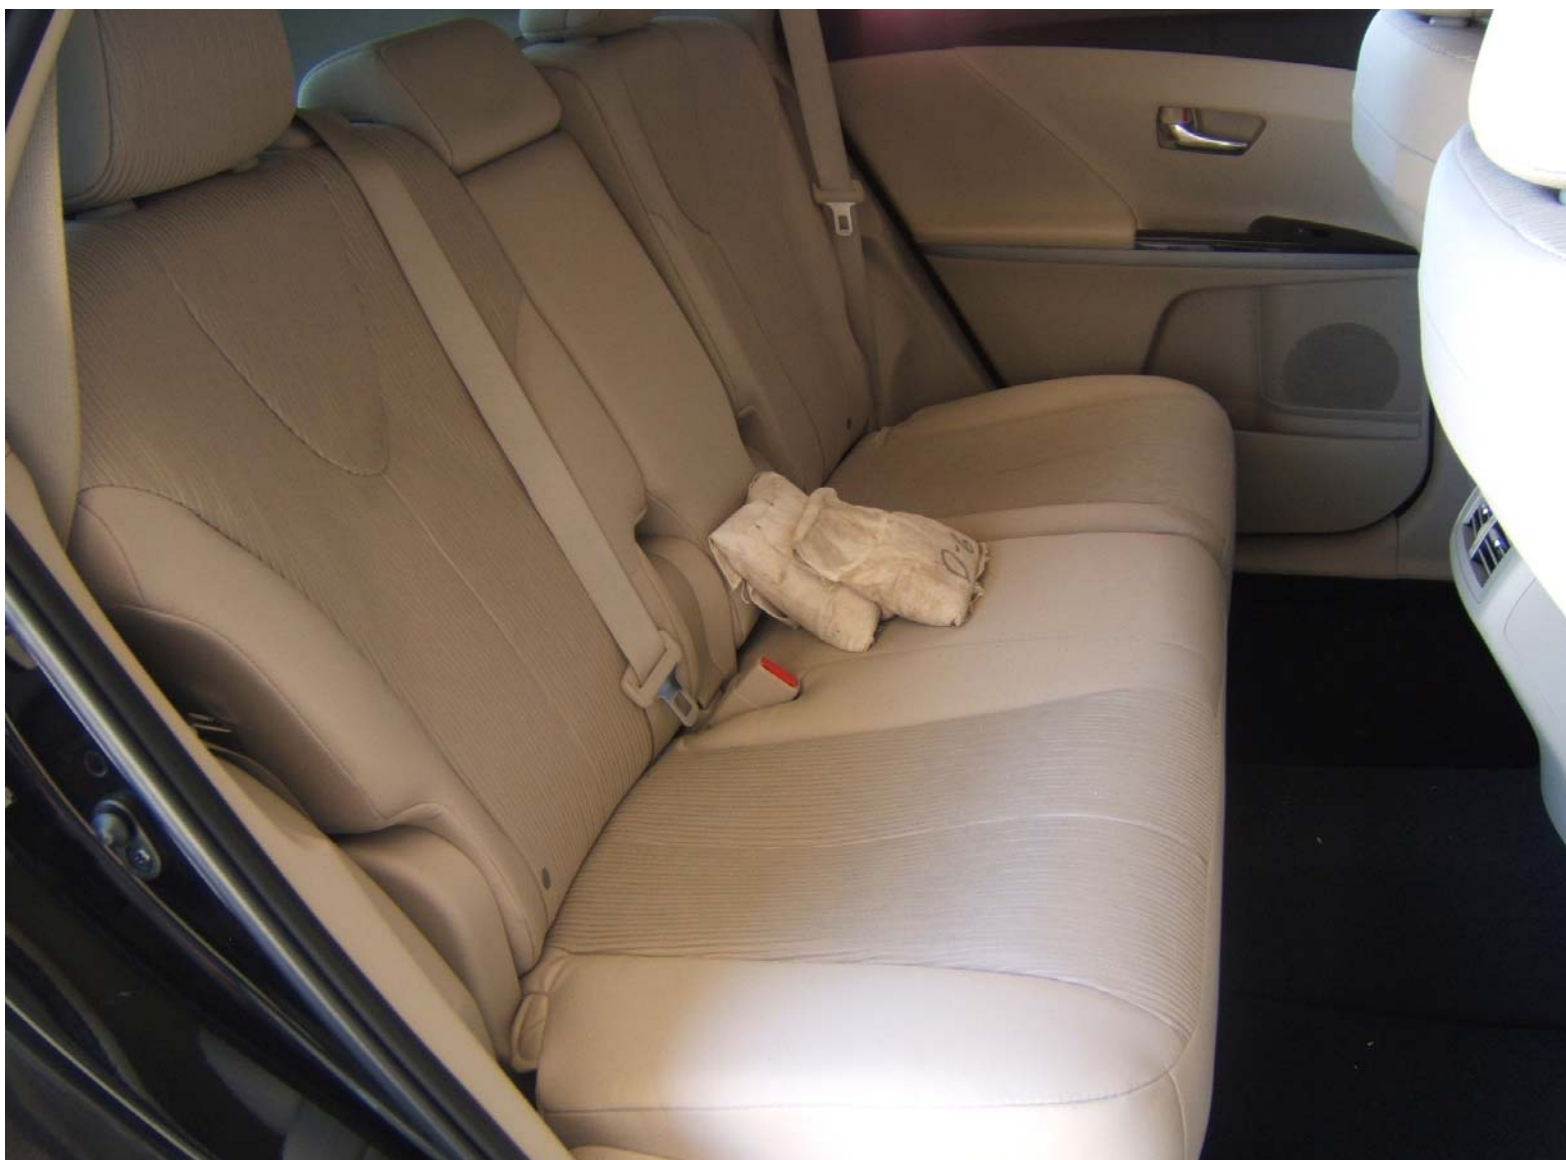
FIGURE 5.13
VEHICLE REAR SEAT BALLAST FOR LLVW LOAD

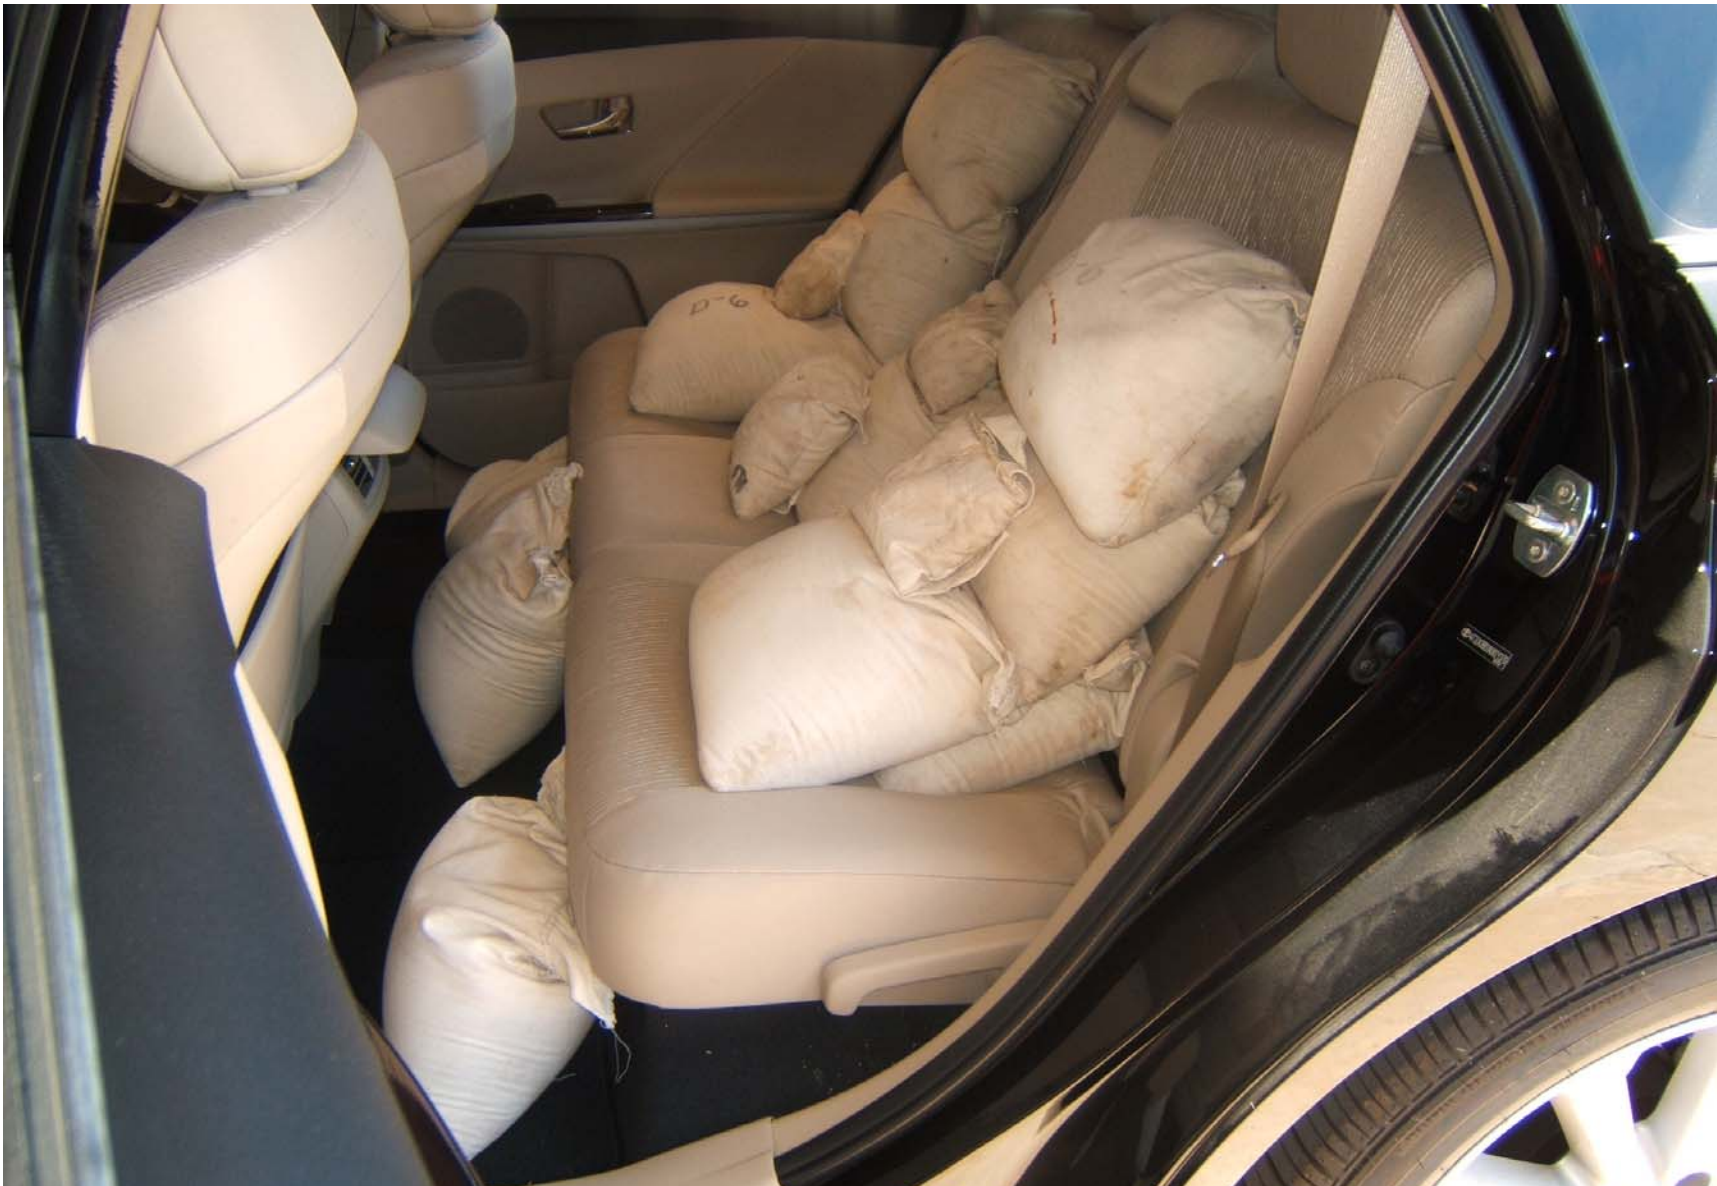
FIGURE 5.14
VEHICLE REAR SEAT BALLAST FOR UVW + VCW LOAD
