REPORT NUMBER 138-STF-10-003

SAFETY COMPLIANCE TESTING FOR FMVSS NO. 138 TIRE PRESSURE MONITORING SYSTEMS

TOYOTA MOTOR MANUFACTURING
2010 TOYOTA VENZA
FOUR-DOOR MPV
NHTSA NO. CA5105

FINAL REPORT

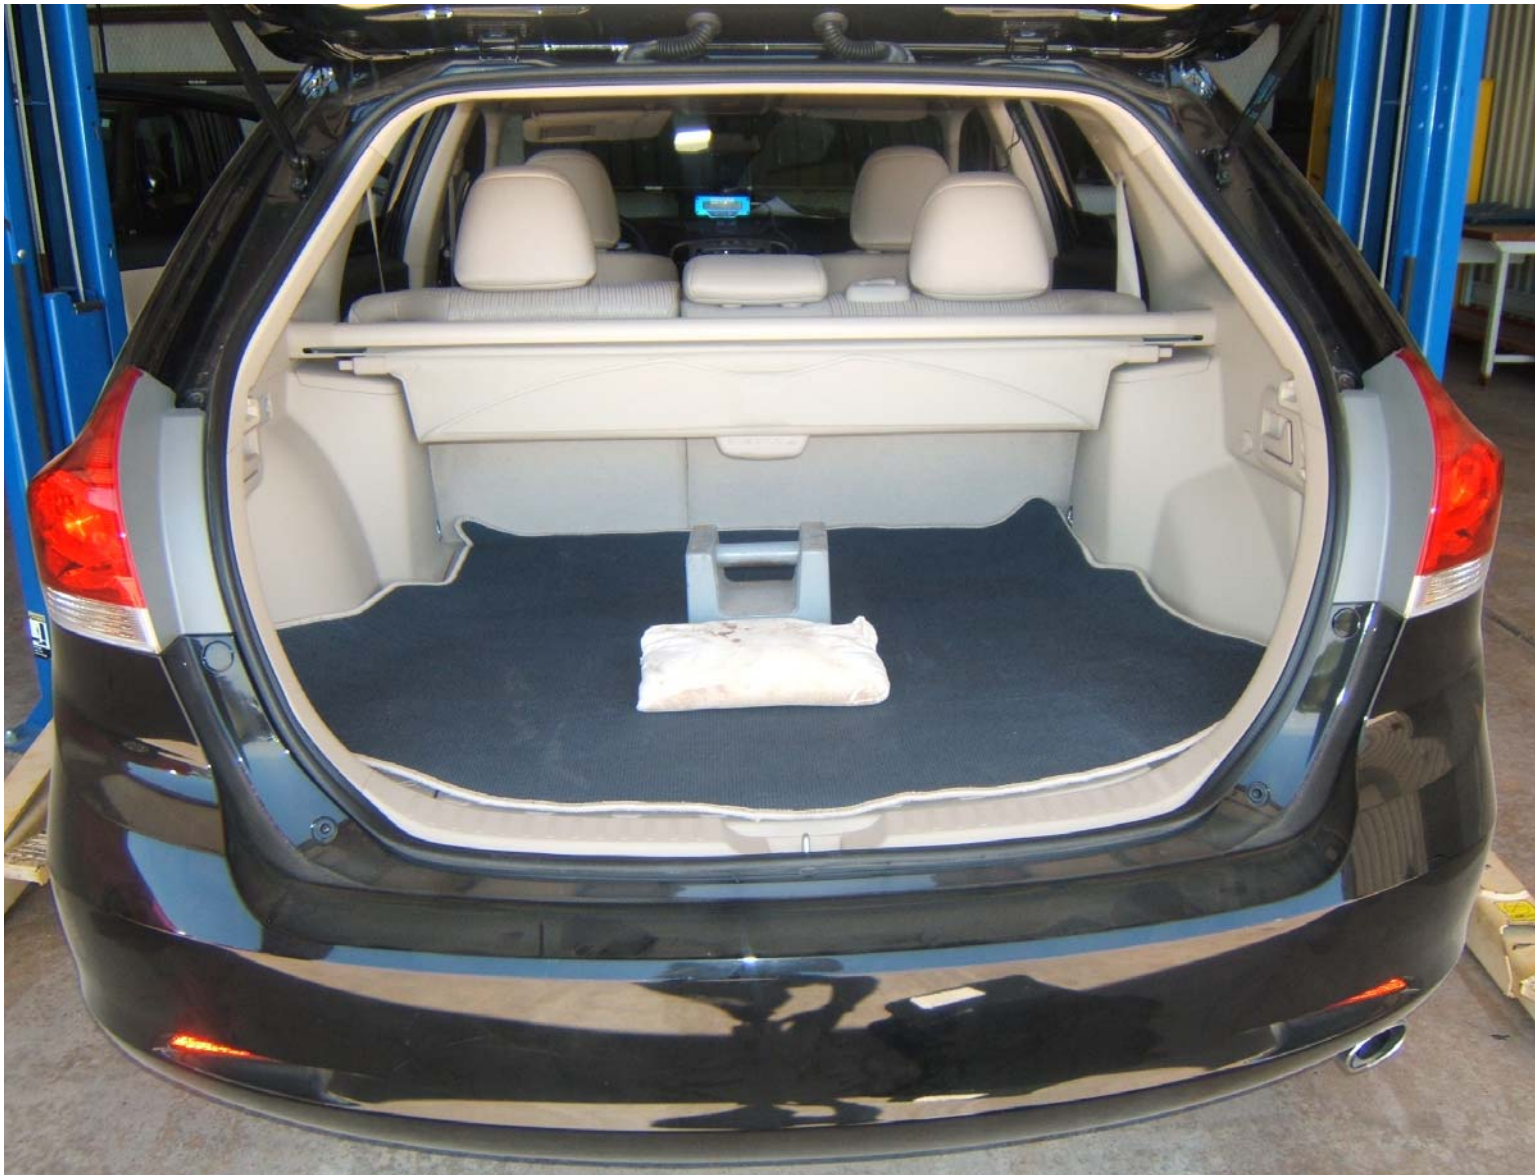
FIGURE 5.15
VEHICLE CARGO AREA BALLAST FOR UVW + VCW LOAD

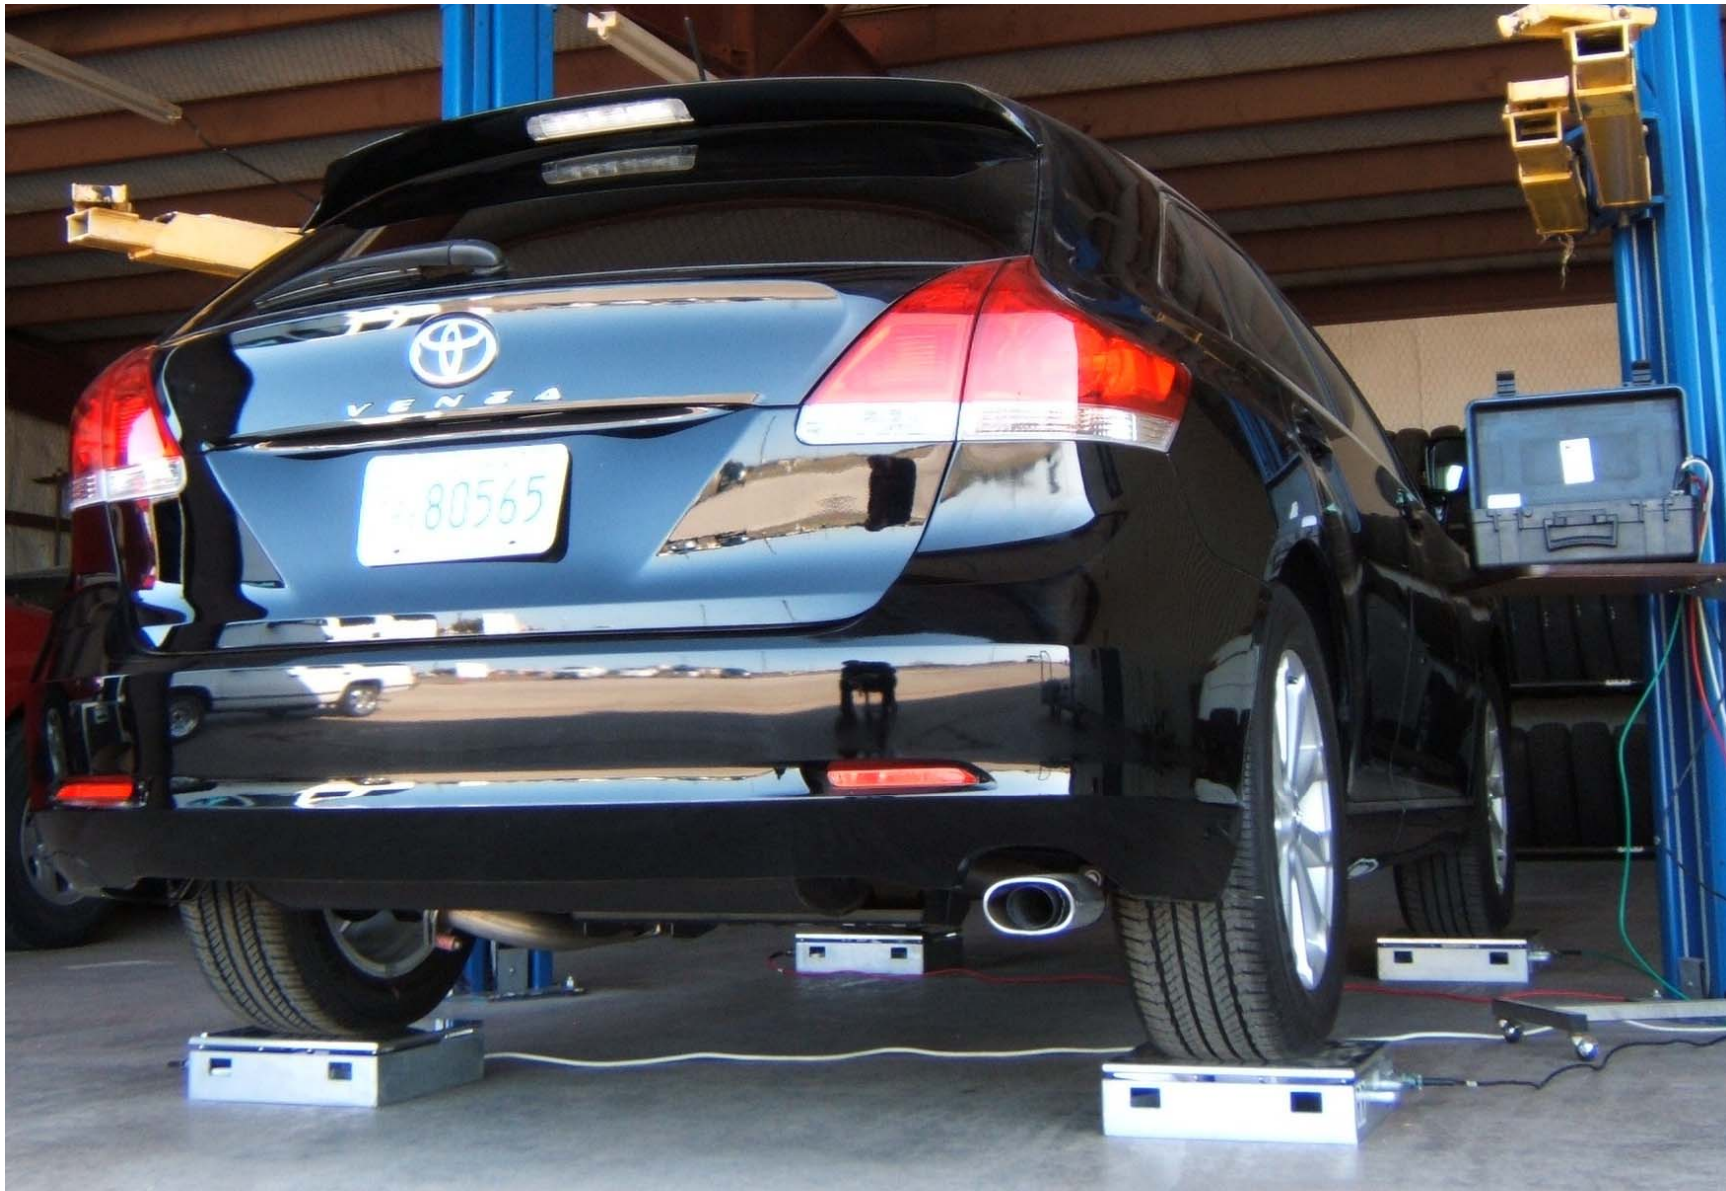
FIGURE 5.16
VEHICLE ON WEIGHT SCALES

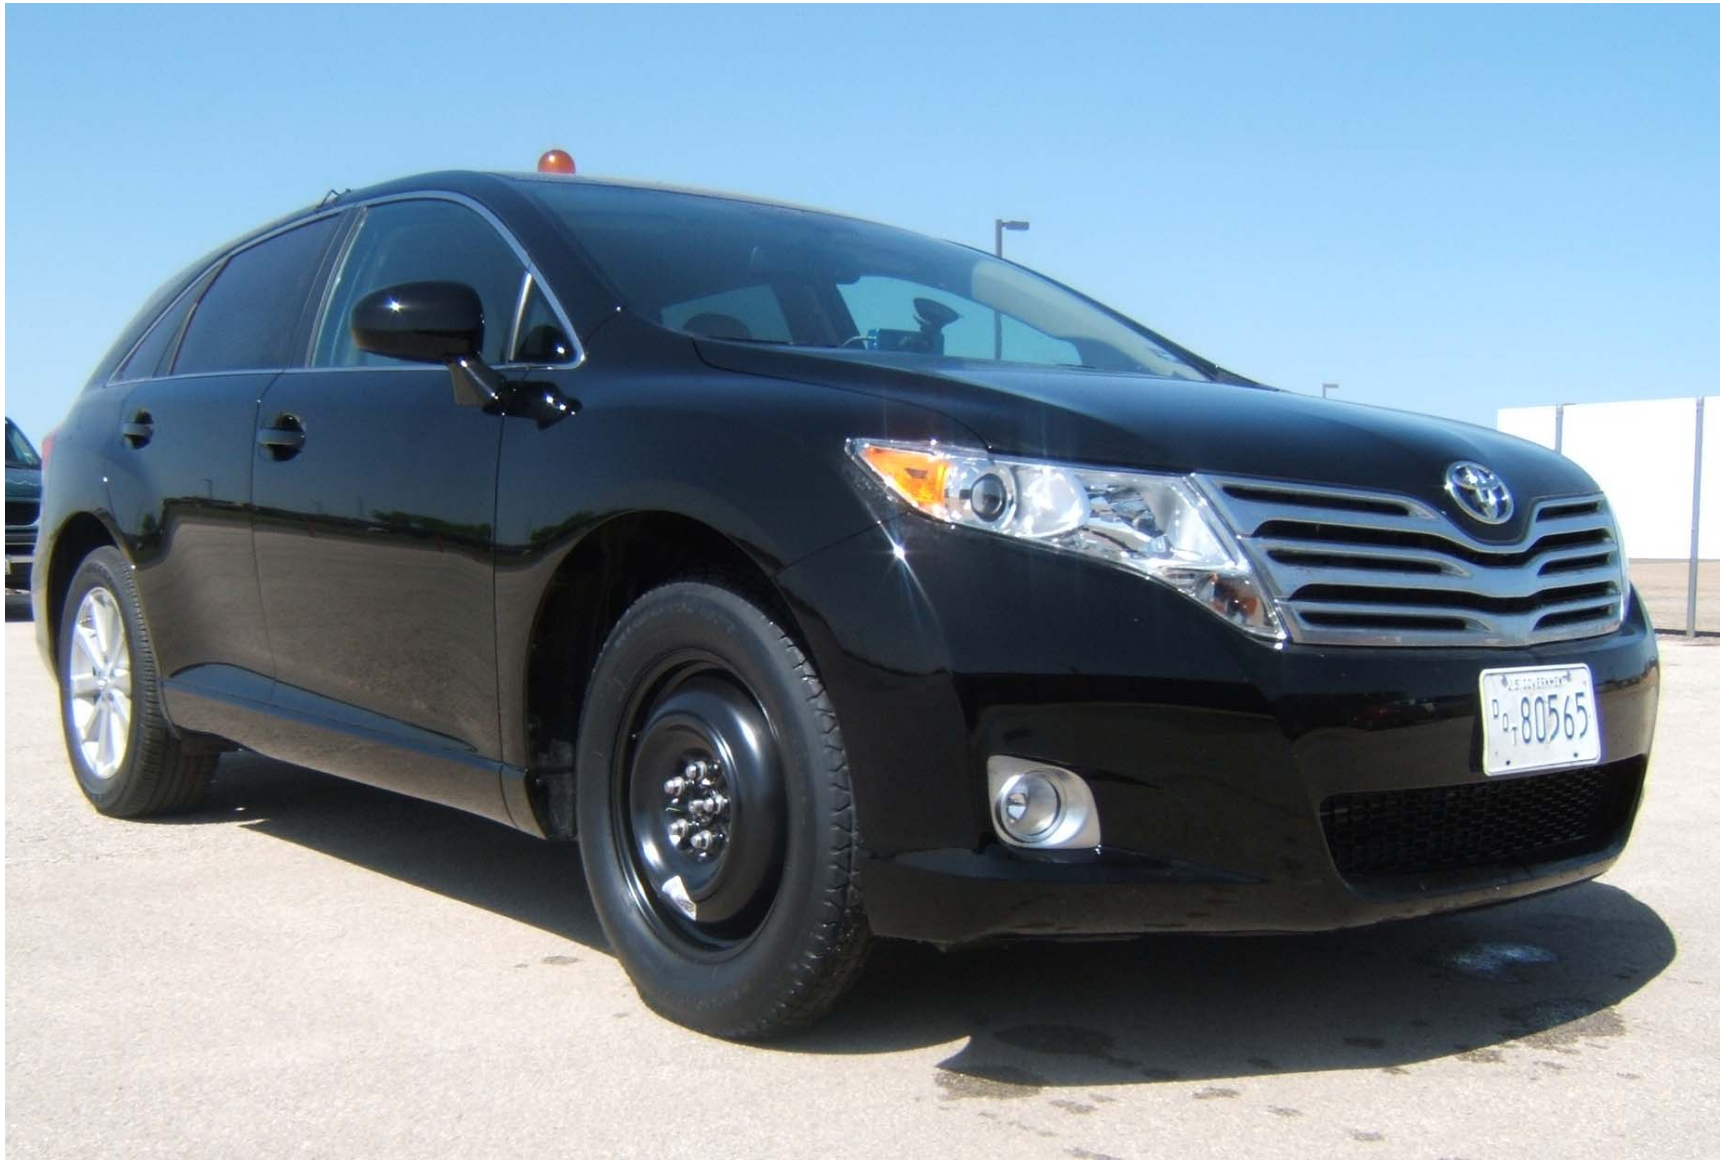
FIGURE 5.17
SPARE INSTALLED ON RIGHT FRONT

- G. Spare tire without TPMS sensor was applied to right front wheel position.

TPMS MALFUNCTION PERFORMANCE TEST RESULTS (PASS/FAIL) PASS
Spare without TPMS sensor was applied to right front at LLVW.
