REPORT NUMBER 138-STF-10-006

# SAFETY COMPLIANCE TESTING FOR FMVSS NO. 138 TIRE PRESSURE MONITORING SYSTEMS

HONDA MOTOR COMPANY  
2010 HONDA ODYSSEY  
FOUR-DOOR MPV  
NHTSA NO. CA5305

FINAL REPORT

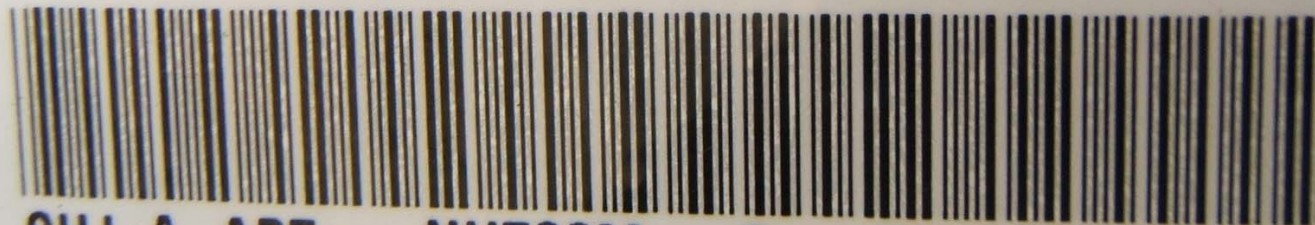
FIGURE 5.2  
VEHICLE CERTIFICATION LABEL

V.I.N.:5FNRL3H21AB039382 TYPE: MPV

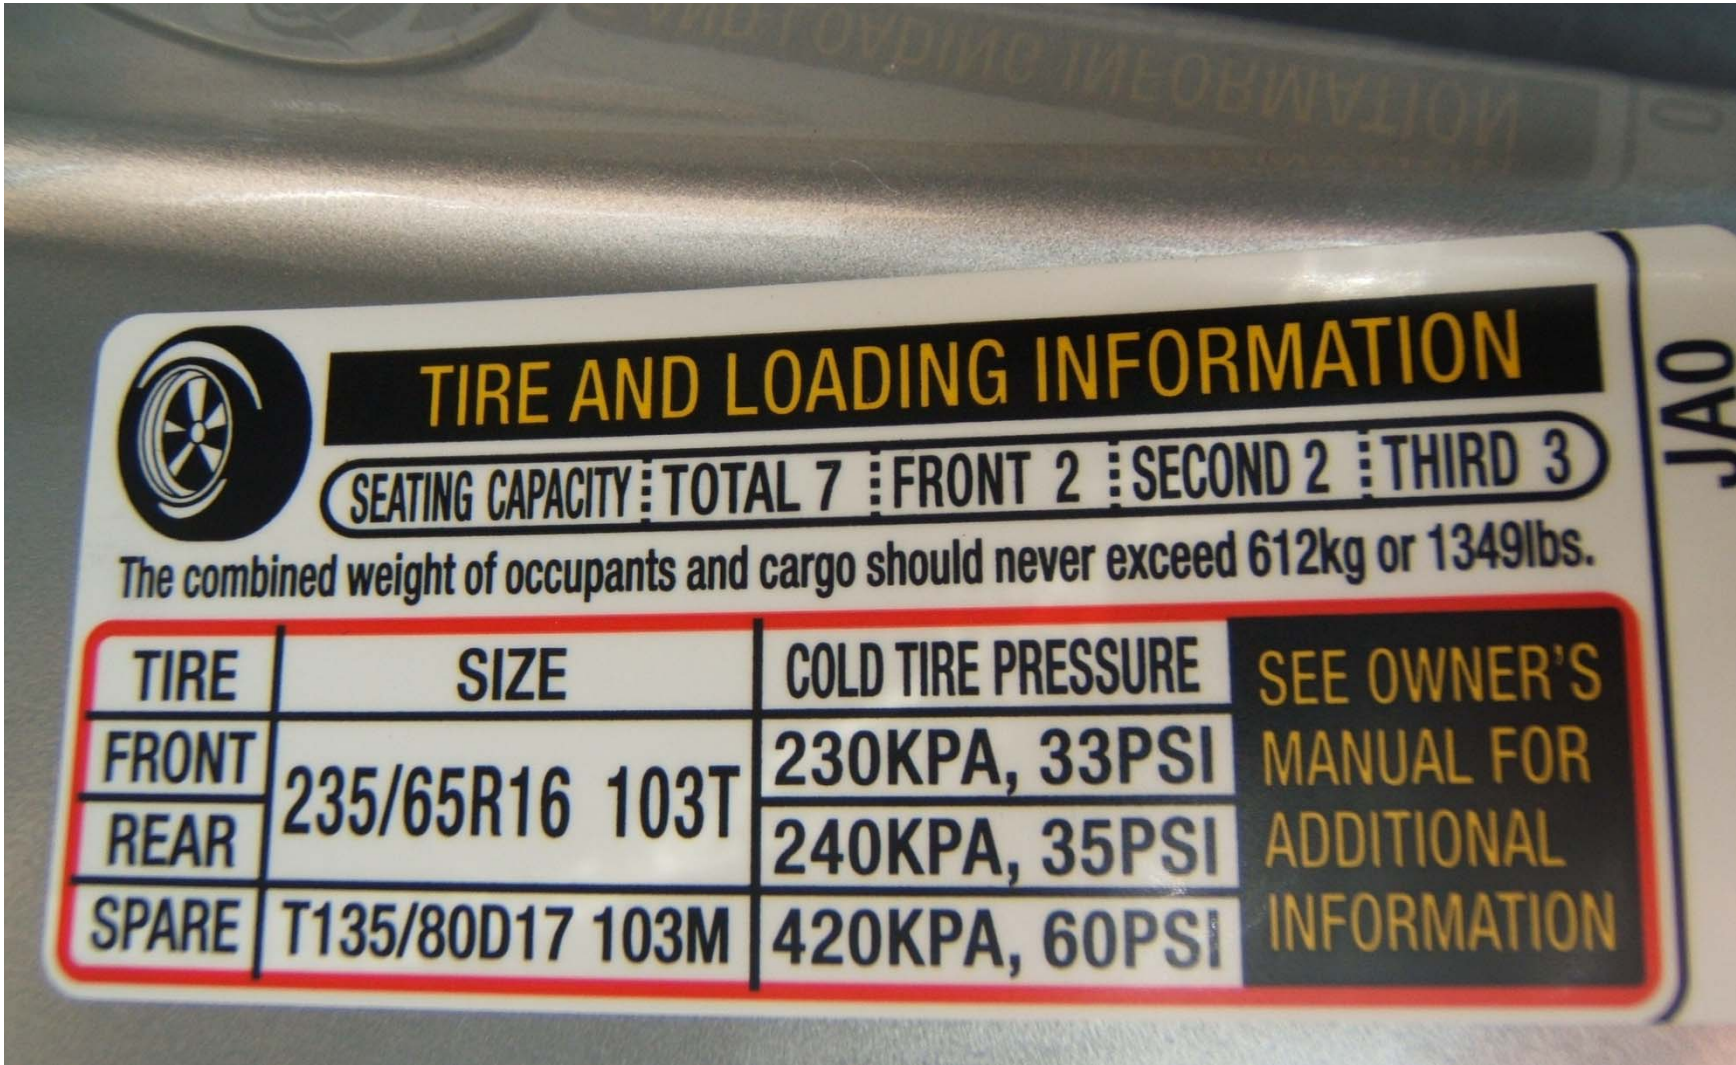
FIGURE 5.3  
 VEHICLE PLACARD

| Axle | Tire Size | Recommended Cold Inflation Pressure | Source |
|---|---|---|---|
| Front | 235/65R16 | 230 kPa (33 psi) | Vehicle placard |
| Rear | 235/65R16 | 240 kPa (35 psi) | Vehicle placard |

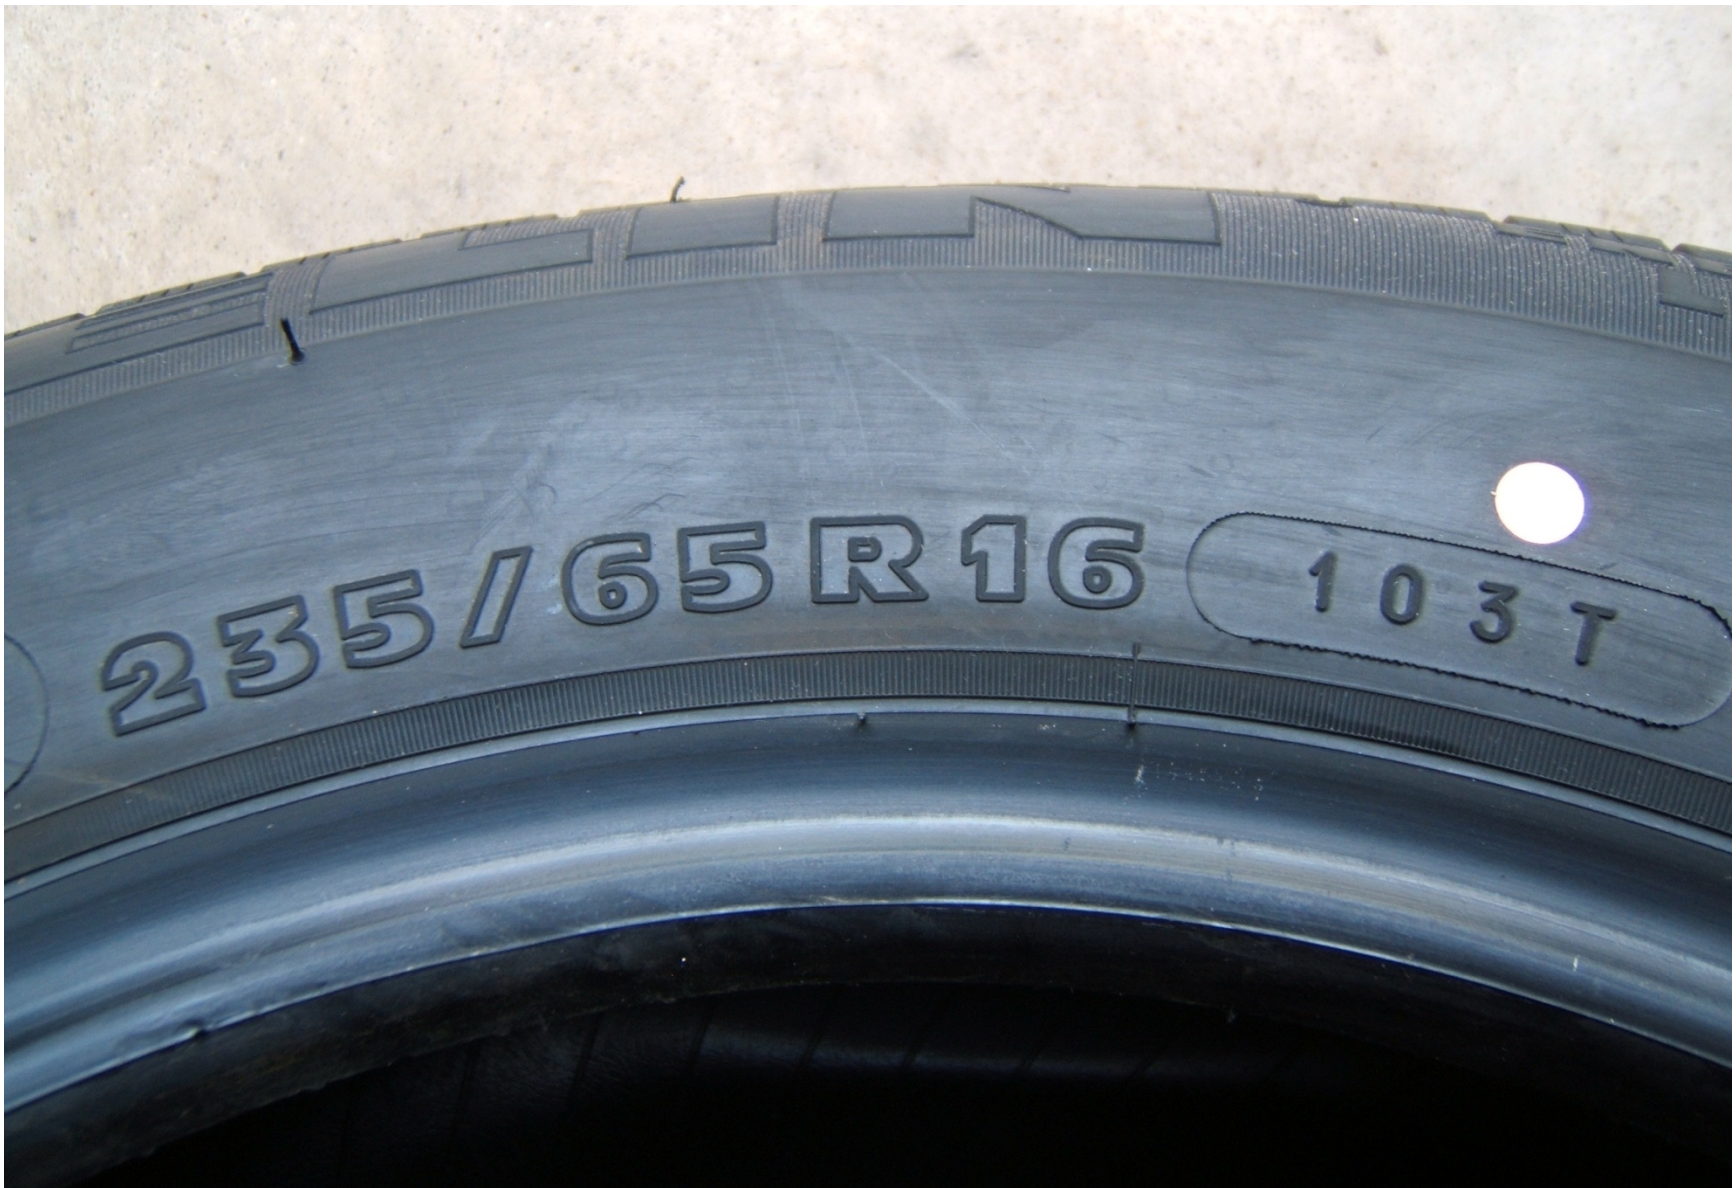
FIGURE 5.6  
TIRE SHOWING SIZE AND LOAD INDEX/SPEED RATING

Tire Size and Load Index / Speed Rating: 235/65R16 103T

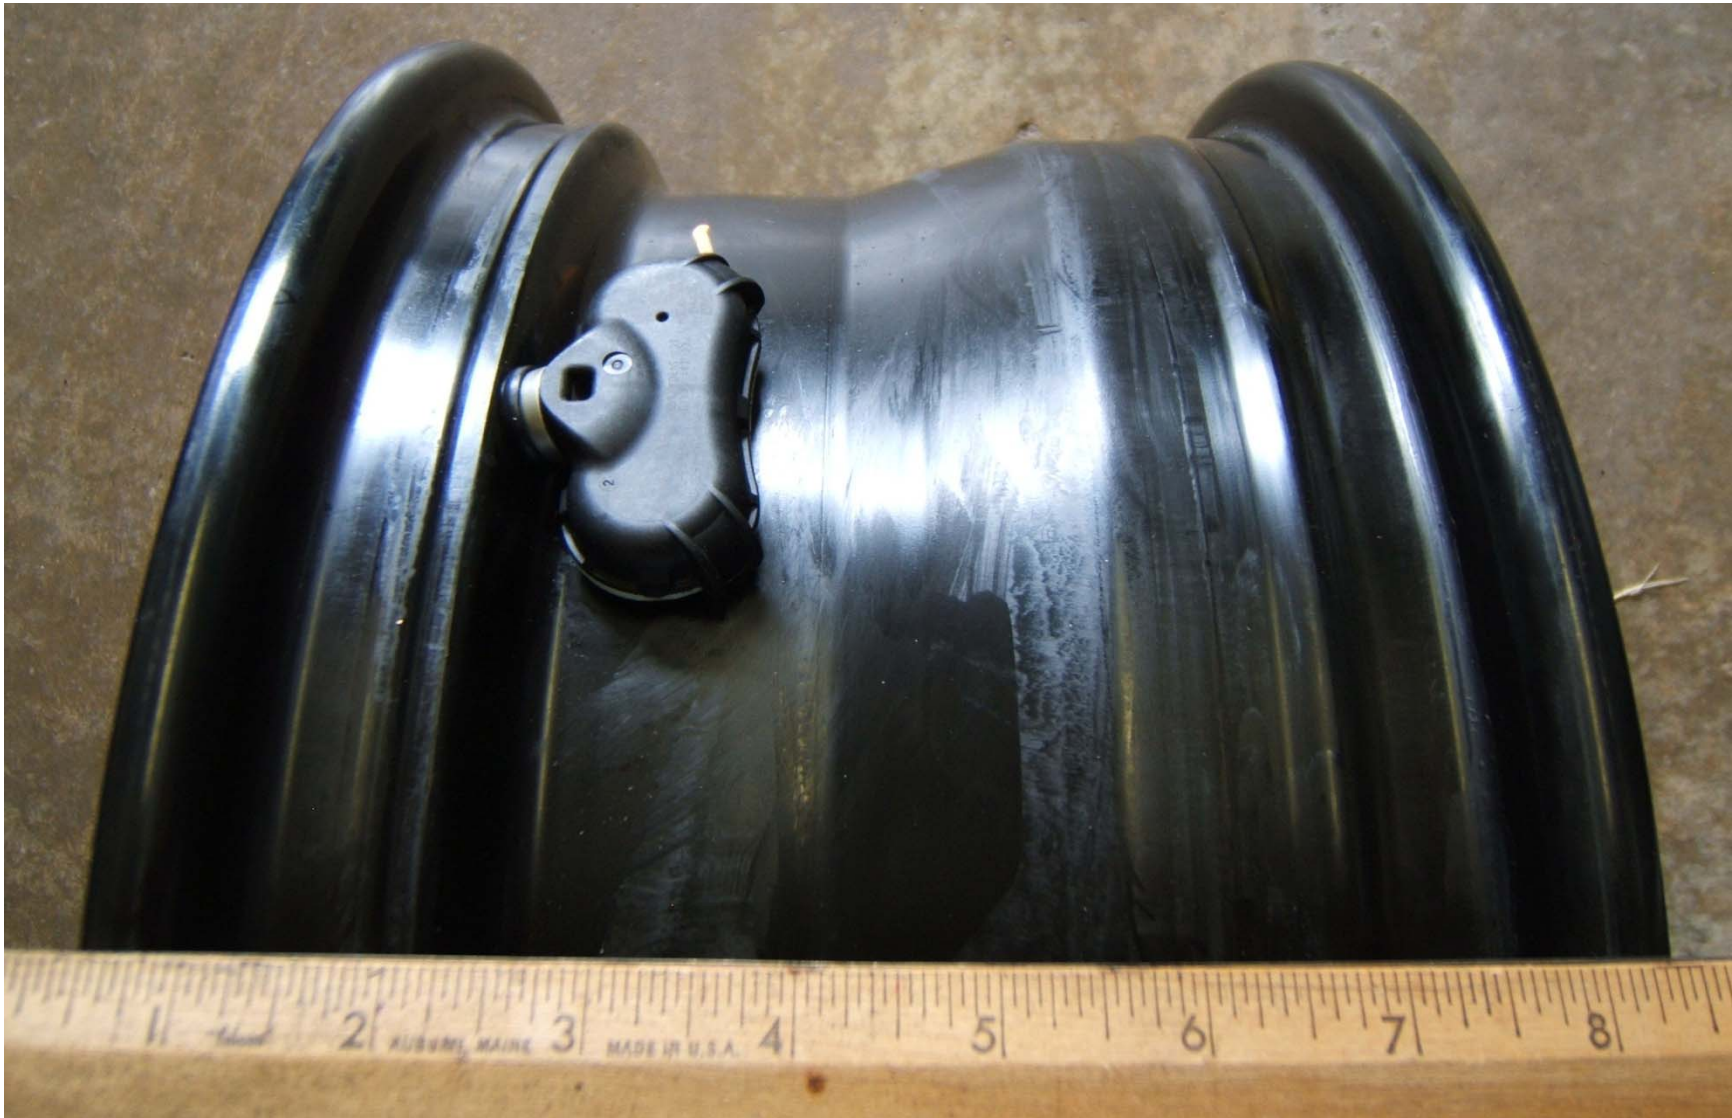
FIGURE 5.10  
RIM SHOWING TPMS SENSOR AND RIM  
CONTOUR FOR FULL WIDTH OF CROSS SECTION

Each wheel (except the compact spare tire wheel) is equipped with a tire pressure sensor mounted inside the tire behind the valve stem. You must use TPMS specific wheels. It is recommended that you always have your tires serviced by your dealer or qualified technician.

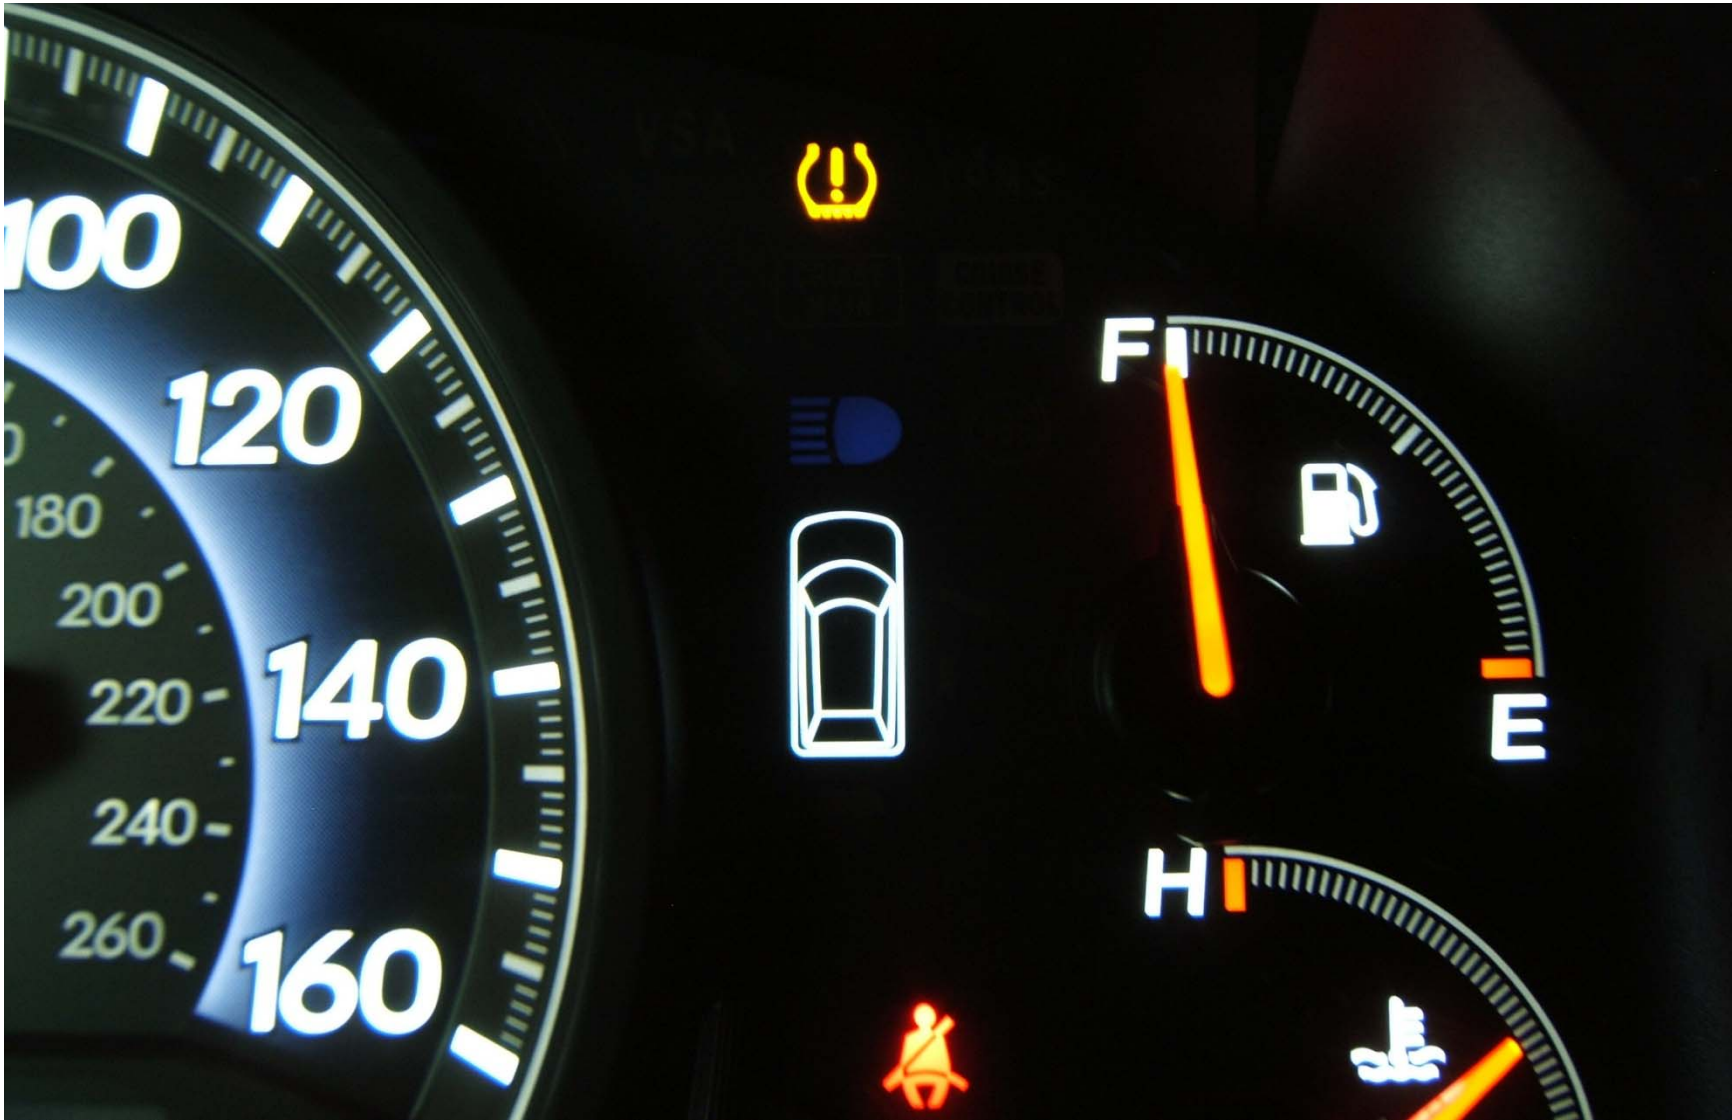
FIGURE 5.11  
DISPLAY SHOWING LOW TIRE PRESSURE WARNING TELLTALE

Telltale is mounted inside the occupant compartment in front of and in clear view of the driver?  
( X )YES ( )NO (fail)

Is the telltale yellow in color?      ( X )YES    ( )NO (fail)

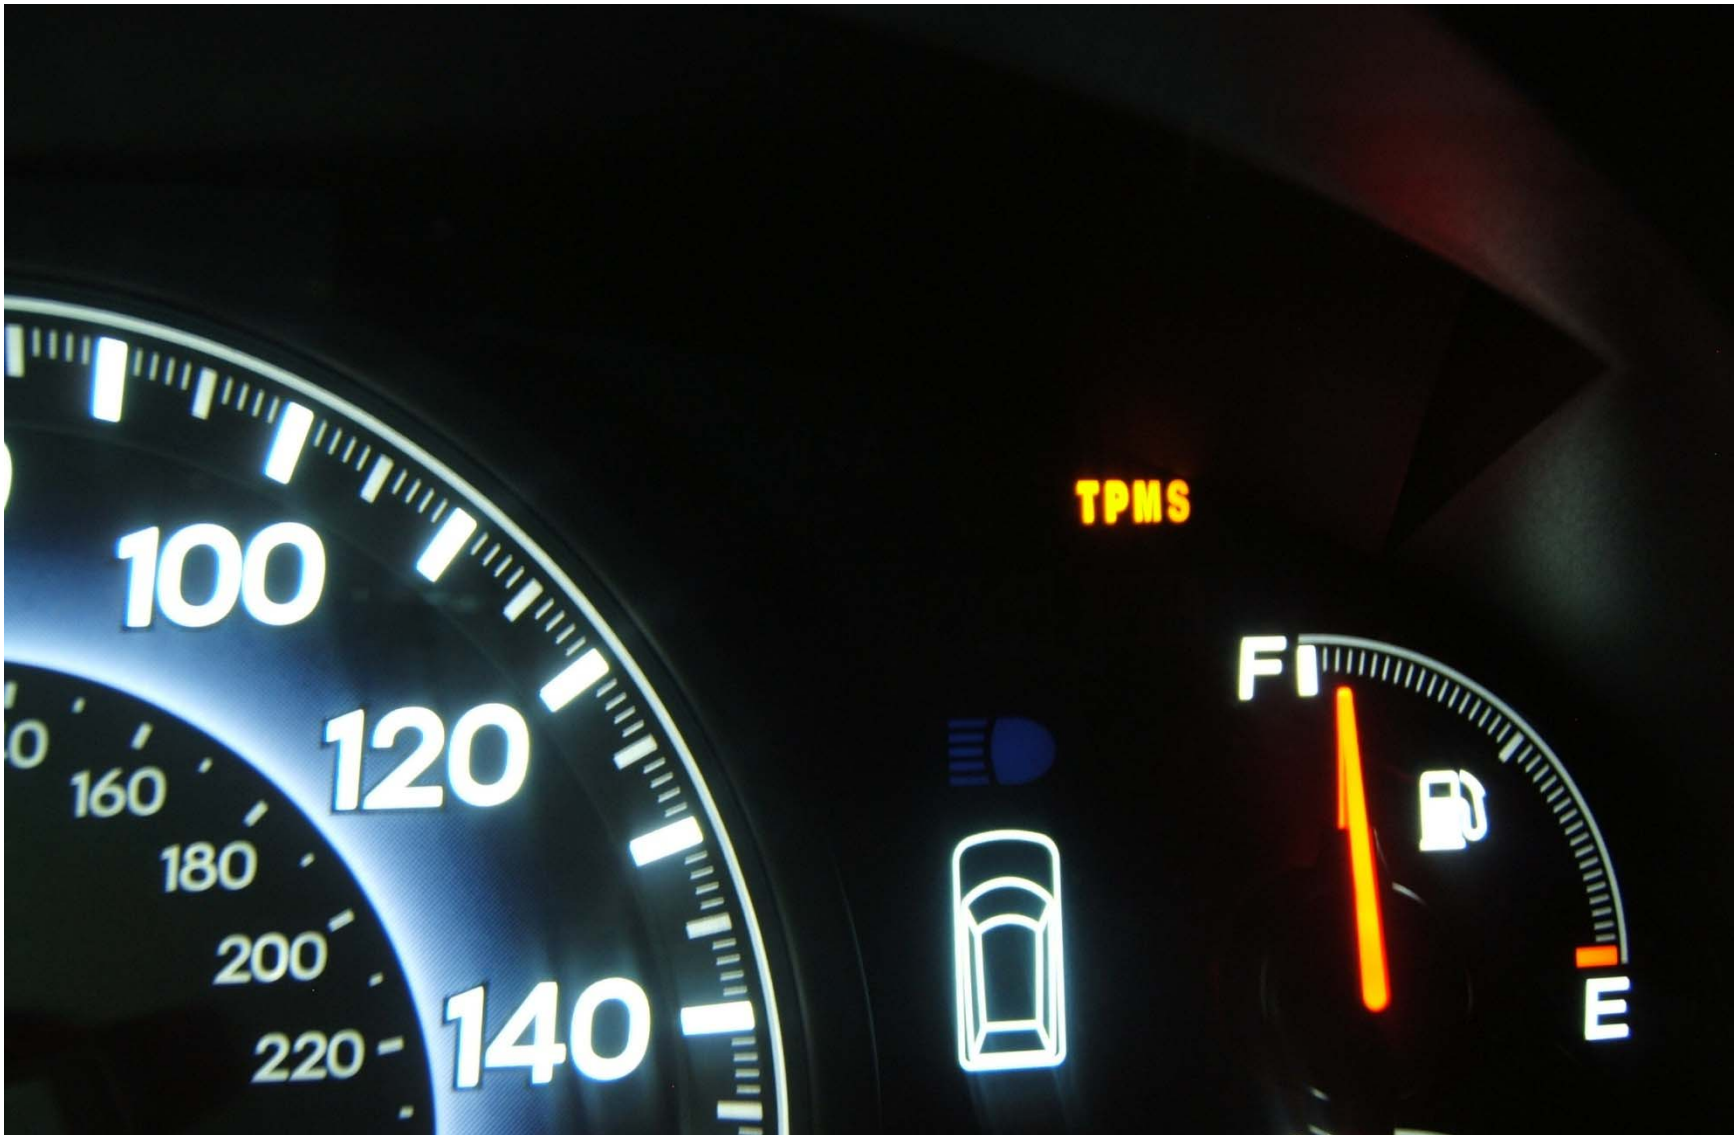
FIGURE 5.12  
DISPLAY SHOWING DEDICATED TPMS  
MALFUNCTION WARNING TELLTALE

Telltale is mounted inside the occupant compartment in front of and in clear view of the driver?  
( X )YES ( )NO (fail)

Identify Dedicated Telltale Symbol Used: ( X ) "TPMS" ( ) OTHER (fail)

Is the telltale yellow in color?      ( X )YES    ( )NO (fail)

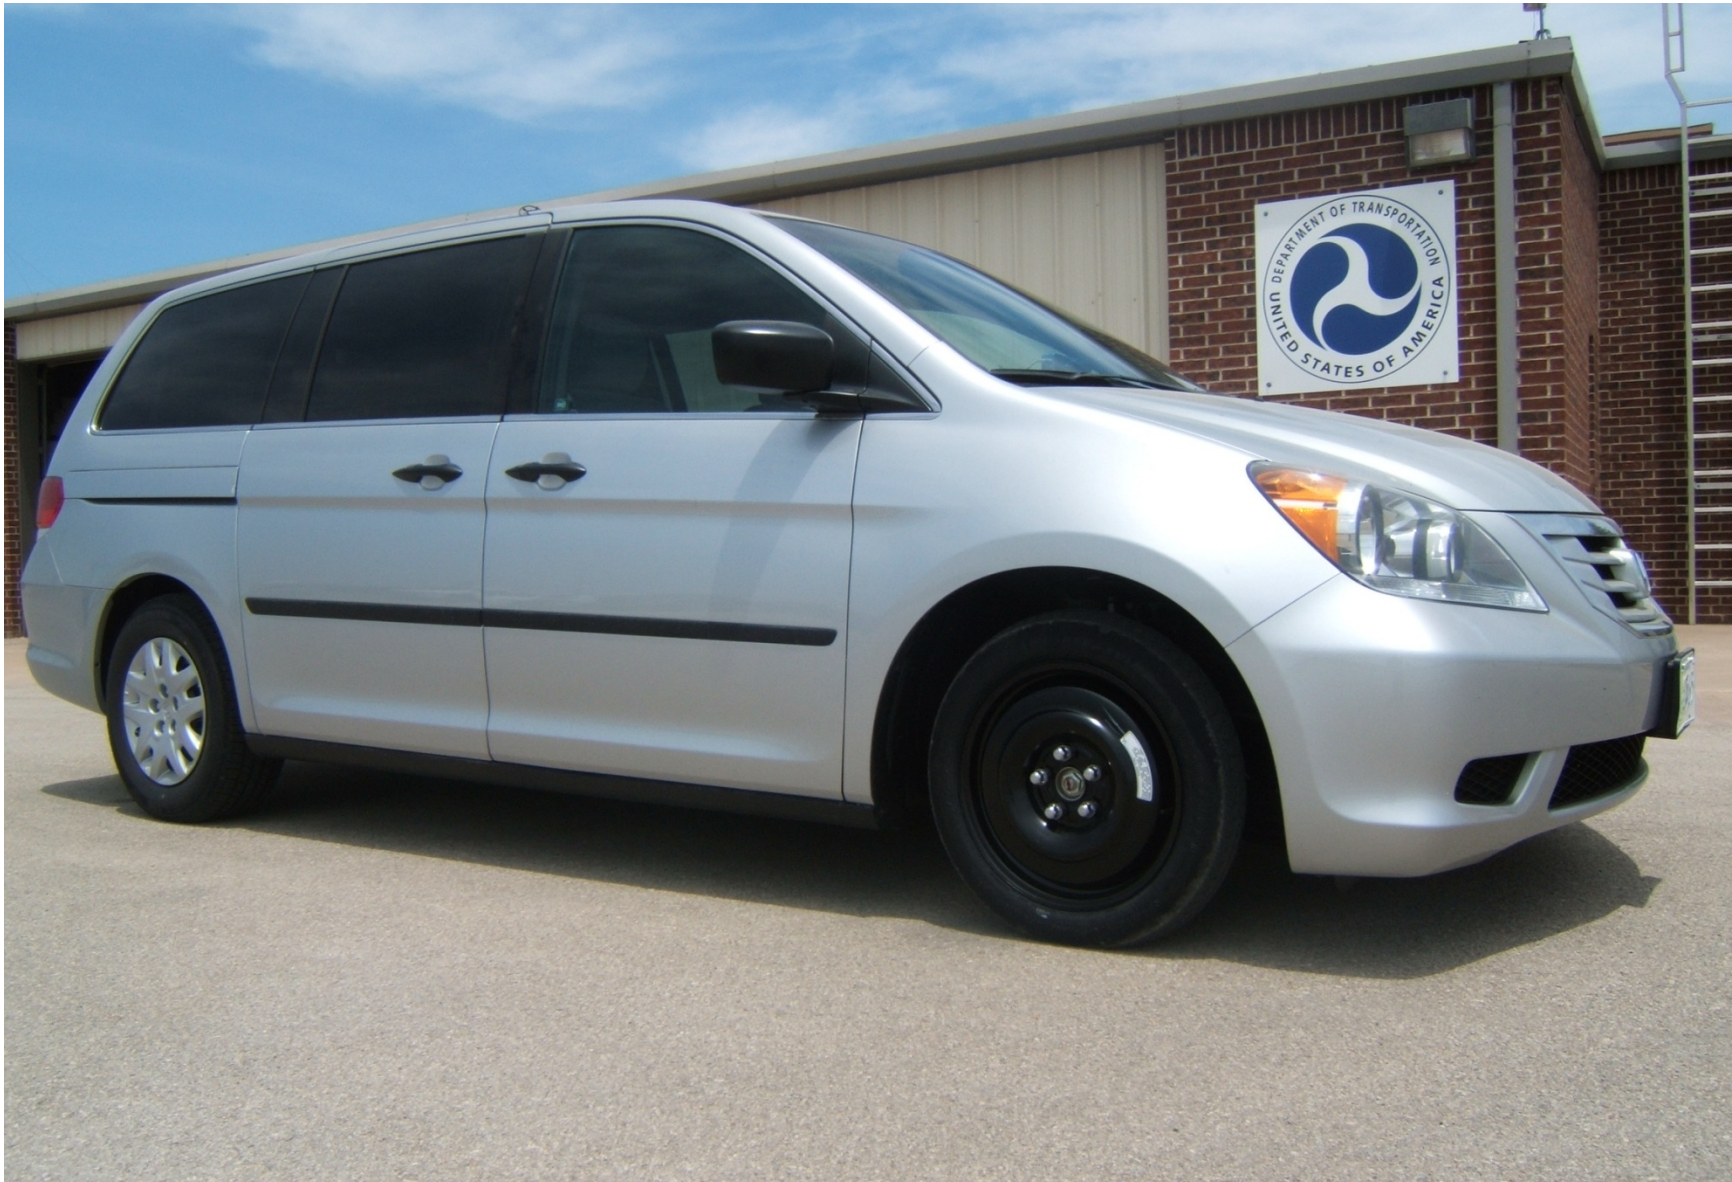
FIGURE 5.20  
SPARE INSTALLED ON RIGHT FRONT

**TPMS MALFUNCTION PERFORMANCE TEST RESULTS (PASS/FAIL)**                    PASS  
Spare without TPMS sensor was applied to right front at LLVW.

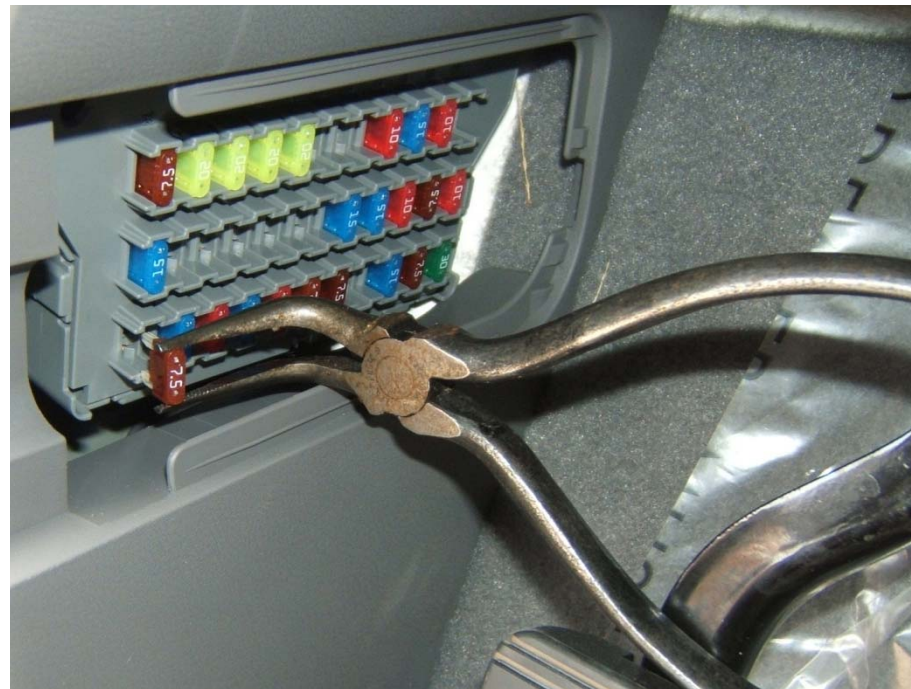
FIGURE 5.20  
 FUSE CHART -  
 TPMS FUSE REMOVED

**TPMS MALFUNCTION PERFORMANCE TEST RESULTS (PASS/FAIL) PASS**  
TPMS fuse was removed.

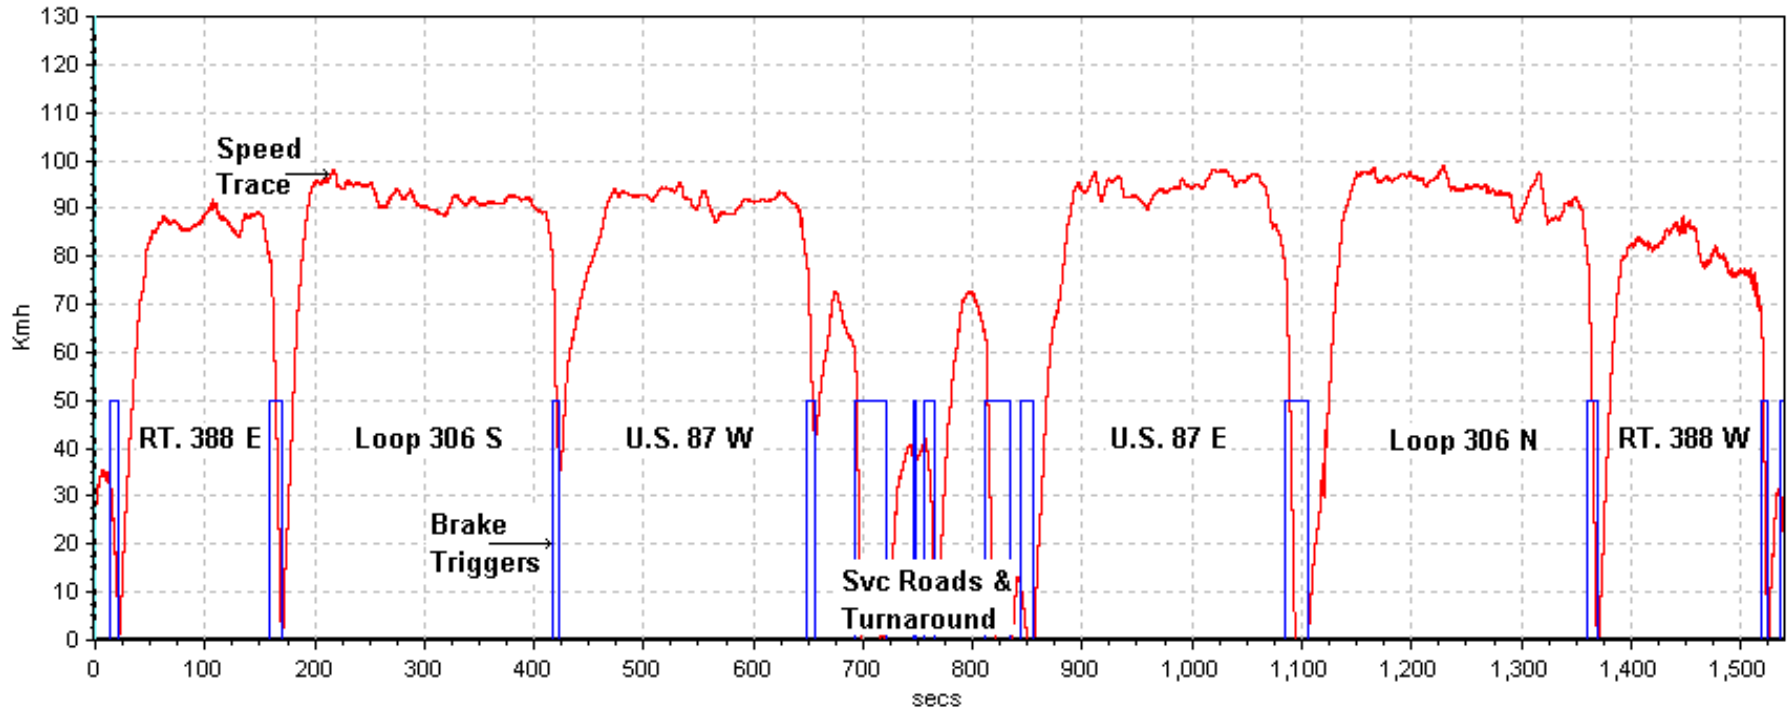
2010 Honda Odyssey (CA5305) LR Calibration LLVW

LR Detection Phase: Telltale illuminated 1:32 minutes after lamp check. Driving above 50 km/h was not necessary.

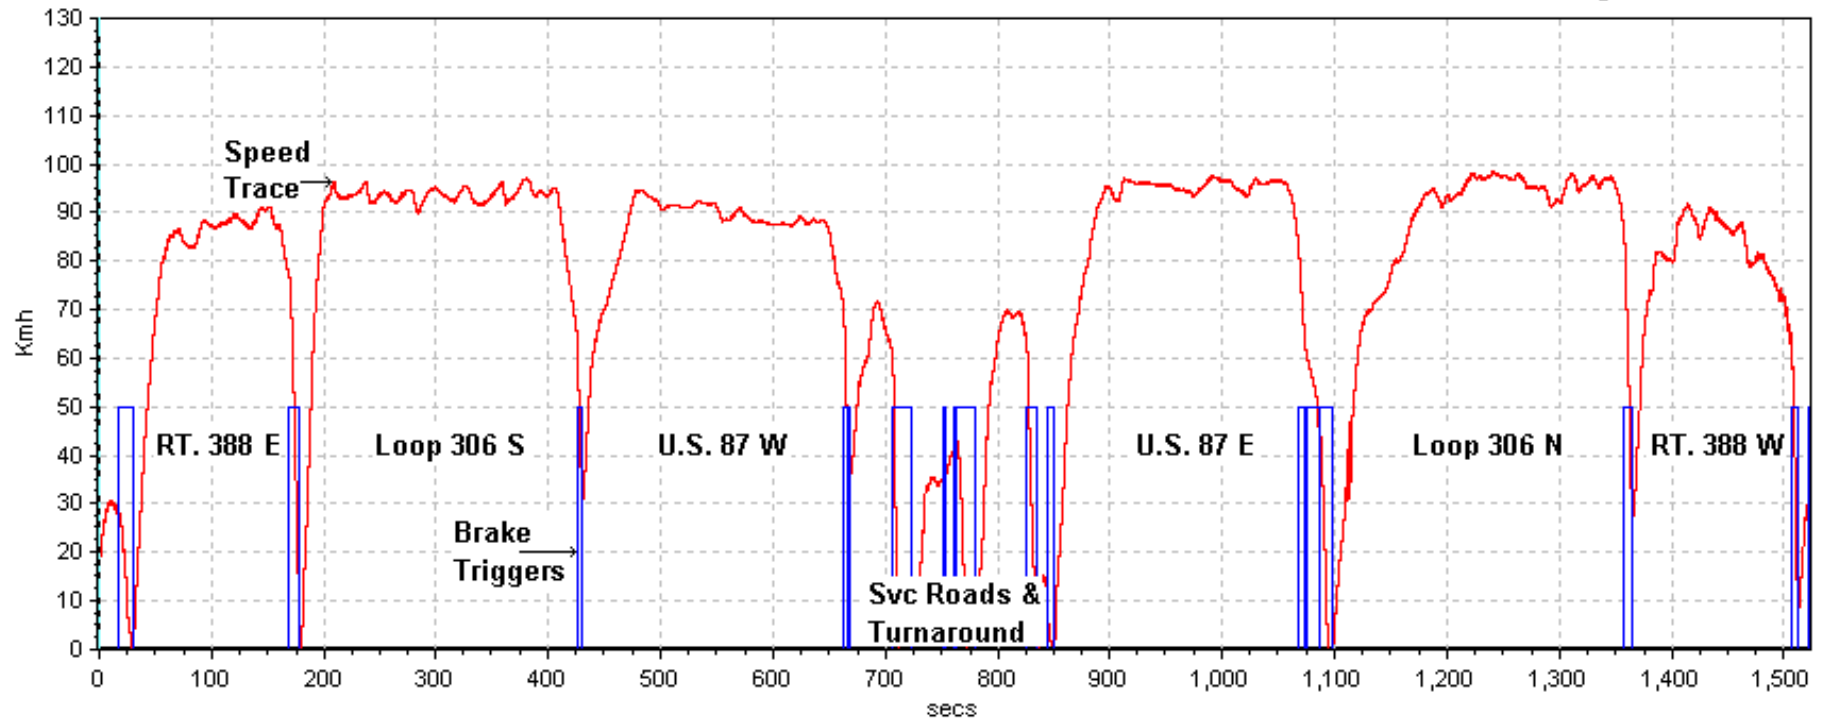
2010 Honda Odyssey (CA5305) LR, RR Calibration LLVW

LR, RR Detection Phase: Telltale illuminated 2:17 minutes after lamp check. Driving above 50 km/h was not necessary.

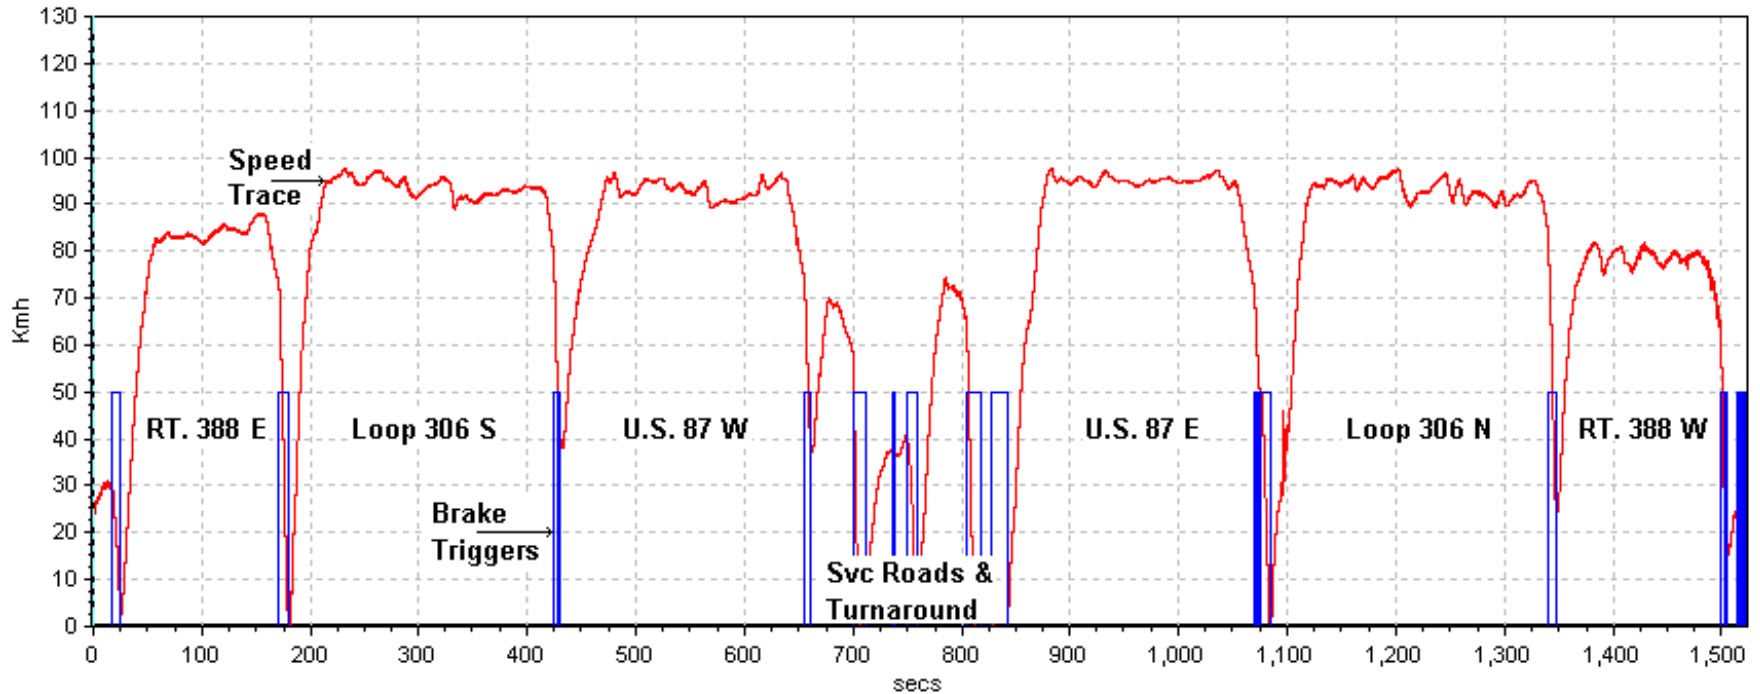
2010 Honda Odyssey (CA5305) LF, LR, RR, RF Calibration LLVW

LF, LR, RR, RF Detection Phase: Telltale illuminated 1:13 minutes after lamp check. Driving above 50 km/h was not necessary.

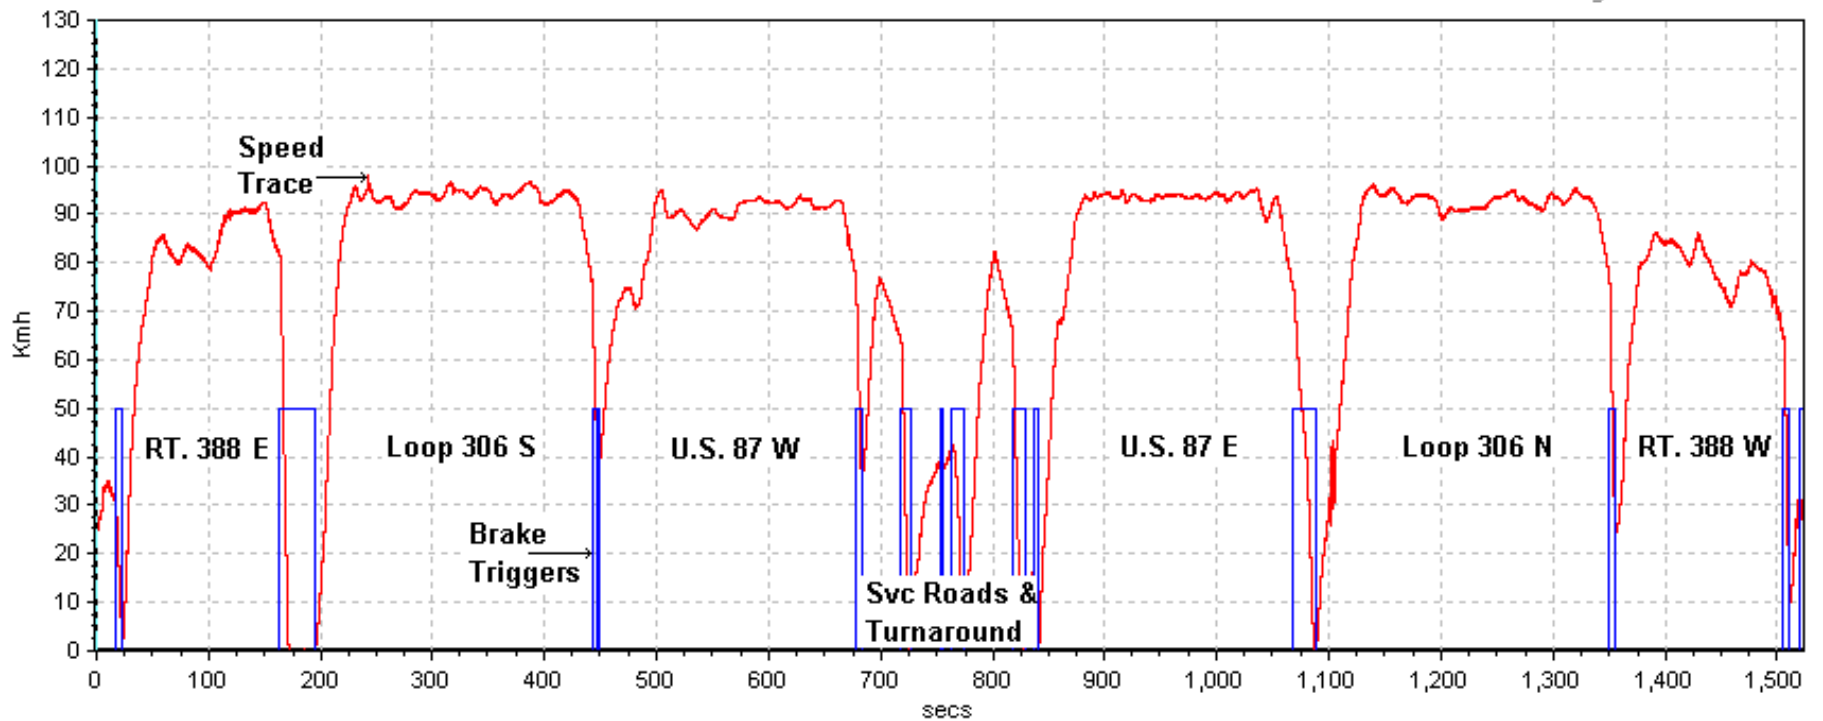
2010 Honda Odyssey (CA5305) LF Calibration UVW+VCW

LF Detection Phase: Telltale illuminated 0:49 minutes after lamp check. Driving above 50 km/h was not necessary.

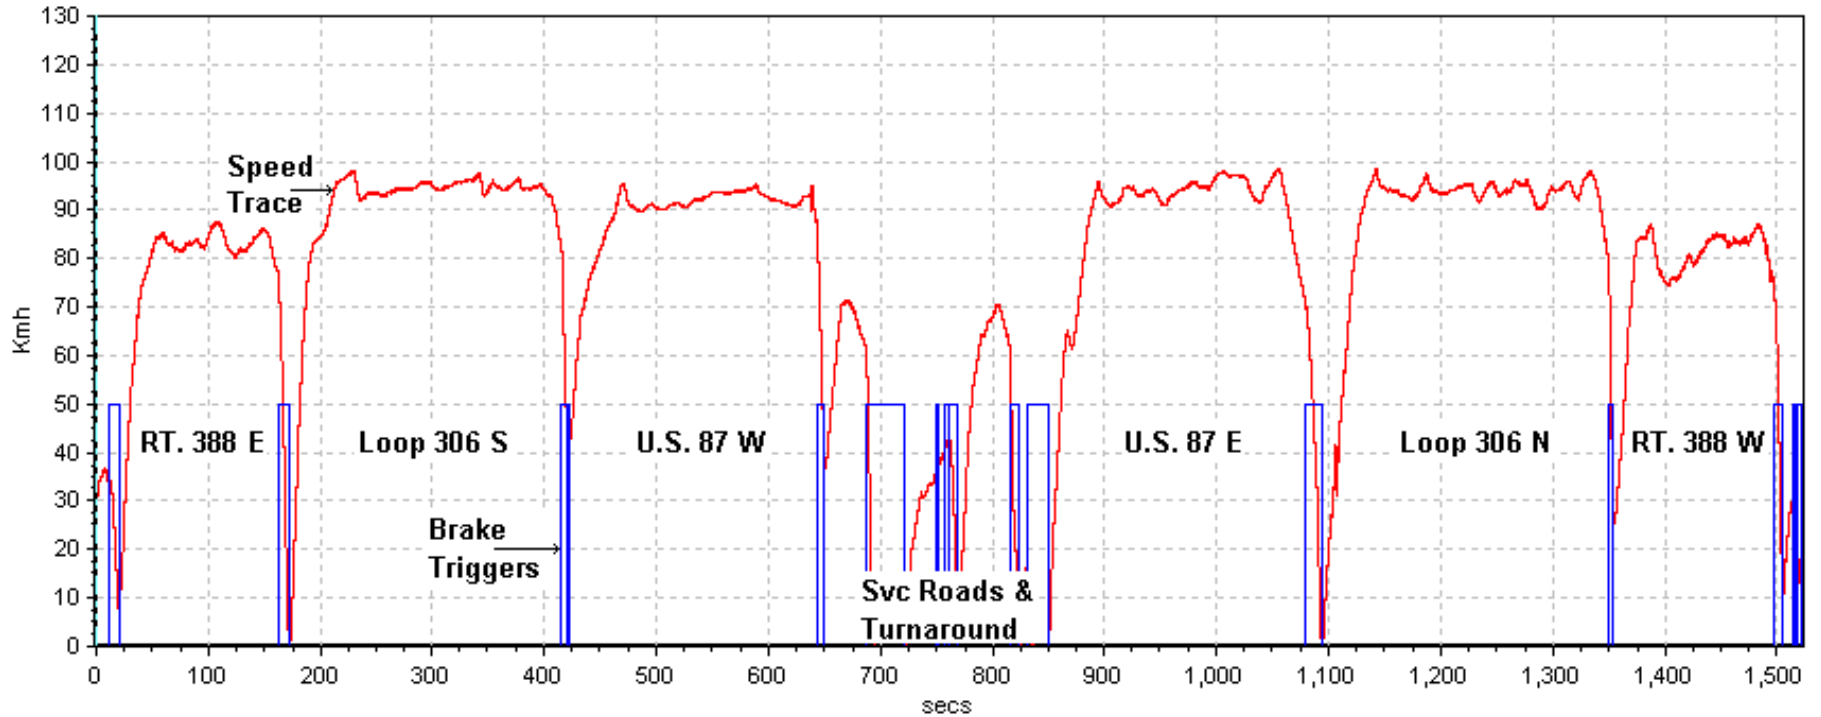
2010 Honda Odyssey (CA5305) LF, RR Calibration UVW+VCW

LF, RR Detection Phase: Telltale illuminated 0:51 minutes after lamp check. Driving above 50 km/h was not necessary.

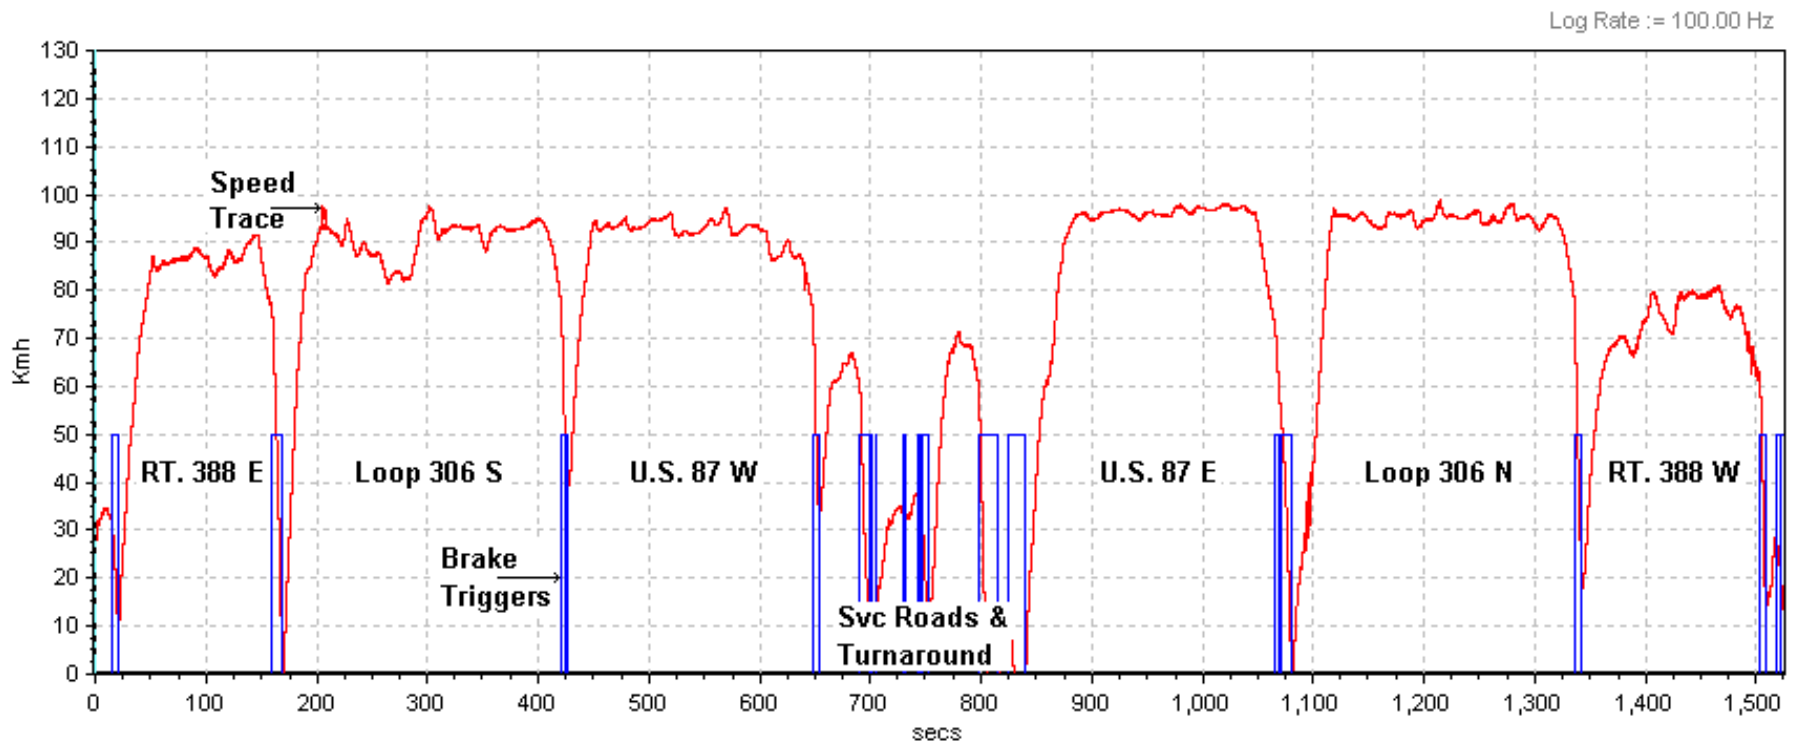
2010 Honda Odyssey (CA5305) LF, LR, RR Calibration UVW+VCW

LF, LR, RR Detection Phase: Telltale illuminated 1:24 minutes after lamp check. Driving above 50 km/h was not necessary.

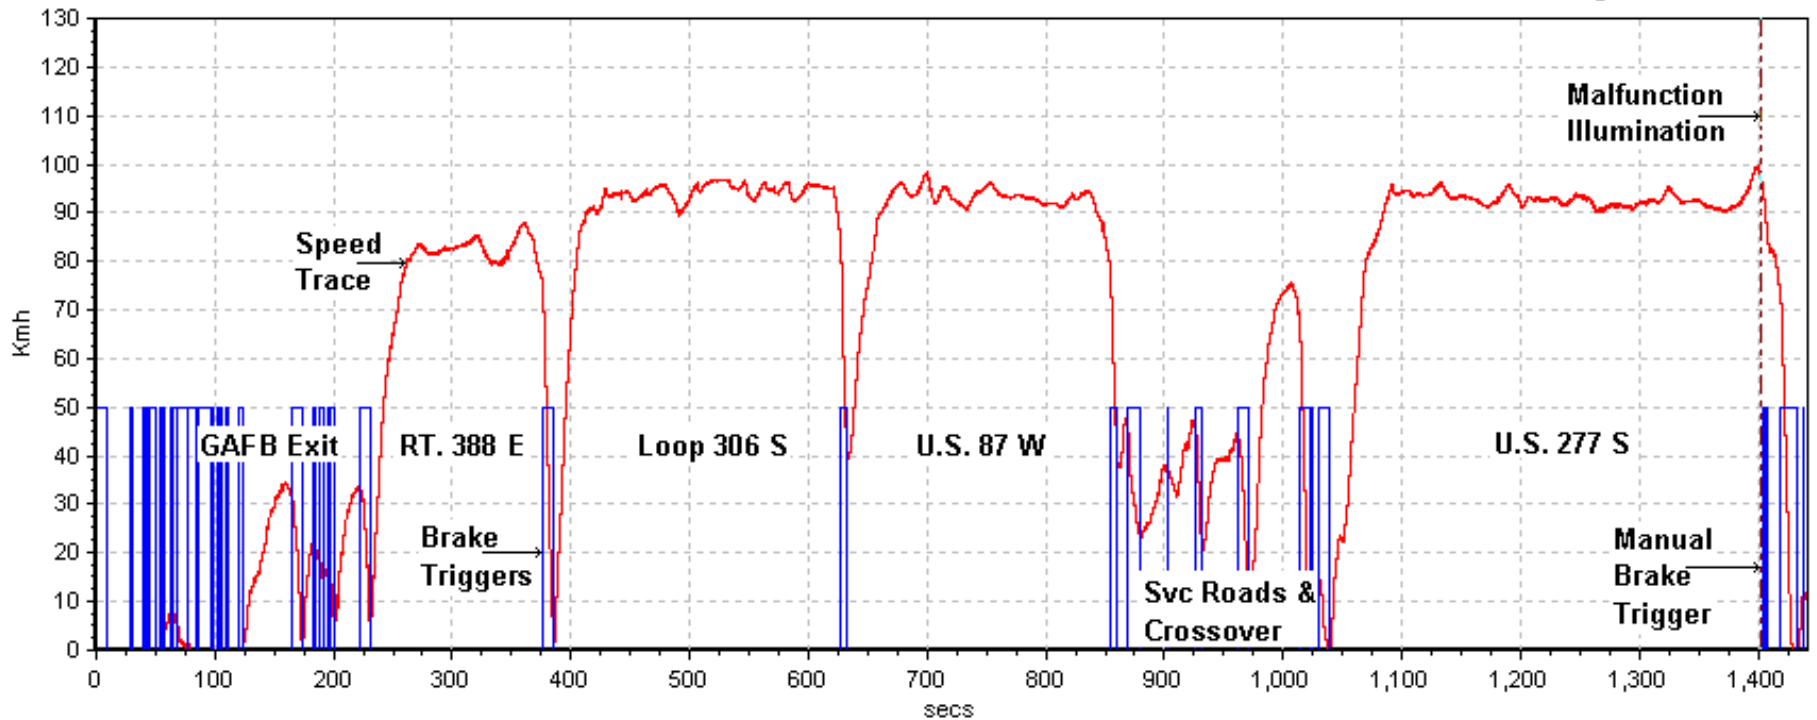
2010 Honda Odyssey (CA5305) RF Spare Tire Malfunction Illumination LLVW

Scenario G: Malfunction Detection Test at LLVW  
Test Date: 5/10/10  
Data File Time: 24:02 minutes  
Cumulative Driving Time: 15:56 minutes  
Start Point: San Angelo Test Facility shop
