FINAL REPORT NUMBER 201UI-MGA-11-13

**SAFETY COMPLIANCE TESTING FOR FMVSS 201
Occupant Protection In Interior Impact
Upper Interior Head Impact Protection**

**NISSAN MOTOR CO., LTD.
2011 Nissan Quest 3.5 S
NHTSA No. CB5203**

**MGA RESEARCH CORPORATION
446 Executive Drive
Troy, Michigan 48083**

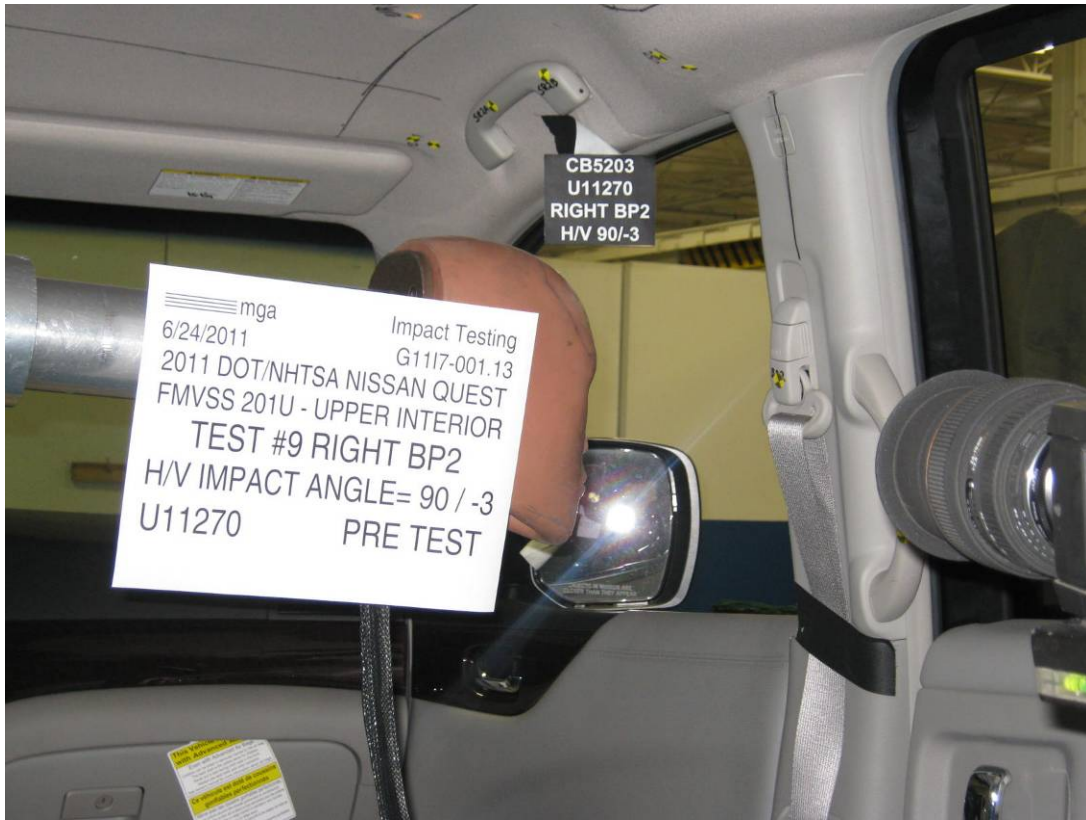
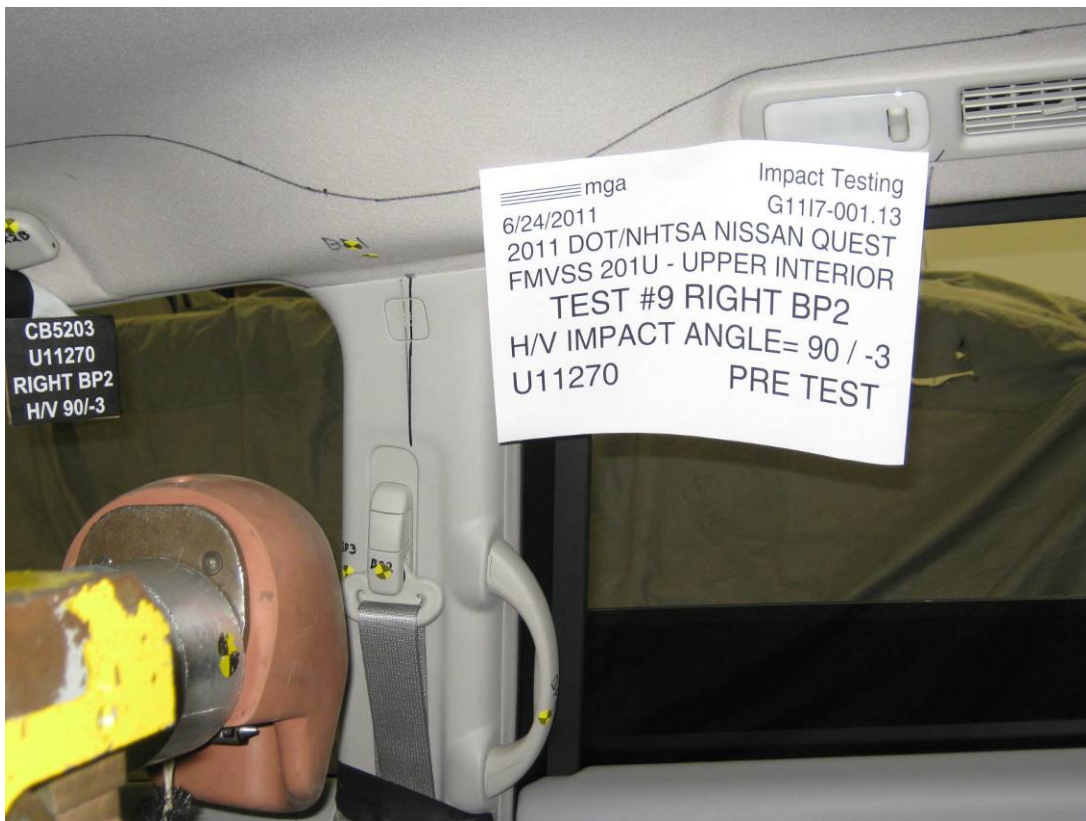
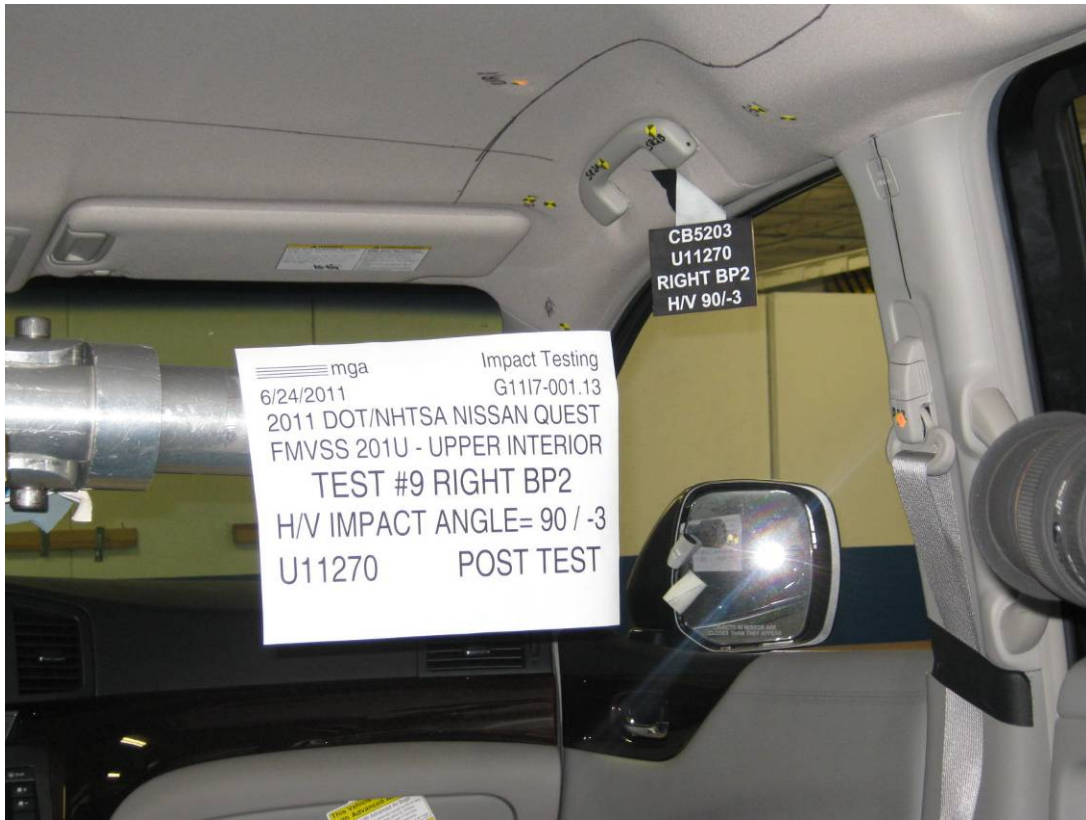
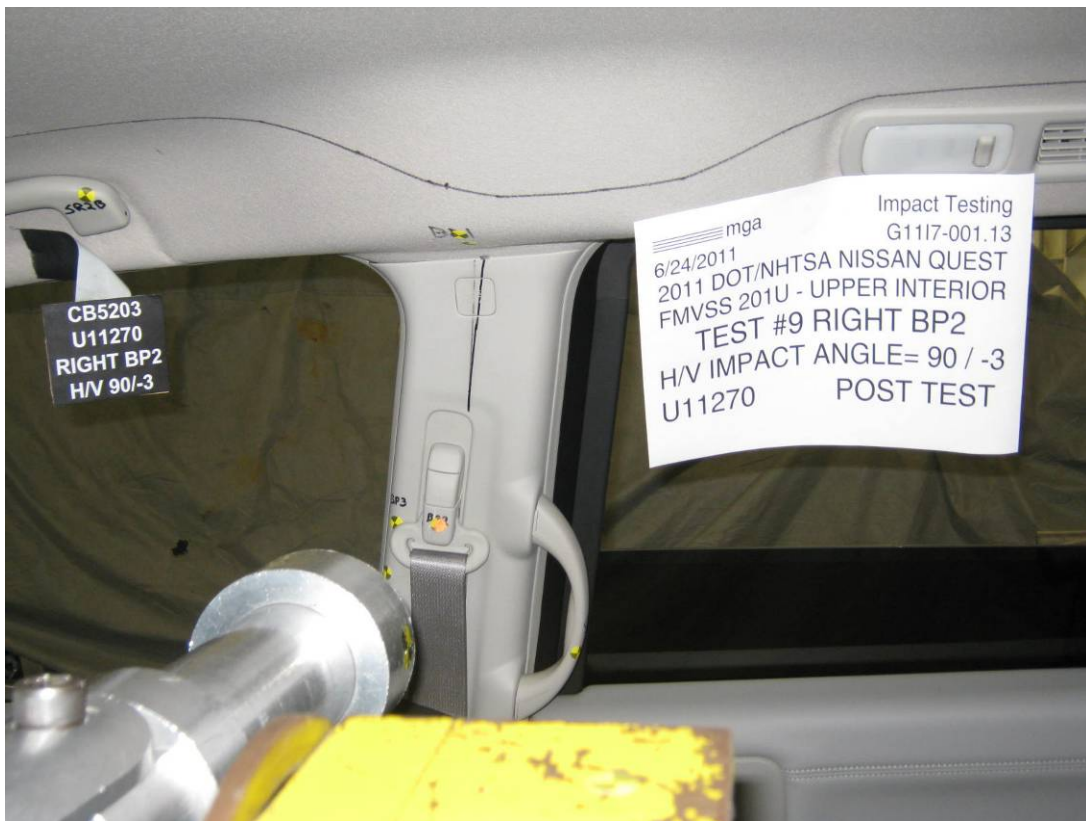
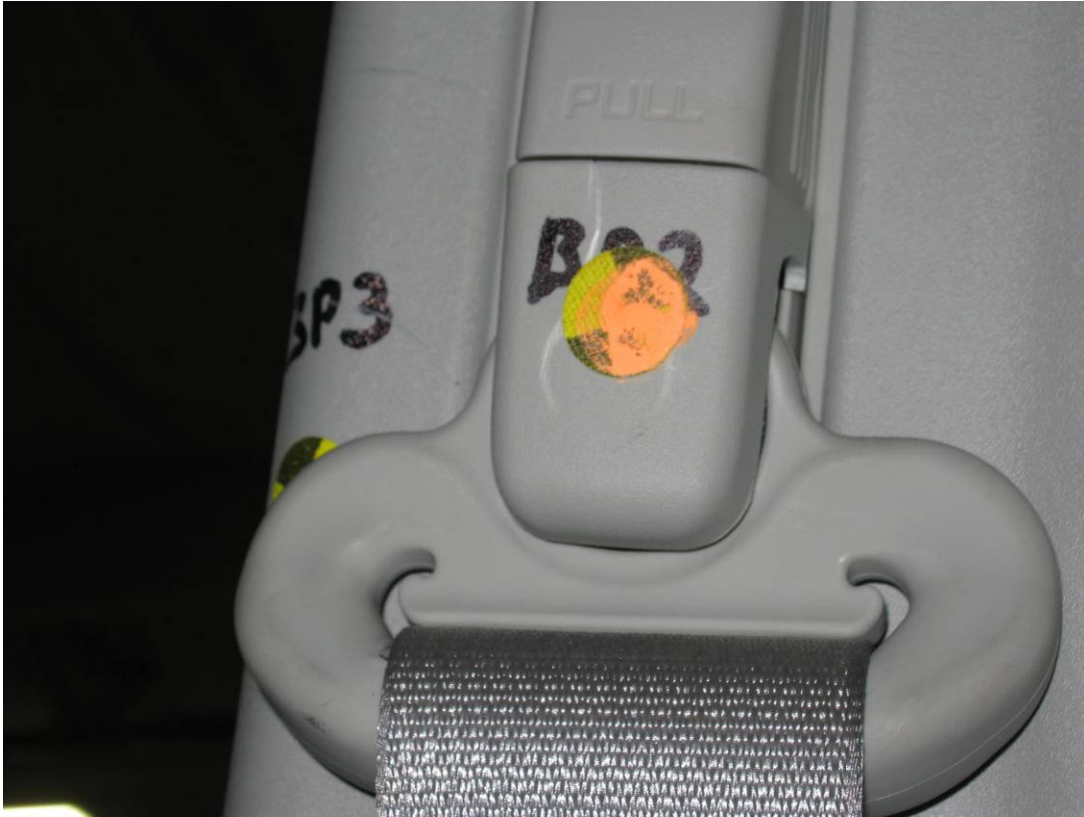
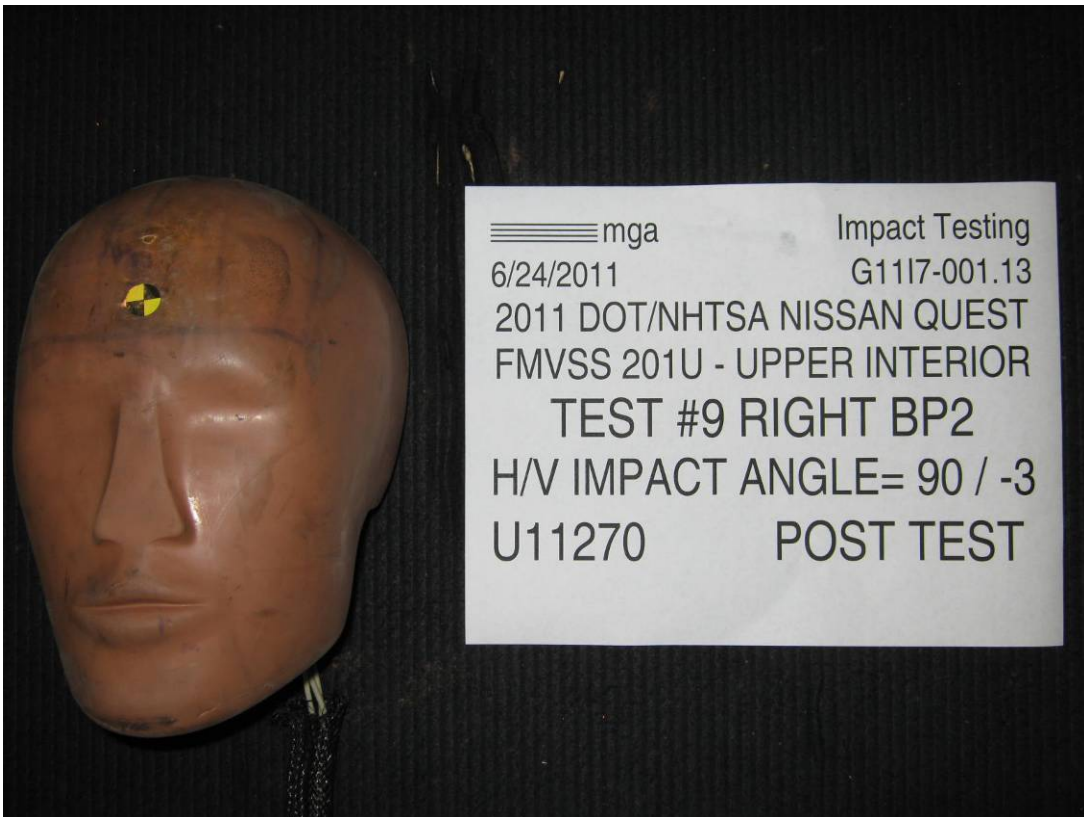
No visible damage

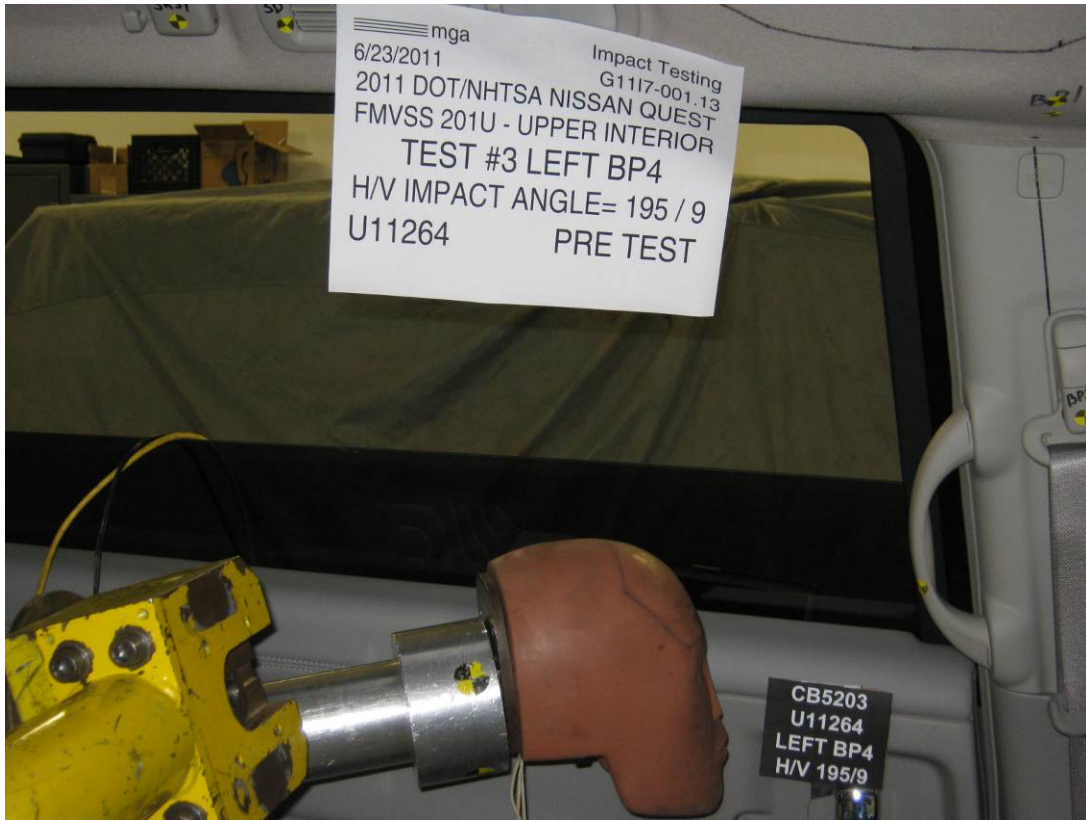
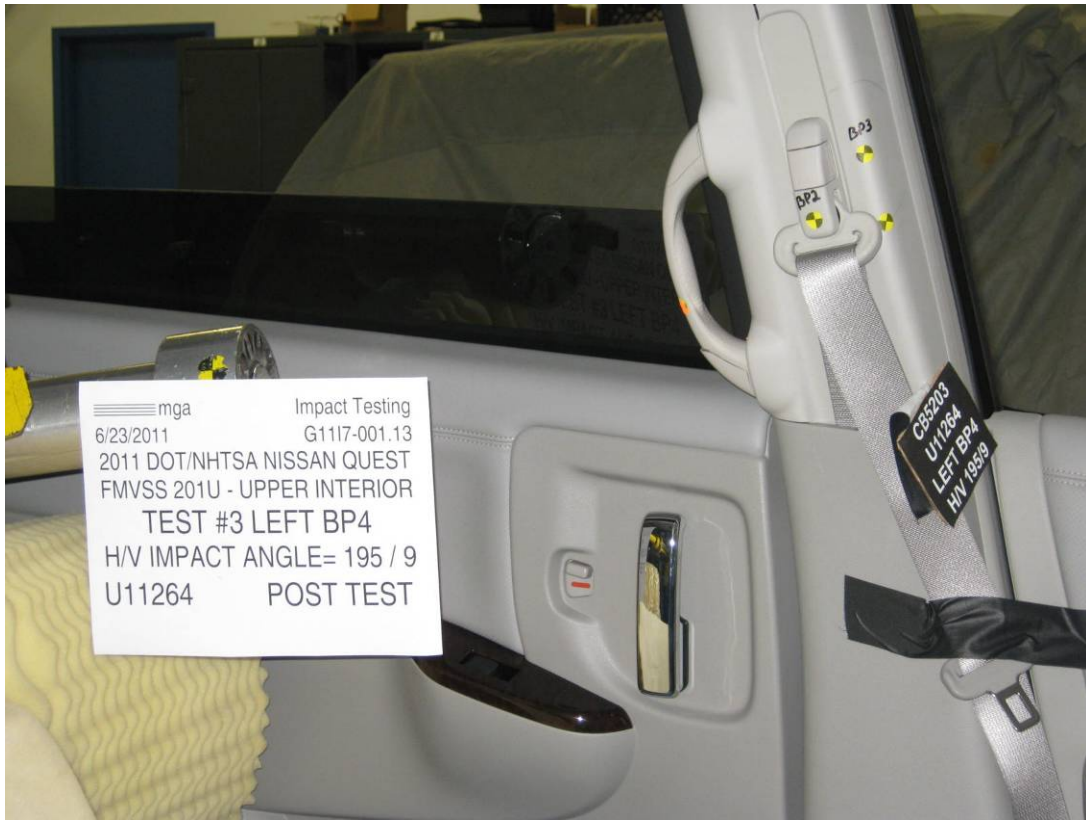
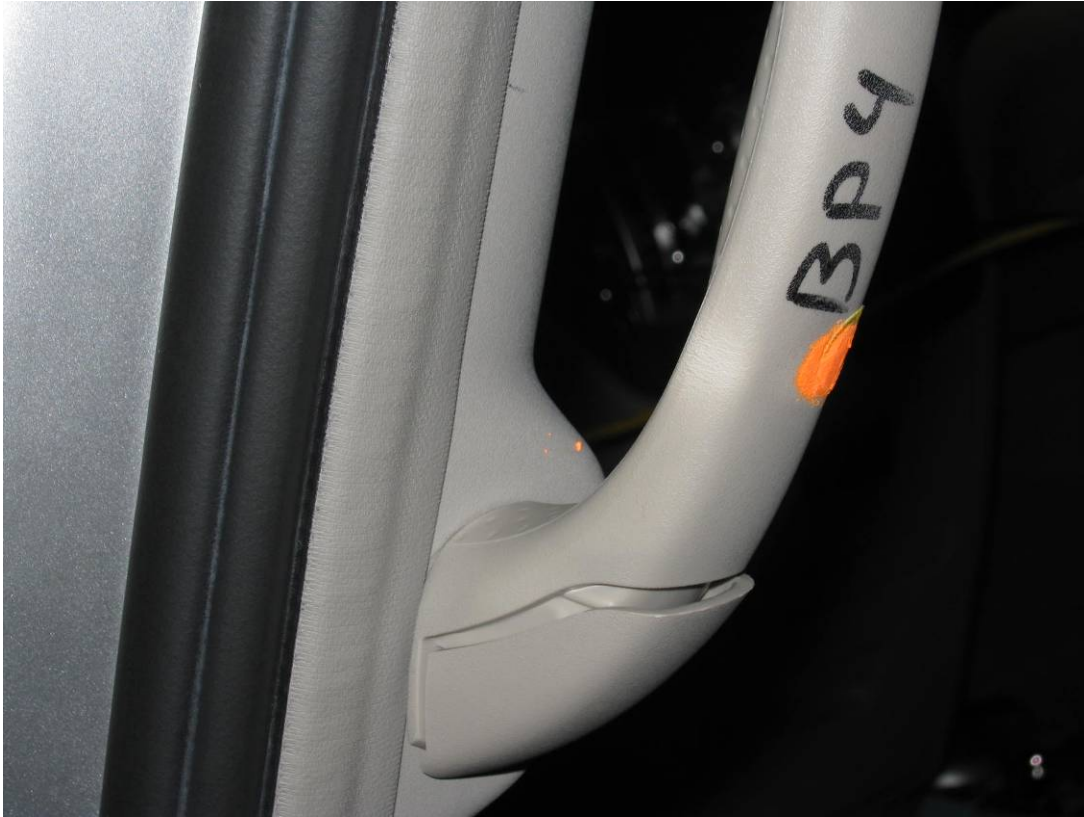
BP2 Right: Anchorage adjuster cover cracked; stress marks on anchorage adjuster cover.

Anchorage adjuster cover cracked, stress marks on anchorage adjuster cover
