REPORT NUMBER: 201U-CAL-10-03

**SAFETY COMPLIANCE TESTING FOR FMVSS 201  
OCCUPANT PROTECTION IN INTERIOR IMPACT  
UPPER INTERIOR HEAD IMPACT PROTECTION**

**SUZUKI MOTOR CORPORATION  
2010 SUZUKI KIZASHI**

NHTSA NUMBER: CA0510

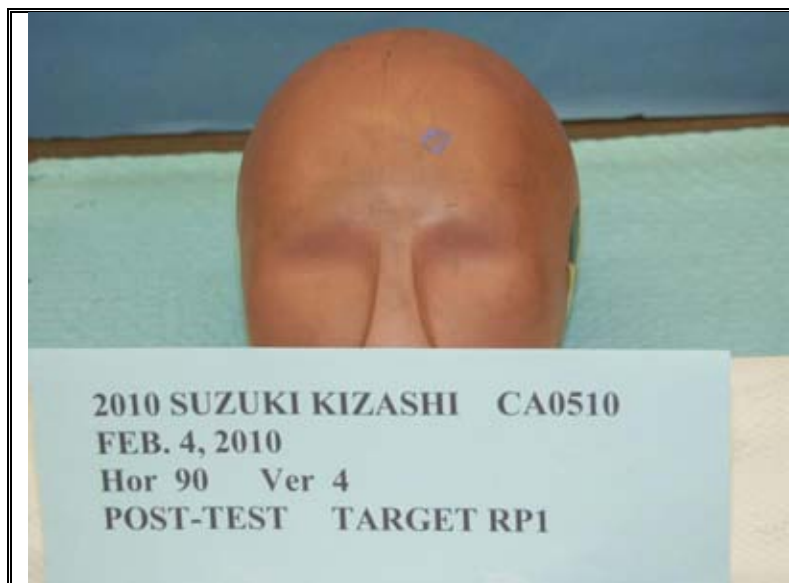
POST-IMPACT RP1 HEADFORM

Test Number:	01
Test Date:	02/04/10
Target Location:	REAR PILLAR
Target Code:	RP1
Horizontal Impact Angle:	90
Vertical Impact Angle:	4
Ambient Temperature:	20°C
Relative Humidity:	17
Time of Impact:	10:30
Headform Number:	1140

Impact Point Description (from lower midpoint on midsagittal line)					
On Centerline	10	<input type="checkbox"/>	mm right	<input checked="" type="checkbox"/>	mm left
On Centerline	15				mm up

Free Motion HIC	152.4
HIC(d)	281.4
Impact Velocity (kph)	18.79
HIC T1 (msec)	4.8
HIC T2 (msec)	16.9

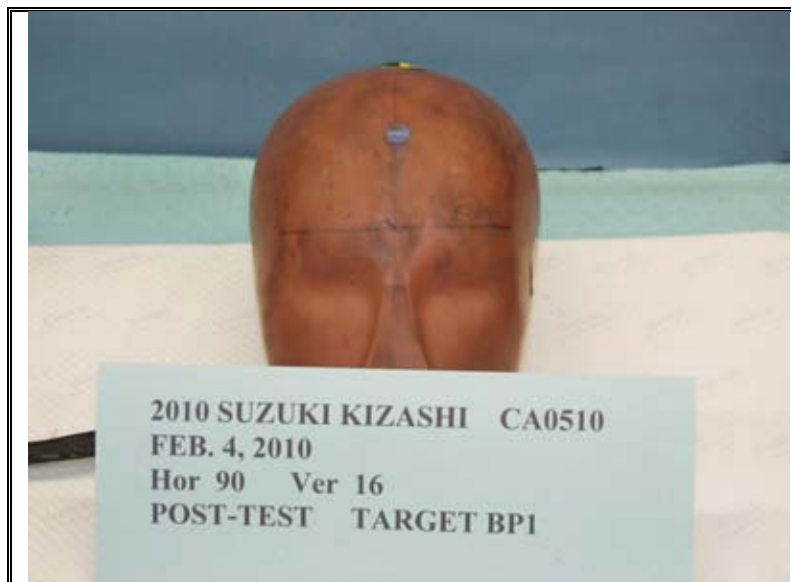
POST-IMPACT BP1 HEADFORM

Test Number:	05
Test Date:	02/04/10
Target Location:	B-PILLAR
Target Code:	BP1
Horizontal Impact Angle:	90
Vertical Impact Angle:	16
Ambient Temperature:	20°C
Relative Humidity:	17
Time of Impact:	13:25
Headform Number:	62

Impact Point Description (from lower midpoint on midsagittal line)					
On Centerline	2	<input checked="" type="checkbox"/>	mm right	<input type="checkbox"/>	mm left
On Centerline	45				mm up

Free Motion HIC	229.0
HIC(d)	339.2
Impact Velocity (kph)	18.47
HIC T1 (msec)	4.4
HIC T2 (msec)	14.6

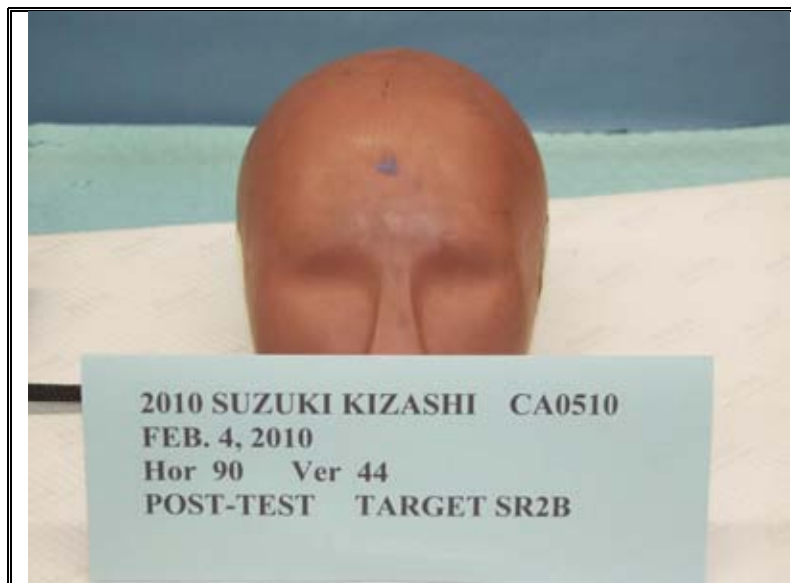
POST-IMPACT SR2B HEADFORM

Test Number:	06
Test Date:	02/04/10
Target Location:	SIDE RAIL
Target Code:	SR2B
Horizontal Impact Angle:	90
Vertical Impact Angle:	44
Ambient Temperature:	20°C
Relative Humidity:	17
Time of Impact:	14:00
Headform Number:	1140

Impact Point Description (from lower midpoint on midsagittal line)					
On Centerline	1	<input checked="" type="checkbox"/>	mm right	<input type="checkbox"/>	mm left
On Centerline	20				mm up

Free Motion HIC	390.6
HIC(d)	461.1
Impact Velocity (kph)	18.84
HIC T1 (msec)	2.7
HIC T2 (msec)	9.4

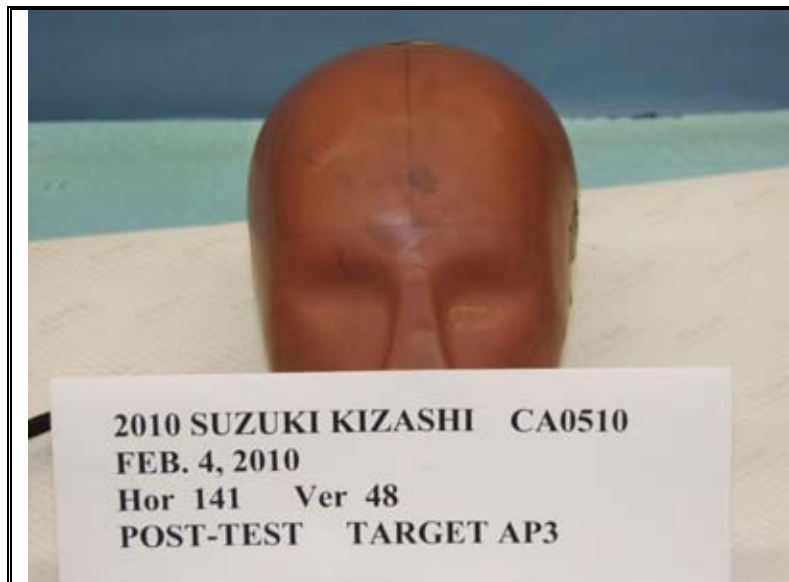
POST-IMPACT AP3 HEADFORM

Test Number:	07
Test Date:	02/04/10
Target Location:	A-PILLAR
Target Code:	AP3
Horizontal Impact Angle:	141
Vertical Impact Angle:	48
Ambient Temperature:	20°C
Relative Humidity:	17
Time of Impact:	14:45
Headform Number:	355

Impact Point Description (from lower midpoint on midsagittal line)			
On Centerline	0	<input type="checkbox"/>	mm right <input type="checkbox"/> mm left
On Centerline	45		mm up

Free Motion HIC	244.3
HIC(d)	350.8
Impact Velocity (kph)	18.66
HIC T1 (msec)	1.6
HIC T2 (msec)	14.8

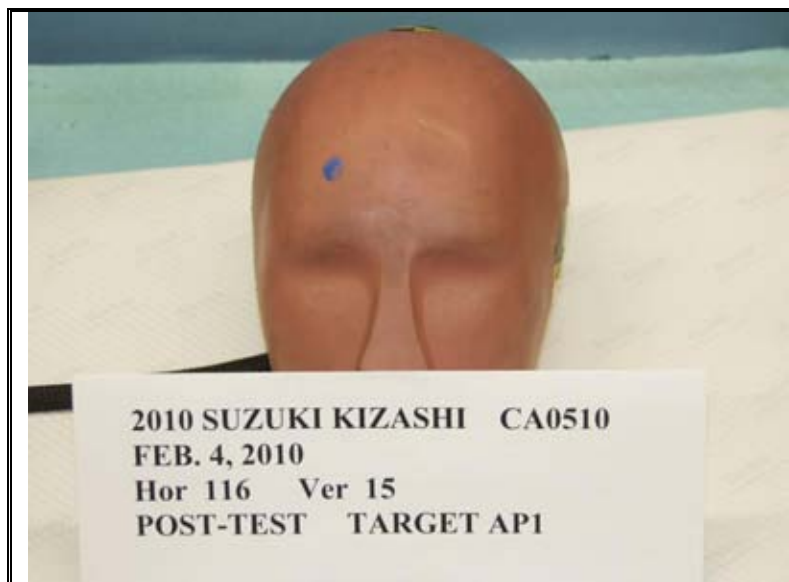
POST-IMPACT AP1 HEADFORM

Test Number:	08
Test Date:	02/04/10
Target Location:	A-PILLAR
Target Code:	AP1
Horizontal Impact Angle:	116
Vertical Impact Angle:	15
Ambient Temperature:	20°C
Relative Humidity:	17
Time of Impact:	15:30
Headform Number:	1142

Impact Point Description (from lower midpoint on midsagittal line)			
On Centerline	28	<input checked="" type="checkbox"/>	mm right <input type="checkbox"/> mm left
On Centerline	15		mm up

Free Motion HIC	152.6
HIC(d)	281.5
Impact Velocity (kph)	18.86
HIC T1 (msec)	6.1
HIC T2 (msec)	15.6

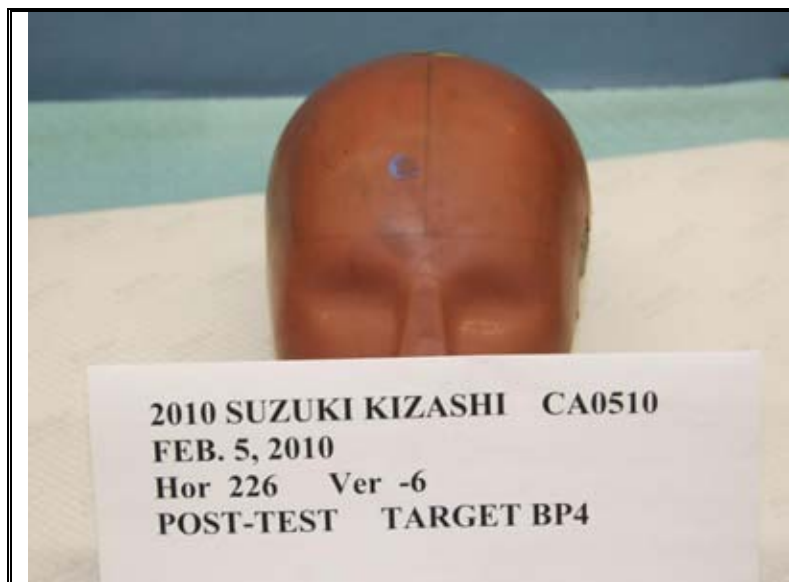
POST-IMPACT BP4 HEADFORM

Test Number:	10
Test Date:	02/05/10
Target Location:	B-PILLAR
Target Code:	BP4
Horizontal Impact Angle:	226
Vertical Impact Angle:	-6
Ambient Temperature:	20°C
Relative Humidity:	17
Time of Impact:	9:45
Headform Number:	355

Impact Point Description (from lower midpoint on midsagittal line)			
On Centerline	10	<input checked="" type="checkbox"/>	mm right <input type="checkbox"/> mm left
On Centerline	28		mm up

Free Motion HIC	566.1
HIC(d)	593.5
Impact Velocity (kph)	23.6
HIC T1 (msec)	3.4
HIC T2 (msec)	11.2

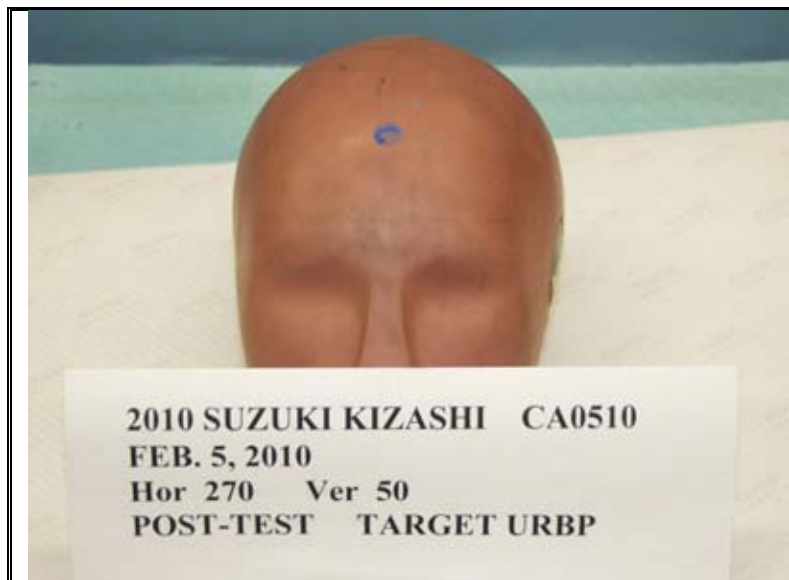
POST-IMPACT URBP HEADFORM

Test Number:	11
Test Date:	02/05/10
Target Location:	UPPER ROOF
Target Code:	URBP
Horizontal Impact Angle:	270
Vertical Impact Angle:	50
Ambient Temperature:	20°C
Relative Humidity:	17
Time of Impact:	10:20
Headform Number:	1140

Impact Point Description (from lower midpoint on midsagittal line)					
On Centerline	0	<input type="checkbox"/>	mm right	<input type="checkbox"/>	mm left
On Centerline	27				mm up

Free Motion HIC	466.6
HIC(d)	518.5
Impact Velocity (kph)	23.54
HIC T1 (msec)	4.0
HIC T2 (msec)	12.4

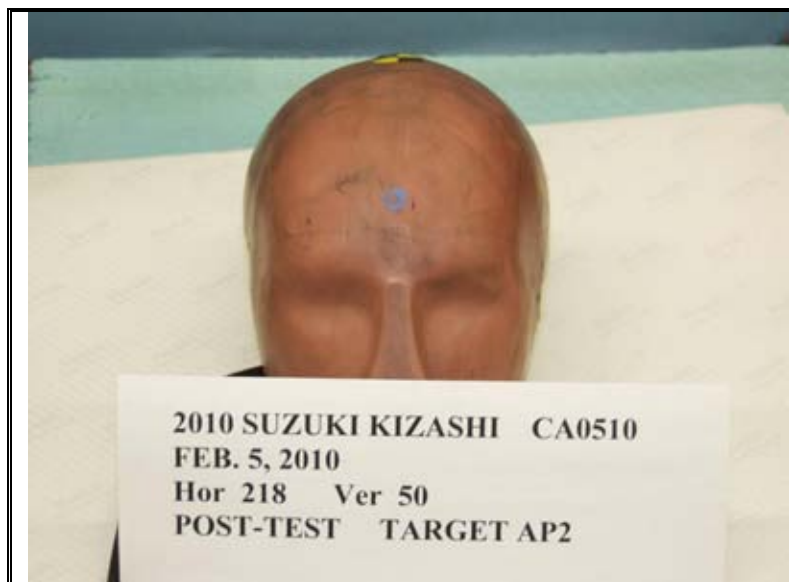
POST-IMPACT AP2 HEADFORM

Test Number:	12
Test Date:	02/05/10
Target Location:	A-PILLAR
Target Code:	AP2
Horizontal Impact Angle:	218
Vertical Impact Angle:	50
Ambient Temperature:	20°C
Relative Humidity:	17
Time of Impact:	11:00
Headform Number:	805

Impact Point Description (from lower midpoint on midsagittal line)					
On Centerline	3	<input checked="" type="checkbox"/>	mm right	<input type="checkbox"/>	mm left
On Centerline	15				mm up

Free Motion HIC	212.1
HIC(d)	326.4
Impact Velocity (kph)	18.56
HIC T1 (msec)	2.2
HIC T2 (msec)	15.8
