REPORT NUMBER: 214P-MGA-2011-007

**SAFETY COMPLIANCE TESTING FOR FMVSS 214
DYNAMIC SIDE IMPACT PROTECTION
RIGID POLE**

**HONDA MOTOR CO., LTD
2011 HONDA CR-Z 3-DR HATCHBACK
NHTSA NUMBER: CB5302**

**PREPARED BY:
MGA RESEARCH CORPORATION
5000 WARREN ROAD
BURLINGTON, WI 53105**

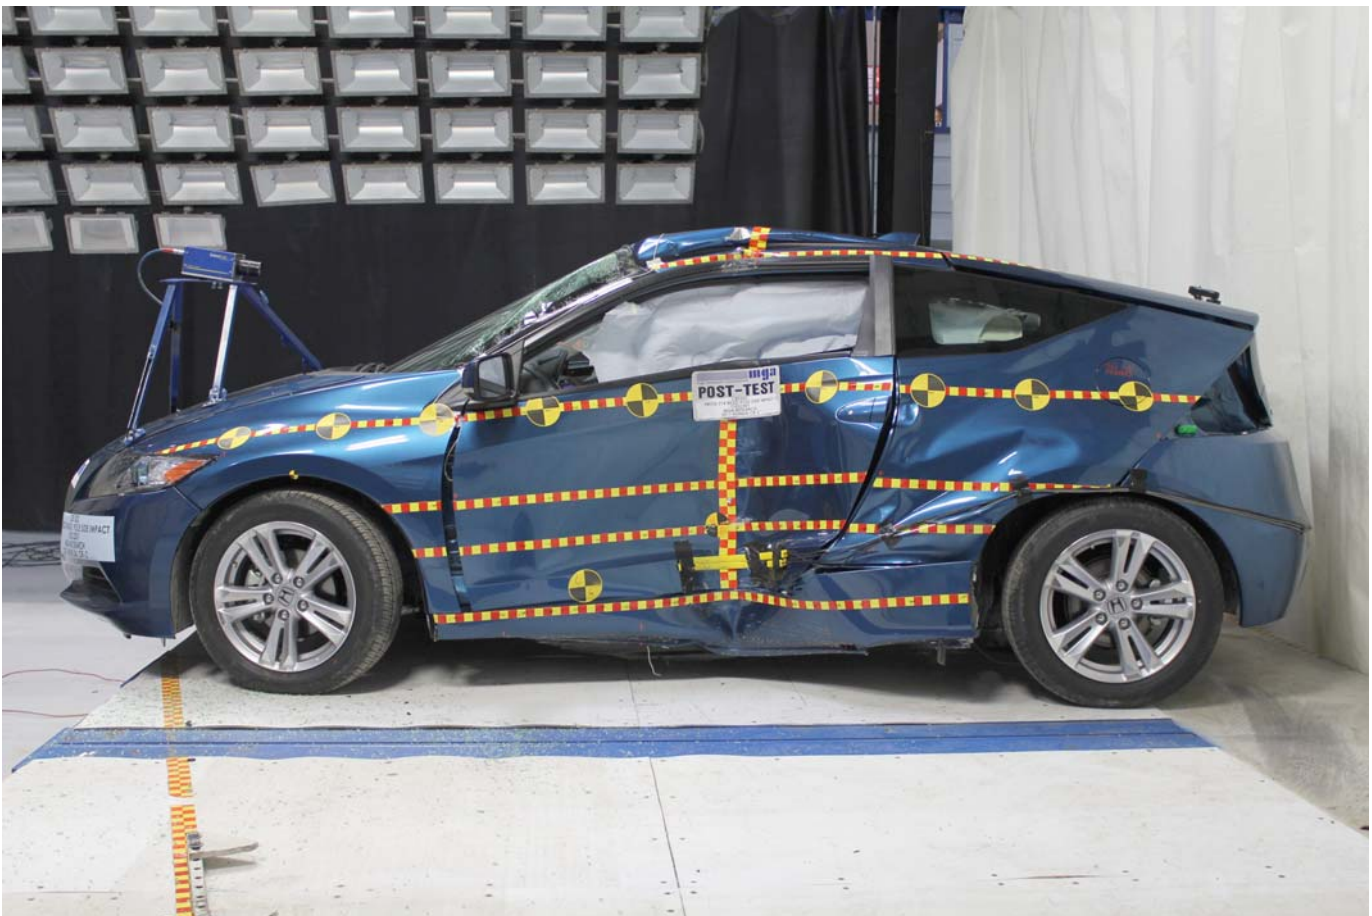
Post-Test Impacted Side View of Test Vehicle

Critical Areas of Performance	Observations and Conclusions
Pillar Performance	No Separation
Sill Separation	None
Windshield Damage	Cracked
Window Damage	Left Window Broke
Other Notable Effects	None

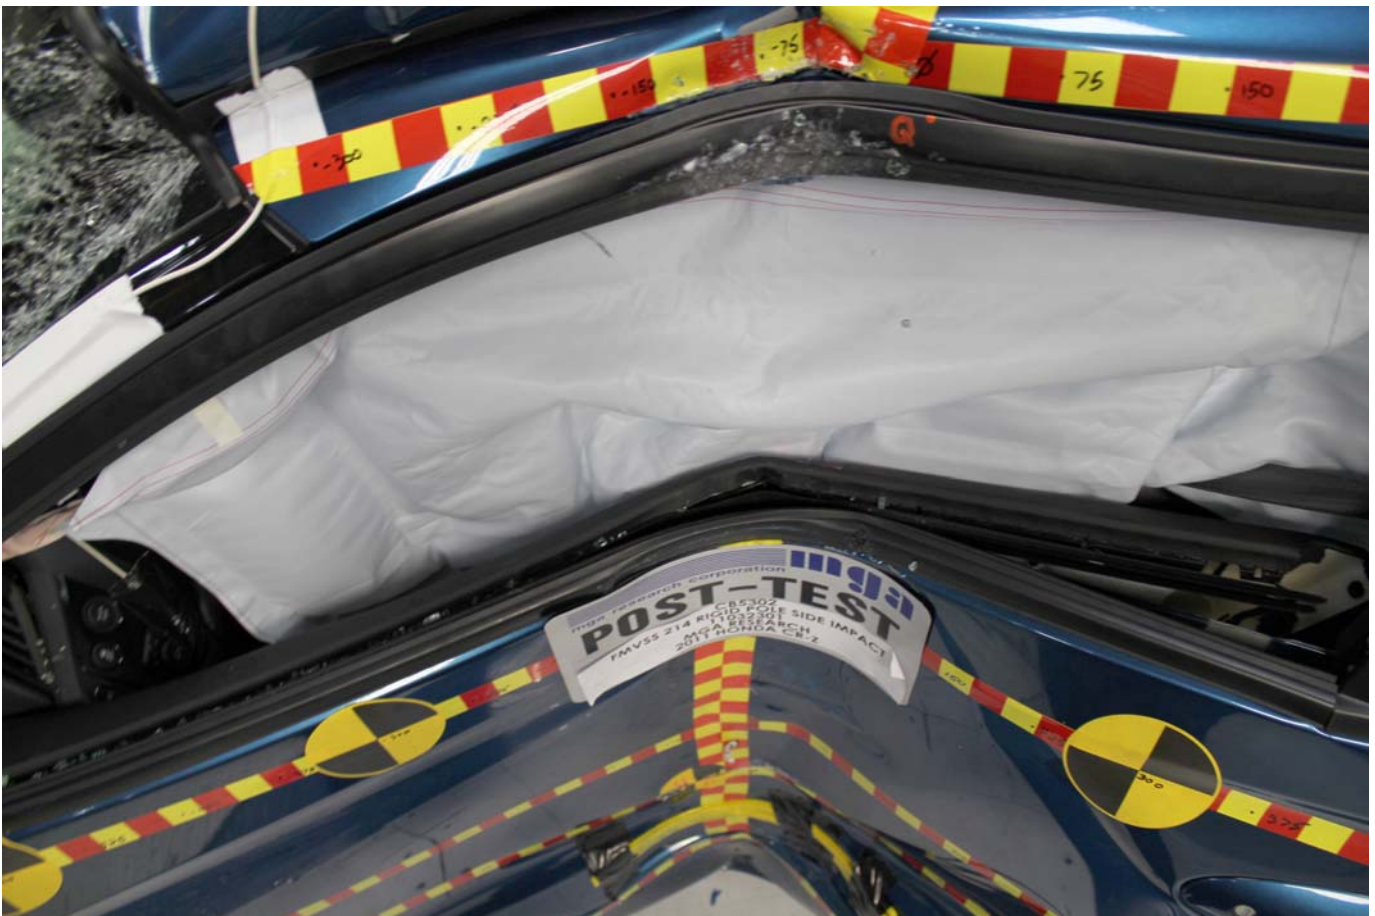
Post-Test Dummy Shoulder and Door Top View

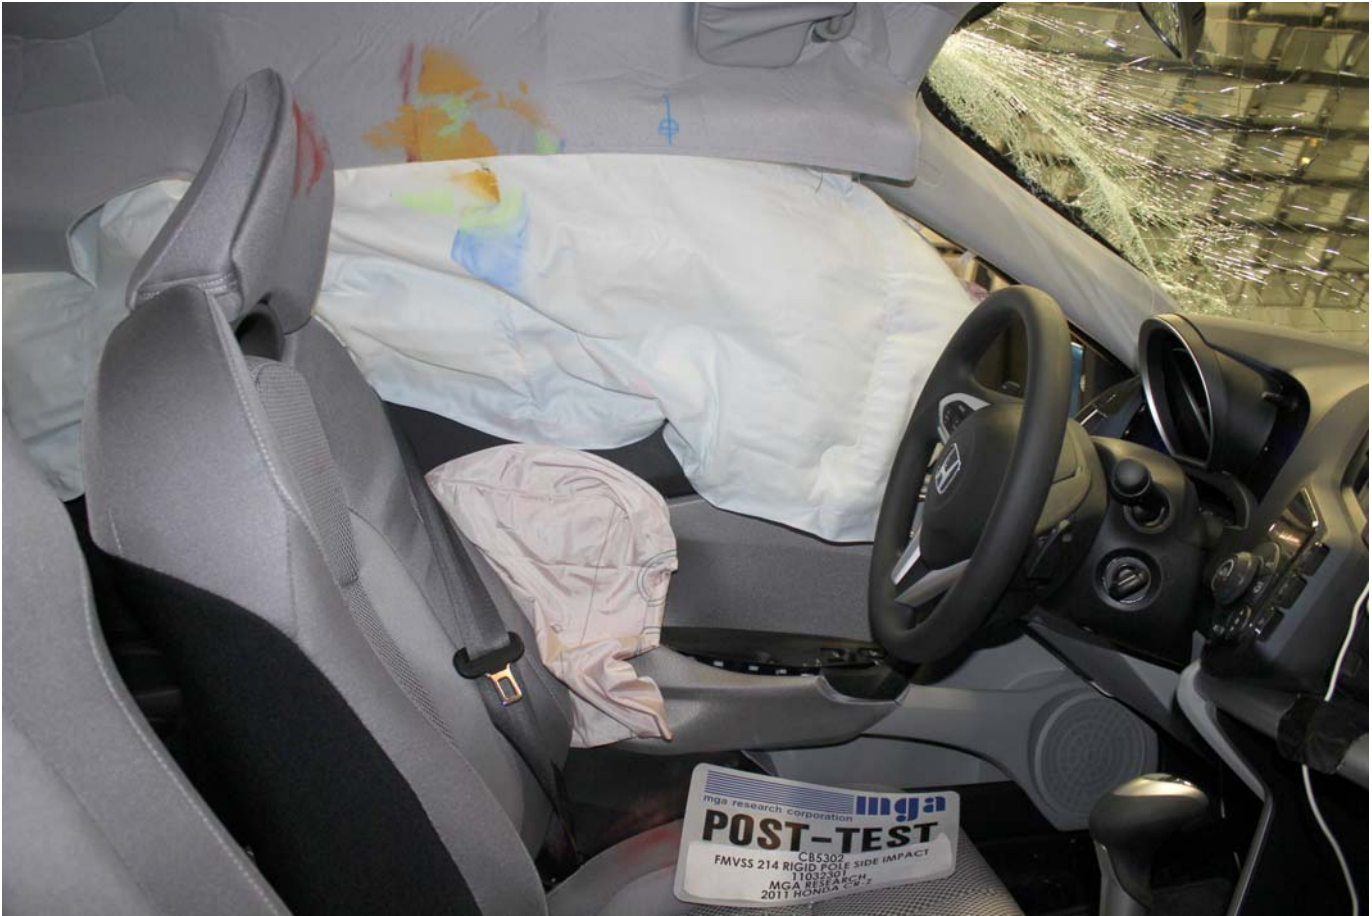
Post-Test Interior of Front Door Showing Dummy Impact Locations

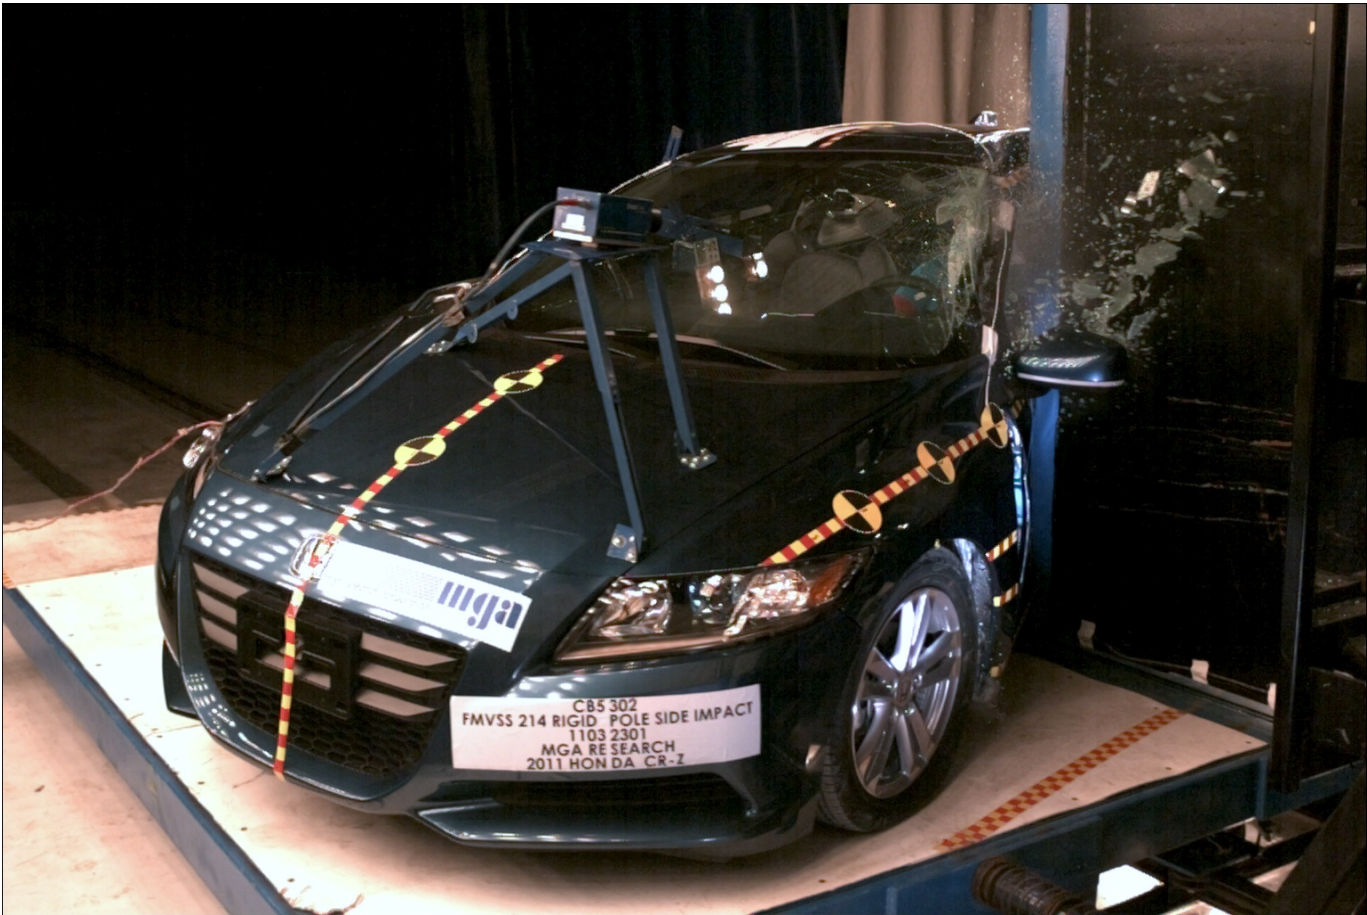
Impact Event

A rigid pole side impact test was conducted on a 2011 Honda CR-Z 3-Dr Hatchback. The subject vehicle was towed into the rigid pole at an angle of 75° and a velocity of 31.6 km/h. The test was conducted by MGA Research Corporation in Burlington, Wisconsin, on March 23, 2011. Pre-test and post-test photographs of the test vehicle and side impact dummy are included in Appendix A of this report.

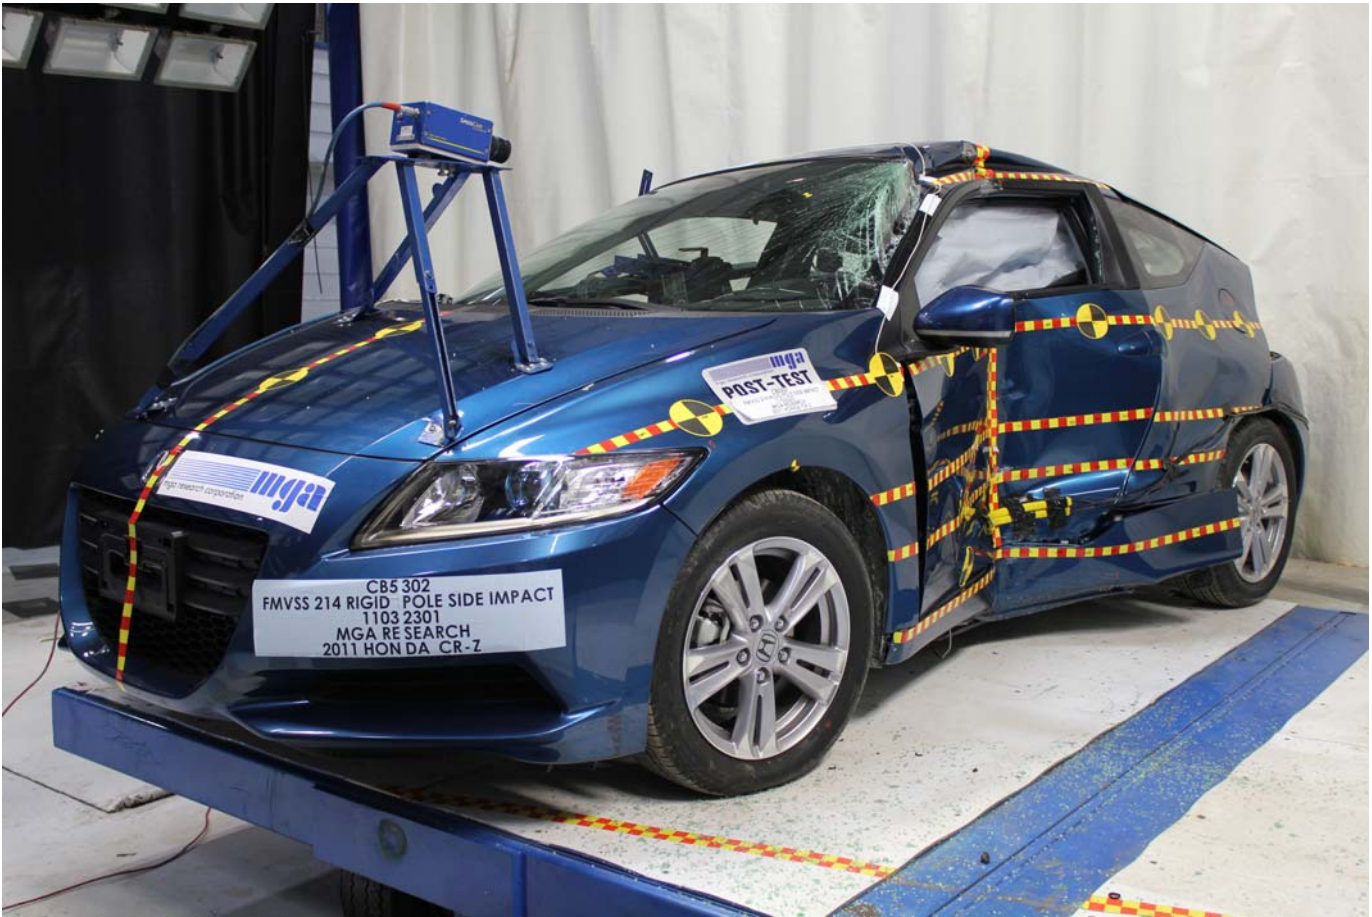
Post-Test $\frac{3}{4}$ Front View of Impact Zone

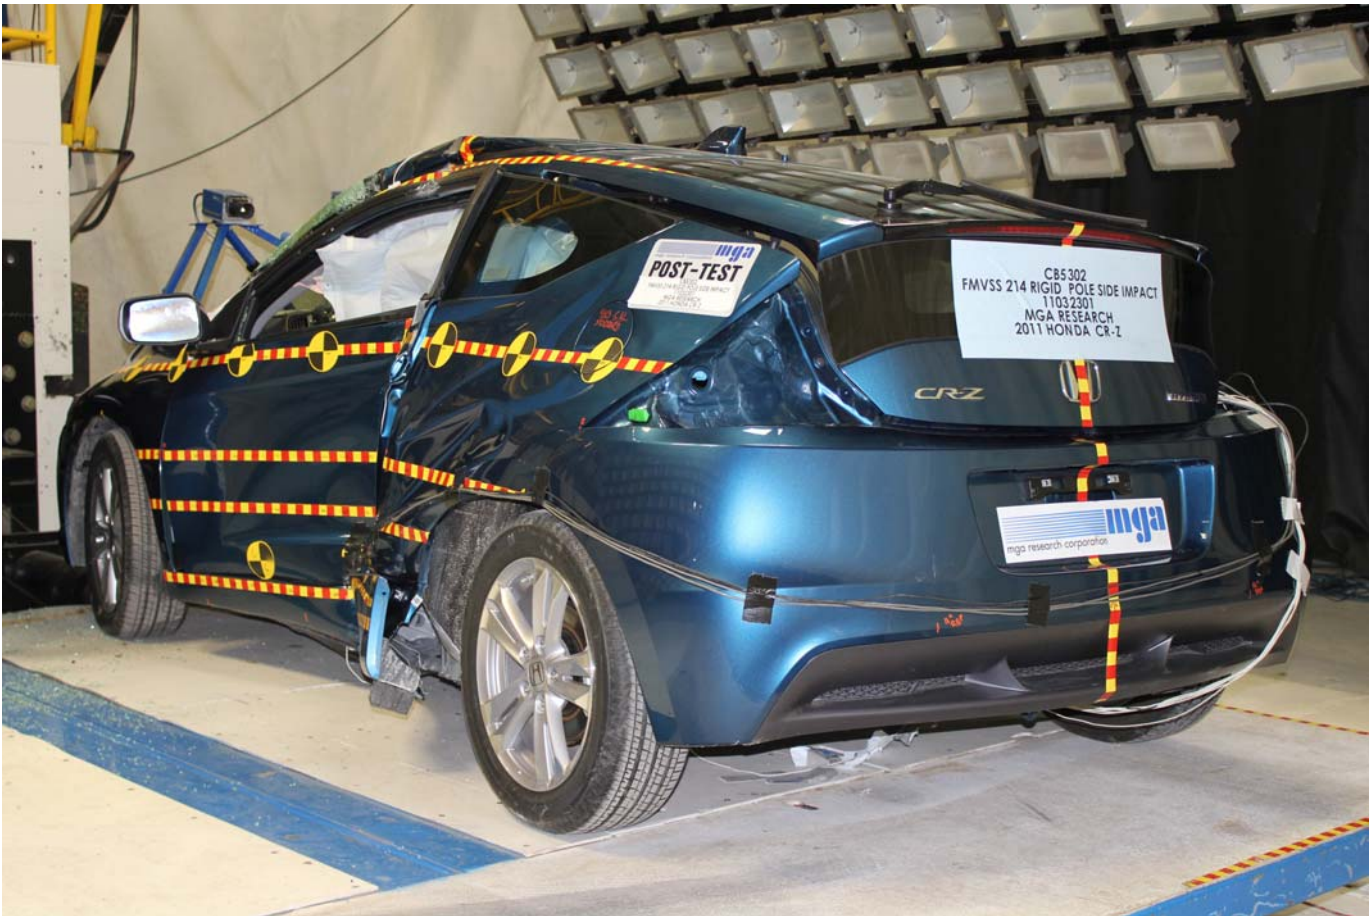
Post-Test $\frac{3}{4}$ Rear View of Impact Zone

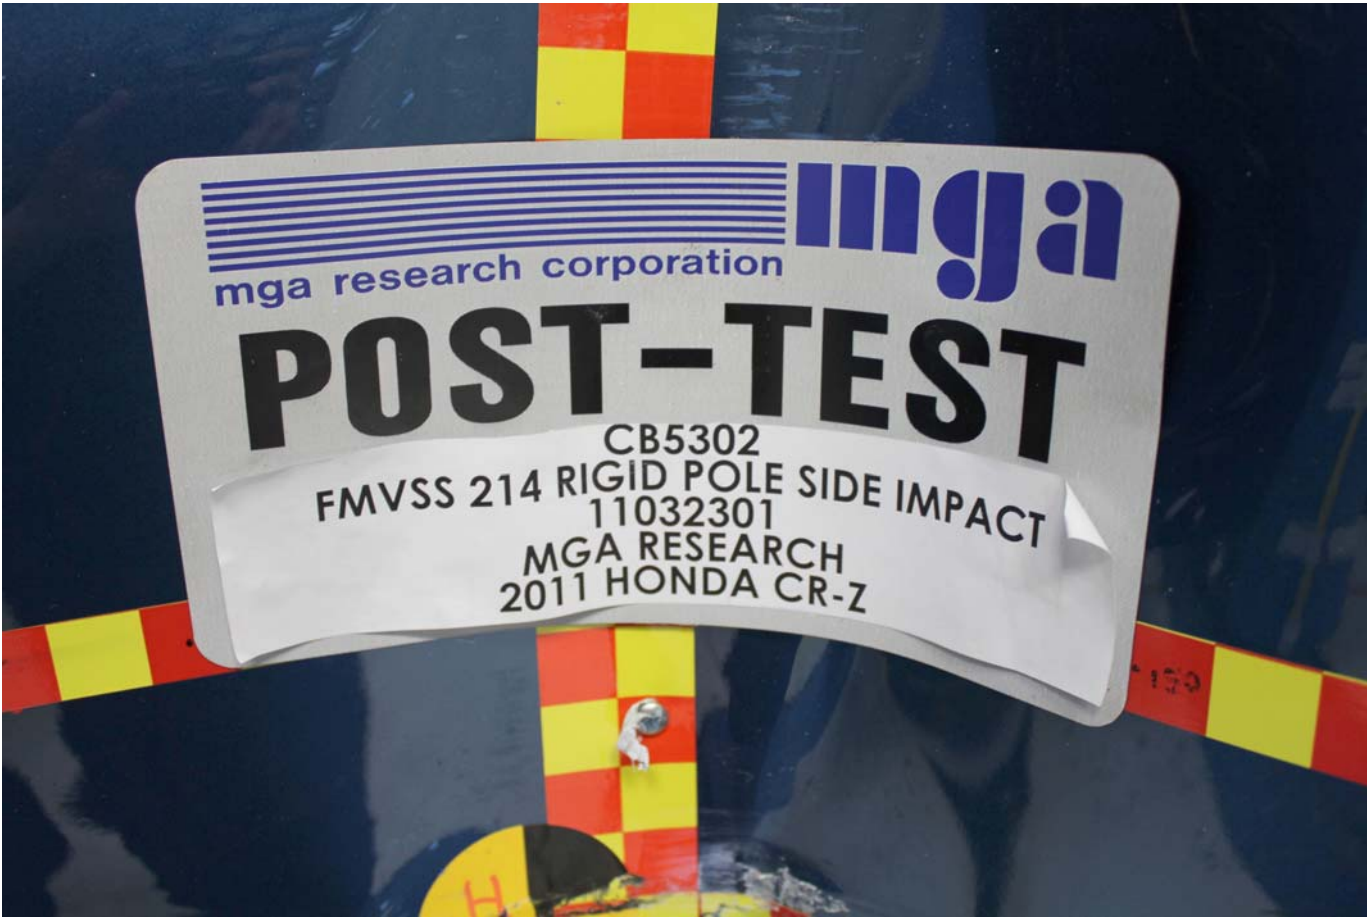
Post-Test Close-up View of Impact Point Target
