**REPORT NUMBER: 214P-MGA-2011-002**

**SAFETY COMPLIANCE TESTING FOR FMVSS 214  
DYNAMIC SIDE IMPACT PROTECTION  
RIGID POLE**

**NISSAN MOTOR CO., LTD.  
2011 NISSAN ALTIMA S 4-DR SEDAN  
NHTSA NUMBER: CB5204**

**PREPARED BY:  
MGA RESEARCH CORPORATION  
5000 WARREN ROAD  
BURLINGTON, WI 53105**

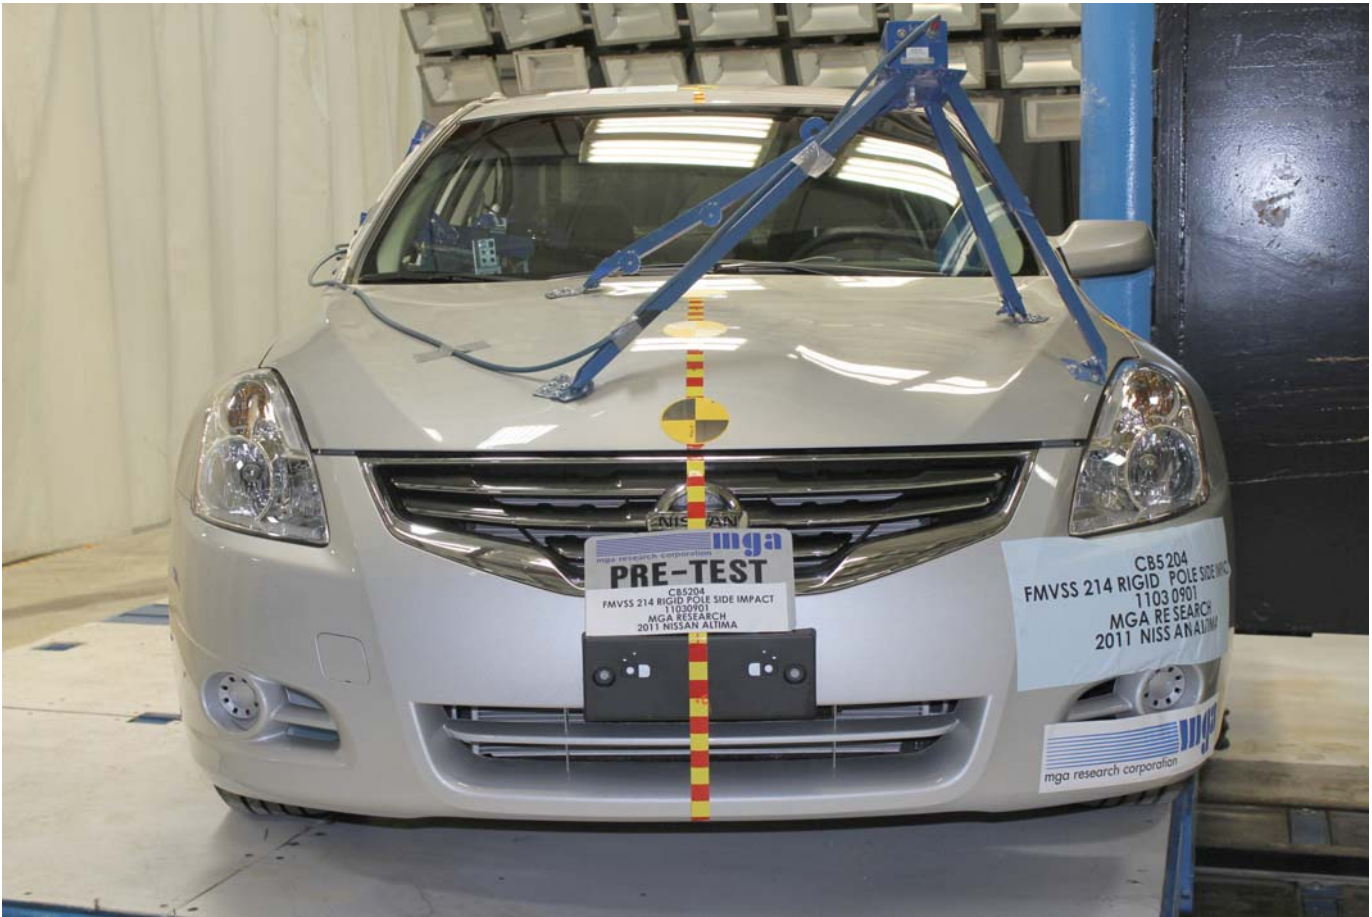
Pre-Test Frontal View of Test Vehicle

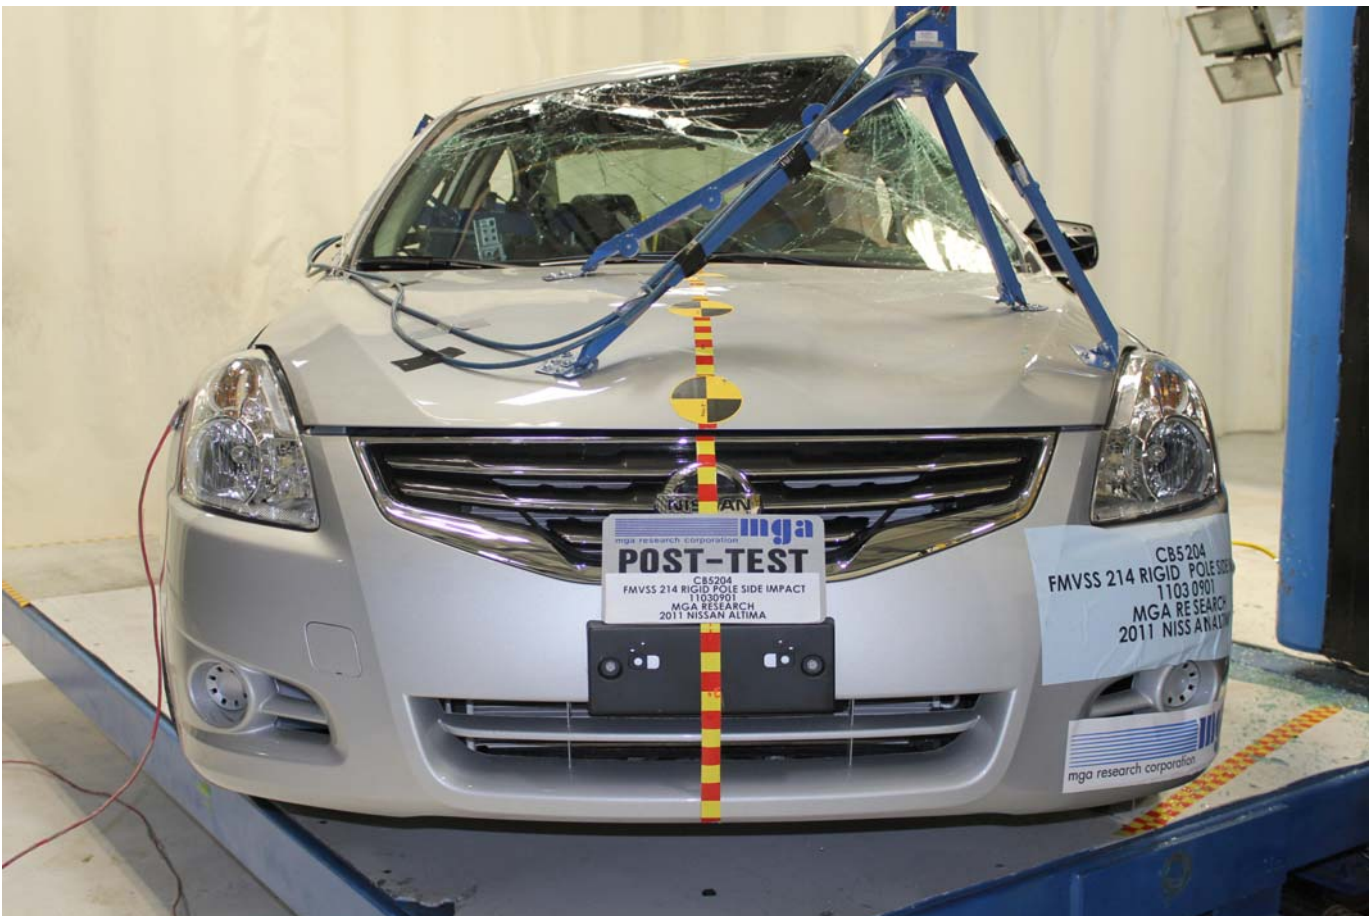
Post-Test Frontal View of Test Vehicle

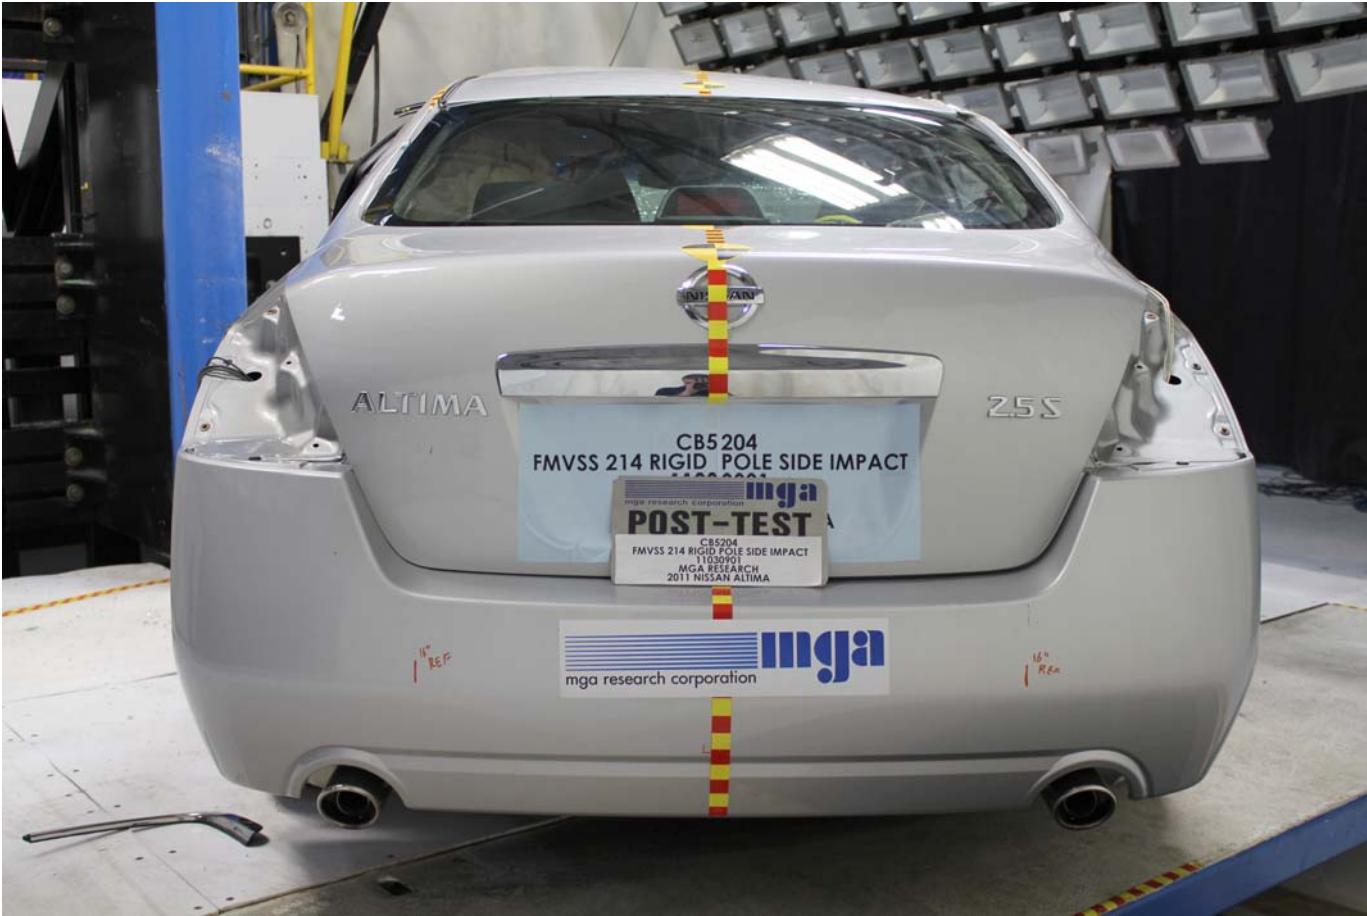
Post-Test Rear View of Test Vehicle

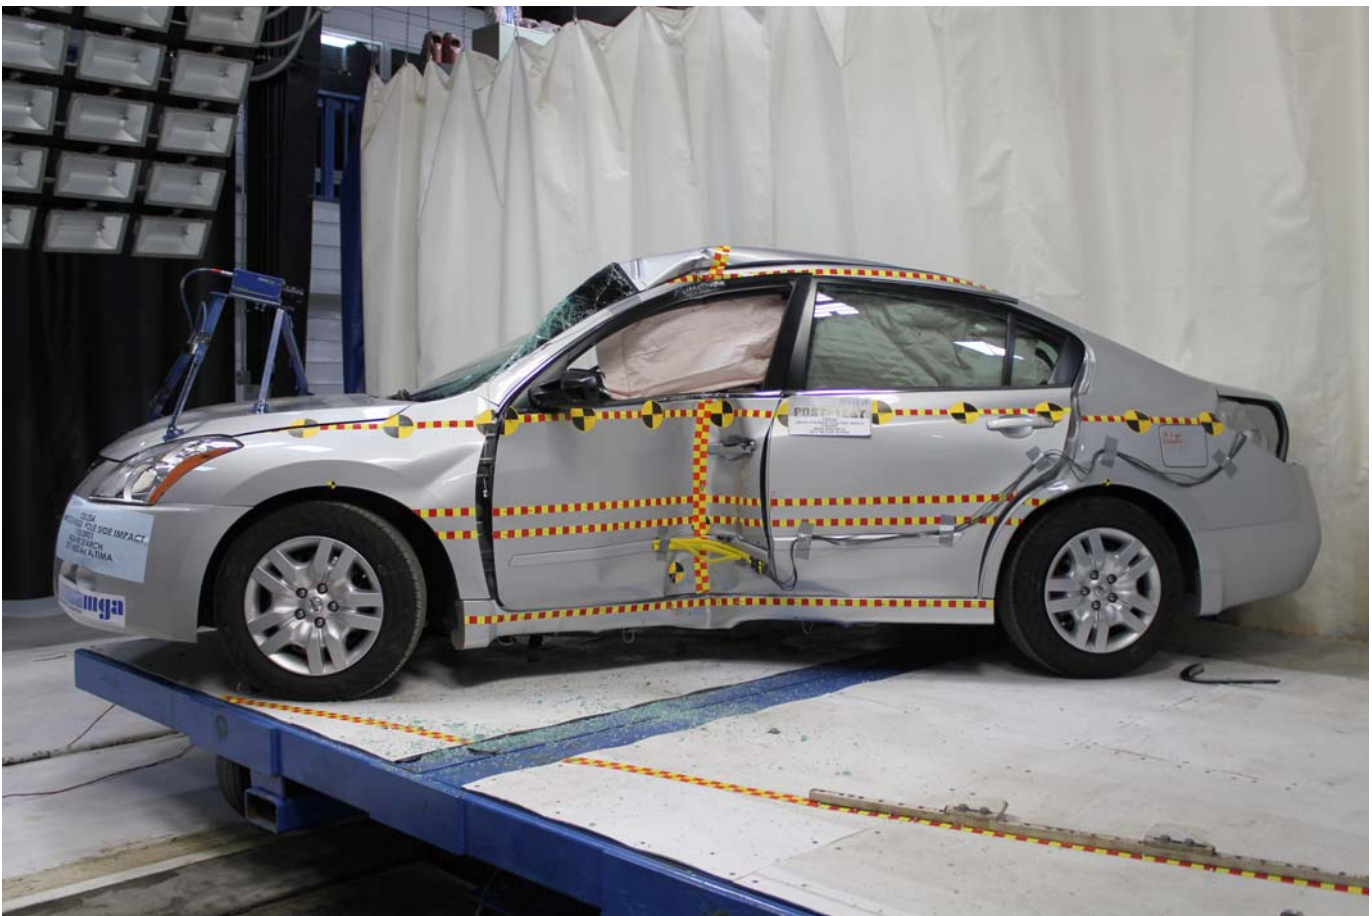
Post-Test Impacted Side View of Test Vehicle

Description	Front	Rear
Left Side Doors	Remained closed and jammed shut	Remained closed and jammed shut
Right Side Doors	Remained closed and operational	Remained closed and operational
Hatch and Other Doors		
Seat Movement	0	0
Seat Back Failure	None	None

Critical Areas of Performance	Observations and Conclusions
Pillar Performance	No Separation
Sill Separation	None
Windshield Damage	Cracked
Window Damage	Left Front Window Broke
Other Notable Effects	None

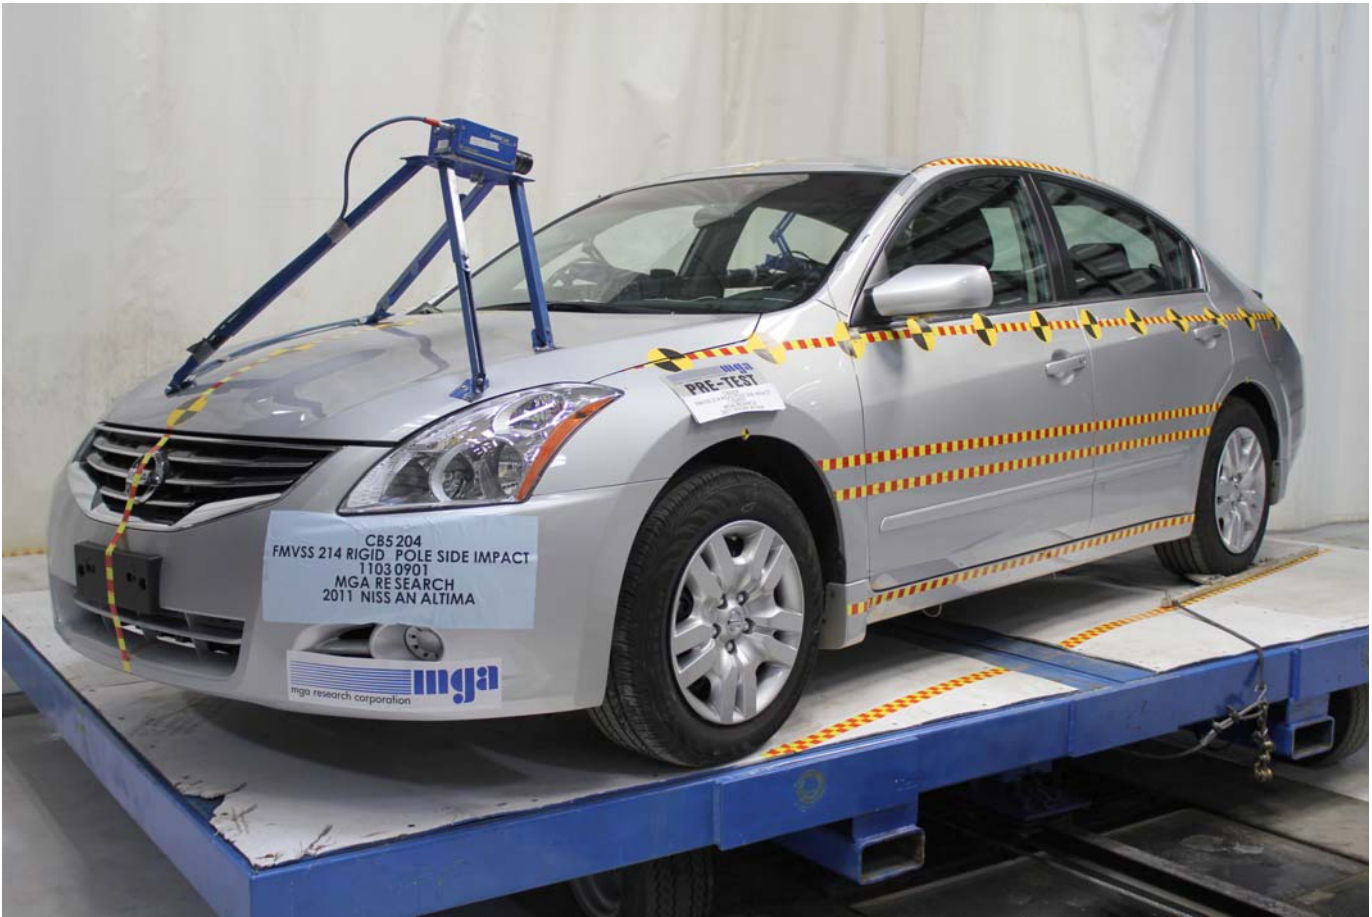
Pre-Test Left  $\frac{3}{4}$  Front View of Vehicle and Pole

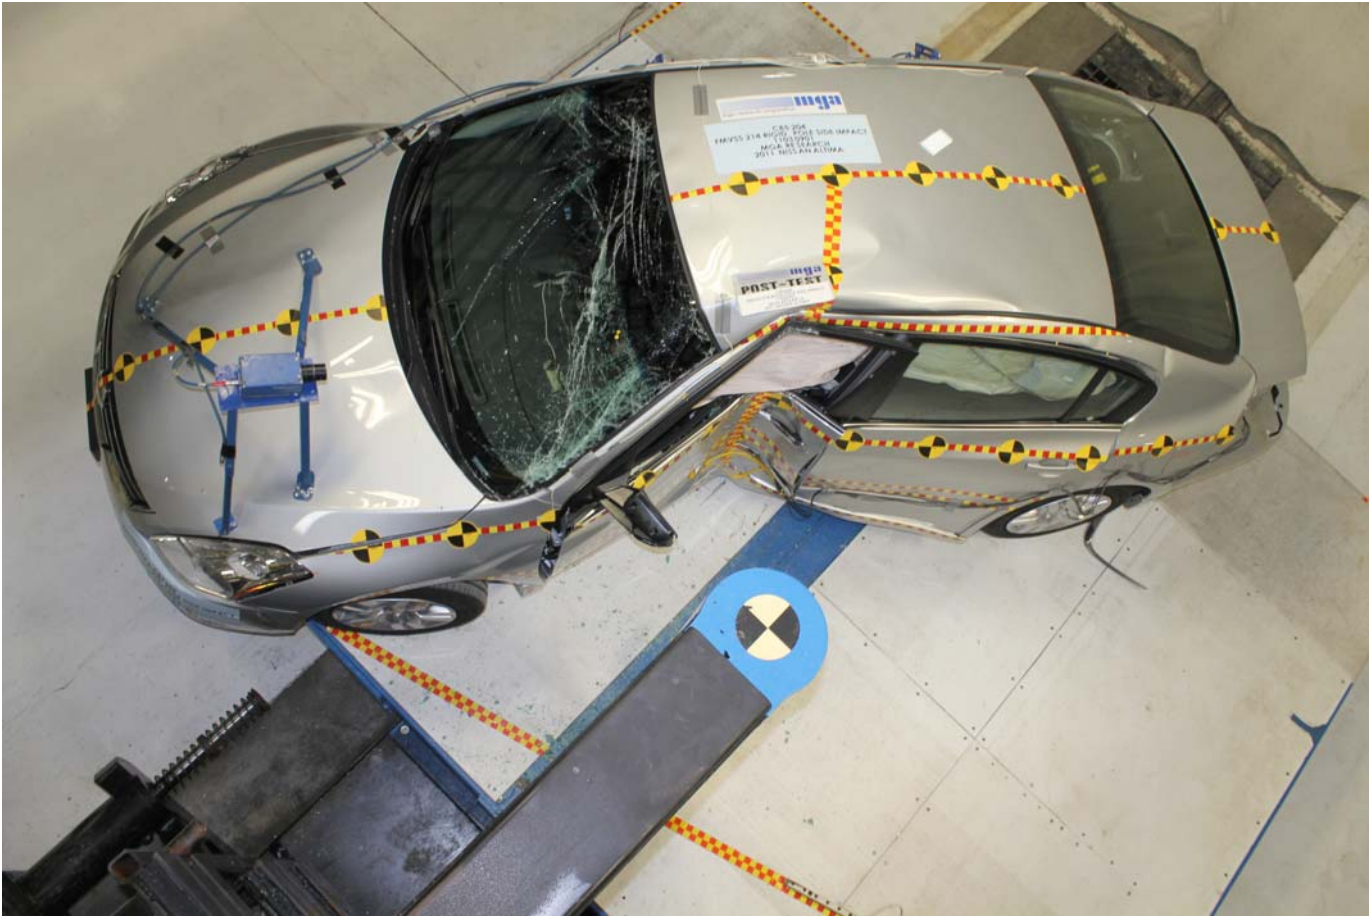
Post-Test Overhead View of Test Vehicle

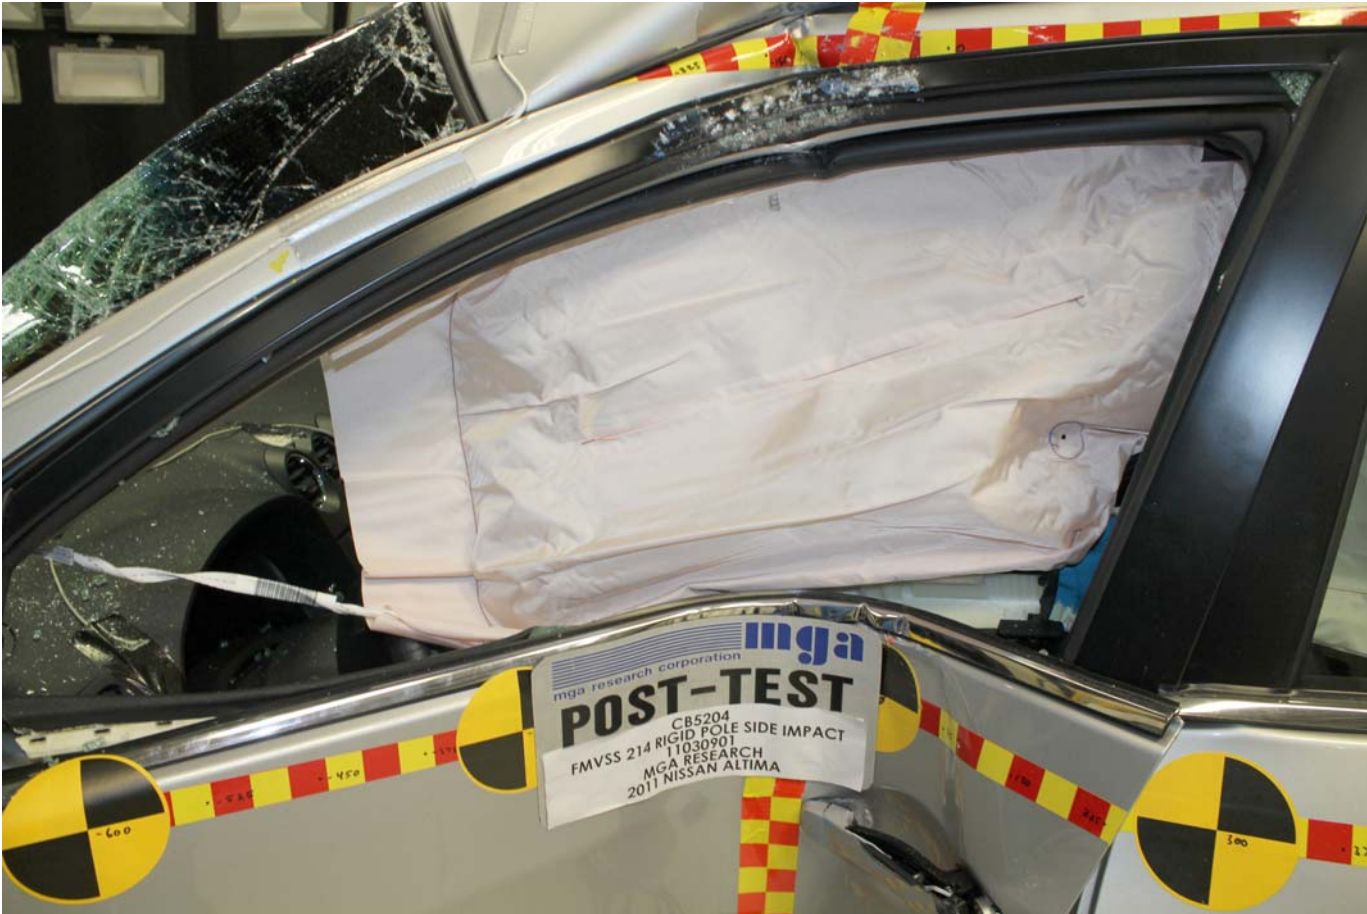
Post-Test Dummy with Door Closed (Impact Side)

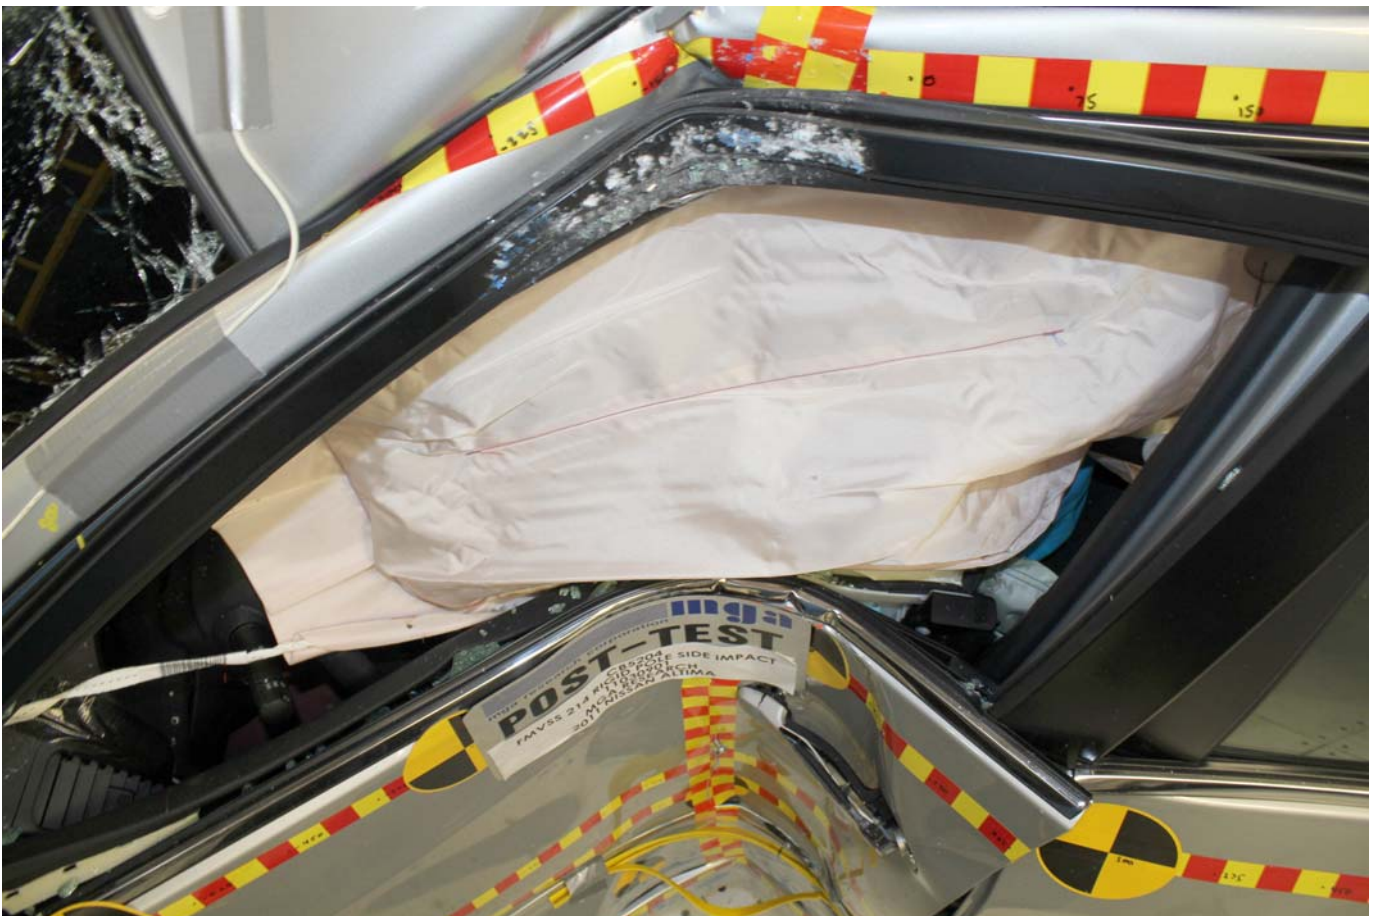
Post-Test Dummy Shoulder and Door Top View

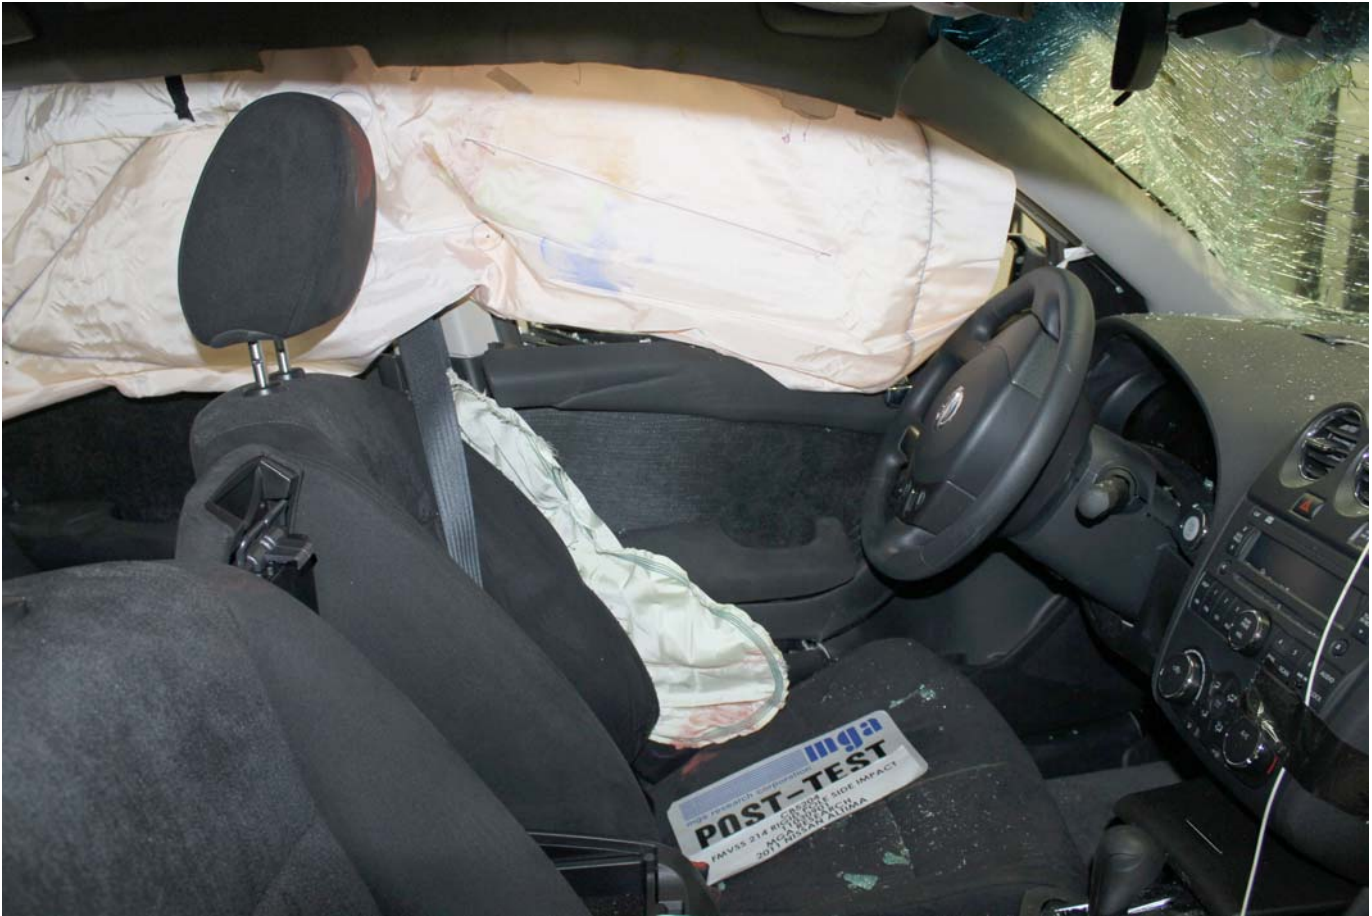
Post-Test Interior of Front Door Showing Dummy Impact Locations

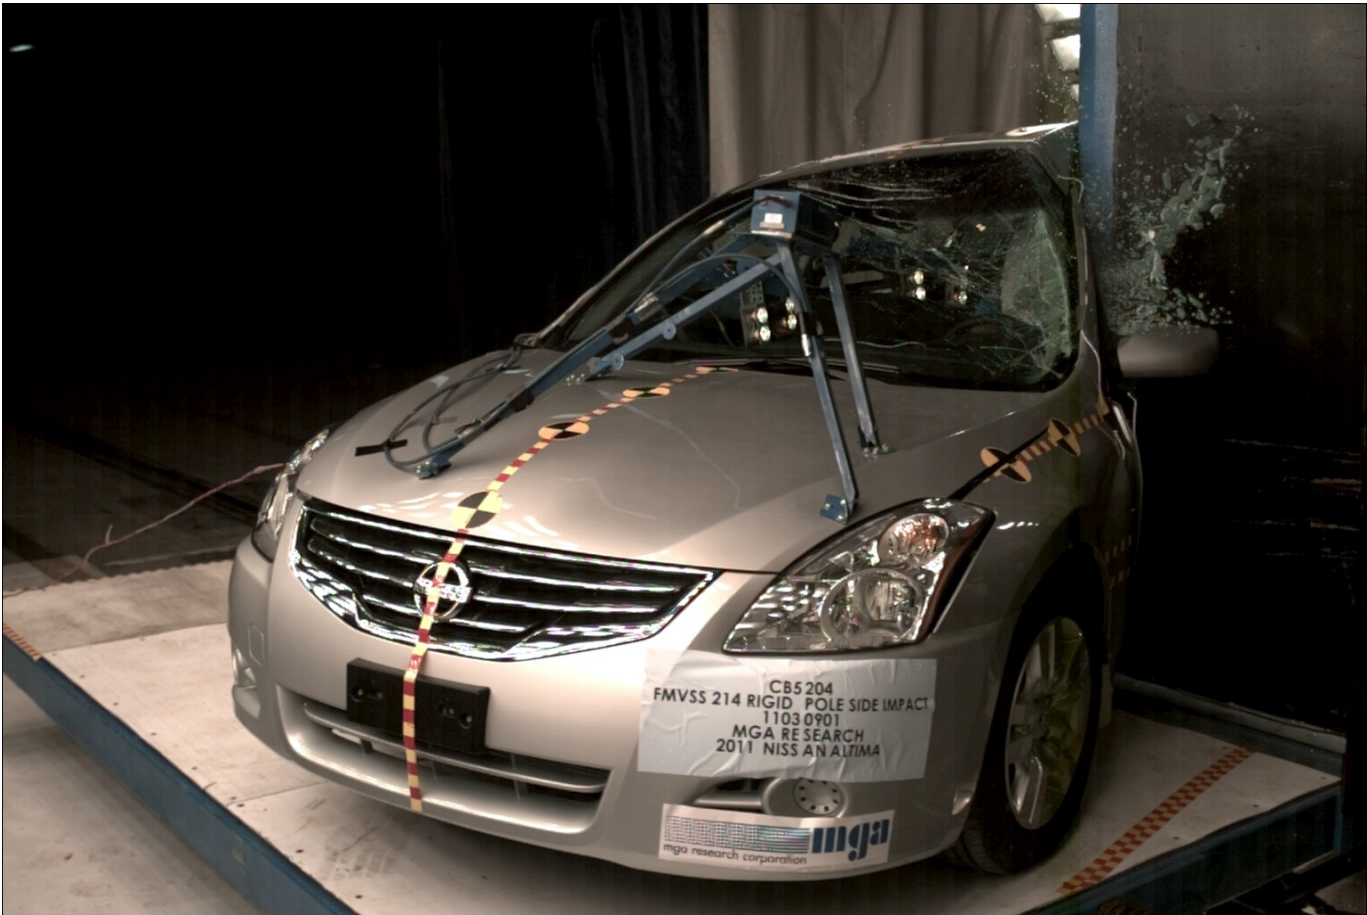
Impact Event

A rigid pole side impact test was conducted on a 2011 Nissan Altima S 4-Dr Sedan. The subject vehicle was towed into the rigid pole at an angle of 75° and a velocity of 31.5 km/h. The test was conducted by MGA Research Corporation in Burlington, Wisconsin, on March 9, 2011. Pre-test and post-test photographs of the test vehicle and side impact dummy are included in Appendix A of this report.

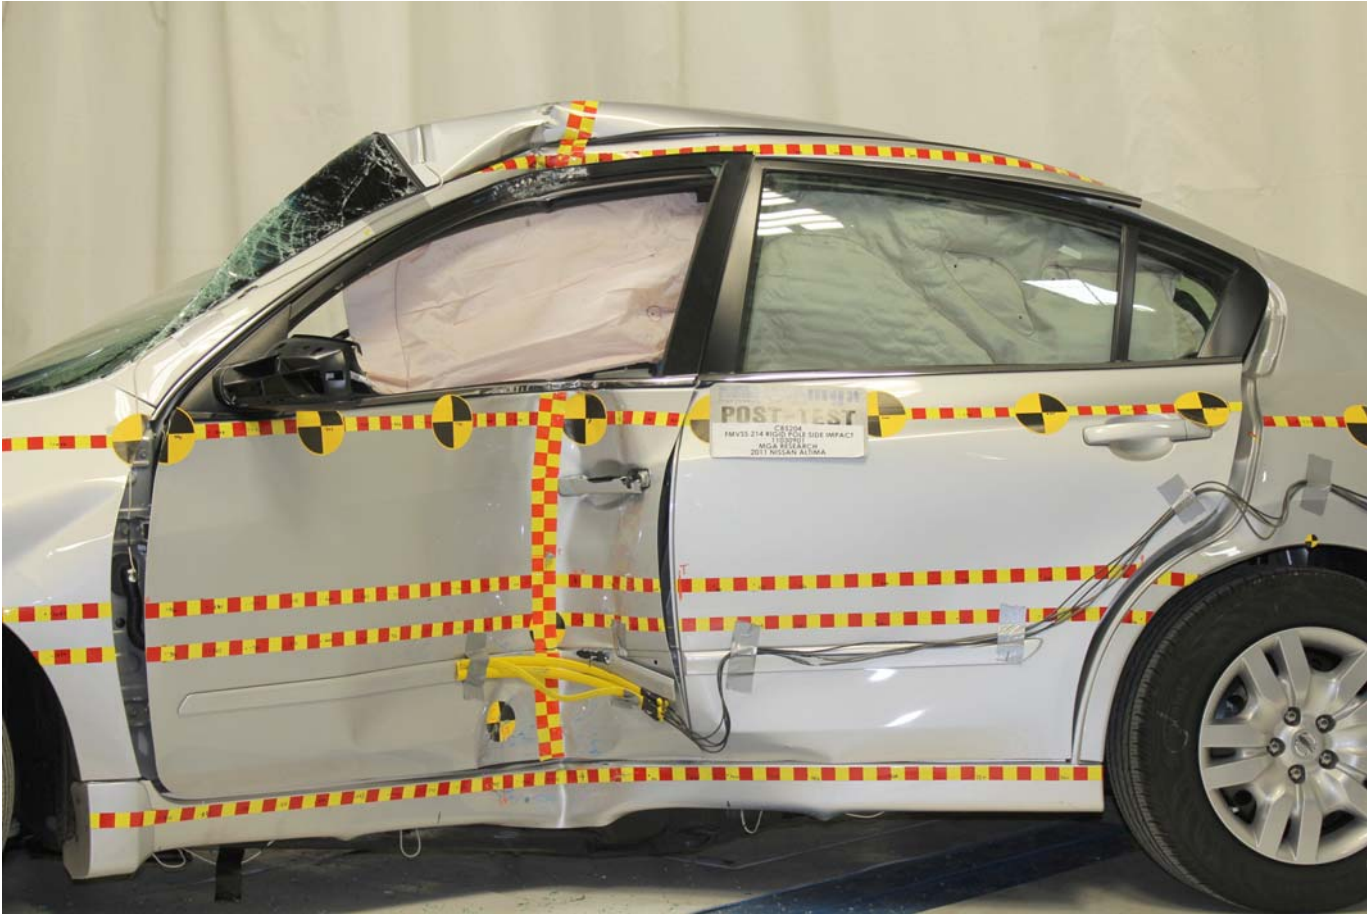
Post-Test Impact Zone Close-up View

<b>1. Report No.</b> 214P-MGA-2011-002	<b>2. Government Accession No.</b>	<b>3. Recipient's Catalog No.</b>																
<b>4. Title and Subtitle</b> Final Report of FMVSS 214P Compliance Test Side Impact Protection Testing of 2011 Nissan Altima S 4-Dr Sedan; NHTSA No.: CB5204		<b>5. Report Date</b> April 14, 2011																
		<b>6. Performing Organization Code</b> MGA																
<b>7. Author(s)</b> Donna Janovicz, Project Manager Joe Fleck, Project Engineer		<b>8. Performing Organization Report No.</b> 214P-MGA-2011-002																
<b>9. Performing Organization Name and Address</b> MGA Research Corporation 5000 Warren Road Burlington, WI 53105		<b>10. Work Unit No.</b>																
		<b>11. Contract or Grant No.</b> DTNH22-07-D-00062																
<b>12. Sponsoring Agency Name and Address</b> U.S. Department of Transportation National Highway Traffic Safety Administration Office of Vehicle Safety Compliance (NVS-220) 1200 New Jersey Ave, SE Washington, DC 20590		<b>13. Type of Report and Period Covered:</b> Final Test Report 3/09/2011 to 4/14/2011																
		<b>14. Sponsoring Agency Code</b> NVS-220																
<b>15. Supplementary Notes</b>																		
<b>16. Abstract</b> A 32 km/h (20 mph), 75° oblique impact compliance test was conducted on the subject 2011 Nissan Altima S 4-Dr Sedan in accordance with the specifications of the Office of Vehicle Safety Compliance TP-214P-01 for the determination of FMVSS No. 214 Side Impact Protection compliance. The test was conducted at MGA Research Corporation, in Burlington, Wisconsin, on March 9, 2011.  The impact velocity was 31.5 km/h, and the ambient temperature at the struck (driver's) side of the test vehicle at the time of impact was 21°C. The test vehicle post-test maximum crush was 393 mm at level 3. The test vehicle's performance follows:

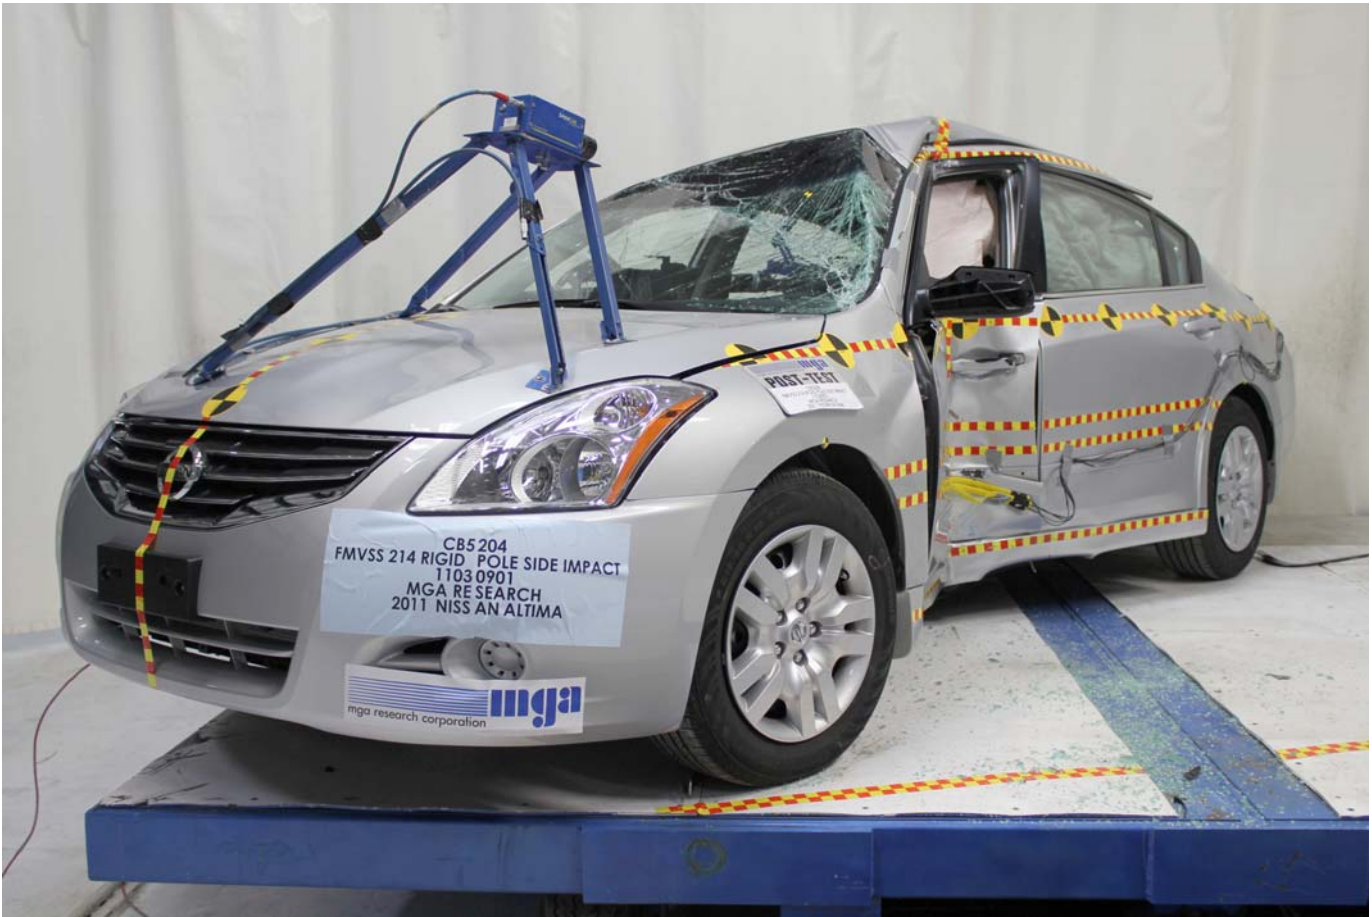
Post-Test  $\frac{3}{4}$  Front View of Impact Zone

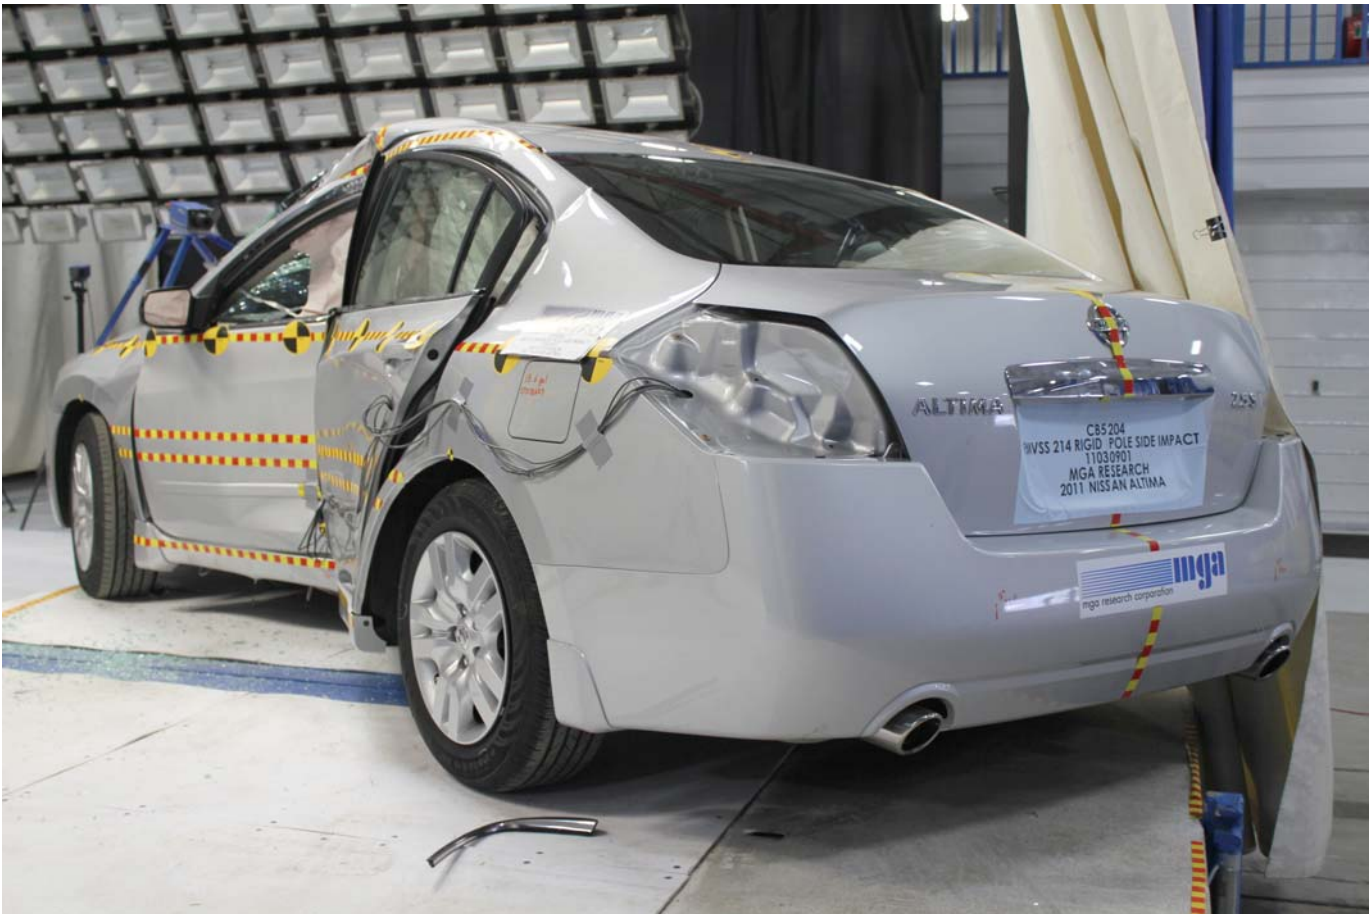
Post-Test  $\frac{3}{4}$  Rear View of Impact Zone

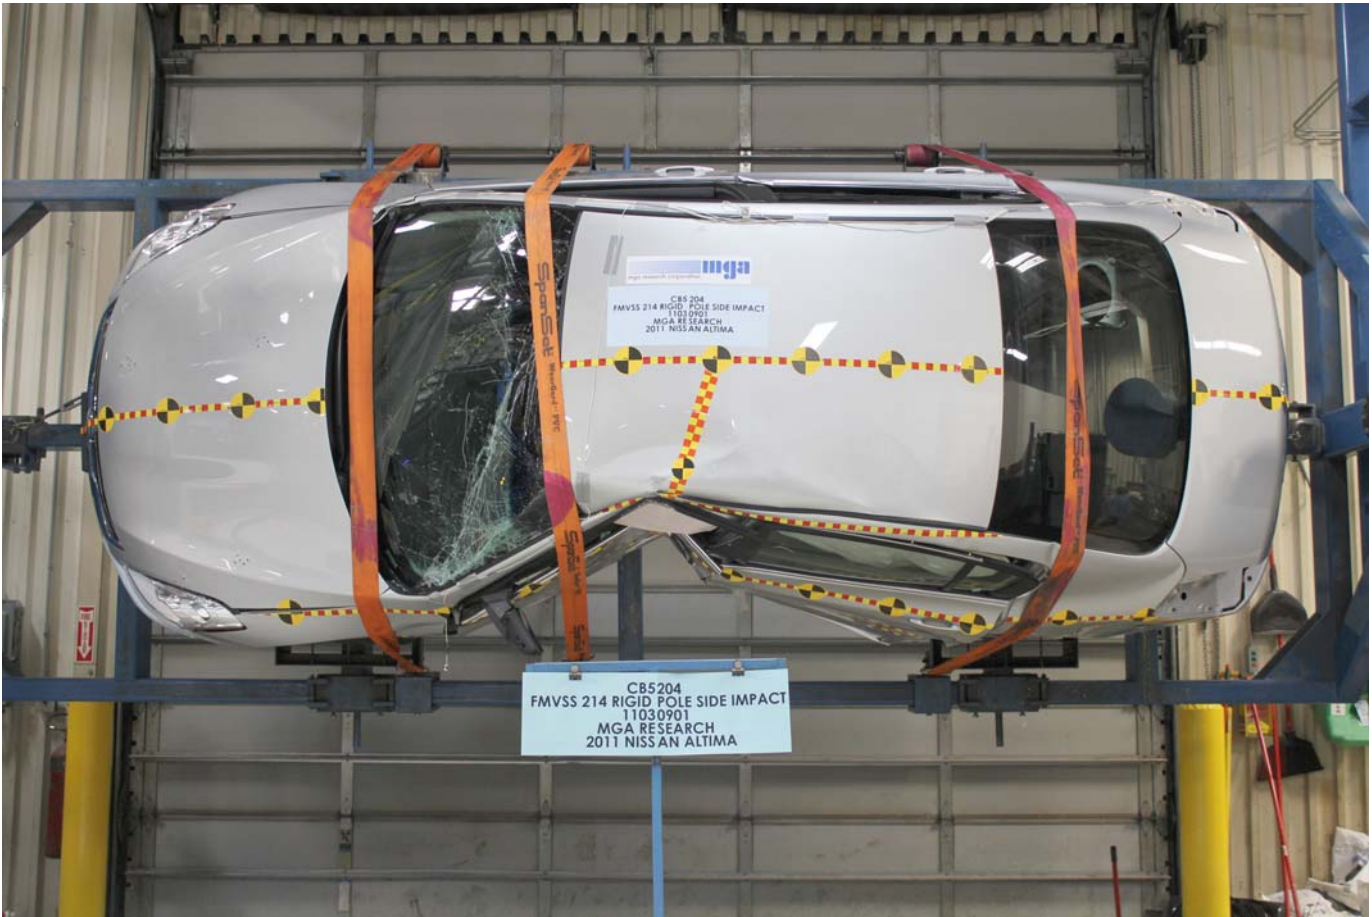
Post-Test Vehicle at 90 Degree Rollover

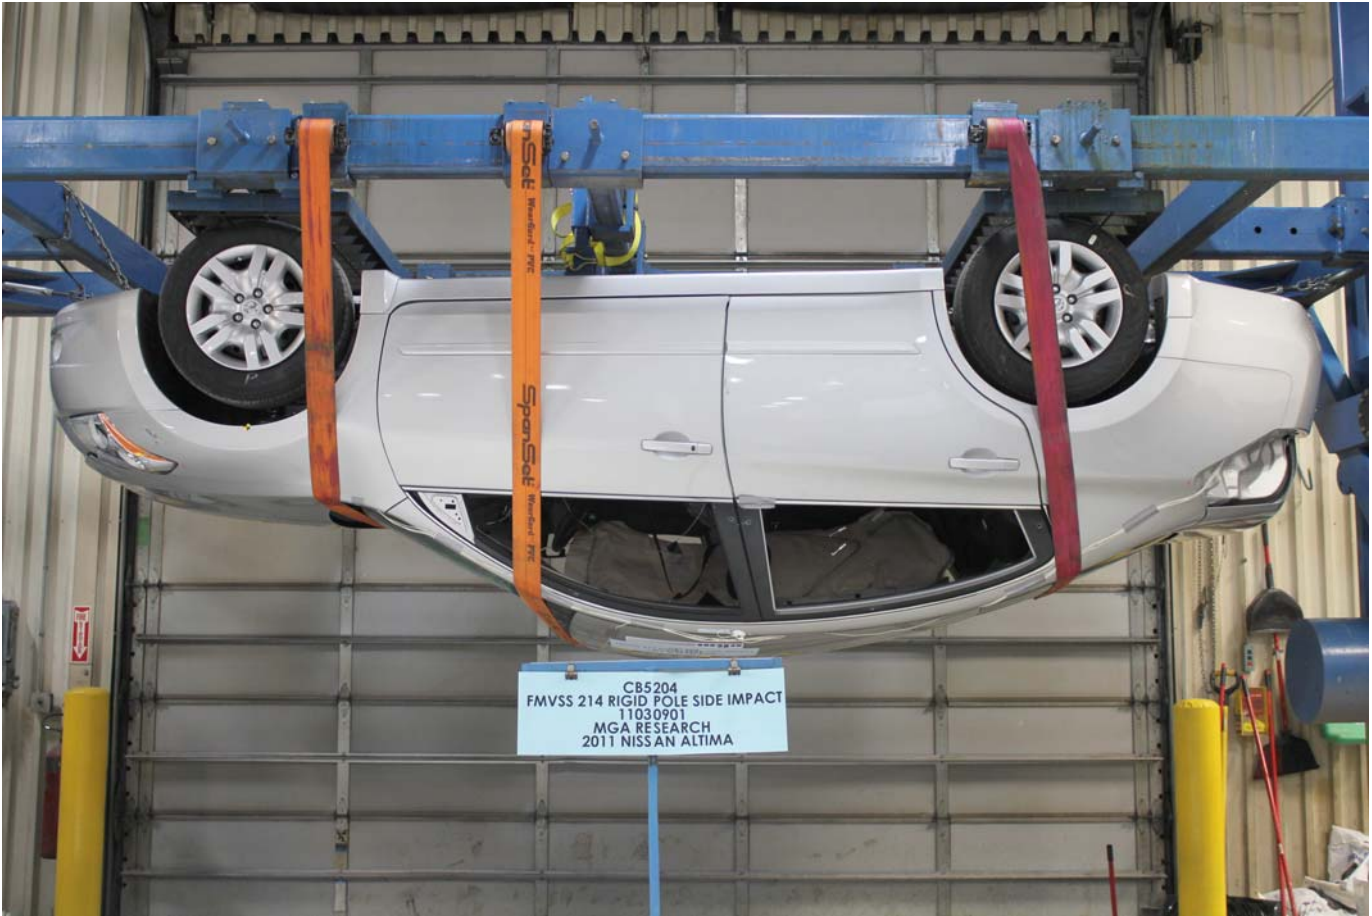
Post-Test Vehicle at 180 Degree Rollover

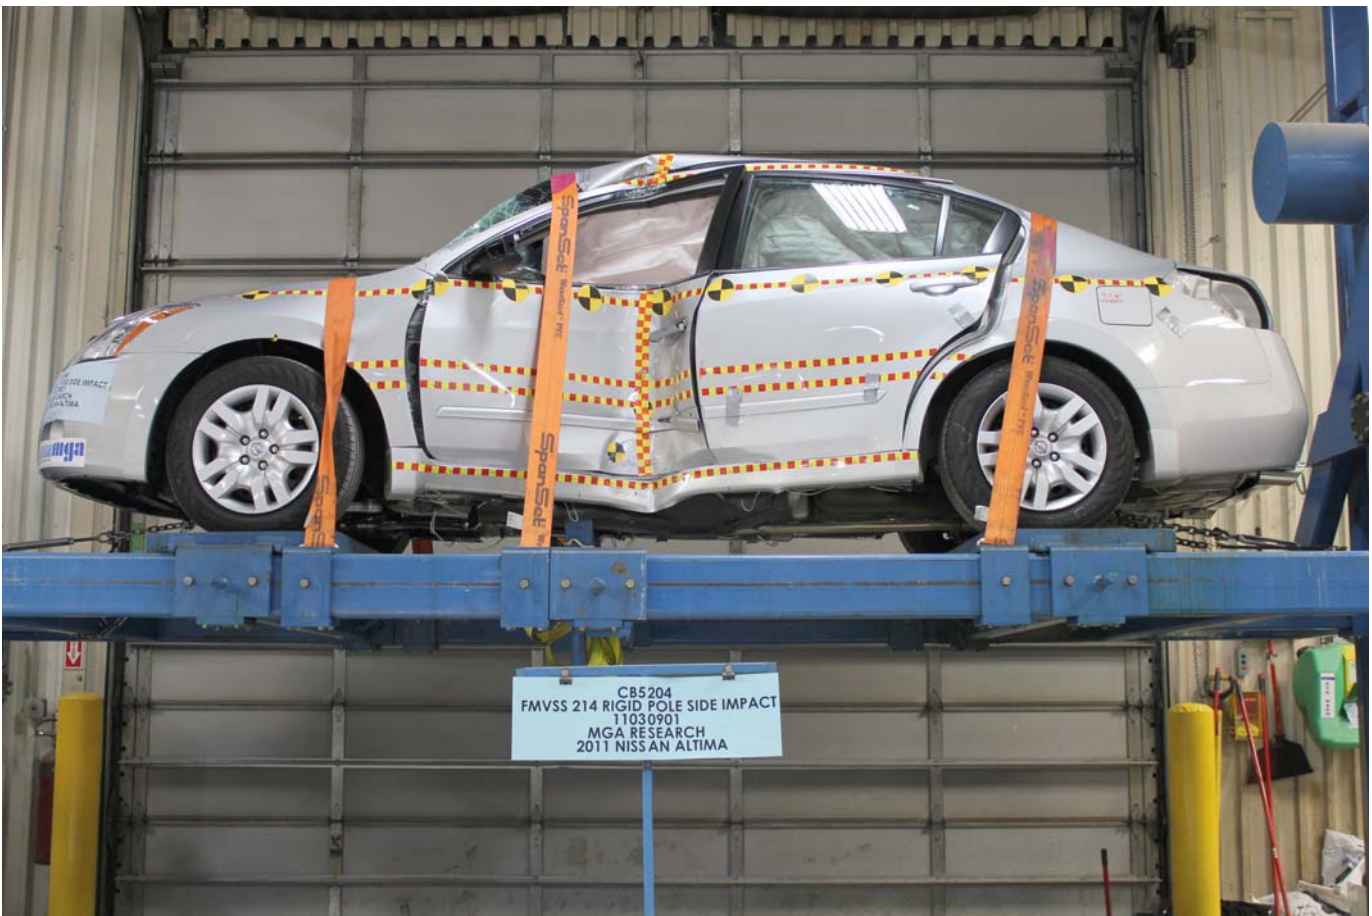
Post-Test Vehicle at 360 Degree Rollover
