REPORT NUMBER: 214P-MGA-2011-015

**SAFETY COMPLIANCE TESTING FOR FMVSS 214
DYNAMIC SIDE IMPACT PROTECTION
RIGID POLE**

**FUJI HEAVY INDUSTRIES LTD.
2011 SUBARU LEGACY 4-DR SEDAN
NHTSA NUMBER: CB5502**

**PREPARED BY:
MGA RESEARCH CORPORATION
5000 WARREN ROAD
BURLINGTON, WI 53105**

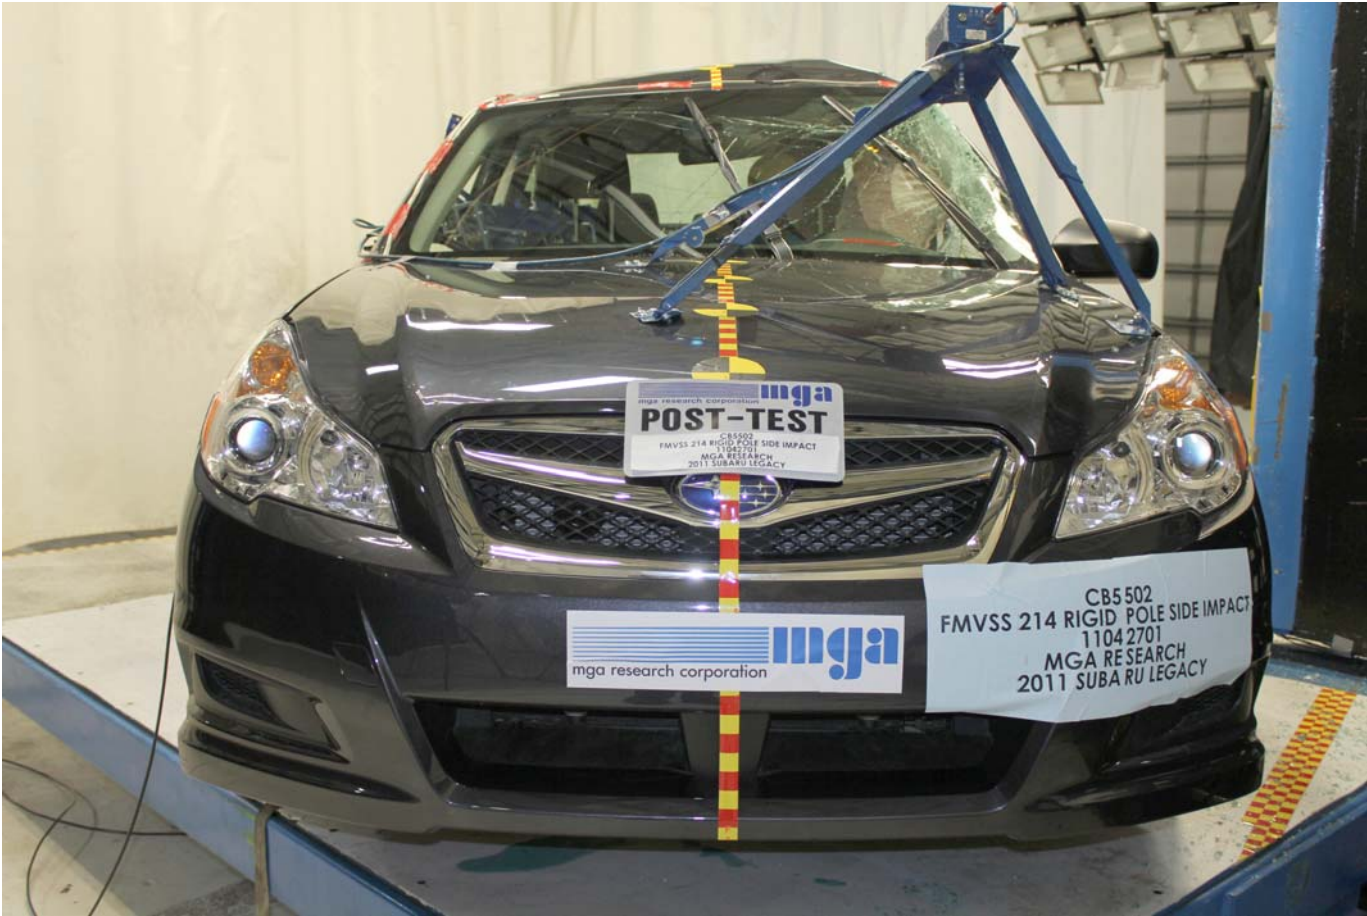
Post-Test Frontal View of Test Vehicle

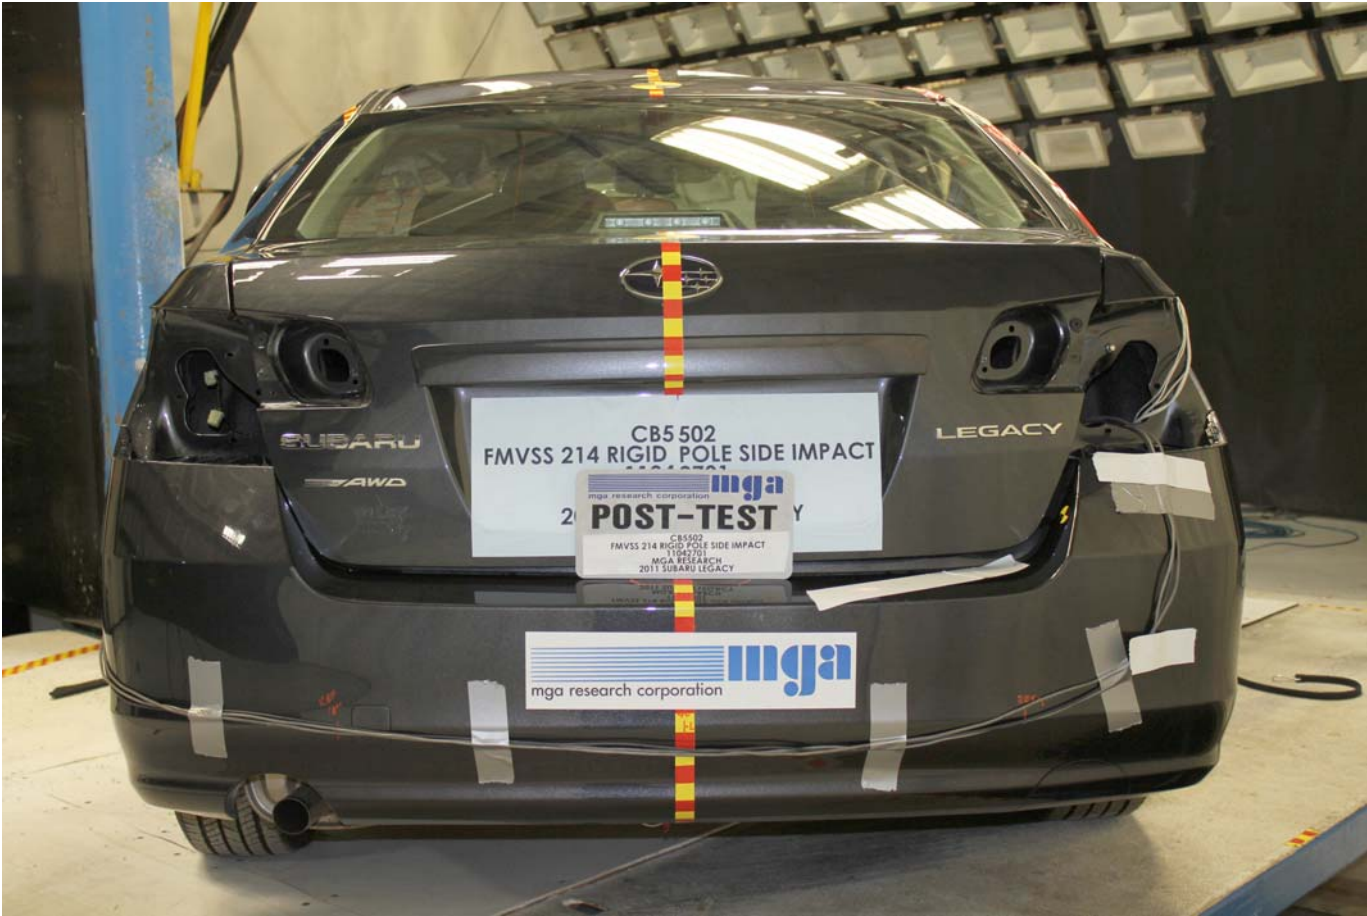
Post-Test Rear View of Test Vehicle

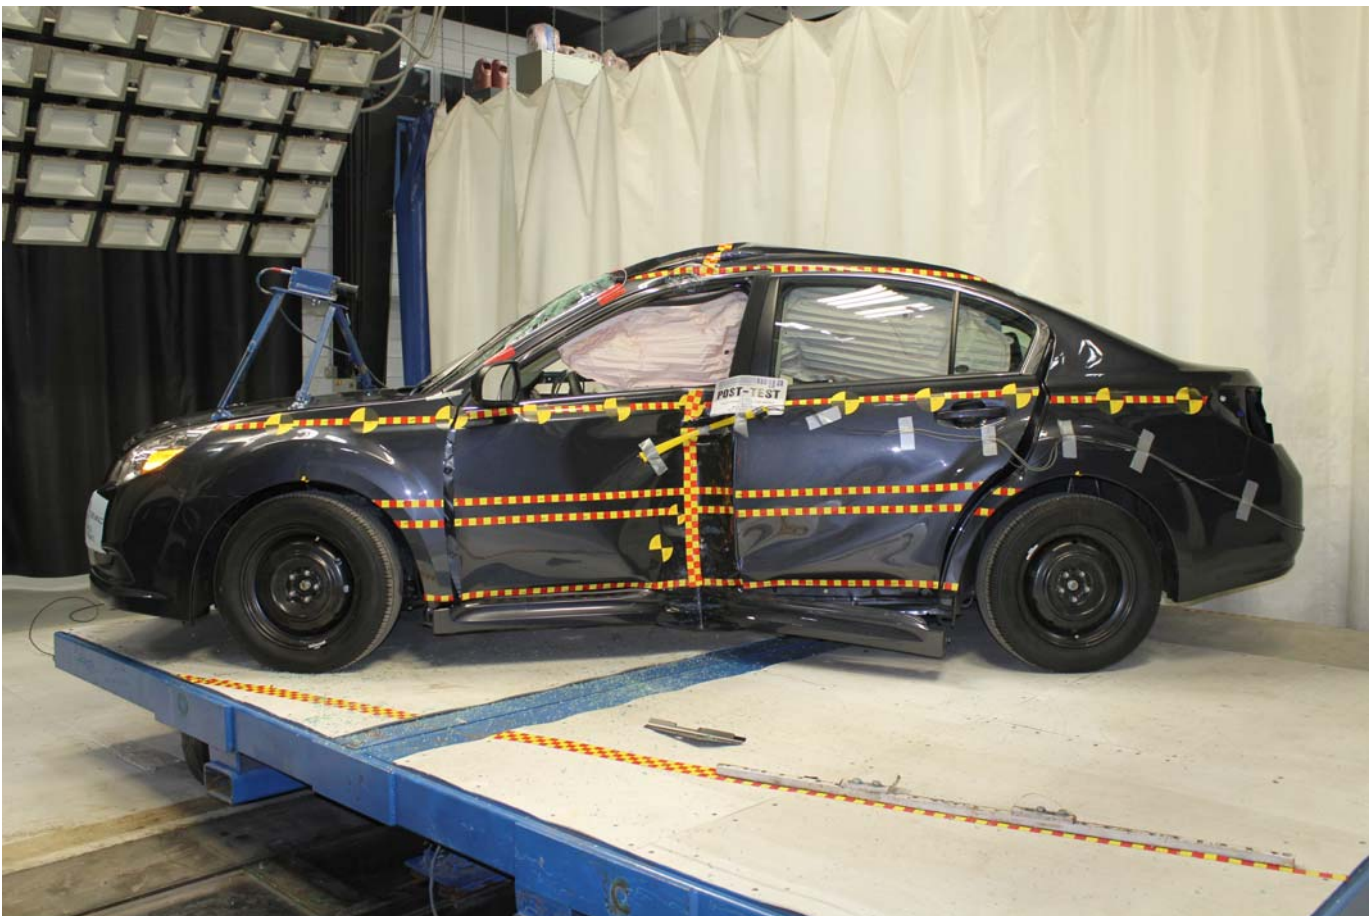
Post-Test Impacted Side View of Test Vehicle

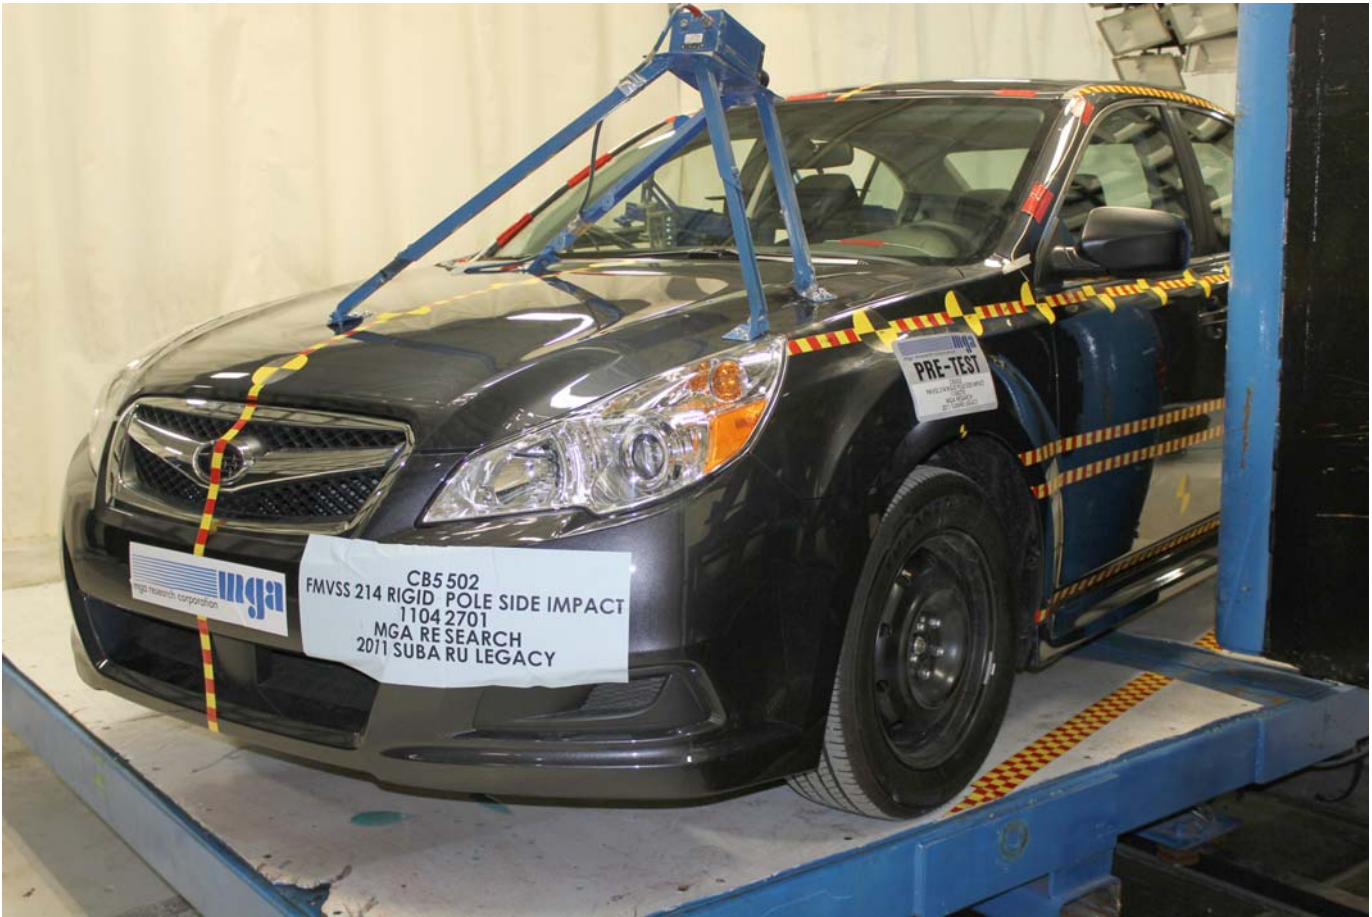
Pre-Test Left $\frac{3}{4}$ Front View of Vehicle and Pole

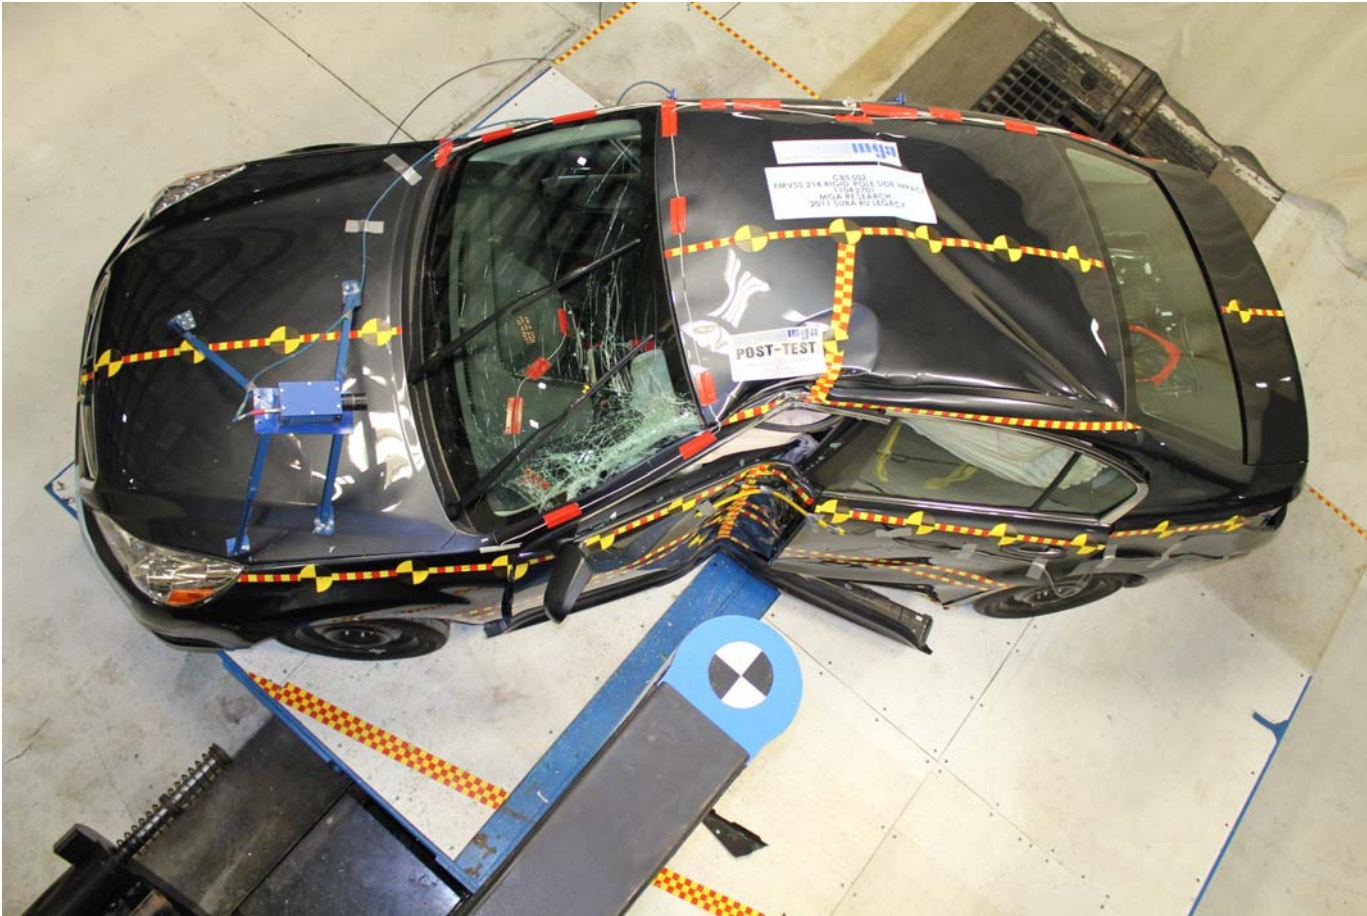
Post-Test Overhead View of Test Vehicle

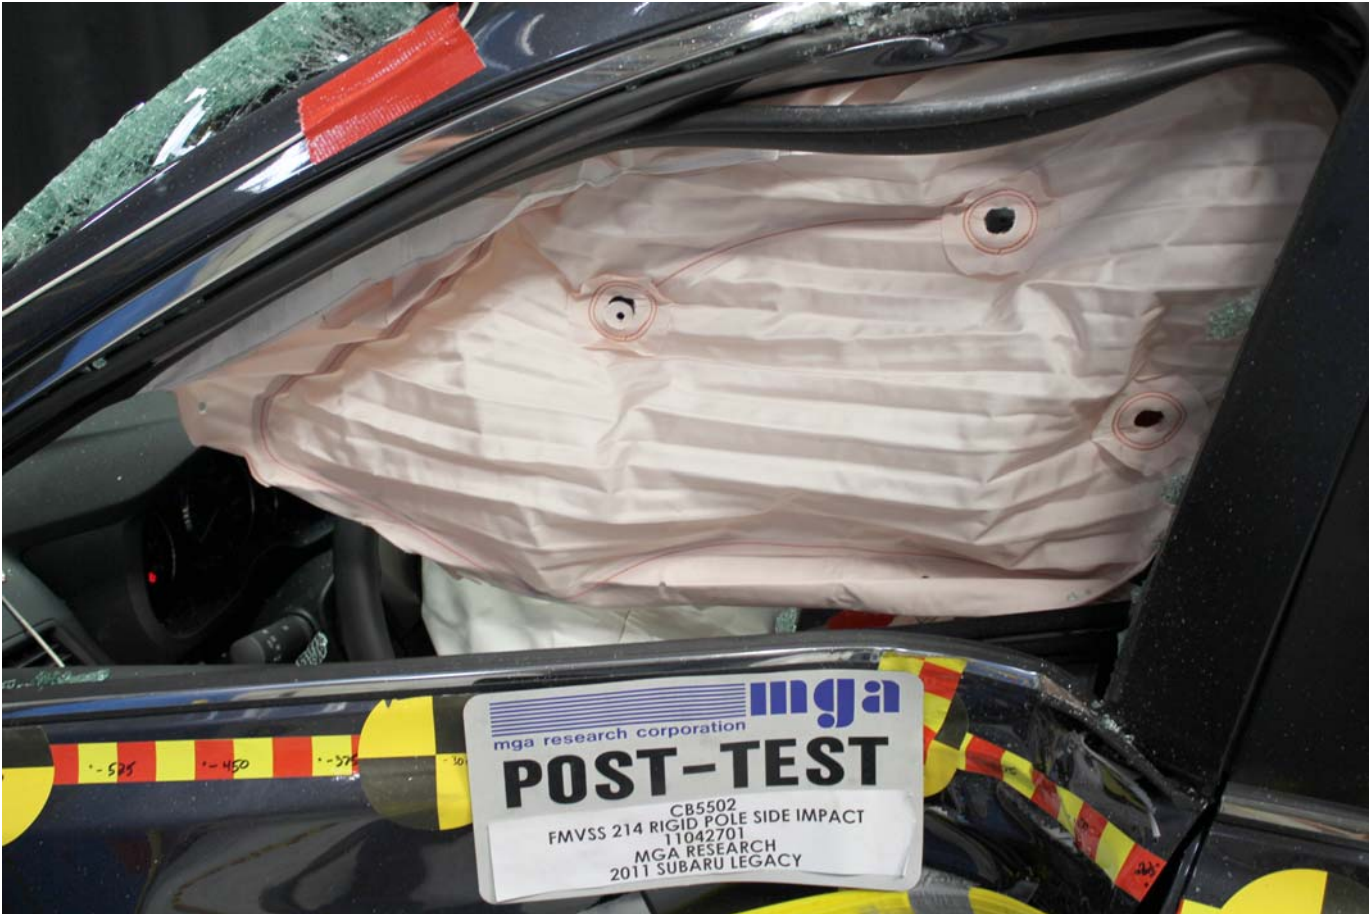
Post-Test Dummy with Door Closed (Impact Side)

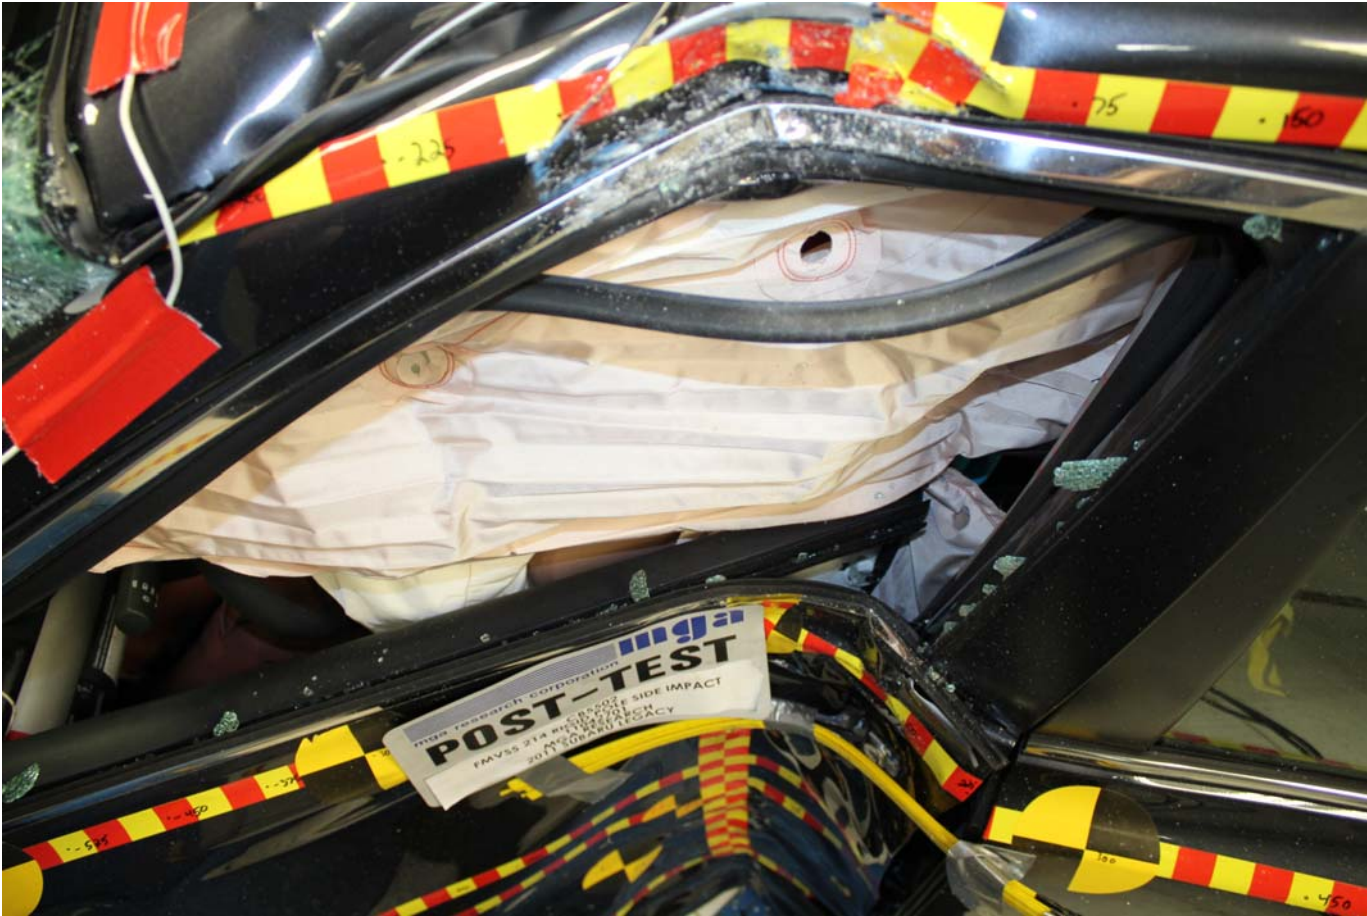
Post-Test Dummy Shoulder and Door Top View

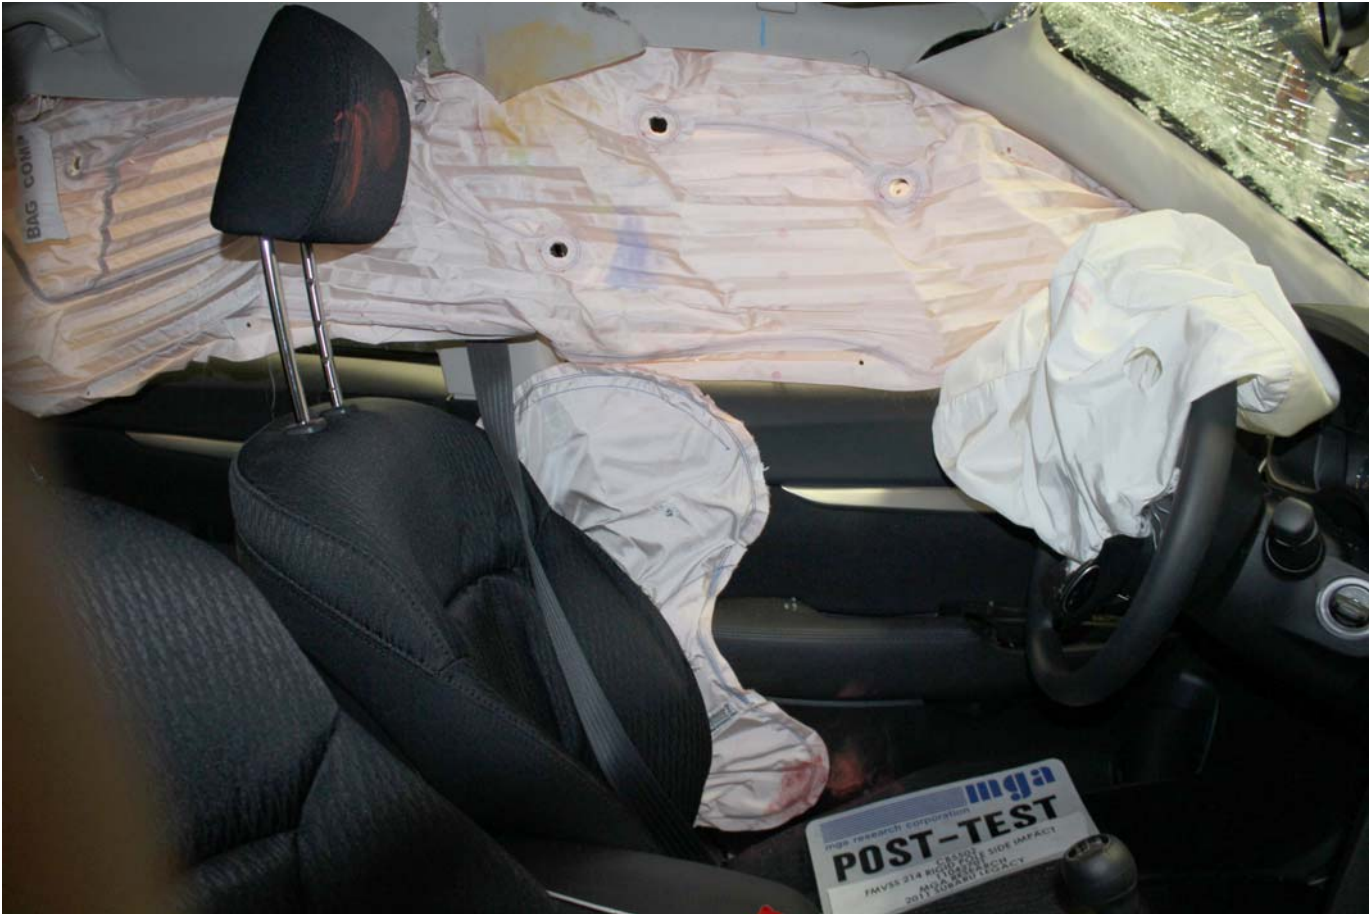
Post-Test Interior of Front Door Showing Dummy Impact Locations

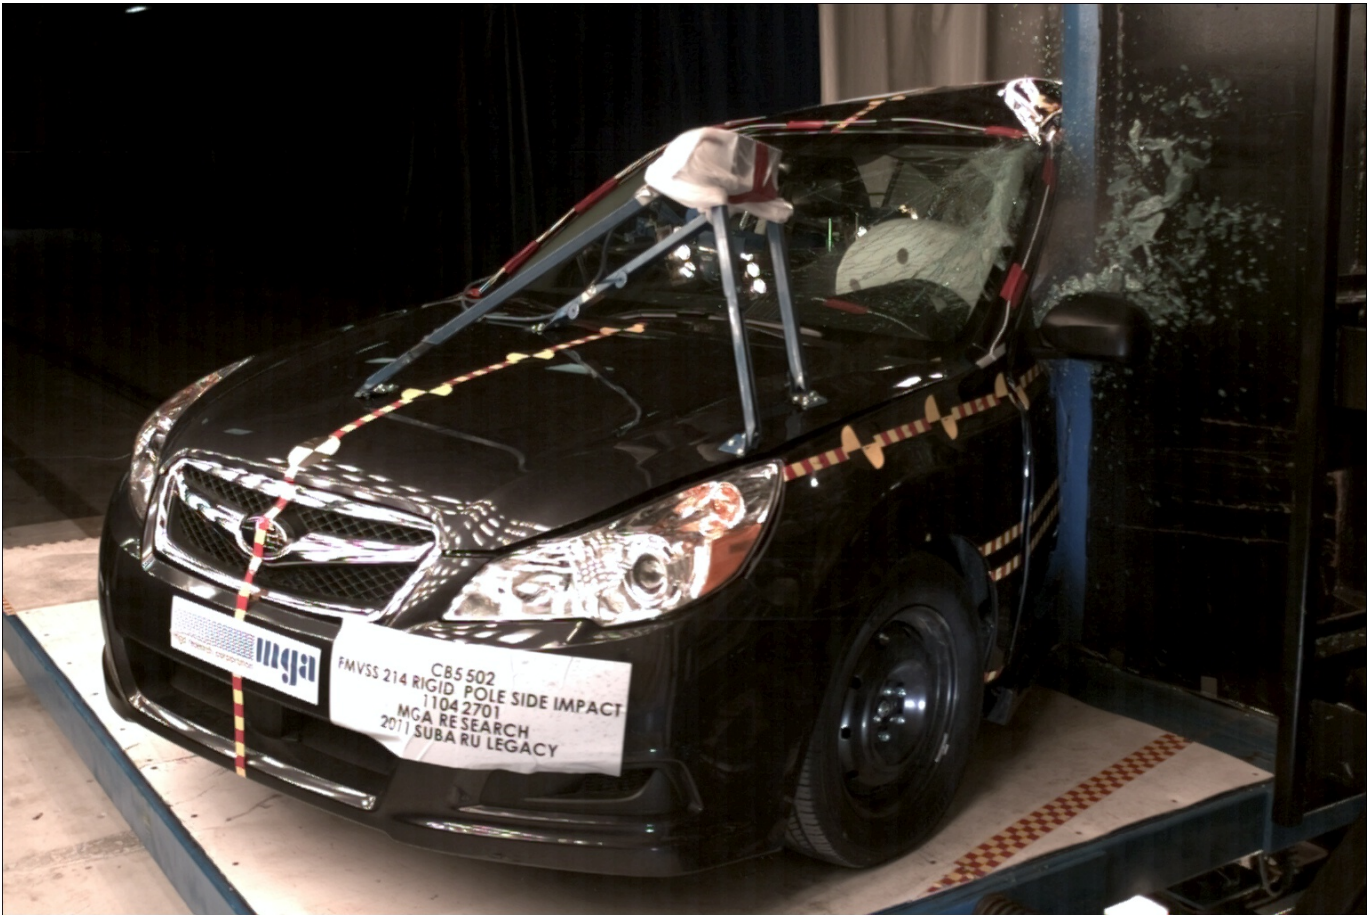
Impact Event

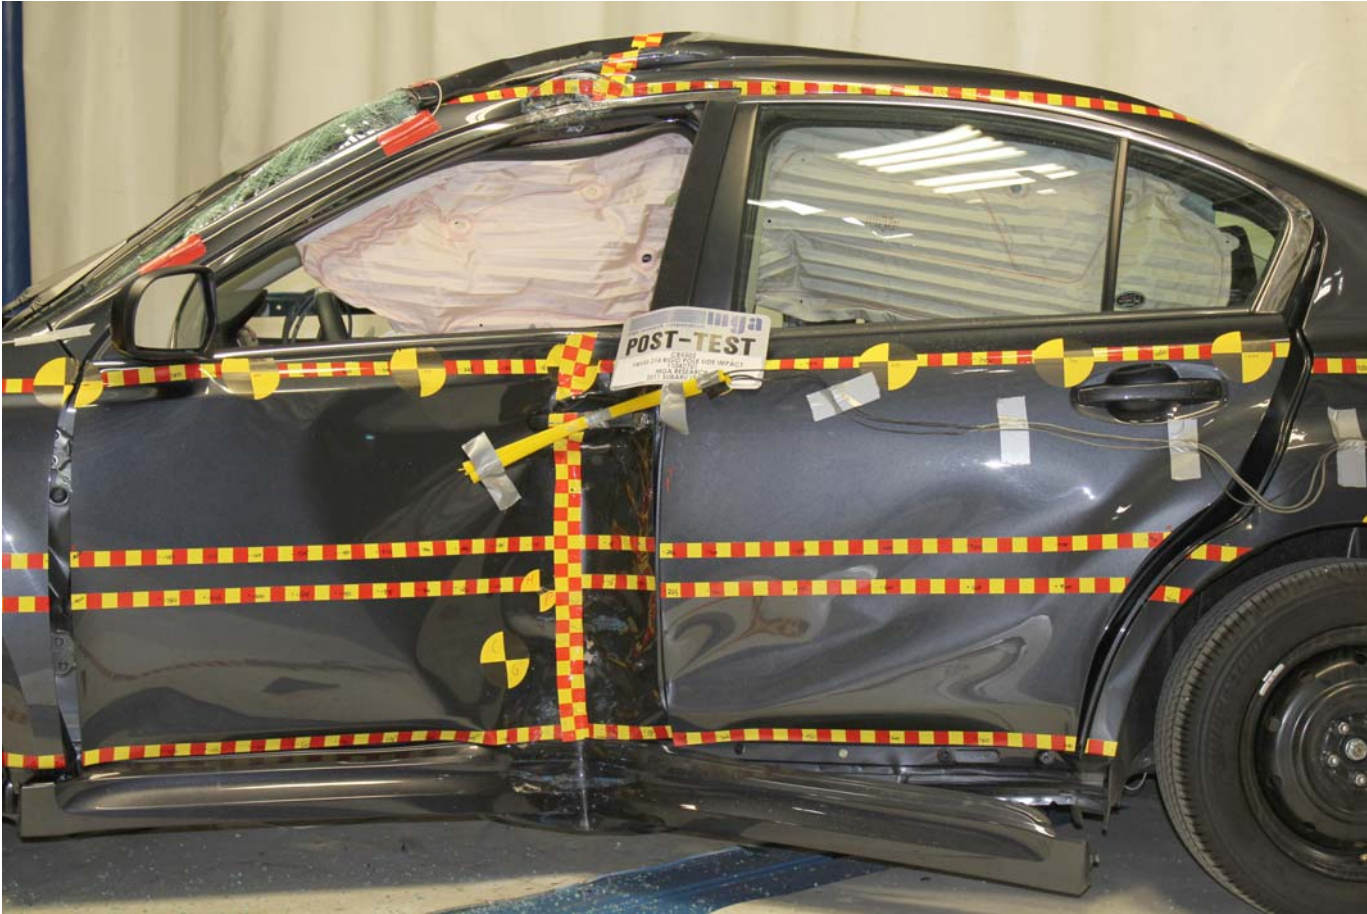
Post-Test Impact Zone Close-up View

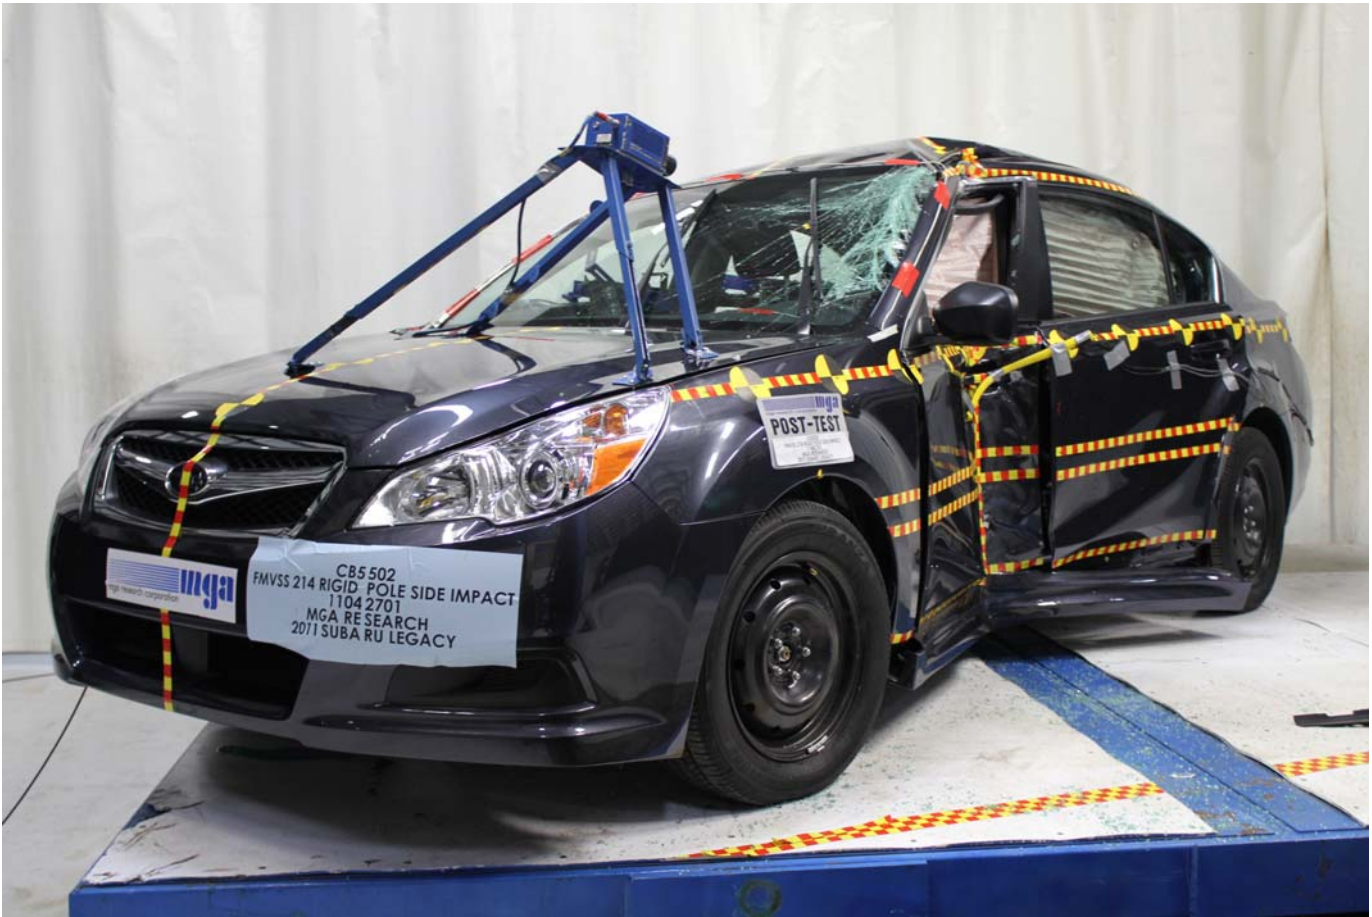
Post-Test $\frac{3}{4}$ Front View of Impact Zone

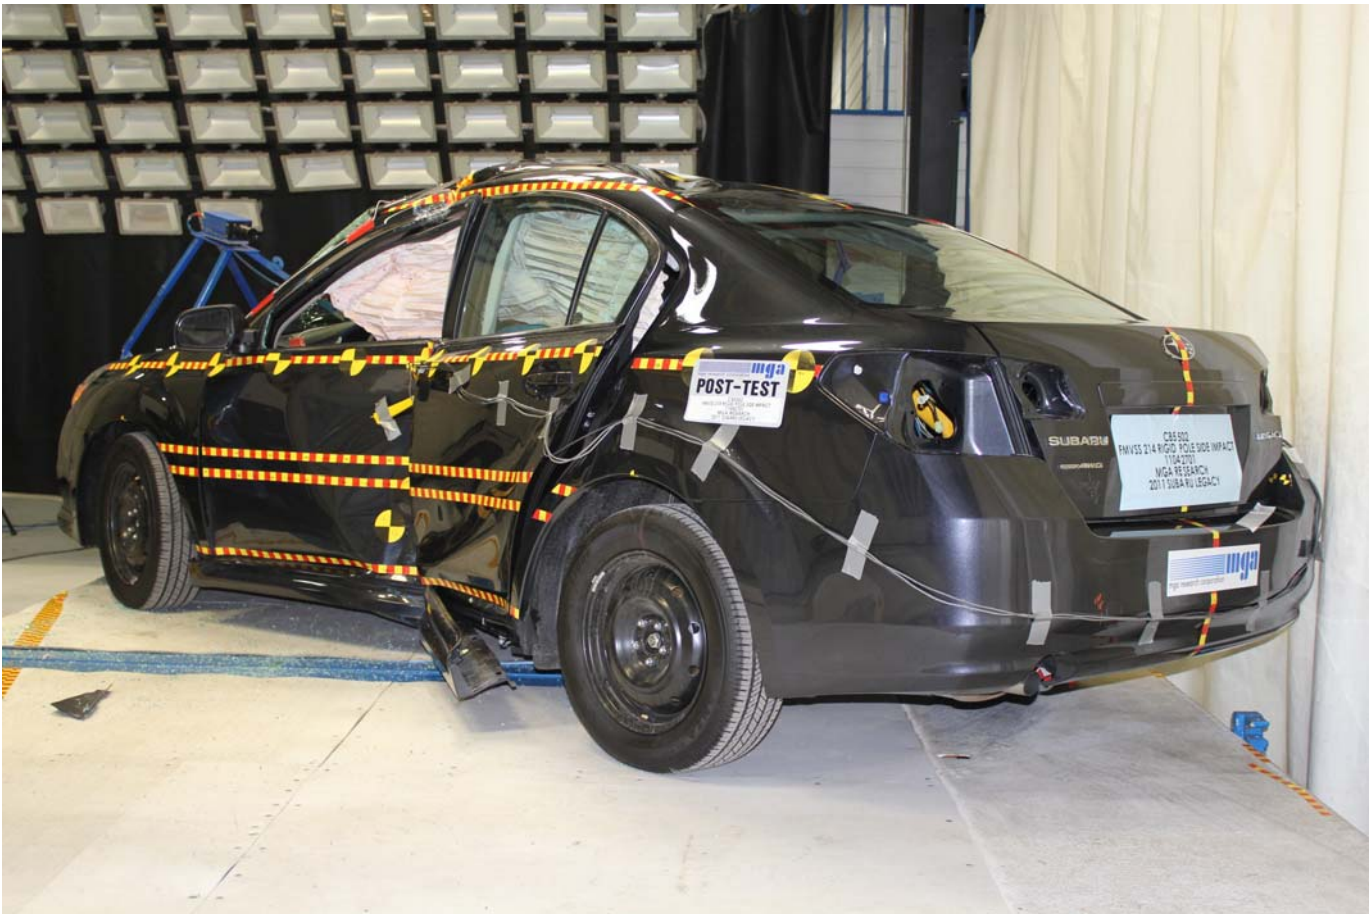
Post-Test $\frac{3}{4}$ Rear View of Impact Zone

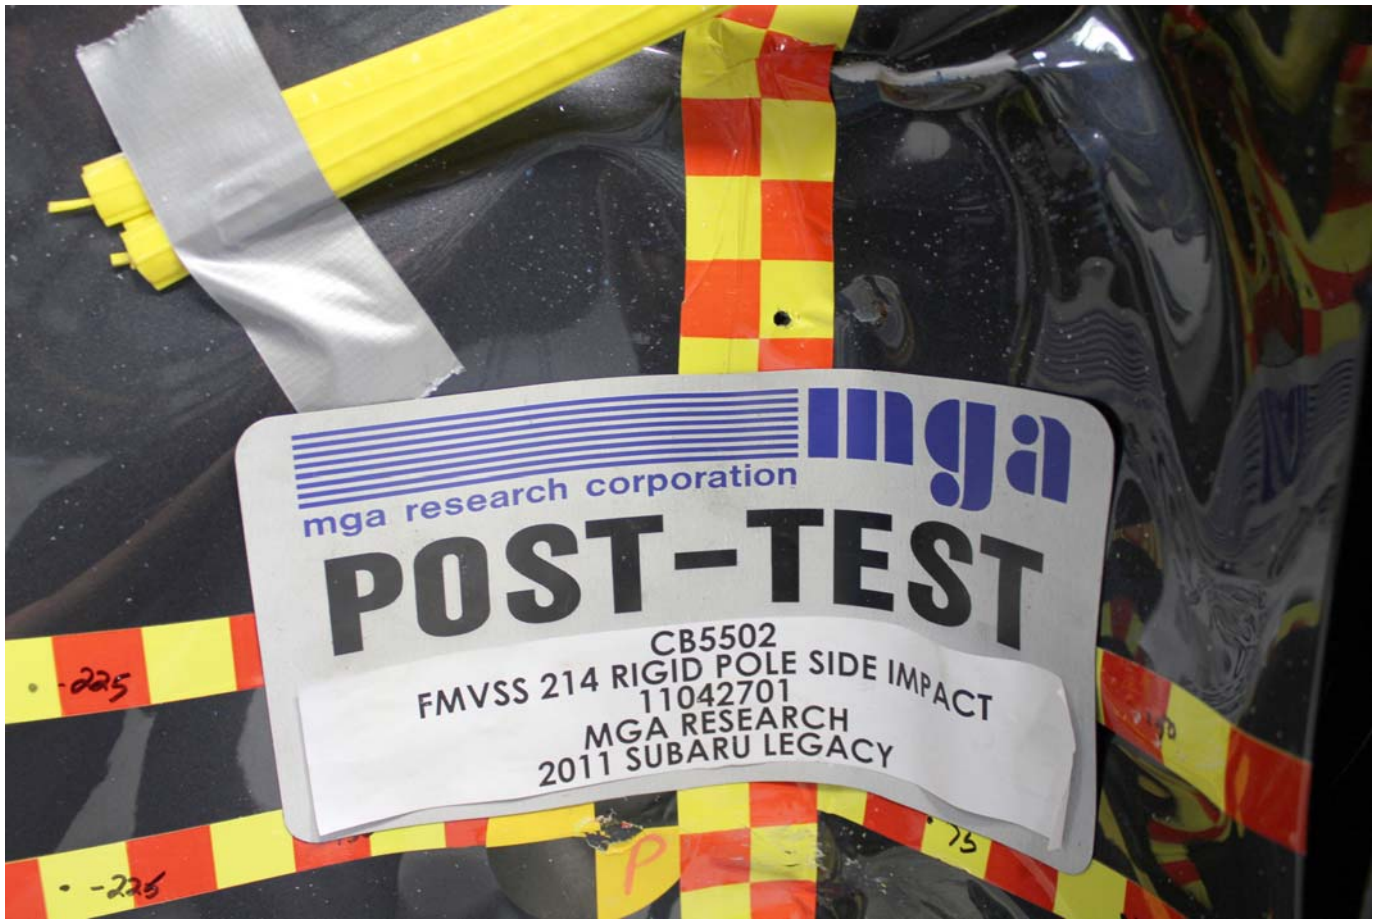
Post-Test Close-up View of Impact Point Target
