REPORT NUMBER: 214P-MGA-2011-005

**SAFETY COMPLIANCE TESTING FOR FMVSS 214
DYNAMIC SIDE IMPACT PROTECTION
RIGID POLE**

**TOYOTA MOTOR MANUFACTURING, INDIANA, INC.
2011 TOYOTA HIGHLANDER SUV
NHTSA NUMBER: CB5105**

**PREPARED BY:
MGA RESEARCH CORPORATION
5000 WARREN ROAD
BURLINGTON, WI 53105**

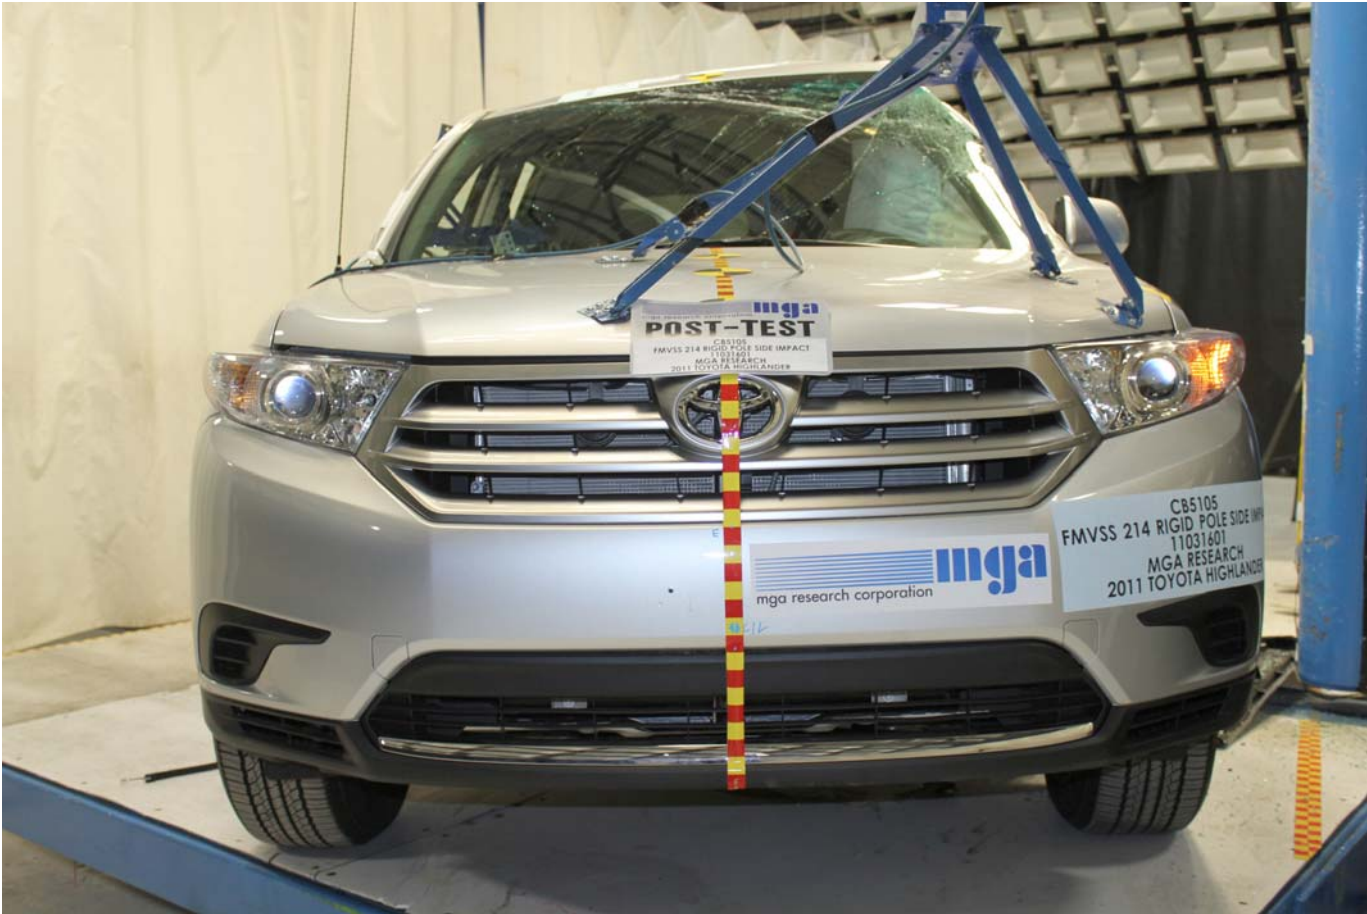
Post-Test Frontal View of Test Vehicle

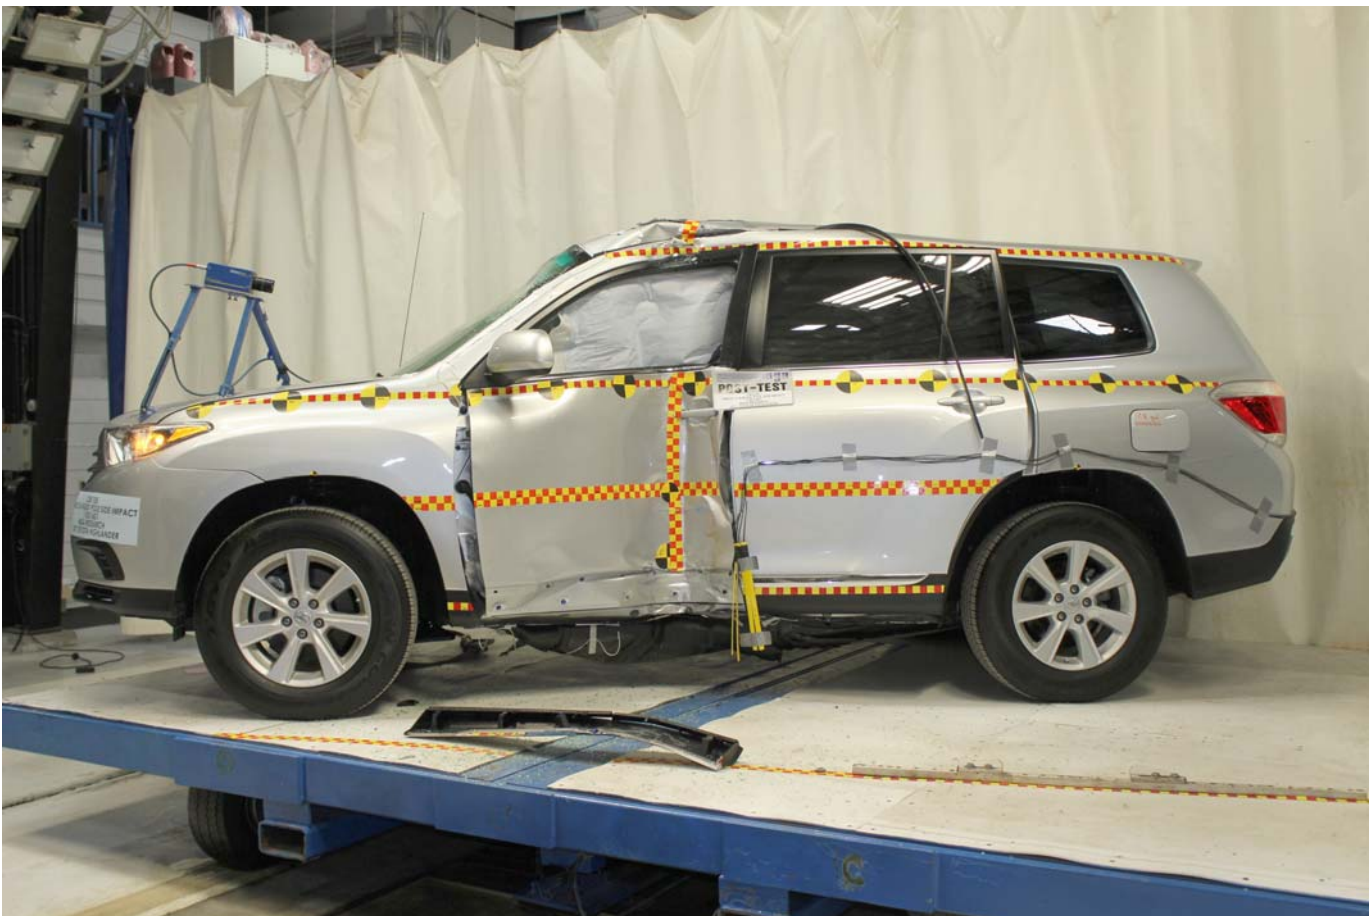
Post-Test Impacted Side View of Test Vehicle

Critical Areas of Performance	Observations and Conclusions
Pillar Performance	No Separation
Sill Separation	None
Windshield Damage	Cracked
Window Damage	Left Front Window Broke
Other Notable Effects	None

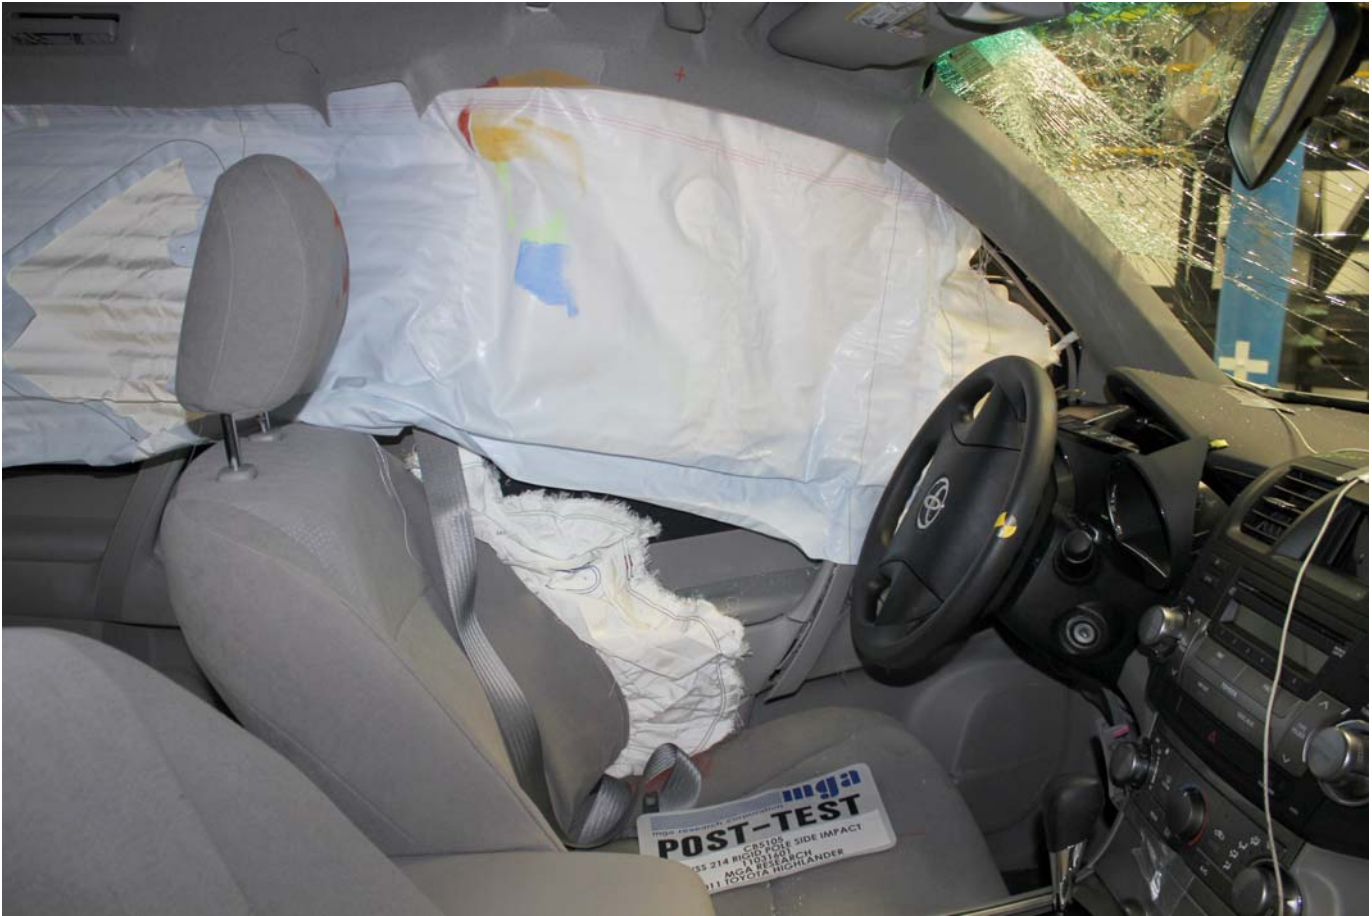
Post-Test Interior of Front Door Showing Dummy Impact Locations

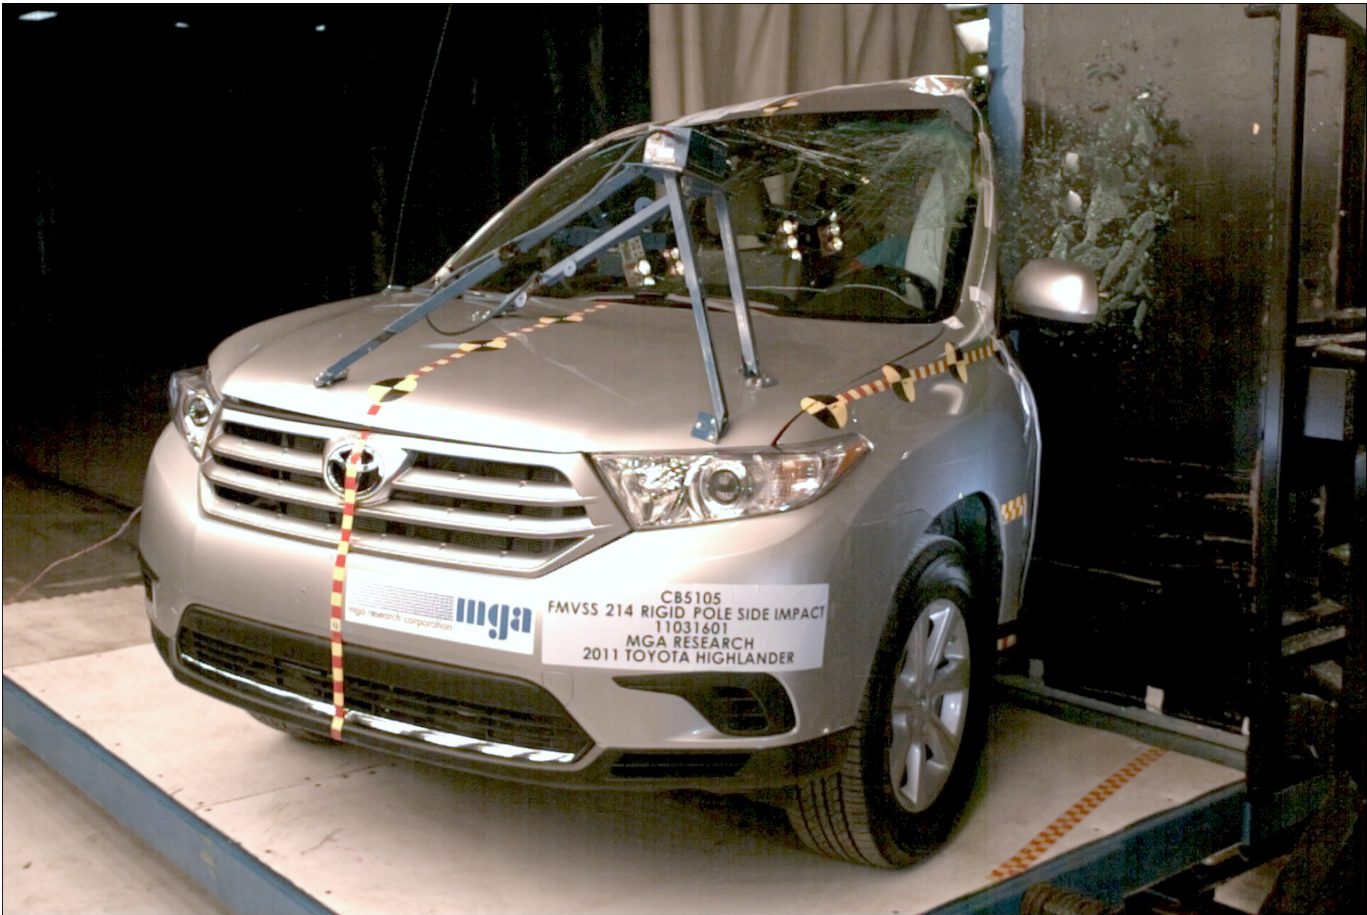
Impact Event

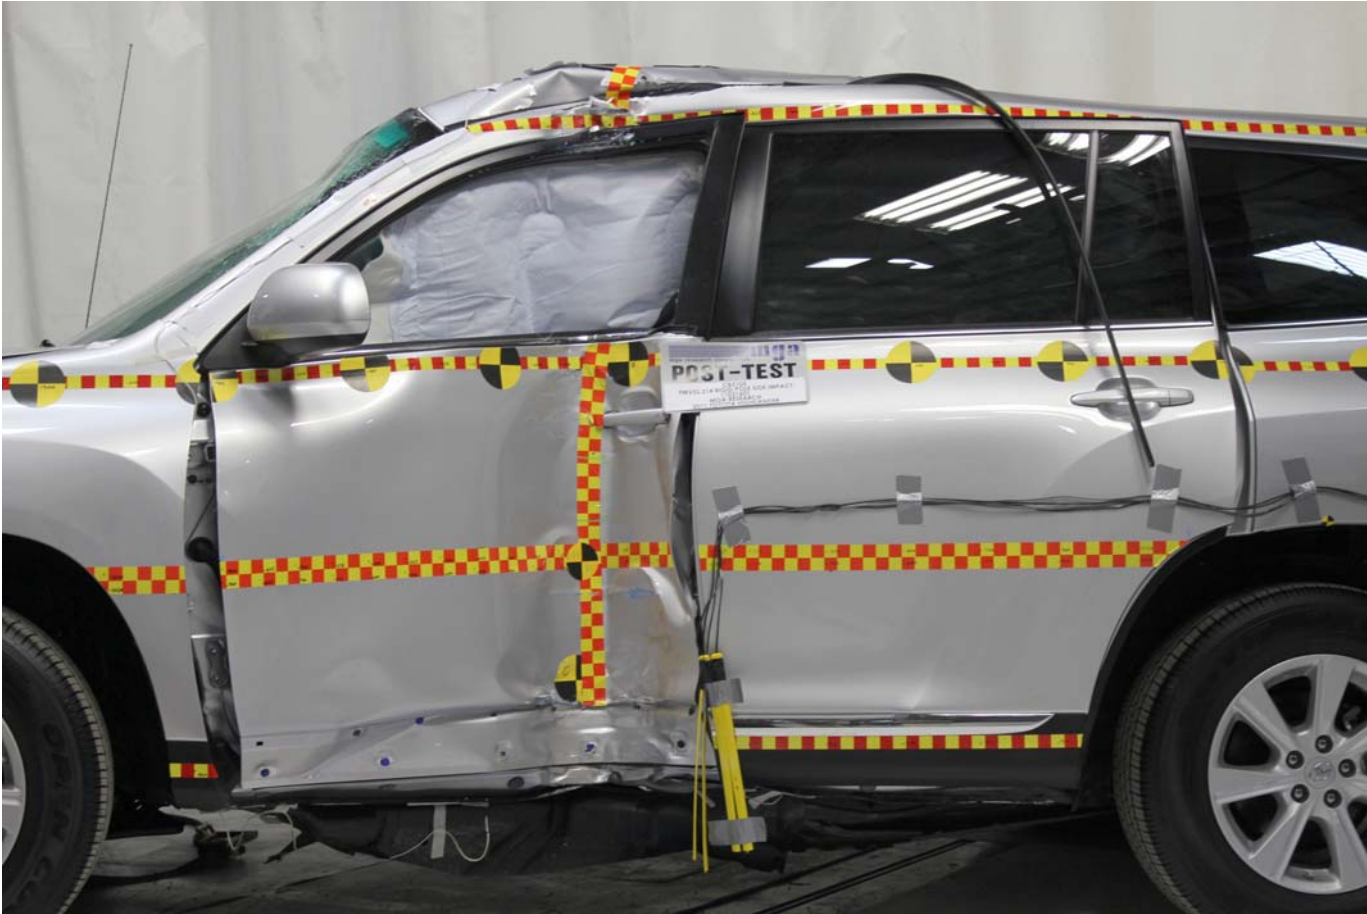
Post-Test Impact Zone Close-up View

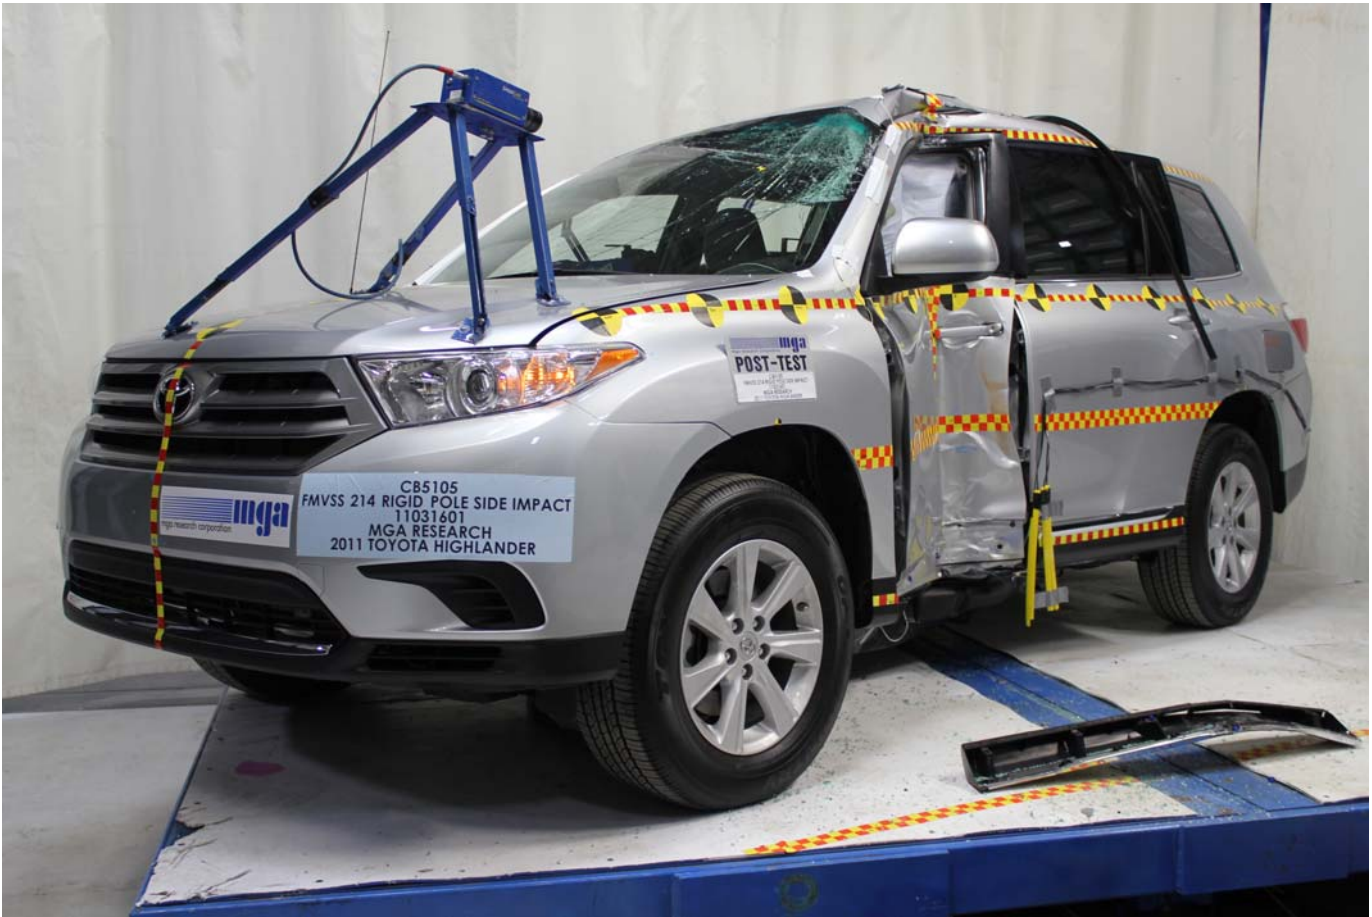
Post-Test $\frac{3}{4}$ Front View of Impact Zone

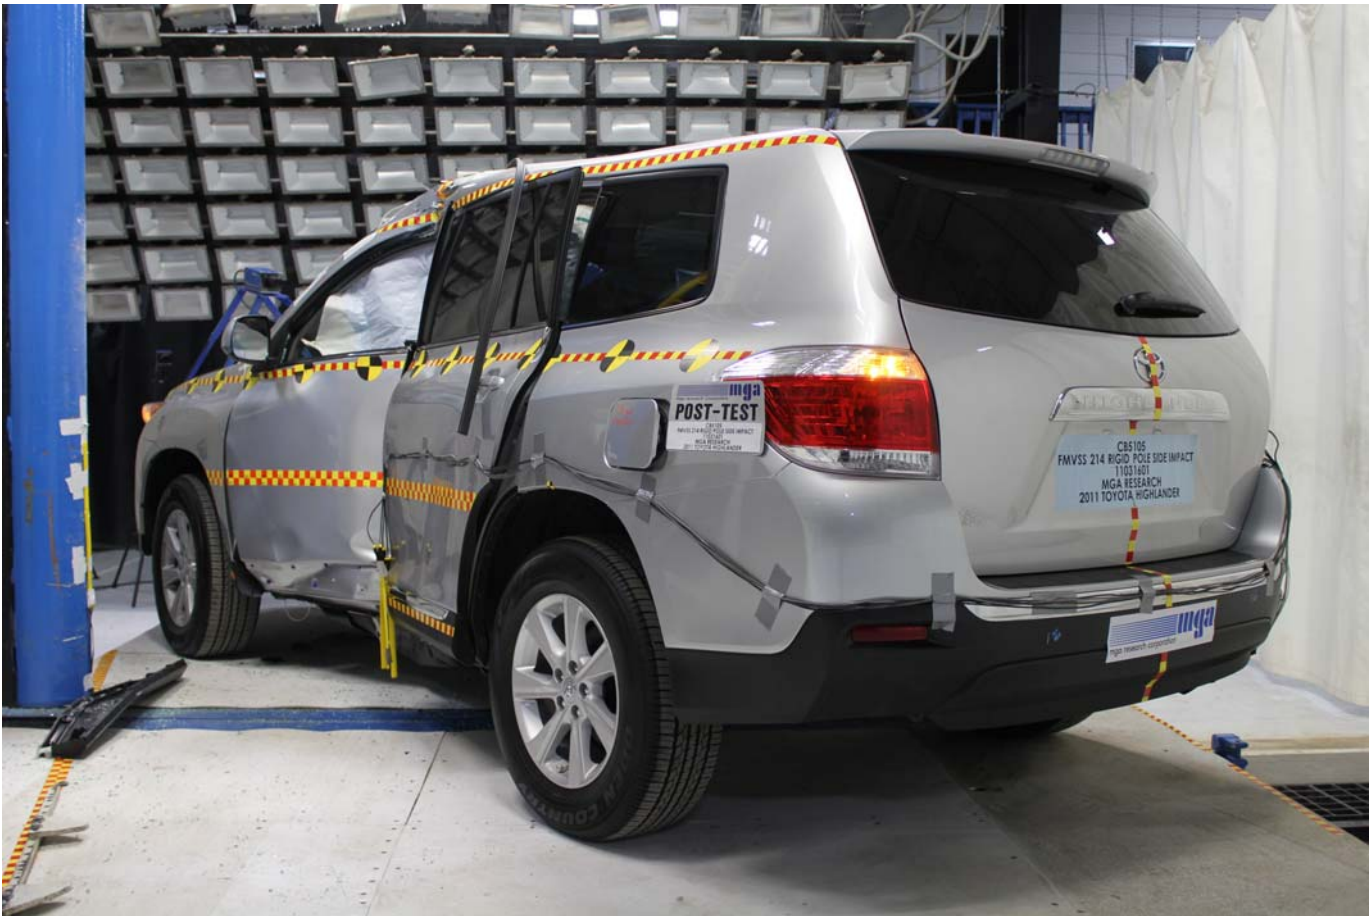
Post-Test $\frac{3}{4}$ Rear View of Impact Zone

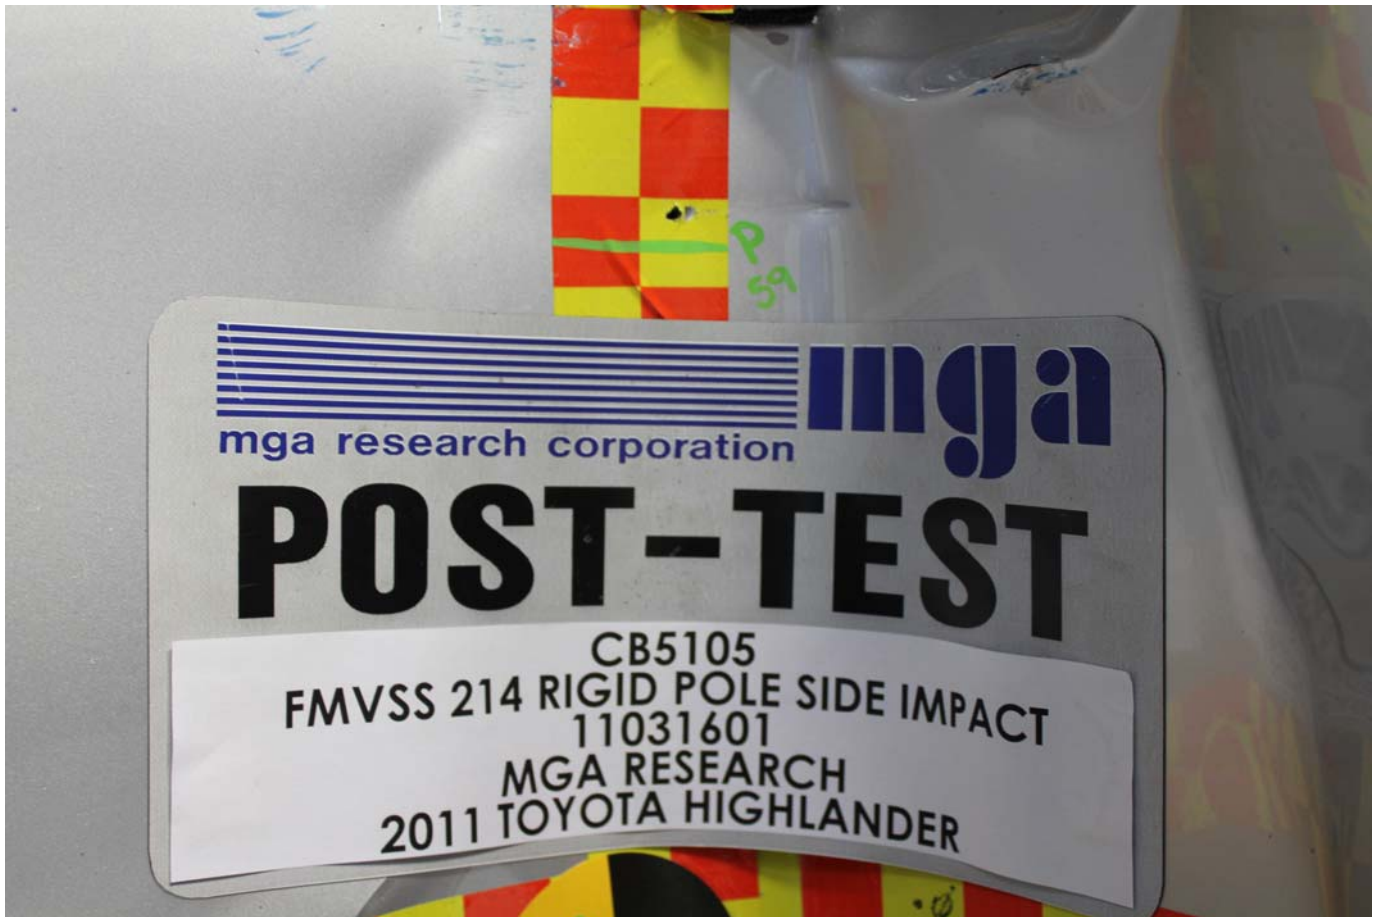
Post-Test Close-up View of Impact Point Target
