On-scene Investigation / Vehicle to Vehicle
Dynamic Science, Inc. / Case Number: DS00-002
2000 Ford Taurus
California
February, 2000

1. Report No. DS00-002		2. Government Accession No.		3. Recipient Catalog No.	
4. Title and Subtitle In-Depth Accident Investigation				5. Report Date November 15, 2000

Dynamic Science, Inc.
Accident Investigation
Case Number: DS00-002

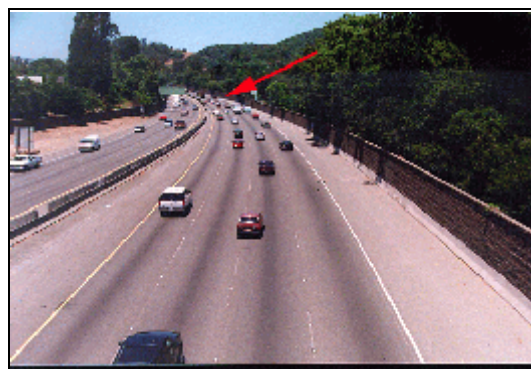
Figure 1. Overview of vehicle paths. Crash occurred 640 m (2100 ft) north. Arrow shows approximate area of impact.

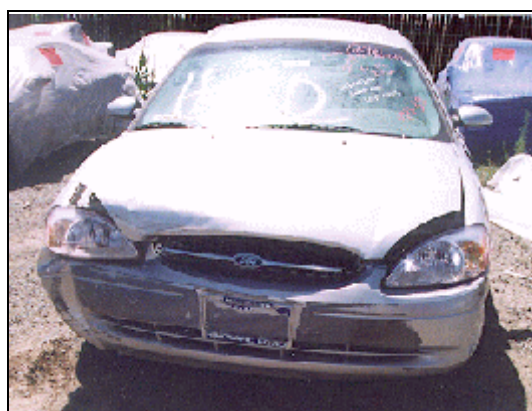
Figure 2. Front view of case vehicle (2000 Ford Taurus)

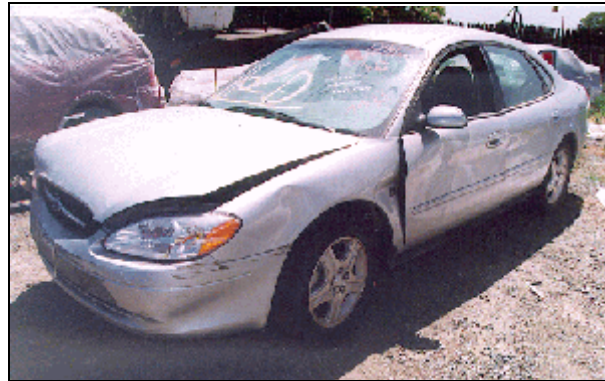
Figure 3. Exterior, case vehicle. Shows impact #1.

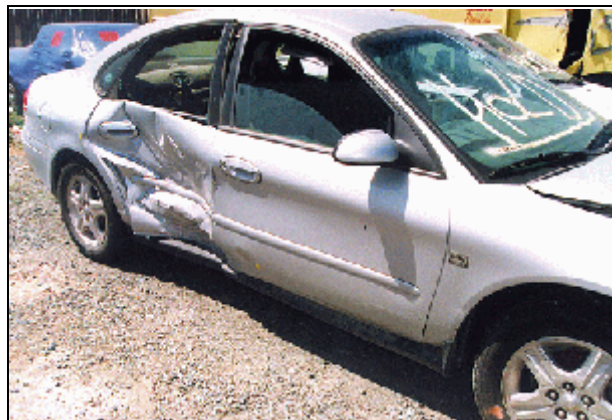
Figure 4. Exterior, case vehicle. Shows impact #2.

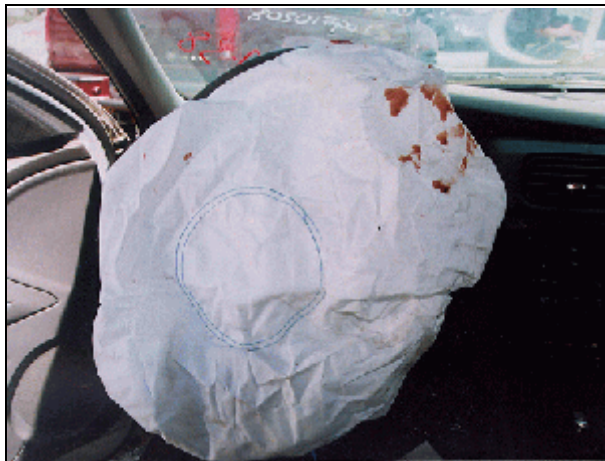
Figure 5. Driver's frontal air bag

The driver's air bag was circular and measured 54 cm (21.2 in.) in diameter. It was equipped with two tethers and two vent holes. There appeared to be eight horizontal folds. Blood was found on the top right quadrant. On the bottom of the rear portion of the air bag there was lipstick and makeup transfers that measured 15 cm (5.9 in.) wide by 11 cm (4.3 in.) high. The module cover opened in an "H" configuration. There were no indications of any damage to the cover.

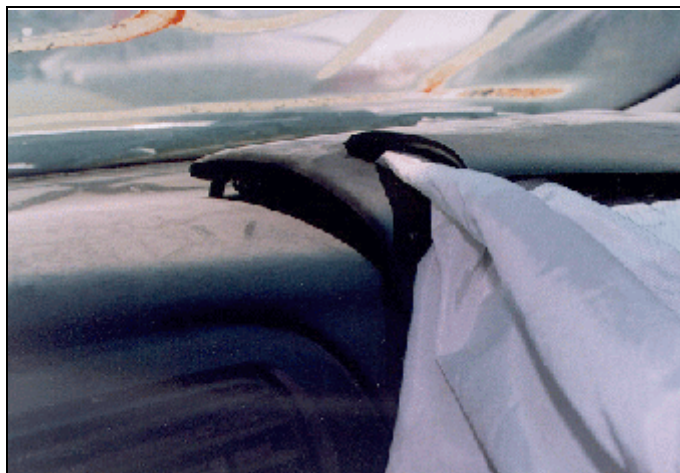
The front right occupant's frontal air bag was rectangular and measured 60 cm (23.6) laterally. It was equipped with two vent ports and did not have any tethers. On the face of the air bag there was a diagonal plastic transfer that began at the bottom of the air bag, extended for 26 cm (10.2) up and to the right and ended up being 11 cm (4.3) across. The right hand longitudinal seam was measured at 13 cm (5.1 in), while the left hand side measured 9 cm (3.5 in.). The module itself was displaced vertically on the left side.

Figure 7. Passenger module cover displacement

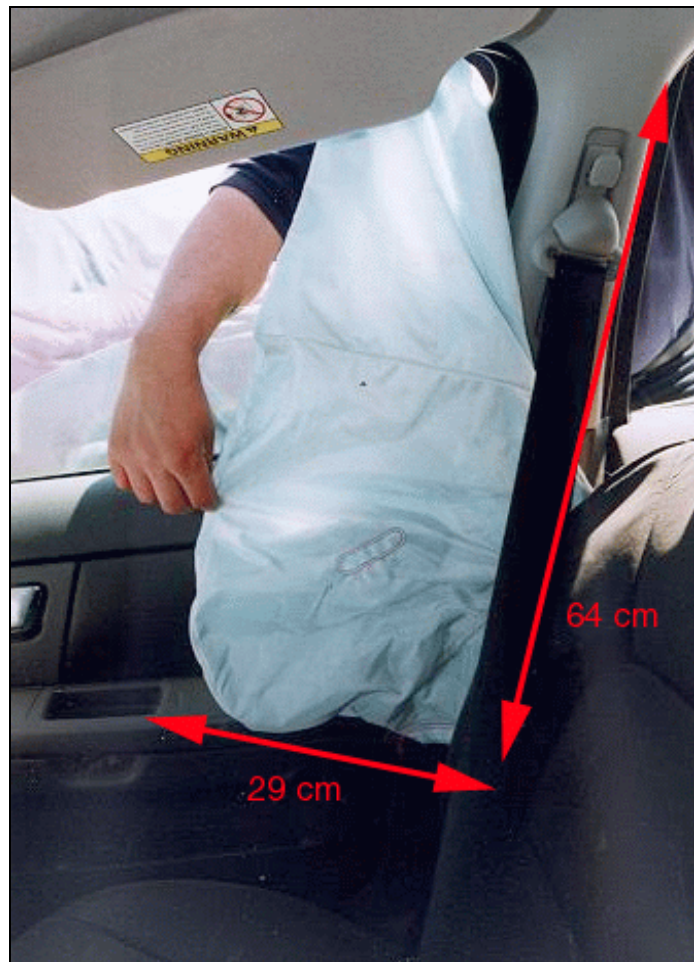
The front right seat position was equipped with a seat-mounted side air bag. The air bag was equipped with a single tether and no vent ports. The bag is vaguely rectangular and measures 64 cm (25 in.) high by 29 cm (11.4 in.) wide at its base. There was no indication of a contact to the air bag nor any damage.

Figure 8. Right front side air bag

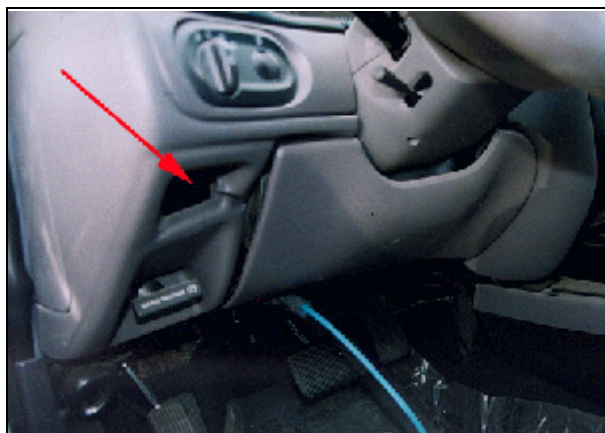
Both of the driver's knees struck the lower instrument panel—causing the contusion to the left knee. The driver's face was close to the steering wheel and as the air bag deployed she engaged the back side of the air bag. This contact likely caused the facial injuries, including the blow-out fracture, the broken nose, and the forehead laceration.

Figure 11. Left knee contact to lower instrument panel.

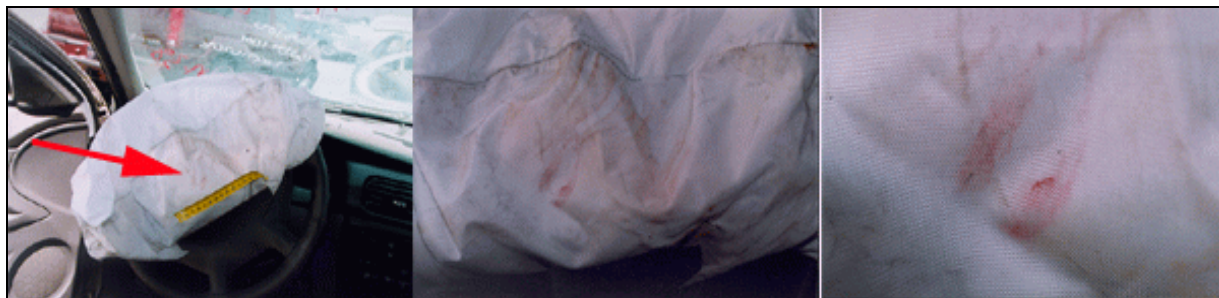
Figure 12. Driver's air bag. Contact points to back side of air bag.

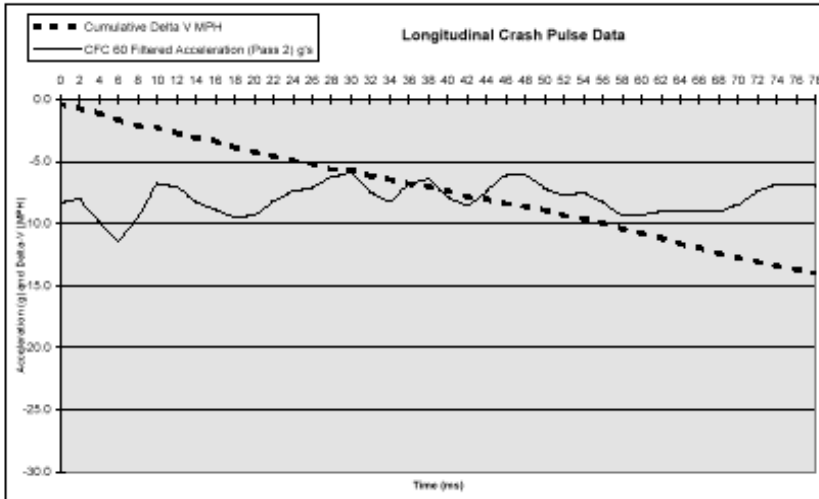
Longitudinal Cumulative Delta-V

Time (ms)	0	10	20	30	40	50	60	70	78
Delta-V (MPH)	-0.4	-2.3	-4.2	-5.6	-7.4	-8.3	-10.2	-12.0	-14.0
