**VERIDIAN ON-SITE ADVANCED OCCUPANT PROTECTION
SYSTEM (AOPS) INVESTIGATION**

NASS/SCI COMBO CASE NO. 2001-02-057E

VEHICLE - 2001 FORD TAURUS SE

CRASH DATE - JUNE, 2001

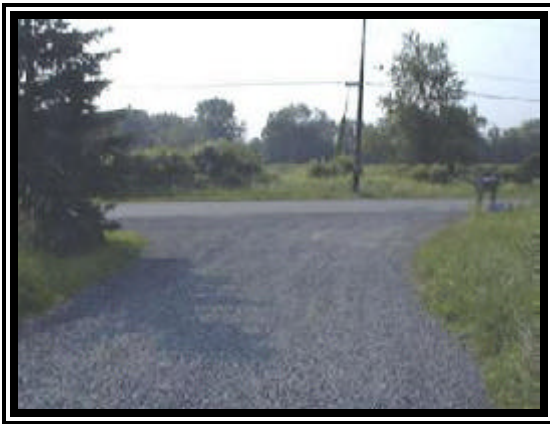
Figure 1. Eastbound approach view for the 1996 Jeep Cherokee.

The 16 year old male driver of the 1996 Jeep Grand Cherokee Limited 4x4 was initially stationary and facing east (**Figure 1**) when he proceeded to turn left (north) onto the main thoroughfare. The Jeep driver reported to police that tree branches from an adjacent tree cluster blocked his full view of the environment (*looked but did not see*), thus contributing to pre-crash circumstances. The police reported no tire marks at the scene indicative of driver avoidance maneuvers.

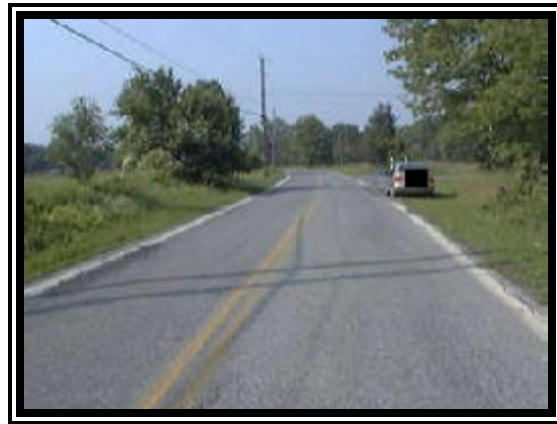
Figure 2. Southbound approach view for the 2001 Ford Taurus SE.

The 60 year old male driver of the 2001 Ford Taurus SE was operating the vehicle southbound (**Figure 2**) and negotiating a left curve at a (driver reported) speed of 89 km/h (55 mph) when he observed the 1996 Jeep Grand Cherokee cross his path of travel. Upon recognition of the impending harmful event, he steered left in avoidance and partially entered the northbound lane prior to the collision.

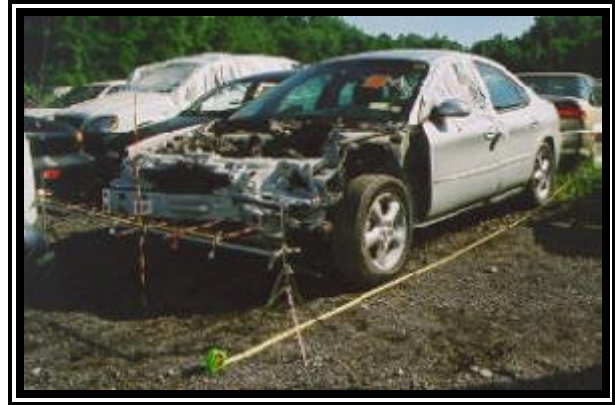
The 2001 Ford Taurus SE sustained moderate frontal damage as a result of the impact with the Jeep Grand Cherokee (**Figures 3 & 4**). The direct contact damage began at the front left bumper corner and extended 118.0 cm (46.5 in) inboard. The impact deformed the entire front end width resulting in a combined direct and induced damage length (Field L) of 124.0 cm (48.8 in). Six crush measurements were documented at the level of the reinforcement bar (*bumper fascia separation*): C1= 6.0 cm (2.4 in), C2= 25.0 cm (9.8 in), C3= 24.0 cm (9.4 in), C4= 17.0 cm (6.7 in), C5= 8.0 cm (3.1 in), C6= 0 cm. The Collision Deformation Classification (CDC) assigned for this impact to the Ford was 01-FDEW-2 with a principal direction of force of (+)20 degrees. An indentation was documented along the reinforcement bar and attributed to the front left bumper corner of the opposing Jeep. The hood was deformed slightly up and rearward from the impact force. The left fender was deformed rearward which produced a partial restriction of the left front door opening. The windshield was fractured at the left lower A-pillar from exterior impact forces (only). The left front tempered glazing was disintegrated post-crash by salvage personnel. Reduction in the left side wheelbase measured 3.0 cm (1.2 in).

Figure 3. Frontal damage to the 2001 Ford Taurus SE (hood and fenders removed).

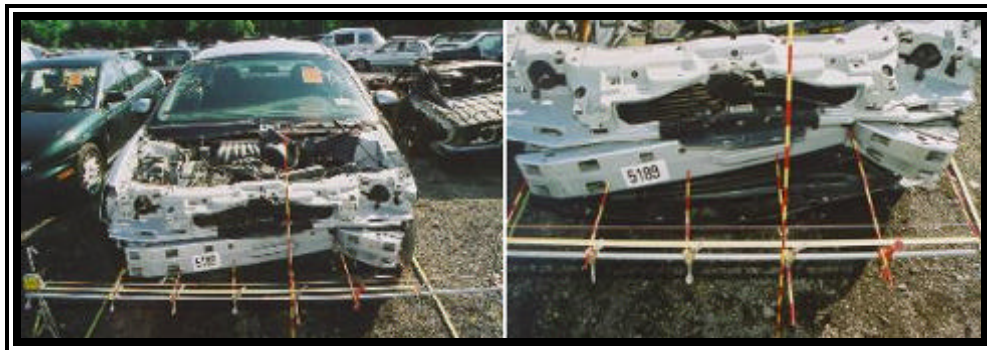
Figure 4. Contour gauge overview.

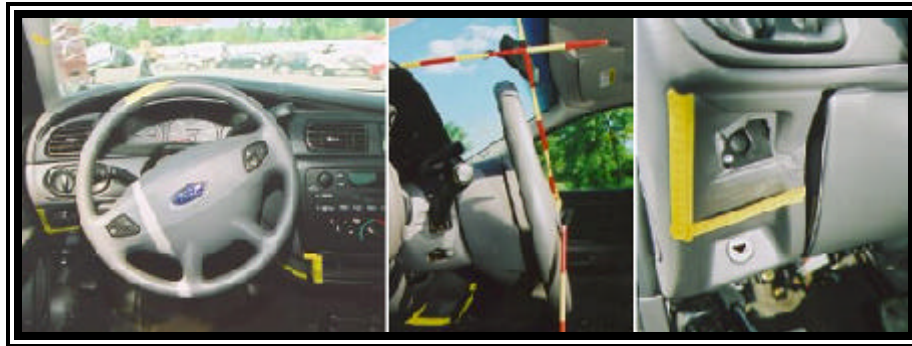
Interior damage to the Ford Taurus was minimal and was attributed to occupant contact (**Figure 5**). Large indentations and scuff marks were documented on the left knee bolster. Deformation to the upper portion of the steering wheel rim measured 3.4 cm (1.3 in) along with 1.0 cm (0.4 in) to the lower portion. Steering column compression measured 3.0 cm (1.2 in) at the left shear capsule and 2.5 cm (1.0 in) at the right shear capsule (compressed forward completely off the shear plate). The column mounted transmission selector lever was displaced forward. A small scratch mark was identified on the left A-pillar. White colored dog hair was found throughout the vehicle interior. No component intrusions were found in the vehicle.

Figure 5. Interior damage to the 2001 Ford Taurus SE.

At impact, the driver initiated a forward trajectory in response to the 1 o'clock impact force and loaded the knee bolster and steering wheel rim. Loading of the knee bolster was evidenced by the indentations and scuff marks documented on each side of the steering column, however, no injury was reported as a result. His head struck the *upper* portion of the steering wheel rim resulting in a superficial laceration and contusion to the forehead, evidenced by 3.4 cm (1.3 in) of deformation identified to this component. He also sustained a contusion to the right abdomen which was a result of loading to the *lower* portion of the steering wheel rim, evidenced by 1.0 cm (0.4 in) of deformation. Following the crash, the driver was removed from the vehicle through the left front door with some assistance from rescue personnel (driver refused the stabilizing backboard) and subsequently transported by ambulance to the emergency room of a local hospital for treatment and released within two hours. Deployment of the Ford's redesigned driver frontal air bag system would have mitigated the injuries sustained by the driver, thus preventing contact to the steering wheel hub and rim.

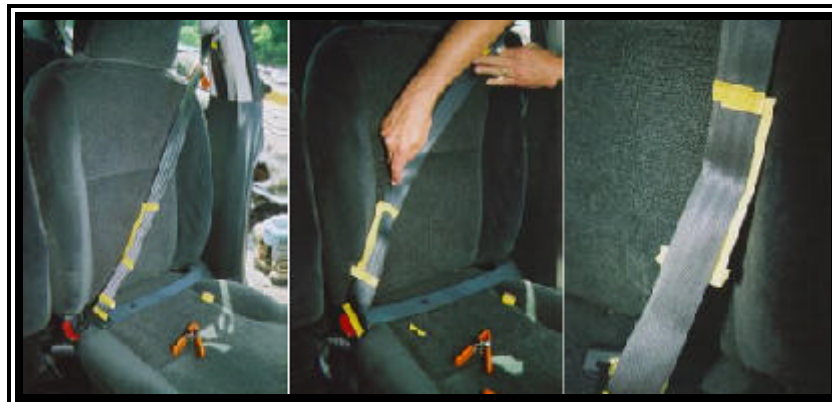
The interior of the Ford Taurus consisted of a six passenger seating configuration with front bucket (with a “flip and fold” center console that converted to a center seat position) and a rear bench seat. The driver 3-point manual lap and shoulder belt system consisted of a continuous loop belt webbing with a sliding latchplate and a dual mode retractor (inertial lock/belt sensitive). A stowage crease mark was noted on the shoulder webbing of the driver restraint (**Figure 6**) which followed the pattern of the inboard seat back taper. The specific location of these distinct line marks on the webbing indicated the driver probably sat on/against the belt in an *unrestrained fashion*. The driver stated during the SCI interview that he routinely buckled the belt in this manner to defeat the vehicle (restraint) audible chimes. Furthermore, loading marks on the lap and shoulder belt webbing (from the latchplate and D-ring) confirmed the latchplate was in the buckle at the time of collision induced pretensioner activation. The front center seat was equipped with a 2-point manual lap belt and a locking latchplate. The front right (and rear) seating position was equipped with a 3-point manual lap and shoulder belt system which consisted of a continuous loop belt webbing with a sliding latchplate and a retractor equipped with an inertial and switchable lock mechanism.

Figure 6. Crease marks to the front left restraint.

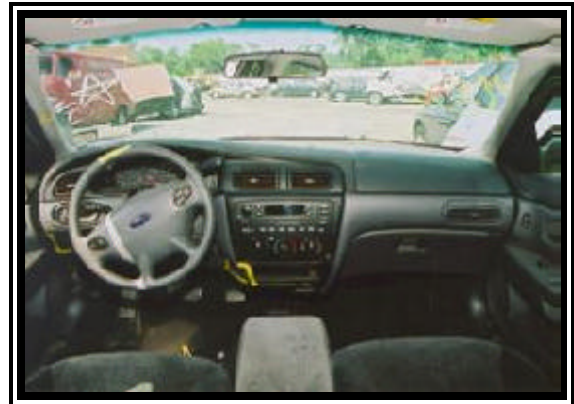
The 2001 Ford Taurus SE was equipped with dual stage redesigned frontal air bags (*vehicle not equipped with the seat mounted side impact air bag system option*) for the driver and front right passenger positions which did not deploy as a result of the crash (**Figure 7**). The driver air bag was housed in the center of the steering wheel with a horizontally oriented flap tear seam (H-configuration). The front right passenger air bag was housed in the right mid-instrument panel area with a single cover flap design hinged at the top aspect.

Figure 7. 2001 Ford Taurus SE non-deployed redesigned frontal air bag system.

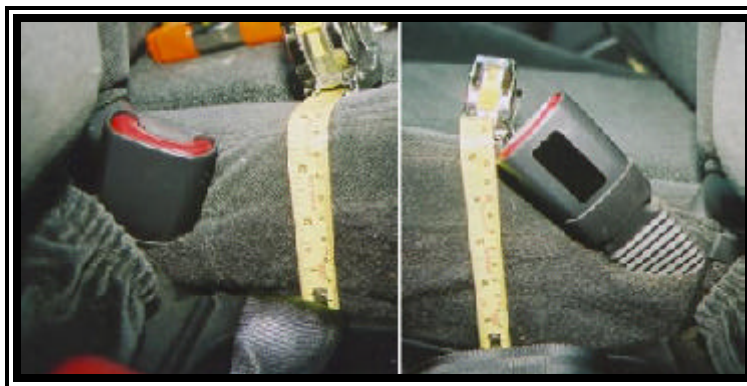
The front restraint systems also included buckle pretensioners mounted longitudinally alongside the seat cushions. The activation of the driver side pretensioner resulted in 100.0 millimeters (3.9 in) of piston movement (**Figure 8**). The piston pulls a cable which lowers the height of the buckle assembly, reducing slack in both the lap and shoulder belt webbing. The front right seating position was not occupied, therefore, the buckle pretensioner did not activate.

Figure 8. 2001 Ford Taurus SE driver (activated) and front right passenger (non-activated) buckle pretensioners.
