On Site Side Air Bag Investigation / Vehicle to Vehicle
Dynamic Science, Inc. / Case Number: DS02021
2002 Kia Optima
California
October, 2002

1. Report No. DS02021	2. Government Accession No.		3. Recipient Catalog No.	
4. Title and Subtitle On Site Side Air Bag Investigation		5. Report Date January 29, 2004

Dynamic Science, Inc.
Crash Investigation
Case Number: DS02021

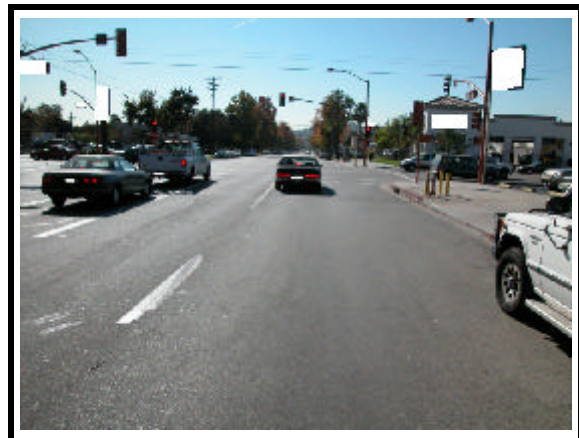
Figure 1. Case vehicle stopped at intersection.

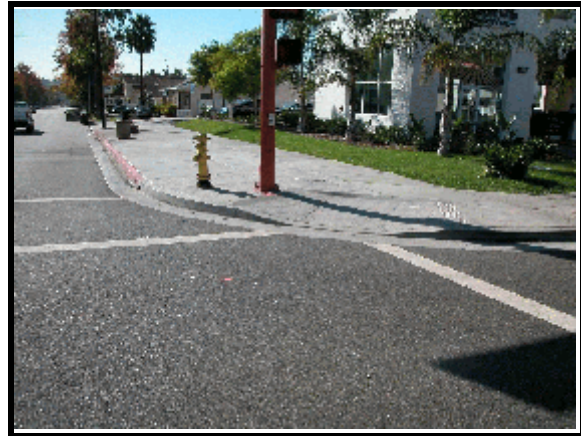
Figure 2. Impact 2 (pole)

After impact, the Kia Optima rotated clockwise and crossed through the intersection. The front of the case vehicle struck the traffic signal pole on the southwest corner of the intersection with its front (12FLEN1). The Kia sustained a total delta v of 20.0 km/h (12.4 mph). The longitudinal and lateral components were -20 km/h (-12.4 mph) and 0 km/h (0 mph), respectively. The results appear high. The collision did not exceed the manufacturer's front air bag deployment threshold and neither the driver's nor the front right passenger's air bags deployed.

The Kia Optima sustained minor frontal damage as a result of the impact with the pole. The direct damage began 13.0 cm (5.1 in) from the left front bumper corner and extended laterally to the right for 25.0 cm (9.8 in). The direct and induced damage included the entire front bumper. Six C measurements were taken along the front bumper beam and were as follows: C1=0 cm (0 in), C2=23.5 cm (9.3 in), C3=18.0 cm (7.0 in), C4=10.5 cm (4.1 in), C5=1.0 cm (0.4 in), and C6=0 cm (0 in). Maximum crush was located at C2.

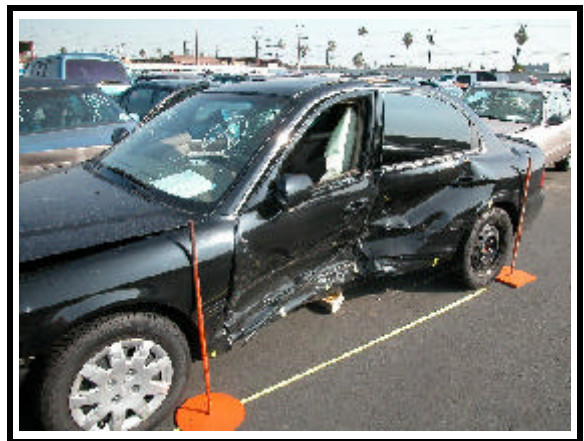
Figure 3. Left side damage (impact 1) to case vehicle.

The front of the Toyota struck the left side of the case vehicle (10LYEW3). On impact, the case vehicle sustained a total delta v of 23.0 km/h (14.3 mph)¹, a longitudinal delta v -7.9 km/h (-4.9 mph) and a lateral delta v of 21.6 km/h (13.4 mph). Results fit the collision model and appear reasonable for the case vehicle. At impact, the driver's seat mounted side air bag deployed in the case vehicle.

The Kia Optima sustained major left side damage as a result of the impact with the Toyota Camry. The direct contact damage began 47.0 cm (18.5 in) forward of the rear axle and extended forward for 169.0 cm (66.5 in). The direct plus induced damage began 10.0 cm (3.9 in) forward of the rear axle and extended for 206.0 cm (81.1 in). Both left side doors were jammed shut. The driver's window glazing was disintegrated from impact forces. Six C measurements were taken along the sill and were as follows: C1=0 cm (0 in), C2=11.5 cm (4.5 in), C3=24.5 cm (9.6in), C4=29.0 cm (11.4in), C5=19.0 cm (7.4 in), and C6=7.5 cm (2.9 in). Maximum crush was located at C3.

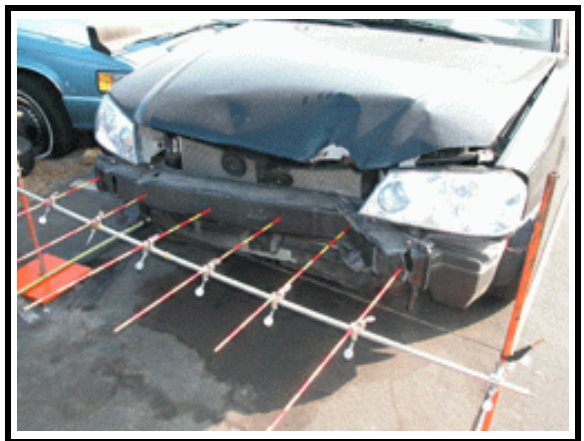
Figure 4. Front damage to case vehicle (impact 2).

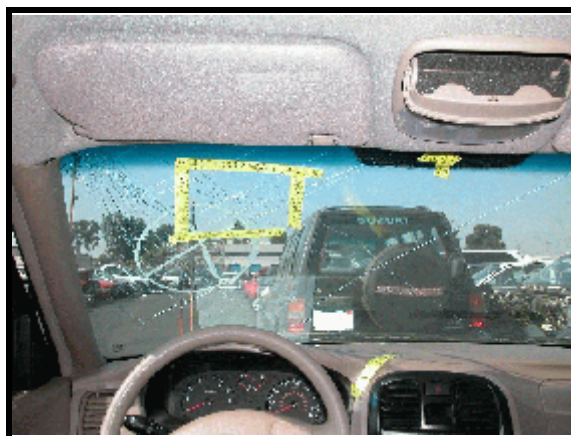
Figure 6. Windshield contact

Interior damage to the Kia Optima was moderate and attributed to occupant contact and passenger compartment intrusion. The left side of the windshield was fractured by impact forces. A star-shaped fracture was found on the windshield directly forward of the steering wheel—possibly from the driver's hand. The rear view mirror was knocked off. Lateral intrusions into the driver's seating position included the left door panel, B pillar, sill, and roof. Lateral intrusions into the left rear seating position included the door panel, sill, and the seat back. The driver knee bolster was deformed longitudinally into the driver's seat position by the left side intrusion.

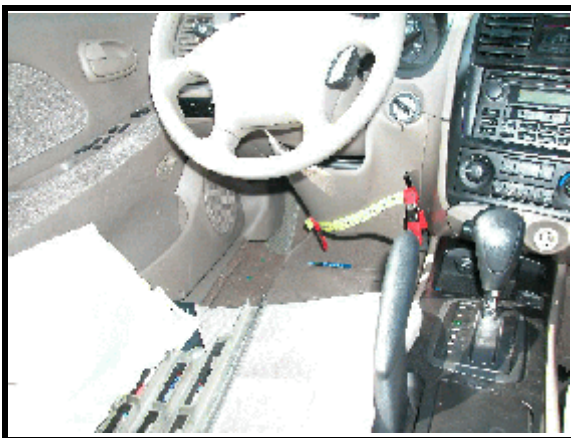
Figure 7. Deformed knee bolster

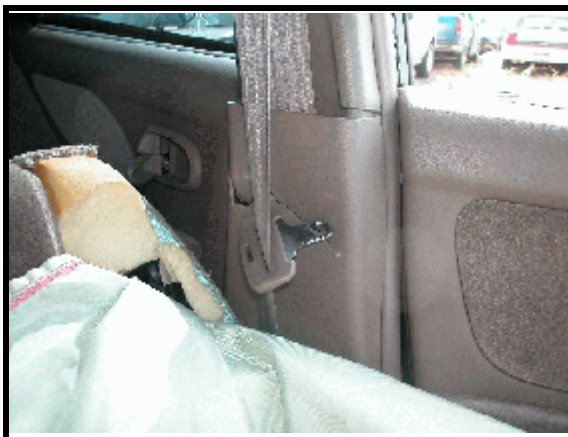
Figure 8. Driver's seat belt

The Kia Optima was equipped with three-point safety belts at all five seating positions with switchable retractors (ELR/ALR) at all but the driver's position (ELR only). The driver's seat belt was found locked, in a retracted position-- pinned/locked between the B-pillar and the seat. The vehicle was also equipped LATCH anchors and tether connections for the two rear outboard seats.

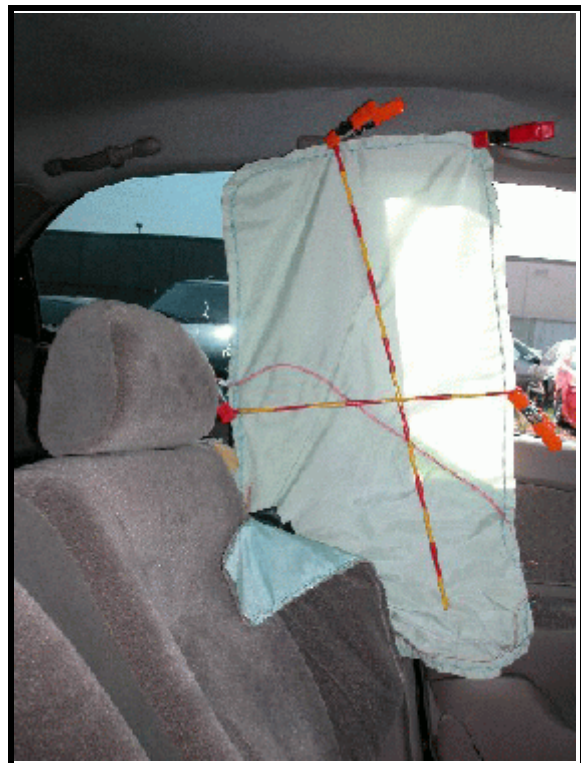
Figure 10. Driver's side air bag

The case vehicle is equipped with four air bags². A driver's steering wheel mounted depowered air bag, a front right passenger's depowered air bag that is mid-mounted in the instrument panel. The vehicle is equipped with a driver's seat mounted and front right seat mounted side air bags. The driver's and front right passenger's frontal air bags did not deploy. The driver's seat mounted side air bag did deploy. It measured approximately 78.0 cm (30.7 in) long by 31.0 cm (12.2 in) wide. It was housed inside a plastic bag that was encased within a metal frame. The side air bag appeared to be tied to the back of the driver's seat. The side air bag had one tether and no vent ports. There was no evidence of occupant contact.
