REMOTE AIR BAG FATALITY REPORT

CASE NUMBER - IN-03-019

LOCATION - Alaska

VEHICLE - 1995 MERCURY MYSTIQUE LS

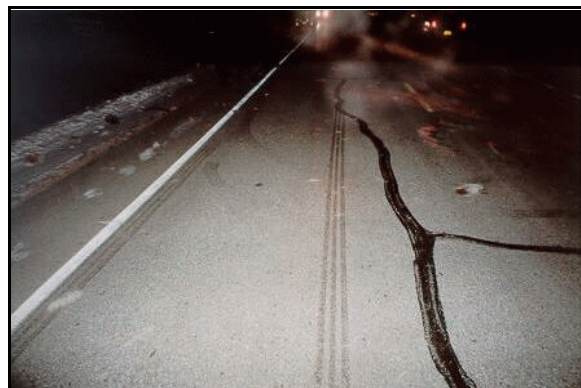
Figure 1: Looking west toward the case vehicle's eastward travel path, with post-impact skid marks visible in the foreground (case photo #01)

The case vehicle was traveling east in the eastbound lane of a two-lane, undivided county roadway and intended to continue in its eastward path of travel (**Figure 1**). The moose was lying, dead (or very seriously injured), in the eastbound lane of the same roadway. The moose had been injured as a result of a previous crash with a pickup truck approximately 15 - 20 minutes prior. (The moose apparently ran away from the first crash and could not be found, but wandered back onto the roadway where it collapsed.) It was dark with no street lights, the asphalt road surface was dry and free of defects, and the speed limit was 86 km.p.h. [55 m.p.h.]. The weather clear and very cold (-22 degrees Fahrenheit). The case vehicle's driver saw the dead moose and braked in an attempt to avoid the crash, depositing 13.7 meters [45 feet] (police measured) of lock-up braking skid marks prior to the impact. The crash occurred in the eastbound lane of the roadway.

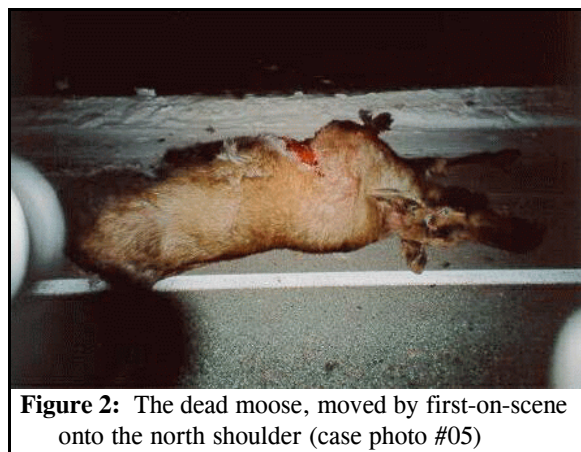
Figure 2: The dead moose, moved by first-on-scene onto the north shoulder (case photo #05)

The lower front and undercarriage of the case vehicle impacted the moose (**Figure 2**), causing the case vehicle's driver and front right passenger air bags to deploy. The police estimated that the case vehicle had been traveling approximately 80 km.p.h. [50 m.p.h.] prior to the crash and had slowed to approximately 64 km.p.h. [40 m.p.h.] when it hit the moose. The case vehicle ran over the moose (the police report indicates "jumped over") and was brought to a controlled stop approximately 45.7 meters [150 feet] beyond the point of impact, on the right (south) shoulder.

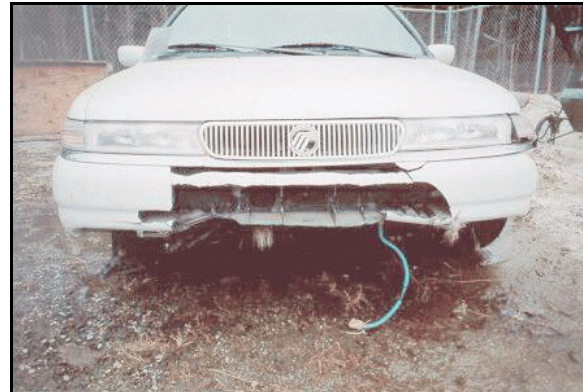
Figure 3: Front of case vehicle at tow yard; note tufts of moose fur (case photo #13)

The case vehicle's front bumper and undercarriage impacted and ran over the moose (**Figure 3**). Portions of the front bumper cover were broken away and moose fur was lodged in the lower edge of the steel bumper and radiator support. The radiator and engine oil pan were damaged, causing substantial leakage of coolant and oil at the scene. There was a star-shaped crack in the windshield on the right and no other glazing damage. The left front wheel was visibly displaced rearward, but there was no other obvious damage to the wheels or tires. A large smear of the moose's blood was splashed onto the left rear wheel and body panels (**Figure 4**). The case vehicle's right side did not sustain any obvious damage (**Figure 5**), except the front right bumper cover was broken away. The CDC was estimated from photographs as **12-FDLW-1 (0)**. This crash is out of scope for the WinSMASH reconstruction program (yielding object). This was a crash of low severity (11-23 km.p.h. [9 - 14 m.p.h.]) for the case vehicle.

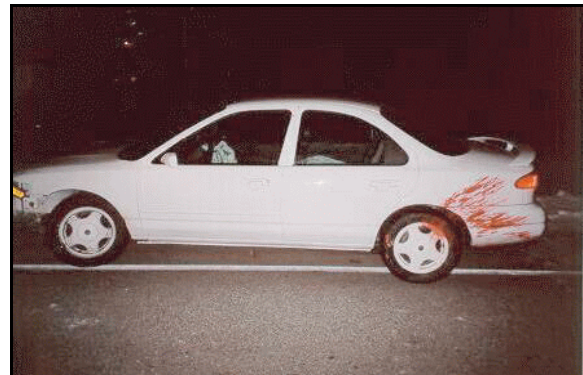
Figure 4: Left side of case vehicle on-scene; note, left bumper cover broken away, left front wheel displaced rearward, blood from moose on left rear quarter panel (case photo #09)

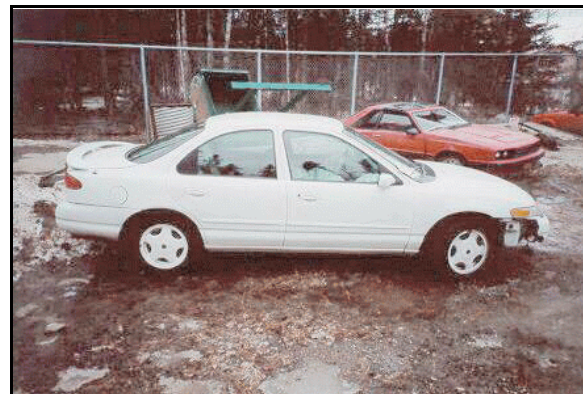
Figure 5: Right side of case vehicle at tow yard; note front right corner of bumper cover broken away (case photo #21)

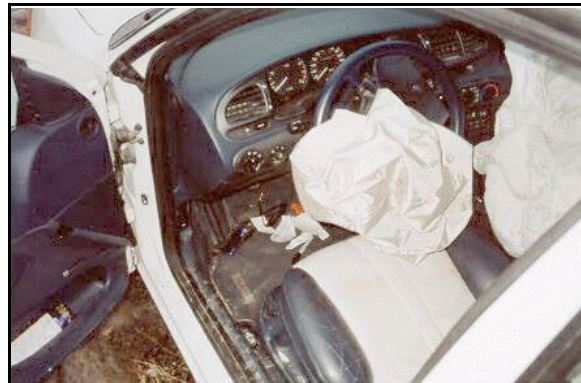
Figure 6: Case vehicle's front seat, showing deployed air bags (case photo #24)

The police photographs show that the driver's air bag was mounted in the steering wheel hub, the front right passenger's air bag was located in the top of the instrument panel and both air bags deployed (**Figure 6**). There was no obvious damage to the driver's air bag or cover flaps, and there was no contact evidence on the driver's air bag fabric visible in the photographs.

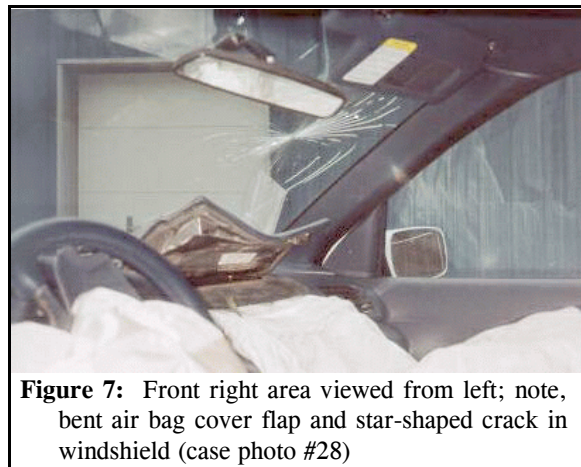
Figure 7: Front right area viewed from left; note, bent air bag cover flap and star-shaped crack in windshield (case photo #28)

The front right passenger's air bag cover flap was visibly deformed, with a V-shaped bend at the front-center of the cover flap (**Figures 7 and 8**). There was a small amount of blood smeared on the air bag's fabric, with no other evidence of contact and no obvious damage to the air bag.

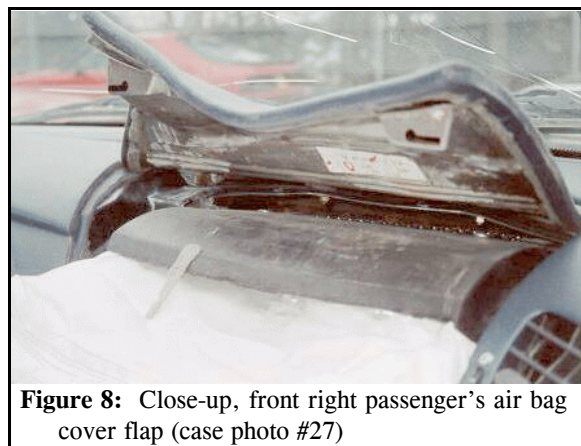
Figure 8: Close-up, front right passenger's air bag cover flap (case photo #27)
