**CALSPAN REMOTE ADULT PASSENGER AIR BAG RELATED SERIOUS
INJURY CRASH INVESTIGATION**

NASS/SCI COMBO CASE NO: 2004-45-245J

VEHICLE: 2004 FORD EXPLORER

CRASH DATE: DECEMBER 2004

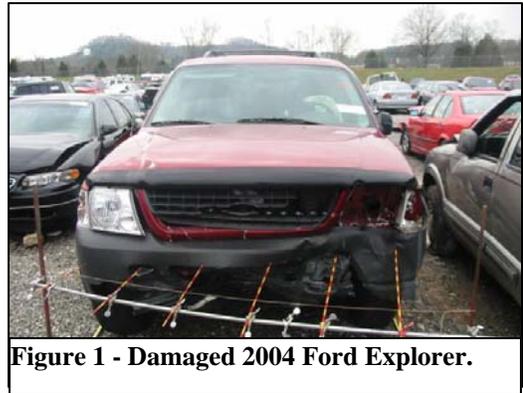
Figure 1 - Damaged 2004 Ford Explorer.

The remote investigation focused on the severity of a crash and the source of a closed head injury for a restrained 14-year old female front right passenger of a 2004 Ford Explorer (**Figure 1**). The Explorer was equipped with dual stage frontal air bags that deployed as a result of a head-on crash with a 2003 Honda Civic. A restrained 40-year old driver was operating the Explorer in a westerly direction on a two-lane roadway as the front right passenger began to experience a seizure. The front right passenger had a medical history of seizures and was taking the prescribed medication for this condition. The driver who instinctively began to aid the front right passenger relinquished control of the vehicle and it crossed the centerline of the roadway. The Explorer drifted into the eastbound lane and struck the Honda in a head-on configuration. A six-year old male child seated in a Cosco backless booster seat the second row center also occupied the Explorer. The six-year old child alerted the driver of the impending crash and the driver applied her brakes in avoidance. The driver of the Explorer sustained a right medial malleolus fracture and multiple soft-tissue injuries to her face and extremities. The front right passenger sustained an 8 mm intraparenchymal hemorrhage of the left frontal region of her brain, a facial contusion from contact with the expanding air bag, and an abdominal contusion from loading the lap belt. The child seated in the second row center position suffered a right eyelid contusion, a left facial contusion, and a left shoulder contusion. The driver was transported to a local hospital by ambulance, where she underwent open reduction internal fixation of the right ankle. The front right passenger was transported to a local hospital by ambulance with a Glasgow Coma Score (GCS) of 15 and was held for a period of 23 hours for observation. She was discharged with the instruction to continue her anti-seizure medication. The 6-year old child was taken to a local hospital by family members later that day for treatment of his soft-tissue injuries and was then released.

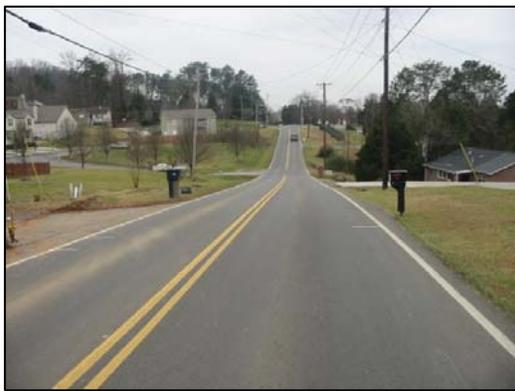
Figure 2 - Westbound approach of Explorer.

The 40-year old female driver of the 2004 Ford Explorer was traveling westbound on a two-lane roadway (**Figure 2**). A 21-year old female was operating the 2003 Honda Civic and was traveling eastbound on the same roadway (**Figure 3**). The driver of the Explorer had recently exited a left curve onto a straight portion of the roadway that contained a steep westbound negative grade. The driver's 14-year old daughter seated in the front right position began to have a seizure, which distracted the driver. The driver attempted to aid her daughter and in doing so crossed the centerline of the roadway and drifted into the eastbound lane. The driver's 6-year old son saw the approaching Honda and cautioned his mother who panicked and applied the brakes resulting in a driver-reported lock-up of the ABS system. The roadway yielded no evidence as to pre-crash avoidance measures by either vehicle.

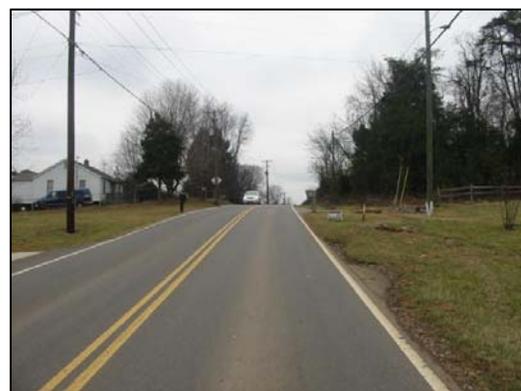
Figure 3 - Eastbound approach of Honda.

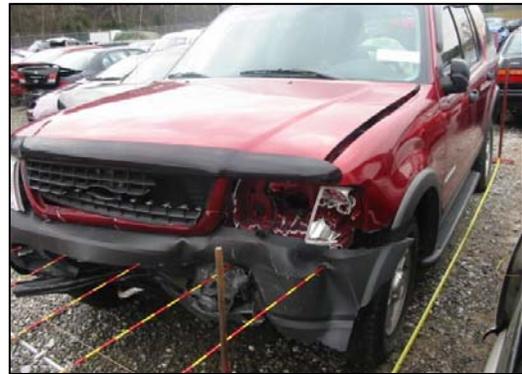
The 2004 Ford Explorer sustained moderate severity frontal damage (**Figure 4**). The direct contact damage began at the left front bumper corner and extended 99 cm (40”) to the right, terminating 20 cm (7.9”) inboard of the right front bumper corner. The combined direct and induced damage encompassed the entire front bumper width measuring 144 cm (56.7”). The maximum crush was located at the left front bumper corner and measured 35 cm (13.8”) in depth. The crush profile was documented along the bumper beam the results of which follow: C1 = 35 cm (13.8”), C2 = 26 cm (10.2”), C3 = 24 cm (9.4”), C4 = 20 cm (7.9”), C5 = 6 cm (2.4”), C6 = 2 cm (0.8”). The SCI revised Collision Deformation Classification (CDC) for this event was 12-FYEW-2.

Figure 4 - Measured 2004 Ford Explorer.

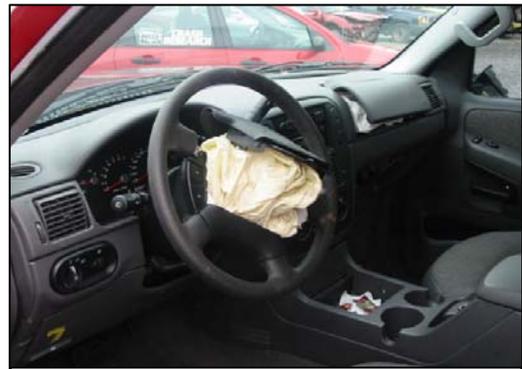
The interior of the 2004 Ford Explorer sustained minor damage in the form of passenger compartment intrusion and occupant contact (**Figure 5**). The intrusion was limited only to the toe pan in the front left position, which intruded longitudinally 8 cm (3.2”). The driver’s air bag was contacted, evidenced by make-up transfers at the center of the air bag. The front right passenger’s air bag was also contacted by the face of the front right passenger. This was supported by make-up transfers on the bottom left quadrant of the air bag.

Figure 5 - Interior of Ford Explorer.

The driver’s lower extremities loaded the left knee bolster causing scuffing and indenting of the rigid plastic cover. The intruded toe pan was sourced to injuries to the driver’s ankle; however, no distinct evidence can be derived from the images. The glove

compartment door was contacted and damaged from the front right passenger's lower extremities. The glove compartment door was found to be opened during the NASS inspection.

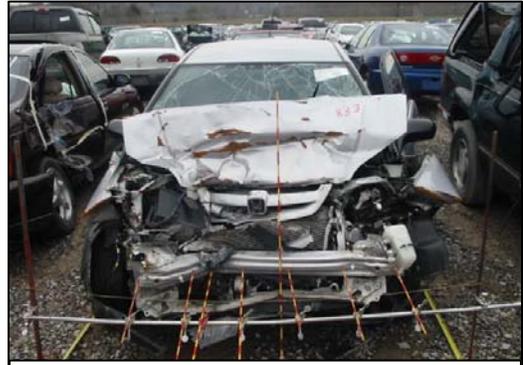
The 2003 Honda Civic sustained moderate damage as a result of the frontal impact (**Figure 6**). The direct contact damage began at the left front bumper corner and extended the full width of the damaged bumper beam measuring 105 cm (41.3"). The combined direct and induced Field-L damage was also 105 cm (41.3"). The maximum crush was located 19 cm (7.5") right of the vehicle's centerline and measured 56 cm (22") in depth. The crush profile was measured along the vehicle's bumper beam the results of which are as follows: C1 = 40 cm (15.7"), C2 = 40 cm (15.7"), C3 = 41 cm (16.1"), C4 = 49 cm (19.3"), C5 = 50 cm (19.7"), C6 = 25 cm (9.8"). The CDC for this impact was 12-FDEW-3.

Figure 6 - Damaged 2003 Honda Civic.

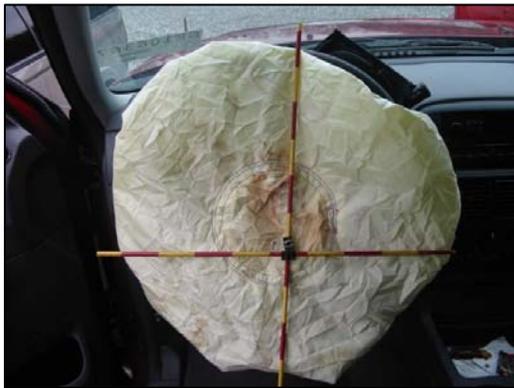
The Explorer was equipped with a dual stage frontal air bag system that deployed as a result of the impact with the Honda Civic (**Figures 7 and 8**). The driver's air bag was concealed within the steering wheel hub by trapezoidal cover flaps. The upper flap was 25 cm (9.8") horizontally and 5 cm (2") vertically. The bottom flap was 15 cm (5.9") horizontally and 6 cm (2.4") vertically. The driver air bag membrane measured 50 cm (19.7") in its deflated state. The air bag was tethered by two straps and was vented by two ports located near the 11 and 1 o'clock positions. The tether straps were sewn to the face of the air bag with three rows of stitching forming a circular pattern. There was a substantial make-up transfer at the central and lower aspects of the air bag.

Figure 7 - Deployed driver's air bag.

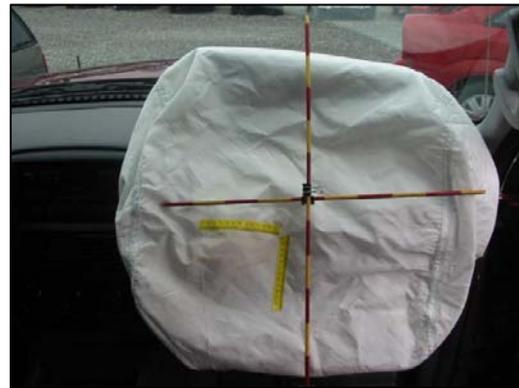
Figure 8 - Deployed front right air bag.

The front right air bag was concealed within the top aspect of the front right instrument panel by a top-hinged cover flap. The cover flap was 35 cm (13.7") horizontally and 18 cm (7.1") vertically. The rectangular air bag membrane measured 55 cm (21.7") in

height and 50 cm (19.7”) in width in its deflated state. The air bag was not tethered and was vented by two ports located near the 10 and 2 o’clock positions. There was significant make-up transfers located on the front bottom left aspect due to occupant loading.

The 14-year old driver was restrained by the manual 3-point lap and shoulder belt, but was likely out of position forward due to experiencing a seizure and was displaced further forward by the pre-crash braking. Due to her forward position, she spooled out the shoulder belt webbing prior to the locking of the ELR. At impact, she initiated a forward trajectory responding to the 12 o’clock direction of force and loaded her safety belt. She was contacted in the head and face by the expanding driver’s air bag. She sustained an 8 mm intraparenchymal hemorrhage of the left frontal region of her brain accompanied by a contusion on the left side of her face from loading the expanding front right air bag. Evidence was present in the form of a substantial make-up transfer to the bottom left quadrant of the air bag membrane. She also loaded the lap portion of the manual belt system sustaining a contusion to the abdomen. She was removed from the vehicle by emergency personnel and transported to a local hospital where she was admitted for one day.

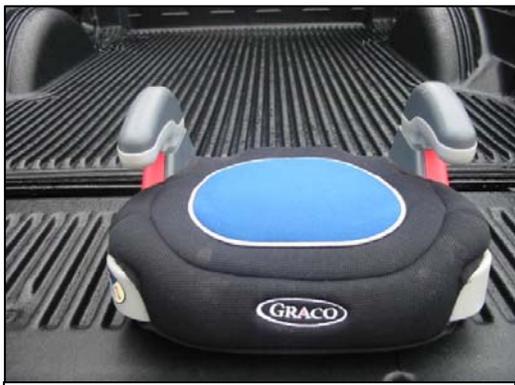
A forward-facing backless booster Child Safety Seat (CSS) was properly installed in the rear center seating position of the 2004 Ford Explorer. The model number was 8491RGB and the date of manufacture was July 13, 2003. The serial number was JJ 0712031095978. The booster seat was designed for forward-facing only and had belt paths on each side of its base. The CSS can be used with a back support or independent of a support. The CSS was used without a back support in this crash. The seat was designed for children between the ages of 3 and 10 years old, who weigh between 14 kg (30 lb) and 45 kg (99 lb), and whose height is within the parameters of 101cm (40”) and 145 cm (57”). The 6-year old child who occupied this booster seat was 145 cm in height and 28 kg in weight. The NASS investigation revealed no contact evidence on the CSS. **Figures 9 and 10** illustrate the CSS at the time of the inspection.

Figure 9 – Front view of Booster CSS.

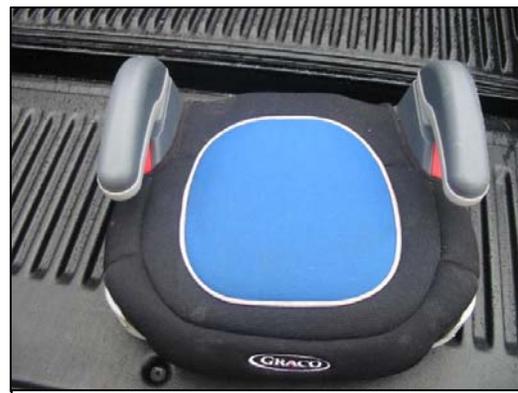
Figure 10 - Top view of booster CSS.

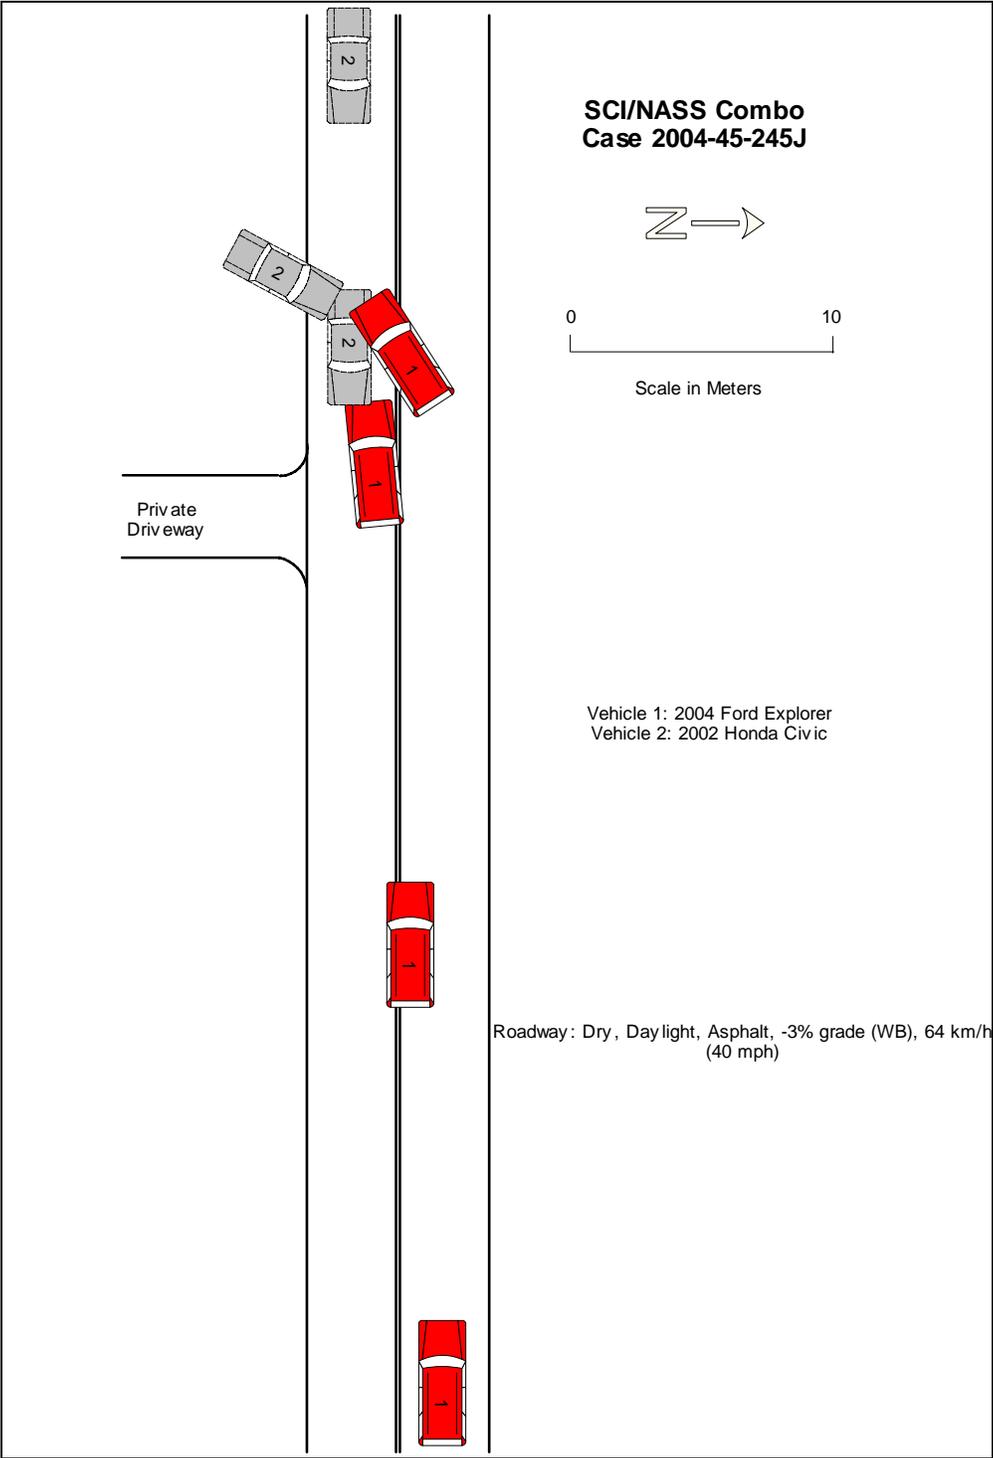
The crash occurred on a two-lane rural roadway during daylight hours. The asphalt roadway was straight at the point of impact; however, it was windy in nature and the Explorer had recently negotiated a left curve prior to the impact. The east/west roadway was delineated by double-yellow painted center lines and the road edges contained asphalt shoulders denoted by white painted edge lines. The lanes were 3.3 m (8.4') in width on a steep grade that was negative (downhill) for westbound traffic. The roadway was bordered by natural growth and sporadic dwellings. The posted speed limit was 64 km/h (40 mph). The scene schematic is included as **Figure 11** at the end of the narrative report.

Figure 11 - NASS Scene Schematic
