**CALSPAN ON-SITE CHILD DRIVER AIR BAG RELATED FATALITY  
INVESTIGATION**

**CASE NO: CA05-020**

**VEHICLE: 1993 TOYOTA TERCEL**

**CRASH DATE: MARCH 2005**

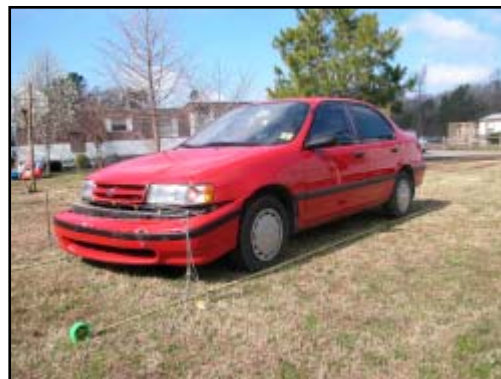
**Figure 1. Damaged 1993 Toyota Tercel**

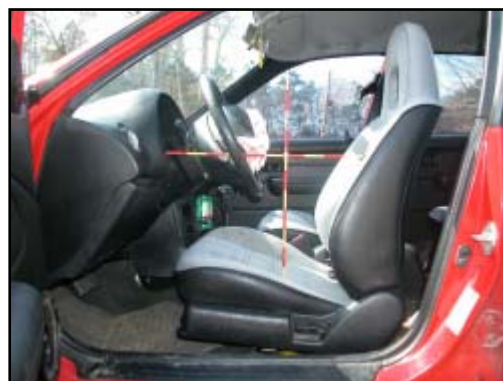
The 1993 Toyota Tercel was configured with front bucket seats with integral, open head restraints for the driver and front right passenger positions. The driver's seat track was adjusted to the full-forward track position at the time of the crash (**Figure 2**), based on on-scene photographs and reports from police. The driver's seat track had been moved since the crash, and both seats were initially found in the full-rear track positions at the time of the SCI vehicle inspection. The Tercel was configured with a rear bench seat.

**Figure 2. View showing position of driver's seat**

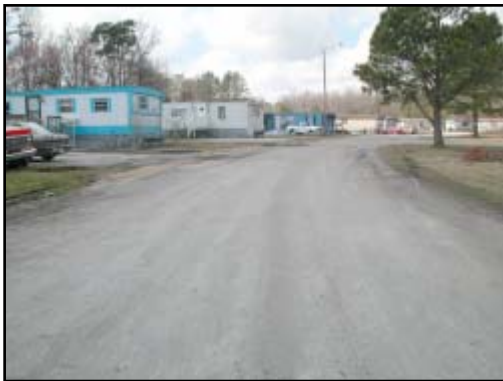
**Figure 3. Westbound approach for the Tercel**

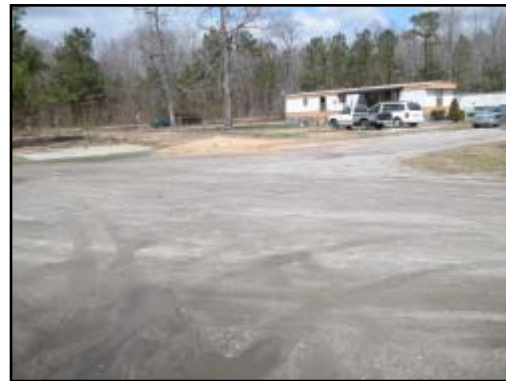
The 7-year-old male driver and his 8-year-old brother took the family vehicle for a joyride within the confines of the trailer park. The investigating officer suggested that the children had operated the vehicle in the trailer park on previous occasions. The 7-year-old was operating the vehicle, and departed the residence in a westbound direction on the dirt roadway (**Figure 3**). According to the statement from the front right passenger, the driver became distracted by something in a yard on the left side of the road as he approached the T-intersection. The driver realized he needed to turn right in order to return to the residence via the continuous loop roadway. When he realized his proximity to the intersection, he initiated a right turn onto the intersecting roadway (**Figure 4**). A 1979 Ford van was stopped at the end of the intersecting roadway, facing south, waiting to initiate a right turn. During the turning maneuver, the Toyota drifted wide left toward the stopped van.

**Figure 4. View of intersection showing trajectory of the Tercel**

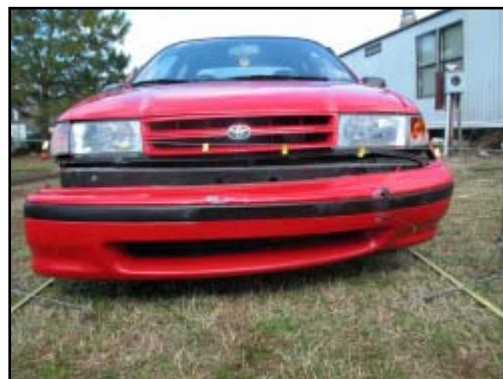
The 1993 Toyota Tercel sustained minor damage as a result of the frontal impact with the Ford van. The direct contact damage on the front bumper fascia began 21.0 cm (8.3") left of the centerline and extended 44.0 cm (17.3") to the left on the face of the bumper fascia (**Figure 5**). The vertical height of the direct damage area measured 12.7 cm (5.0") on the face of the bumper fascia. A tear was present in the direct damage area of the plastic fascia, and significant scuff marks from engagement with the van's wheel also encompassed the direct damage area. The left aspect of the bumper fascia and beam were crushed rearward, and the maximum crush measured 6.6 cm (2.6") at the front left corner. The front left turn signal lens was fractured, and the total width of direct contact measured 44.0 cm (17.3") from the beginning of the scuffmark on the fascia to the fractured turn signal lens on the front left corner. The combined direct and induced damage involved the entire frontal width of the Toyota. The front bumper fascia was displaced and partially separated at the time of the vehicle inspection, and the bumper beam was crushed rearward (**Figure 6**). There was no deformation present on the hood or front fenders. Six crush

**Figure 5. View of frontal damage to bumper fascia**

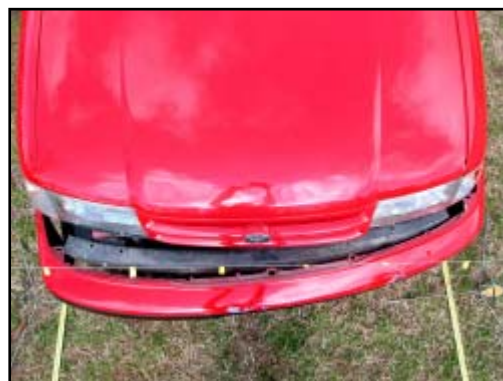
**Figure 6. Overhead view of frontal crush profile**

measurements were documented across the front bumper beam as follows: C1 = 6.6 cm (2.6”), C2 = 3.8 cm (1.5”), C3 = 1.3 cm (0.5”), C4 = 0.0 cm, C5 = 0.0 cm, C6 = 0.0 cm. The Collision Deformation Classification (CDC) for the impact with the Ford was 12-FLEW-1.

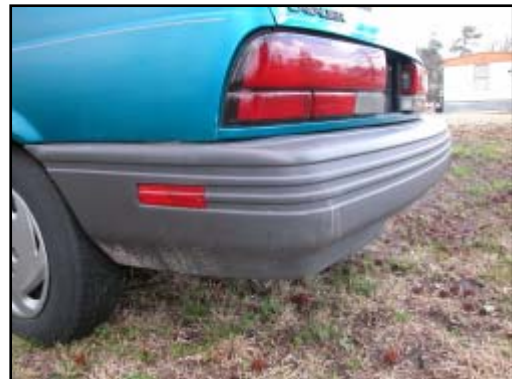
The 1994 Chevrolet Cavalier sustained minor left rear damage (**Figure 7**) as a result of the secondary impact with the Toyota Tercel. The direct damage on the Cavalier was limited to the lower left aspect of the rear bumper. The direct damage began at the left rear bumper corner and extended 7.6 cm (3.0”) forward. The damage consisted of scuff marks and there was no lateral crush. The combined direct and induced damage involved the rear left aspect of the rear bumper. Faint lateral buckling was present on the rear plane of the bumper 67.3 cm (26.5”) left of the centerline. The CDC for the impact with the Toyota was 09-LBEE-1.

**Figure 7. View of left side damaged area to the Cavalier**

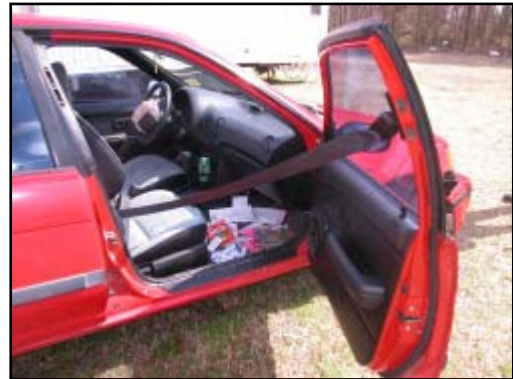
The front right passenger's safety belt system was configured with an automatic door mounted shoulder belt and a manual lap belt (**Figures 8**). The automatic shoulder belt was configured with an ELR retractor mounted on the inboard aspect of the front right seat. The two-point shoulder belt was also configured with a sewn-on latch plate and passed through a plastic guide mounted above the retractor. The latch plate engaged with a fixed-position buckle that was mounted to the rear aspect of the interior door frame, located near the vertical mid-point of the window frame. There was no loading evidence on the automatic shoulder belt. The manual lap belt was configured with an ELR and a sewn-on latch plate. The lap belt passed through a plastic guide that was mounted on the outboard aspect of the seat cushion above the retractor. The guide also acted as a stop for the sewn-on latch plate. There was no loading evidence on the manual lap belt.

**Figure 8. Automatic shoulder belt**

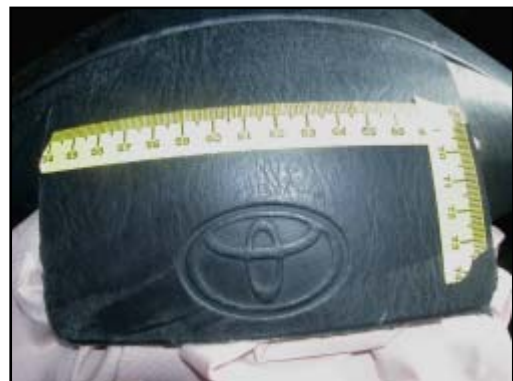
**Figure 9. Top air bag module cover flap**

The 1993 Toyota Tercel was equipped with a frontal air bag for the driver. The driver's air bag deployed from the steering wheel hub through symmetrical H-configuration module cover flaps. The cover flaps measured 15.2 cm (6.0") in width and 8.9 cm (3.5") in height. It should be noted that at the time of the crash, the steering wheel was probably rotated 180 degrees. Both module cover flaps displayed contact evidence (**Figures 9 and 10**). The bottom cover flap exhibited a distinct white fabric transfer on the top left corner from contact to the child driver's T-shirt. The fabric transfer measured 3.8 cm (1.5") in width and 3.5 cm (1.4") in height. The area around the transfer was deformed slightly. The top cover flap also sustained white fabric transfers, although not as pronounced as the transfers on the bottom flap. The transfers on the top flap began at the lower left corner, extended laterally 11.4 cm (4.5") to the right, and extended vertically 2.9 cm (1.1"). Fabric transfers were also located on the tear seam of the top flap.

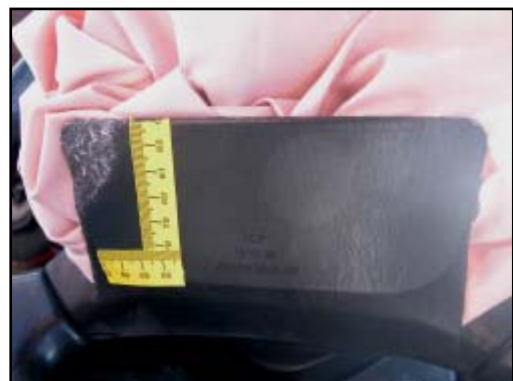
**Figure 10. Bottom air bag module cover flap**

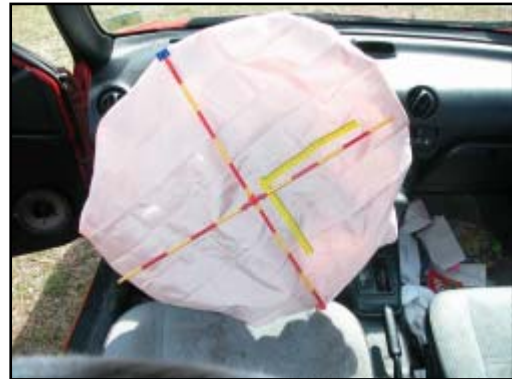
The driver's air bag measured 66.0 cm (26.0") in diameter in its deflated state (**Figure 11**). A faint probable tissue transfer was present on the right aspect of the air bag face. The transfer began 4.4 cm (1.8") above the horizontal centerline and 5.7 cm (2.3") to the right of the vertical centerline. The transfer extended 15.2 cm (6.0") downward and 18.4 cm (7.3") to the right.

**Figure 11. Deployed driver's air bag**

The driver's air bag was vented by two circular ports that measured 3.2 cm (1.3") in diameter. The vent ports were laterally spaced 15.9 cm (6.3") apart, and located 5.7 cm (2.3") inboard of the circumferential seam. The air bag was not tethered.
