## ON-SITE NOT-IN-TRAFFIC SURVEILLANCE BACK OVER INVESTIGATION

CASE NUMBER - IN-07-009

VEHICLE - 1997 FORD TAURUS

CRASH DATE - February 2007

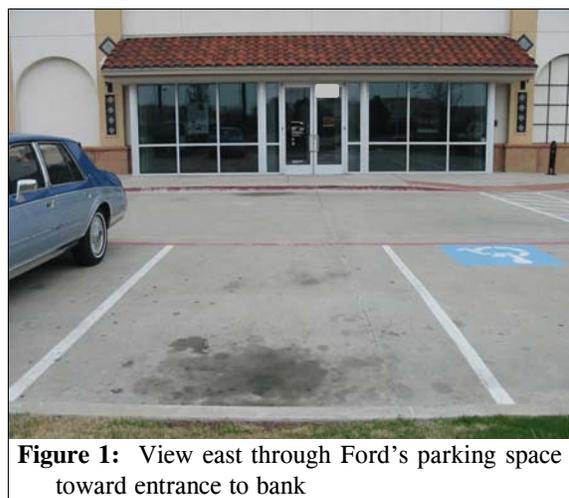
**Figure 1:** View east through Ford's parking space toward entrance to bank

**Crash Environment:** The Ford was parked in a bank parking lot (**Figure 1**). The bank was located on the east side of the parking lot access roadway, which traversed north and south in front of the bank. The Ford was parked in a designated parking space heading west directly across the roadway from the bank entrance. A car was parked in the parking space on each side of the Ford. All the designated parking spaces were oriented east-west. Parking was prohibited along the curb in front of the bank. The grade of the parking lot along the path of travel of the Ford was measured as 2% negative. The width of the parking lot access roadway was 7.2 meters (23.6 feet). At the time of the crash, the light condition was daylight, the atmospheric condition was clear, and the roadway pavement was dry concrete.

**Pre-Crash:** The Ford's driver [82-year-old, male] was in the bank conducting business. He stated that he exited the bank, walked west across the roadway (**Figure 1** above), approached the Ford from the passenger side rear and entered the Ford through the left front door. The driver stated he looked in his side view and rear view mirrors after he entered the Ford. The driver indicated he saw no vehicle's behind him. He indicated he did not look in the mirrors again. The driver estimated the elapsed time between entering the Ford and beginning to back up was in a range of 11 and 30 seconds. As the Ford's driver was preparing to back up, a red 2005 Dodge Ram pickup truck, which was traveling south in the access roadway (**Figure 2**), pulled up to the curb in front of the bank, stopped and the front right passenger exited the vehicle. The passenger stated that he walked to the rear passenger side of the truck to retrieve his briefcase from the truck bed. He was standing beside the rear passenger side of the Dodge facing northeast toward the truck bed when the incident occurred.

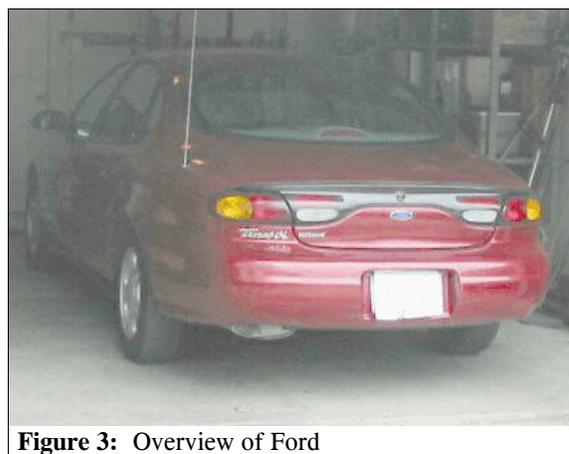
**Figure 3:** Overview of Ford

The 1997 Ford Taurus was a front wheel drive, four-door sedan (VIN: 1FALP52U0VA-----) equipped with a 3.0L, V6 engine and automatic transmission. The Ford's back bumper was covered with a plastic bumper fascia with energy absorbing material between the bumper fascia and bumper bar. The distance from the ground to the bottom of the back bumper was 43 centimeters (16.9 inches). The Ford was equipped with no after-market equipment and was not equipped with any back up/parking aid. The Ford's wheelbase was 276 centimeters (108.7 inches). The rear overhang was 121 centimeters (47.6 inches) and the overall length was 502 centimeters (197.6 inches).

There was no evidence of pedestrian contact to the Ford's back bumper. However, based on the police crash report and the Ford driver's interview, a Collision Deformation Classification was estimated to be: **06-BLLU-1**. The Ford was driven from the scene. Due to the sequence of events in conducting this investigation and the time available for working with the elderly driver, this contractor was only able to acquire a few photographs of the case vehicle and was not able to obtain any interior sight line photographs.
