Not in Traffic Surveillance Back Over Investigation / Vehicle to Non Motorist
Dynamic Science, Inc. / Case Number: DS07037
1997 Land Rover Discovery
Colorado
August 2007

1. Report No. DS07037	2. Government Accession No.	3. Recipient Catalog No.	
4. Title and Subtitle Not in Traffic Surveillance Back Over Investigation		5. Report Date January 3, 2008

Dynamic Science, Inc.
Crash Investigation
Case Number: DS07037
TABLE OF CONTENTS

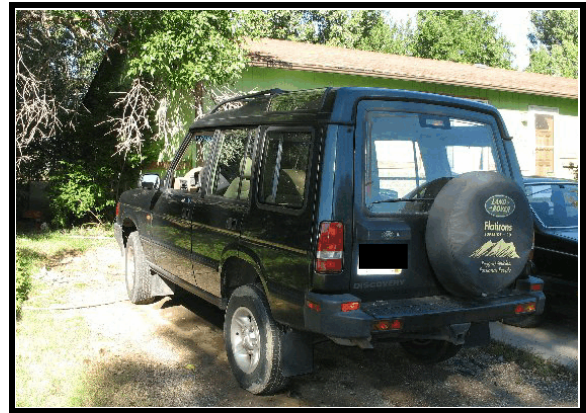
Figure 1. 1997 Land Rover Discovery

This single vehicle incident occurred in August 2007 at 1630 hours. The case vehicle is a 1997 Land Rover Discovery sport utility vehicle (see Figure 1). The incident took place on a sidewalk, just beyond a private driveway. The weather was clear and calm at the time of the incident. The Land Rover was being driven by a 62-year-old male. The 4-year-old child was on a Huffy bicycle with training wheels. The driver of the Land Rover and child are neighbors. The Land Rover was initially parked in a private driveway, facing west. The driveway intersects a north/south city street. The driver indicated that he had entered the vehicle by walking directly from his house. His path took him along the right side of the vehicle, around the back of the vehicle, and then along the left side to the driver's door. He never saw the involved child. The child was traveling northbound on the sidewalk. As the driver began backing to the east, the rear of the Land Rover struck the child on the bicycle. The driver was not aware of the child until he heard yelling from other people in the neighborhood. The child was trapped beneath the vehicle, but was able to be extricated by his relatives. He sustained multiple superficial abrasions. He was transported by his relatives to a local children's hospital. He was examined and then released.

The 1997 Land Rover Discovery was identified by the Vehicle Identification Number (VIN): SALJY1246VAxxxxxx. The Land Rover was a four-door sport utility vehicle that was equipped with a 4.0 liter, eight cylinder engine, four-wheel drive, and a 4-speed automatic transmission. The Land Rover was configured with Continental Contitrac LT225/75R16 tires. There were no tire restrictions or tire damage. All the windows for Land Rover were clear and untinted. The Land Rover was equipped with a spare tire that was mounted to the rear hatch. The spare tire obscured the driver's vision rearward to the right.

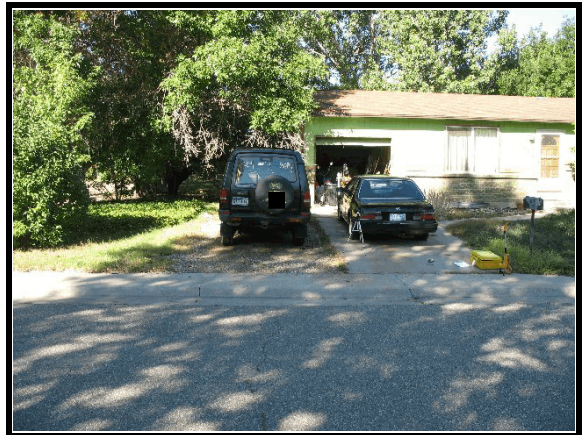
Figure 2. Overview of incident site (west)

This single vehicle incident occurred at 1630 hours in August 2007. The incident took place within the confines of an intersection of a private driveway/parking area and a north/south residential roadway (see Figure 2). The straight and level asphalt roadway was 9.1 m (30 ft) wide. It is bordered to the east and west by shallow, 11.0 cm (4.3 in) high concrete curbs. The east edge of the roadway is bordered by a 1.2 m (4.0 ft) wide concrete curb. The driveway/parking area is

comprised of a 3.0 m (10.1 ft) wide concrete pad that is bordered to the south by a 2.7 m (9.0 ft) wide gravel covered parking area. The concrete pad leads into the garage. The gravel parking area had a negative 2% down grade. The Land Rover was parked in the gravel parking area facing west. The vehicle was parked 1.6 m (5.1 ft) west of the sidewalk edge. A second vehicle (BMW) was parked on the concrete pad facing west. There is a large bush to the south of the driveway. The view of the sidewalk from inside the vehicle disappears at this point. The weather was clear and the driveway/roadway was dry. The temperature at the nearest reporting station was 31 degrees C (88 degrees F).

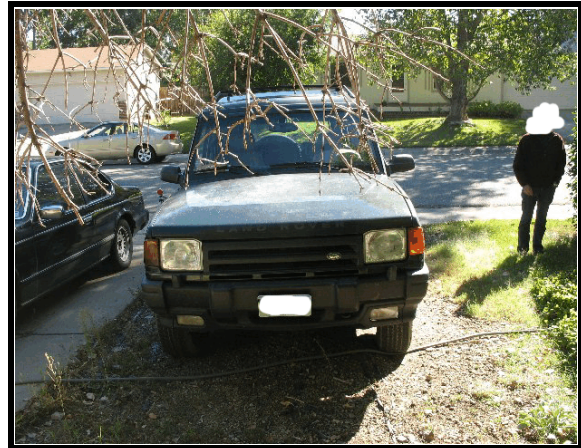
Figure 3. Backing path of Land Rover (East)

The case vehicle is a 1997 Land Rover Discovery four-door sport utility vehicle. The Land Rover was being driven by a 62-year-old male. The driver indicated that he had entered the vehicle by walking directly from his house. His path took him along the right side of the vehicle, around the back of the vehicle, and then along the left side to the driver's door. He never saw the involved child. After entering and starting the vehicle, the driver spent 1-2 minutes going through some kind of paperwork. The driver did not put on his seat belt. He indicated that it was his normal practice to not put on the belt until backing out of the driveway. He indicated that it made it easier for him to turn and look over his right shoulder. His purpose for this trip was go to a local stable to feed his horses. Prior to backing up, the driver indicated that he checked all three mirrors and then turned and looked over this right shoulder. He never saw the child coming from his left. The 4-year-old male child (91 cm/36 in, 16 kg/35 lbs) was riding a Huffy bicycle with training wheels. The child was wearing a T-shirt, blue jean shorts, and tennis shoes. The child lives north of the incident site. The child was initially riding the bicycle north (see Figure 4) on the sidewalk at an estimated speed of 8 km/h (5 mph). The child was visible to his grandmother who was watching him from her house.

The driver began backing at approximately 3 km/h (2 mph). It appears that the child and bicycle got behind the case vehicle just as the vehicle crossed the sidewalk. The bike was knocked down and the child and the bike went under the vehicle on the right side. The vehicle continued slowly backing. The bike and the child were entrapped beneath the vehicle. The driver stopped the vehicle after hearing the child's grandmother yelling.

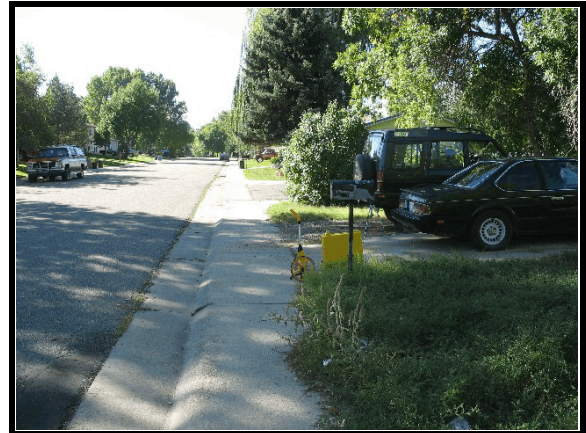
Figure 5. Looking back view along sidewalk (South)

The child was trapped beneath the vehicle, but was able to be extricated by his relatives. His shorts were tangled up with the bicycle handle bars and needed to be cut off of him during the extrication. He sustained multiple superficial abrasions, the worst of which was to his groin area. This latter injury came from the bicycle. He was transported by his relatives to a local children's hospital where he was examined and released. The bicycle was trapped beneath the vehicle facing south. The driver was able to extricate it by using a jack to raise the rear of the vehicle.

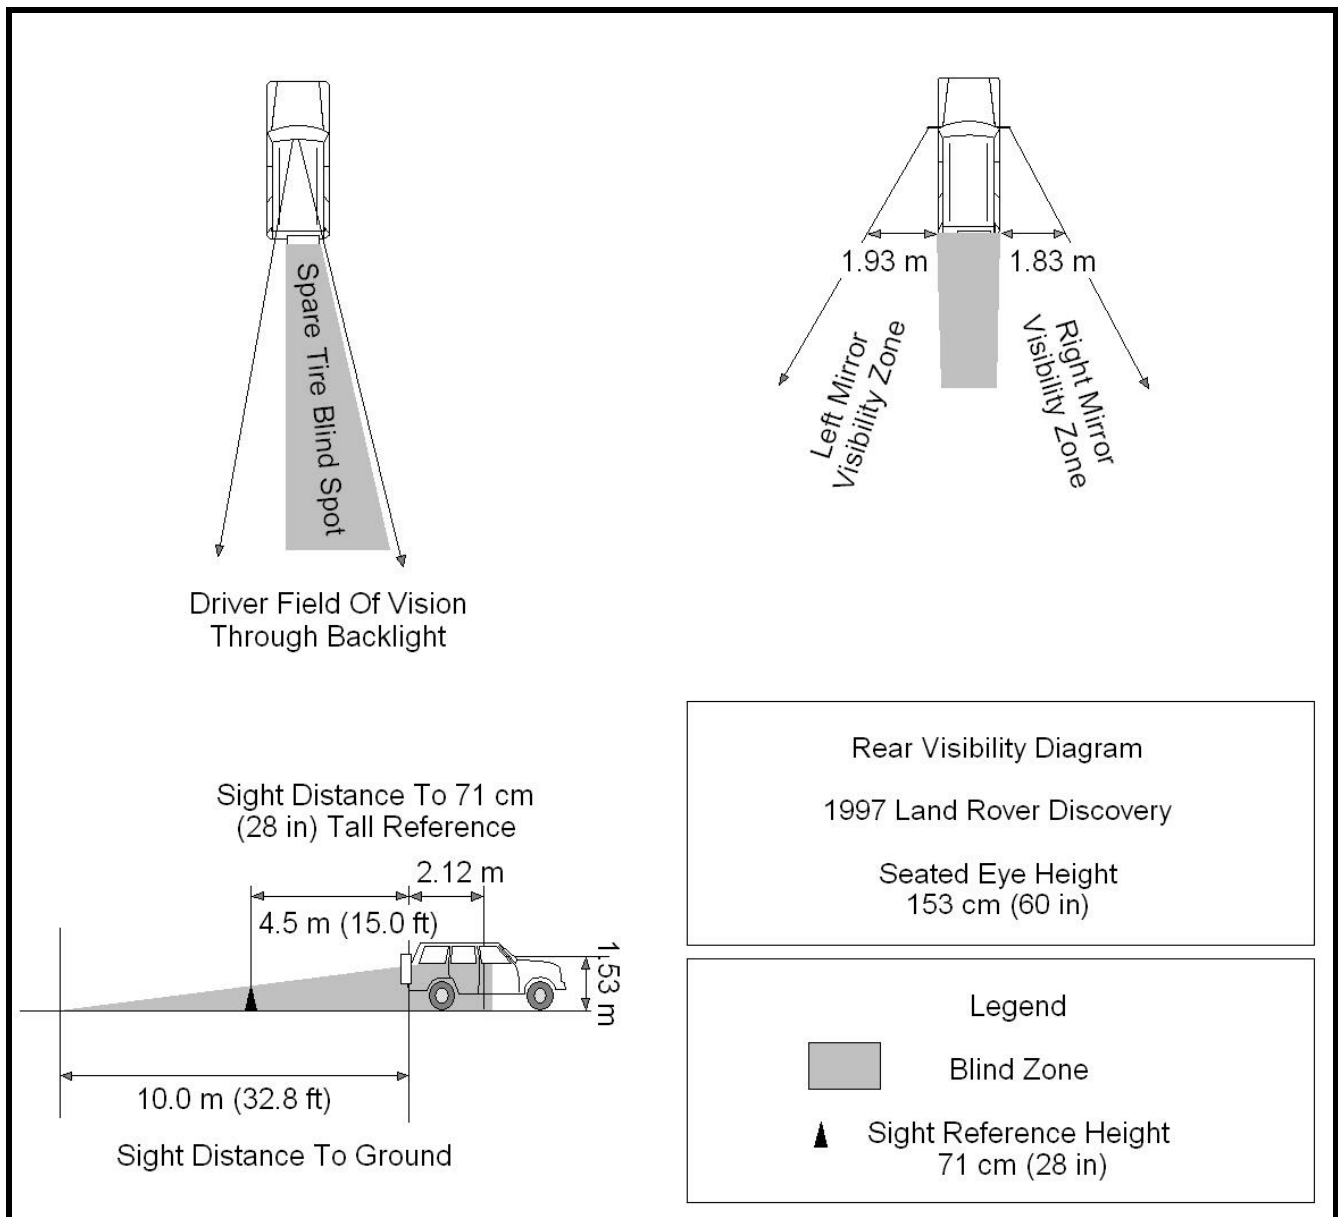
Figure 6. Nominal sight diagram

A visibility study was conducted during the inspection of the Land Rover in order to determine the nominal blind zone behind the Land Rover as well as the nominal blind zone of both side view mirrors. The standard 71 cm (28 in) high target was used for the observations. The Land Rover driver assisted the SCI investigator in making the visibility observations. The observations were conducted with the vehicle positioned in the pre-incident location. See Figure 6 for the nominal visibility diagram.

The driver's seated eye height was 153.0 cm (60.2 in). The initial set of measurements were made as if the driver were looking over his right shoulder through the backlight. The target was moved rearward from the back bumper along the Land Rover's centerline until it came into view. The target had to be moved rearward from the back bumper 4.5 m (15.0 ft) before the top of the target came into view. The Land Rover was equipped with a hatch mounted spare tire that was off-set to the right side of the backlight. The area directly behind the spare tire was completely obscured and not visible to the driver.

The left and right side mirrors had not been moved since the incident. With the driver seated in the vehicle, the side views were examined. The target was moved from the side of the vehicle laterally to the right until the target became visible through the right side view mirror. This occurred as the target moved outboard of the side of the vehicle. The target was then moved laterally to the right until the target was no longer visible. This process was repeated on the left side of the vehicle.

The child would not have been visible at the time of impact due to the blind spot behind the Land Rover.

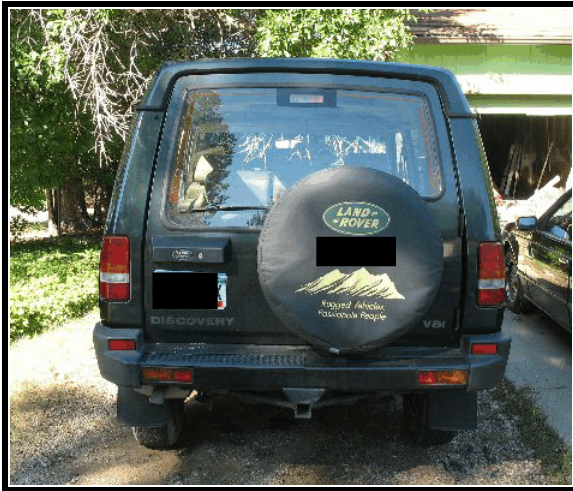
Figure 7. Rear, 1997 Land Rover Discovery

There was no exterior damage to the vehicle. There was some scuffing located on the fuel tank that might have been related to this incident. More than a month had passed between the time of the incident and the vehicle inspection, therefore it is unknown if the scuffing was related to this incident.
