CALSPAN REMOTE HYPERTERMIA DEATH INVESTIGATION

SCI CASE NO.: CA08026

VEHICLE: 2000 FORD EXPLORER XLT

INCIDENT DATE: JUNE 2008

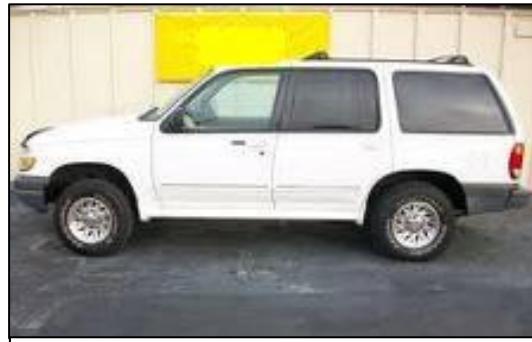
Figure 1. Left side view of an exemplar 2000 Ford Explorer.

vehicle following a work shift. The non-motorist maintained shallow breathing and was removed from the CRS by the driver and carried into an air-conditioned building. The emergency response system was notified of the incident and police and ambulance personnel responded to the scene of the incident. The non-motorist was transported to a local hospital and was then transferred to a regional pediatric trauma center where he was admitted for treatment. The non-motorist was placed on life support and evaluated for recovery. He was diagnosed with brain death and expired four days following the incident. The driver was the grandfather to the non-motorist. He was subsequently charged with involuntary manslaughter. The Police Agency investigated this incident as a crime and compiled a Crime Report for this death. This report will not be provided to State and Federal crash databases. **Figure 1** is a left side view of an exemplar 2000 Ford Explorer.

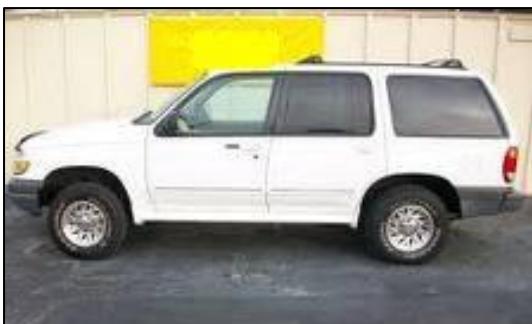
Figure 2. Left side view of an exemplar 2000 Ford Explorer.

The involved vehicle was a 2000 Ford Explorer XLT 4x4, 4-door sport utility vehicle. The Ford was identified by Vehicle Identification Number (VIN): 1FMZU73E1YZ (production number deleted). The Ford was equipped with a 4.0 liter V-6 conventionally-mounted gasoline engine linked to a 5-speed automatic transmission. The exterior color of the Ford was white. **Figures 2 and 3** are exterior views of an exemplar 2000 Ford Explorer.

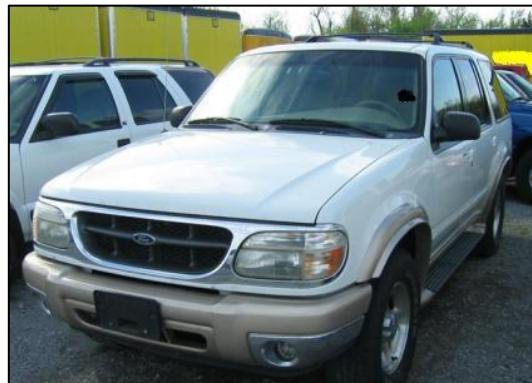
Figure 3. Front left oblique view of an exemplar 2000 Ford Explorer.

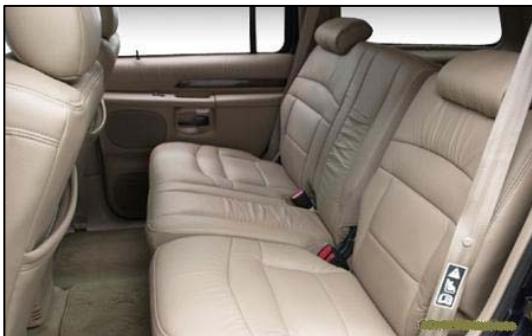
Figure 4. View of the second row left seat position of an exemplar 2000 Ford Explorer.

The interior was configured with front bucket seats and a split, forward folding second row bench seat. All interior and seating surfaces were surfaced in cloth and were light gray in color. **Figures 4 and 5** are interior views of exemplar vehicles.

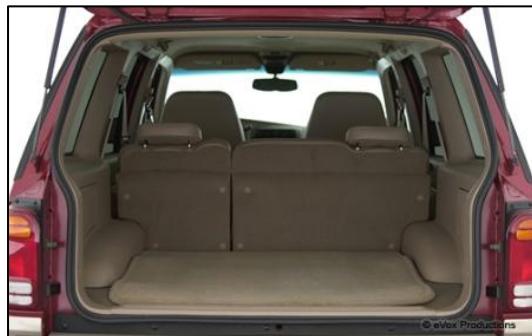
Figure 5. Rear interior view of an exemplar 2000 Ford Explorer.

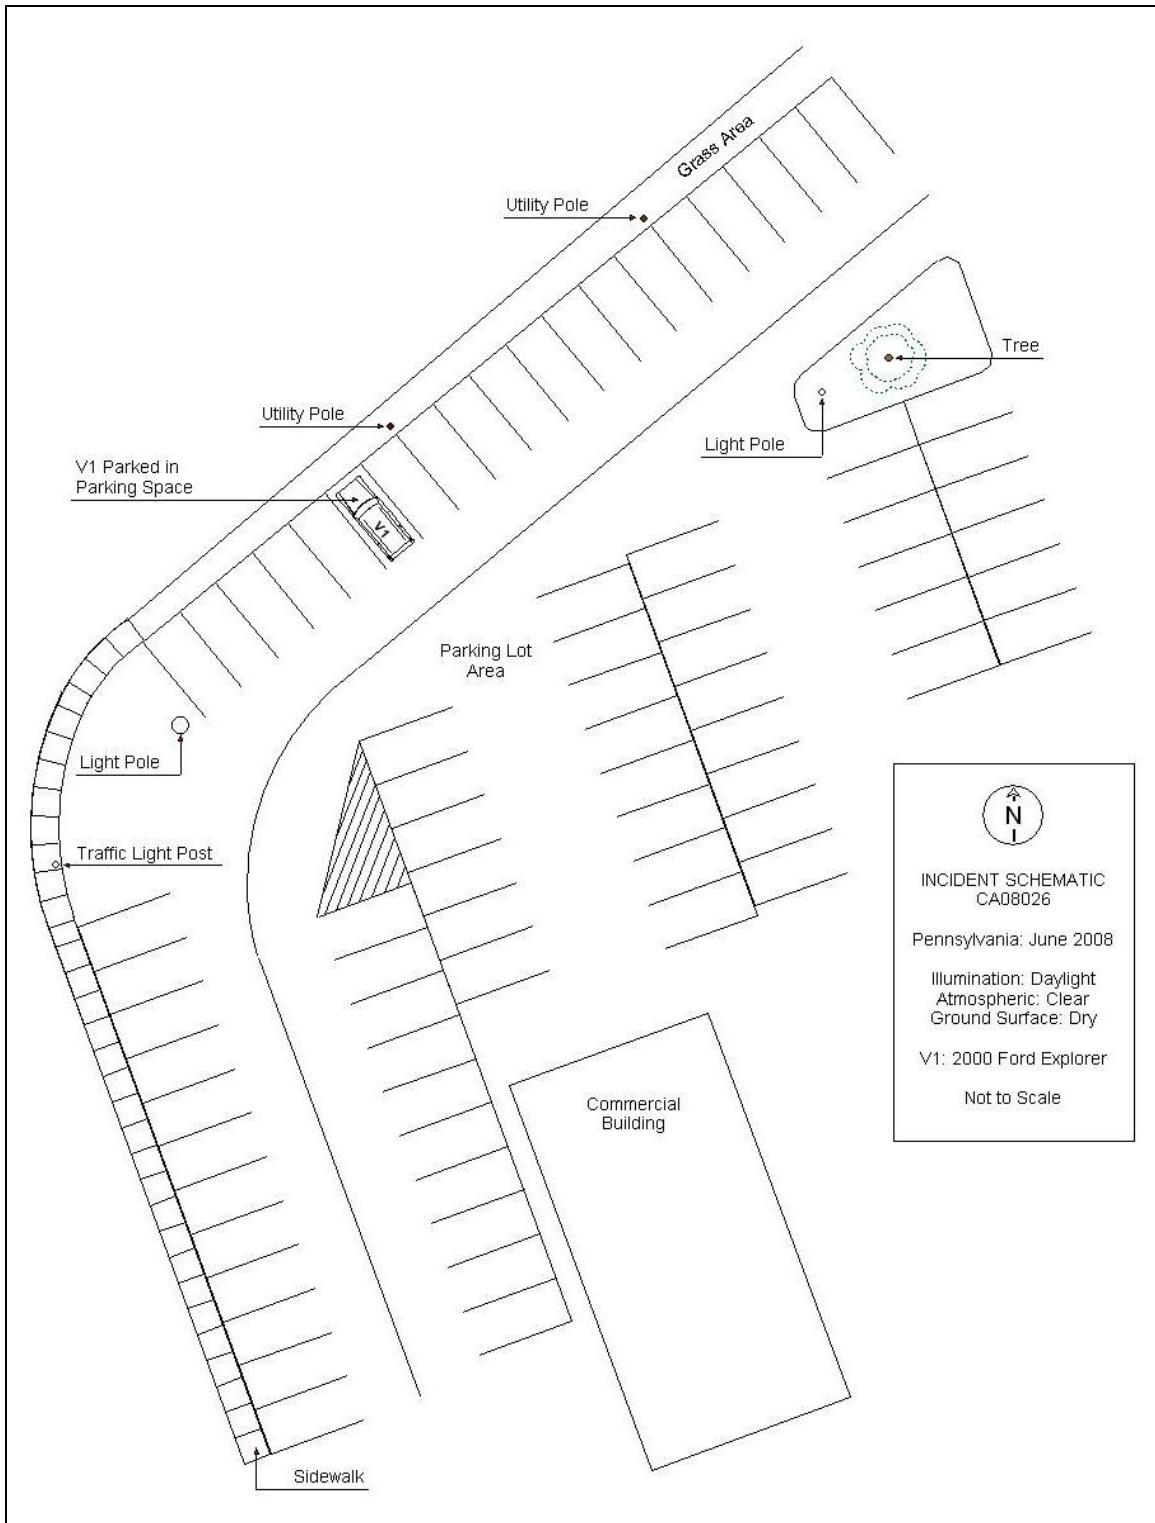
Figure 6: Incident Schematic

This incident occurred in a commercial parking lot during daylight hours. The parking lot was surfaced with asphalt and delineated with parking spaces and driving isles. Small trees were located within curbed islands at the ends of the parking rows. These trees did not shade the Ford as the investigating detective stated the vehicle was parked in full sun for the duration of this incident. The parking lot was level with spaces oriented in northeast and southwesterly directions. The Ford was parked at a perimeter location of the parking lot facing in a police reported north/northwesterly direction. Local weather forecasters indicated the weather conditions on the day of the incident were clear, but hazy, with temperatures ranging from (81 degrees F) at the time the driver arrived at the incident site to (96.8 degrees F) when he returned to the vehicle at the end of his work shift. The humidity levels were 77 percent at the time the Ford was parked and 37 percent at the time the driver returned to the vehicle. Wind speeds averaged 9.3 km/h (5.8 mph) throughout this time period and were variable in direction. It should be noted that the recorded temperature at the time the driver returned to the vehicle was the high temperature for that day. A schematic of the incident site is provided as **Figure 6** of this report.
