On-Site Not-In-Traffic Front Over Investigation
Dynamic Science, Inc. (DSI), Case Number DS09034
2001 Acura MDX
California
October 2009

1. Report No. DS09034	2. Government Accession No.		3. Recipient Catalog No.	
4. Title and Subtitle On-Site Not-In-Traffic Surveillance Front Over Investigation		5. Report Date May 21, 2010

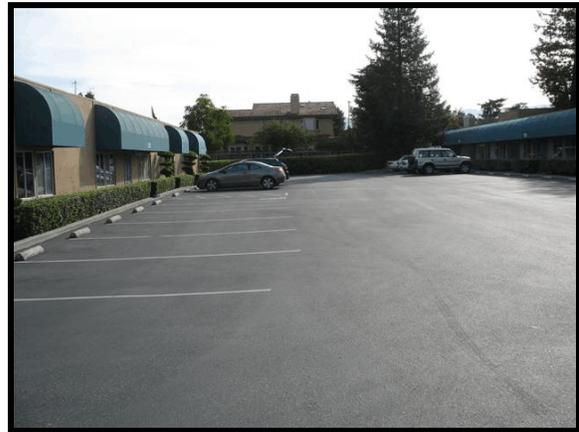
Figure 2. View of parking lot, facing south

The incident occurred in October 2009 at 1515 hours in a parking lot located on the west side of a single story office building. The parking lot was oriented north/south relative to the west side of the building (**Figure 2**). The lot had a negative 1% grade from west to east, was level from north to south, and was constructed of asphalt. Painted parking stalls were located on the east and west sides of the 18.6 m (61.0 ft) wide lot. The stalls were 3.0 m (10.0 ft) wide and 4.9 m (16.0 ft) long. The entrance to the school was located on the west side of the building 13.4 m (44.0 ft) south of the north side of the building. A satellite view of the parking lot and office building is included in this report as Attachment 2. At the time of the incident the weather conditions were clear and dry. The

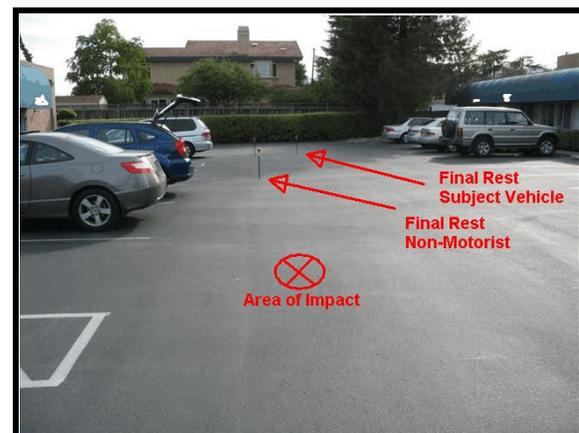
Figure 3. Overview of impact area and final rest

The child was in the driver's blind zone. The driver of the Acura did not see the child and began driving forward. The child was knocked down by the front of the vehicle (**Figure 3**) and was dragged/tumbled for approximately 8.0 m (26.4 ft) before being run over by the left rear tire. According to the investigating officer, the tire

rolled over the child in a diagonal pattern across his anterior torso. The driver reported feeling a bump while driving forward. Investigators found a friction scuff approximately 58.4 cm (23.0 in) long located just before the final rest of the child. The friction mark had pieces of green cloth imbedded in it that probably came from the child's green and white shirt.

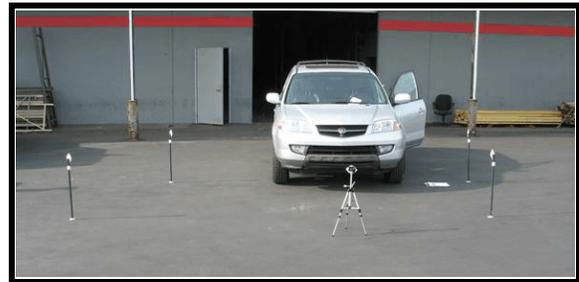
Figure 4. Front view of blind zone targets

The Acura was moved out of the evidence structure onto a parking lot and its front visibility was measured during the SCI inspection. This visibility assessment was measured on level ground using five 71.0 cm (28.0 in) tall targets to identify the location of the front blind zone around the vehicle. The targets were located outboard the left mirror, at the left front, forward centerline, at the right front and outboard the right mirror (**Figure 4**). The seated eye height of a female of the same height of the driver was measured and that height was located in the vehicle. The seated eye height was 142.0 cm (55.9 in) above the ground. The SCI investigator positioned himself at that height location and identified the targets. The target locations were then measured relative to the vehicle. **Figure 5** is a driver view through the windshield to the right front target. **Figure 6** on the following page is a scaled overhead visibility schematic depicting the blind zone forward of the driver based on the measured target locations.
