REMOTE NOT IN TRAFFIC SURVEILLANCE HYPERThERMIA INVESTIGATION

CASE NUMBER - IN09038
LOCATION - LOUISIANA
VEHICLE - 2009 DODGE RAM 1500 CREW CAB
INCIDENT DATE - June 2009

1. <i>Report No.</i> IN09038		2. <i>Government Accession No.</i>		3. <i>Recipient's Catalog No.</i>	
4. <i>Title and Subtitle</i> Remote Not In Traffic Surveillance Hyperthermia Investigation Vehicle - 2009 Dodge Ram 1500 Crew Cab pickup Location - Louisiana			5. <i>Report Date:</i> May 11, 2010

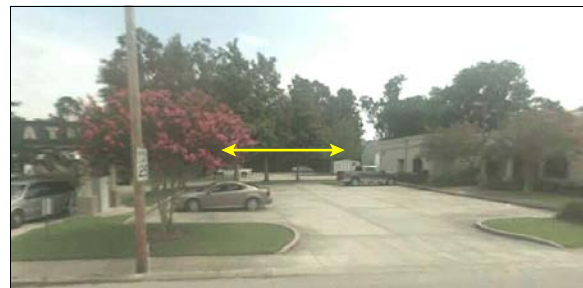
Figure 1: Northward view of branch bank's parking areas; arrow indicates parking area where child occupant was left in child seat and died; parking area was north and west of drive-through canopy which was located on northern side of bank

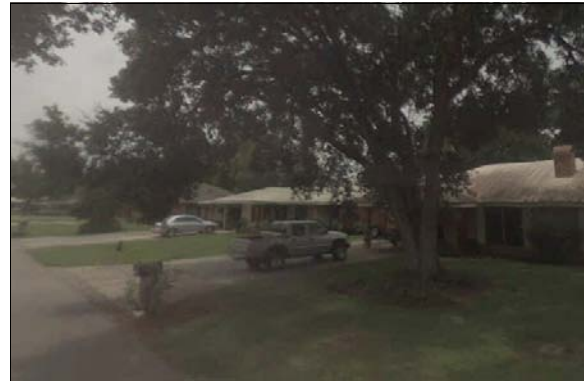
Figure 2: Vicinity of home daycare facility where infant occupant was discovered inside Dodge pickup

Incident: After work, at approximately 1500 hours, the driver entered the vehicle, still never noticing that the child was still inside, and drove to the daycare facility. She arrived at approximately 1530 hours and went inside to pick up her child (**Figure 2**). The operator of the facility told her that she had never dropped off her child. According to the reports, the driver realized that the child had remained in the vehicle. The driver and members of the daycare facility rushed to her vehicle (**Figure 3**). The driver opened the left rear door and located her child still seated and secured in the child safety seat in the second row of the Dodge (**Figure 4**). The mother fainted and fell onto the driveway.

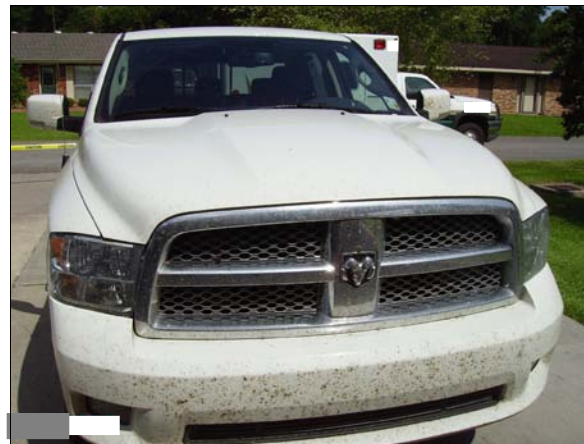
Figure 3: On-scene police photo of Dodge in driveway of daycare facility where infant was discovered in second row seat

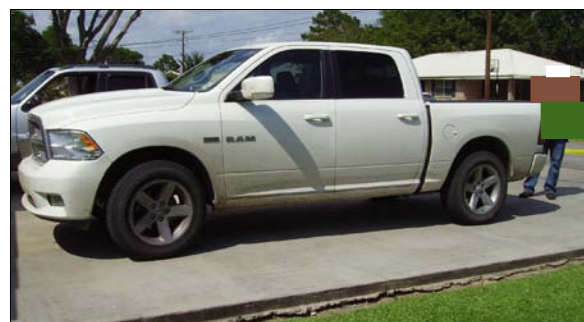
Figure 4: On-scene police photo of left side of Dodge in driveway of daycare facility; infant was found within CSS in second row seat of vehicle

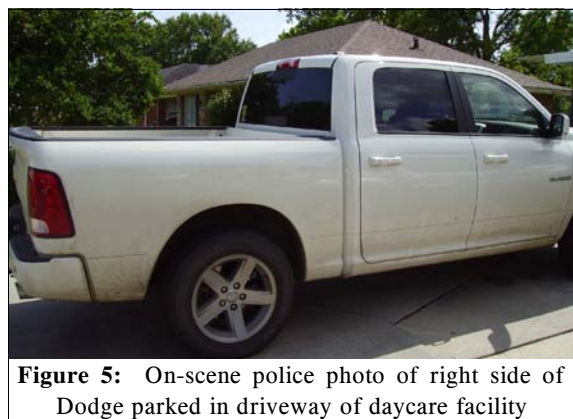
Figure 5: On-scene police photo of right side of Dodge parked in driveway of daycare facility

The 2009 Dodge Ram 1500 rear wheel drive, 6-passenger, 4-door, crew cab, regular bed pickup truck (VIN: 1D3HB13T38S-----) equipped with a 5.7-liter, V-8 engine and a 5-speed automatic transmission. The Dodge was equipped with 4-wheel, anti-lock brakes with electronic brake force distribution and braking assist, traction control, and electronic stability control, and this vehicle’s frontal air bags are certified by the manufacturer to be compliant to the Advanced Air Bag portion of Federal Motor Vehicle Safety Standard (FMVSS) No. 208. The vehicle was equipped with height adjustable seat belts, height adjustable head restraints for at least all outboard positions, Lower Anchors and Tethers for Children (LATCH) system features, a tire pressure monitoring system, and power-adjustable pedals. The vehicle was equipped with tinted windows (Figure 5), and all windows were closed that day.
