### ON-SITE ROLLOVER INVESTIGATION

CASE NUMBER - IN11007  
LOCATION - TEXAS  
VEHICLE - 2009 CHEVROLET EQUINOX LS  
CRASH DATE - December, 2010

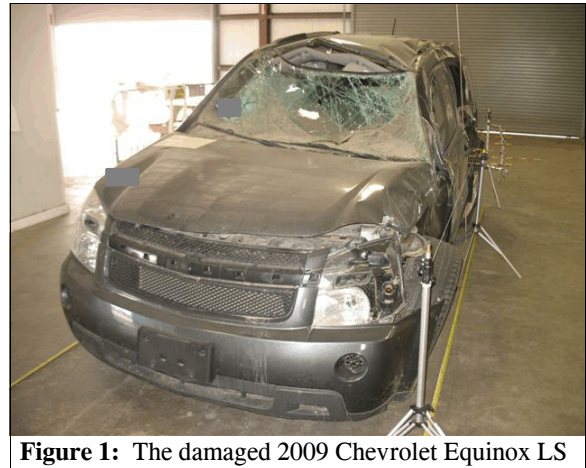
**Figure 1:** The damaged 2009 Chevrolet Equinox LS

The focus of this on-site investigation was the rollover of a 2009 Chevrolet Equinox LS (**Figure 1**). This investigation was initiated by the National Highway Traffic Safety Administration (NHTSA) on February 25, 2011 through the sampling activities of the National Automotive Sampling System (NASS)-General Estimates System (GES). This investigation was assigned on March 4, 2011. The crash occurred in December, 2010, at 0904 hours, in Texas and was investigated by the city police department. The Chevrolet was inspected on March 17, 2011. The crash scene inspection and an interview with the driver of the Chevrolet were conducted on March 18, 2011. The Ford was not inspected since it could not be located.

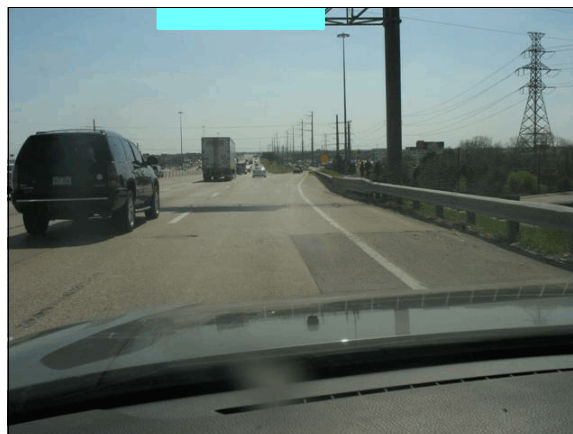
**Figure 2:** Approach of the Chevrolet southeast toward the exit ramp; the Ford was in the second lane from the right

**Pre-Crash:** The Chevrolet and Ford were traveling southeast approaching an exit ramp (**Figure 2**). The Chevrolet was in the first lane from the right and the driver was intending to continue southeast. The Ford was in the second lane from the right and was slightly ahead of the Chevrolet. The driver of the Ford intended to enter the exit ramp. The driver of the Chevrolet stated during the SCI interview that he took no actions to avoid the crash. His statement was supported by the Chevrolet's Event Data Recorder (EDR), which reported no pre-crash braking during the 2.5 seconds of pre-crash recording. The EDR also reported the Chevrolet's speed as 106 km/h (66 mph) at 2.5 sec prior to Algorithm Enable (AE) increasing to 108 km/h (67 mph) at 0.5 sec prior to AE. According to the police crash report, the driver of the Ford was under the influence of alcohol.

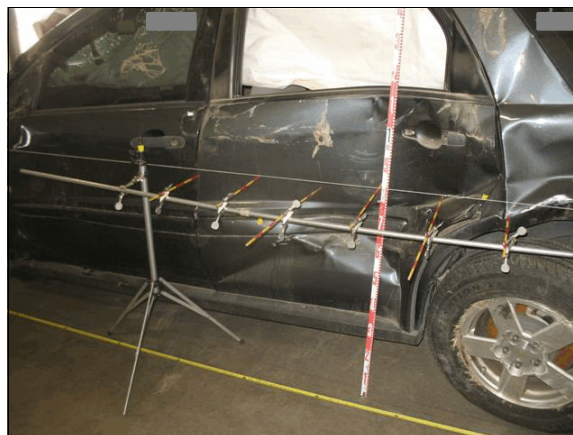
**Figure 3:** Damage on the left rear door of the Chevrolet from the initial impact by the Ford

**Exterior Damage Event 1:** The Chevrolet sustained direct damage to the left rear door during the initial impact with the Ford. The direct damage began 192 cm (34.6 in) rear of the left front axle and extended 77 cm (30.3 in) along the door. Crush measurements were taken at the mid-door level and the maximum residual crush was 16 cm (6.3 in) occurring at C<sub>3</sub>. The height of the maximum door crush was 80 cm (31.5 in) and the door sill differential was 8 cm (3.1 in). The height of the sill was 30 cm (11.8 in).

**Damage Classification Event 1:** The Collision Deformation Classification (CDC) was 09LPEW2 (280 degrees). The Missing Vehicle algorithm of the WinSMASH program calculated the total Delta V as 10 km/h (6.2 mph). The longitudinal and lateral velocity changes were -2 km/h (1.2 mph) and 10 km/h (6.2 mph), respectively. Based on the damage, the results appeared reasonable.

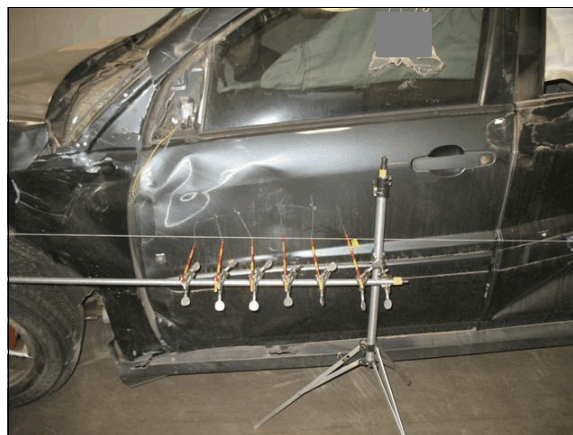
**Figure 4:** Damage on the left front door of the Chevrolet from the secondary impact by the Ford

**Exterior Damage Event 2:** The Chevrolet sustained direct damage on the left front door during the secondary impact with the Ford. The direct damage consisted of a dent in the door, scuffs, and paint transfer from the Ford. The direct damage began 88 cm (34.6 in) rear of the left front axle and extended 35 cm (13.8 in) along door. Crush measurements were taken at the mid-door level and the maximum residual crush was 1 cm (0.4 in) occurring at C<sub>3</sub>. The height of the maximum door crush was 73 cm (28.7 in) and the door sill differential was 0 cm.

**Damage Classification Event 2:** The CDC was 09LPMN1 (260 degrees). The Missing Vehicle algorithm of the WinSMASH program calculated the total Delta V as 3 km/h (1.9 mph). The longitudinal and lateral velocity changes were 1 km/h (0.6 mph) and 3 km/h (1.9 mph), respectively. Based on the damage, the results appeared reasonable.

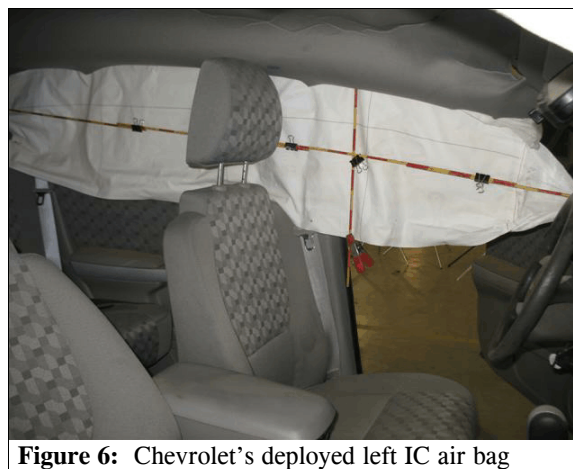
**Figure 6:** Chevrolet's deployed left IC air bag

The deployed left IC air bag extended from the A-pillar to the C-pillar (**Figure 6**). There were no external vent ports. The IC was 181 cm (55.1 in) in width and 41 cm (16.1 in) in height. It was attached to the A-pillar by a 14 cm (5.5 in) nylon tether. A 45 cm (17.7 in) nylon tether attached the back of the IC to the D-pillar. The IC extended 10 cm (3.9 in) below the beltline. The gap between the front of the air bag's sail panel and the A-pillar was approximately 20 cm (7.9 in). Inspection of the IC revealed no discernable evidence of occupant contact. The IC was not damaged in the crash. The right IC air bag was of the same dimensions and features as the left IC.
