CASE: D016-99

Crash Description: 22 Year old, Black, Female, Driver, Inspector

Case Vehicle: 1999 Nissan GXE
Crash Type: Vehicle to Large Truck
Restraint: Lap & Shoulder Belt
Airbag Deployment (front): Driver Side: Deployed Passenger Side: Deployed

Case Vehicle: 1999 Nissan Sentra
POV 1: 1990 International Dump Truck
POV 2: Tractor-Trailer Combo

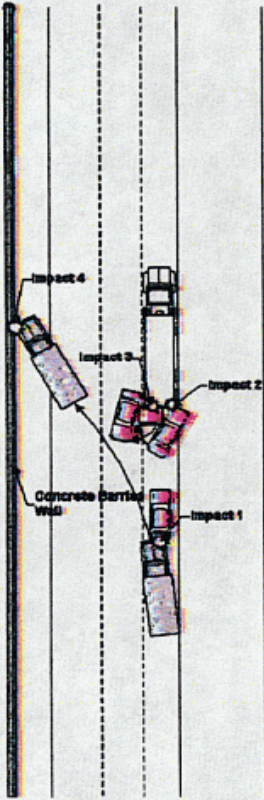
D016-99

D 016 99
Scale 1/200
Case Vehicle: 1999 Nissan Sentra
POV 1: (grey) 1999 International Dump Truck
POV 2: (white) Tractor/trailer combo
