**CALSPAN REMOTE AIR BAG DEPLOYMENT INVESTIGATION
CALSPAN CASE NO. 93-3
VEHICLE - 1991 MERCURY CAPRI
LOCATION - [REDACTED] CT
ACCIDENT DATE [REDACTED] 1992**

14. <i>Sponsoring Agency Code</i>	
15. <i>Supplementary Notes</i> Remote investigation of a front-to-rear impact sequence that resulted in the deployment of the supplemental driver's side air bag system in a 1991 Mercury Capri.

CALSPAN REMOTE AIR BAG DEPLOYMENT INVESTIGATION
CALSPAN CASE NO. 93-3
VEHICLE - 1991 MERCURY CAPRI
LOCATION - ██████████, CT

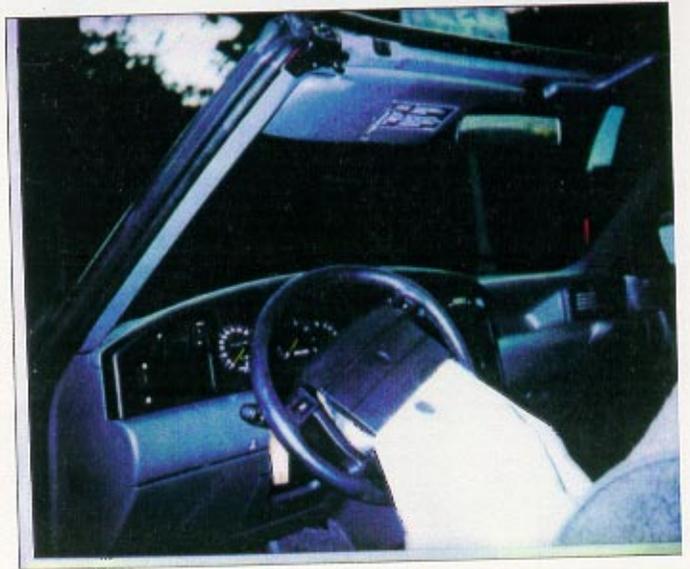
Upper air bag module flap
and the deployed air bag

The deployment of the SRS appeared to be a normal deployment with no damage occurring to the air bag or the module assembly.

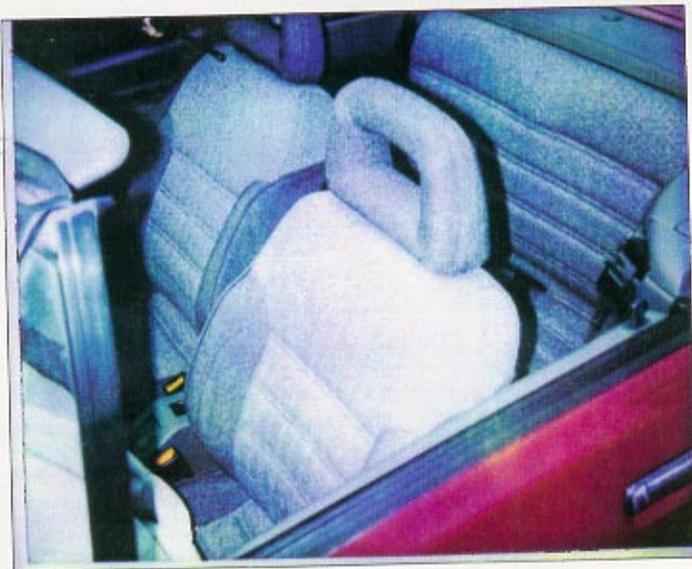
Adjusted mid track position of the
driver's seat

The 22 year old female driver of the Mercury Capri was reportedly looking to her left at impact. She was not wearing the manual 3-point lap and shoulder belt system. The lack of belt usage was determined from the investigating police officer's inspection of the belt system, witness statements who observed the driver immediately following the crash, and from driver statements to the investigating officer. Her driver's license identified her height at 162.6cm (64") and she was reportedly slender to average in weight. The investigating officer noted that the driver's seat was adjusted to a forward track position. His photographs also documented the position of the driver's seat. A similar Mercury Capri was inspected and the seat was adjusted to the approximate position depicted in the police photographs. In this position, the seat track was adjusted 10.8cm (4.25") rearward of its full forward position with a horizontal distance of 48.3cm (19") between the center of the air bag module cover and the seatback. With the seat track adjusted to the full rearward position and the seatback set to a normal adjustment point (slightly reclined from vertical), the horizontal distance between the air bag module assembly and the seatback was 61cm (24"). In the full forward position, this measurement was 37.5cm (14.75").

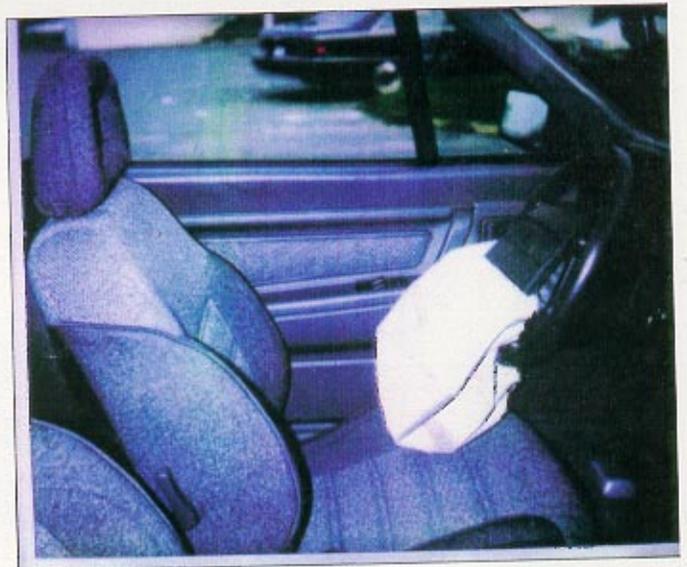
- 1) Perpendicular view of the driver's seat
with respect to the steering assembly
- 2) Bending of the upper steering wheel rim

The police photographs of the interior of the Mercury Capri identified slight deformation of the upper steering wheel rim that probably resulted from air bag expansion between the driver and the steering wheel rim. The body shop repair invoice identified replacement of the steering shaft which was probably compressed from driver loading of the air bag. There were no other interior components listed on the repair estimate; therefore, it was assumed that no other interior damage occurred.

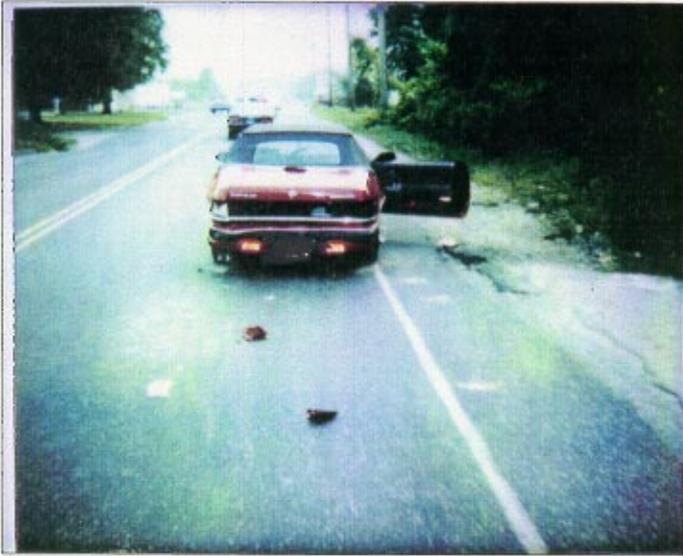
Damage to the rear of vehicle #2

The rear of vehicle #2 sustained moderate damage which involved displacement of the bumper and rear quarter panels. The owner of the vehicle stated that the rear frame rails were buckled near the rear axle area and that extensive undercarriage damage occurred to the vehicle. Maximum crush was estimated at 15-20cm (6-8") located on the rear bumper inboard of the left EAD. The rear quarter panels were buckled at the trailing edge of the wheel openings which resulted in downward displacement of the rear area.

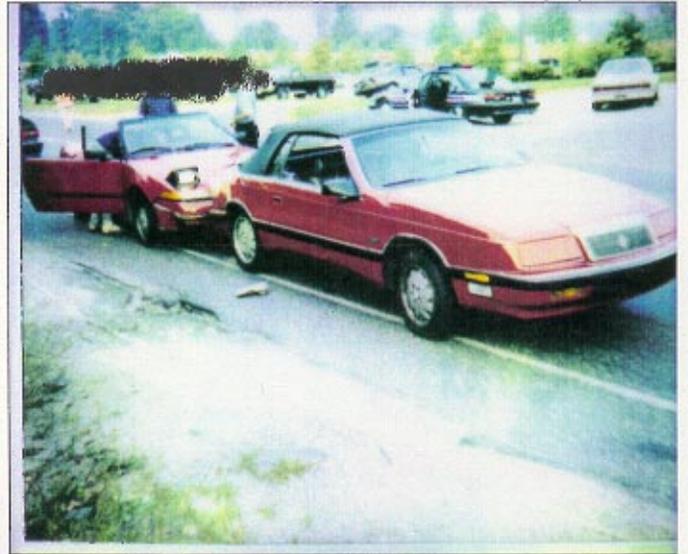
Final rest positions of the
involved vehicles

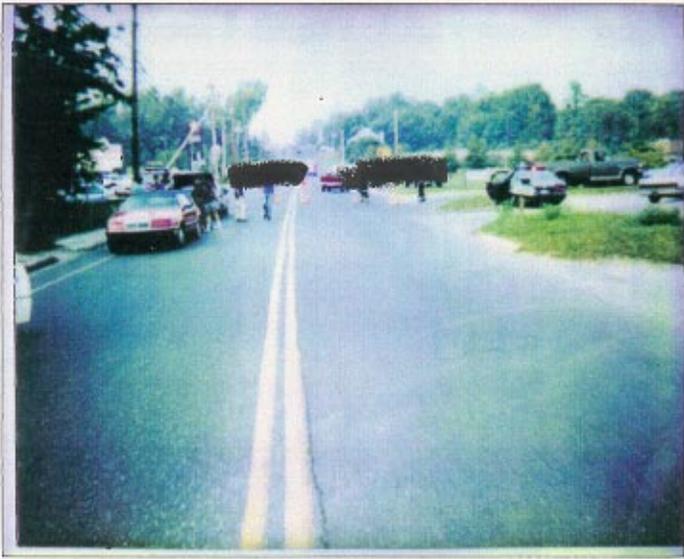
Lookback view of the
vehicle's path of travel

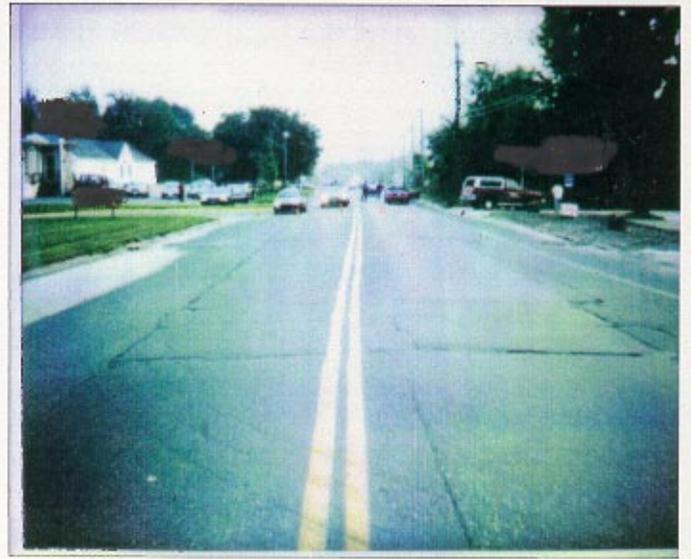
Trajectory of the Mercury Capri

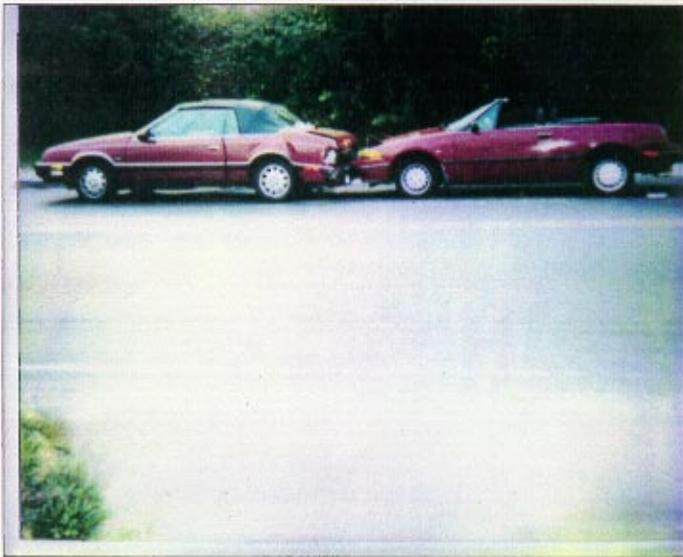
Perpendicular view showing the end plane
damage to the involved vehicles

The frontal area of the Mercury Capri sustained moderate damage from its impact sequences with the rear of vehicle #2. The attached police photographs and the vehicle repair estimate indicate that direct contact damage was distributed across the entire frontal width of the vehicle. The residual crush depth was minimal with an estimated maximum crush of 7.6-12.7cm (3-5"). The Capri was equipped with a 8 KPH (5 mph) front bumper system. The attached repair estimate identified replacement of the front bumper assembly inclusive of the energy absorbing devices (EADs). The EADs

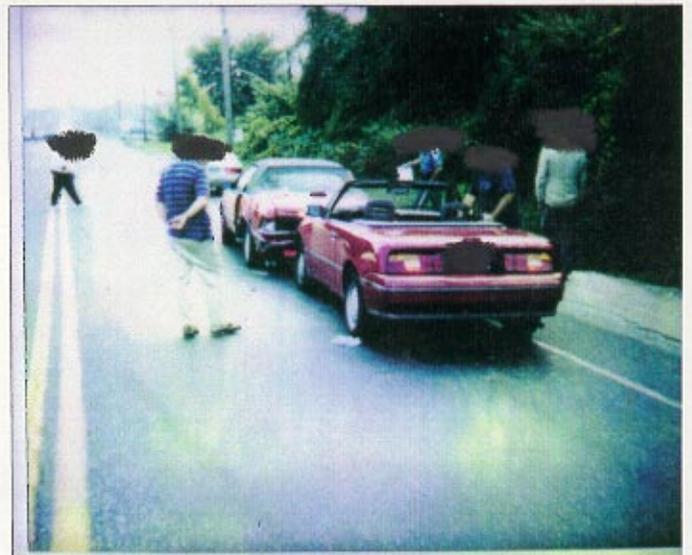
Final rest position of the vehicles
