**CALSPAN INADVERTENT AIR BAG DEPLOYMENT INVESTIGATION
CALPSAN CASE NO. 94-36
VEHICLE: 1987 PORSCHE 944 TURBO
LOCATION: [REDACTED]
DATE: [REDACTED] 1994**

1. Report No. 94-36	2. Government Accession No.	3. Recipient's Catalog No.	
4. Title and Subtitle Calspan On-Site Air Bag Deployment Investigation Vehicle - 1987 Porsche 944 Turbo Location ██████████, VA		5. Report Date ██████████ 1995

14. Sponsoring Agency Code	
15. Supplementary Notes Limited on-site investigation of an inadvertent air bag deployment that involved a 1987 Porsche 944 Turbo.

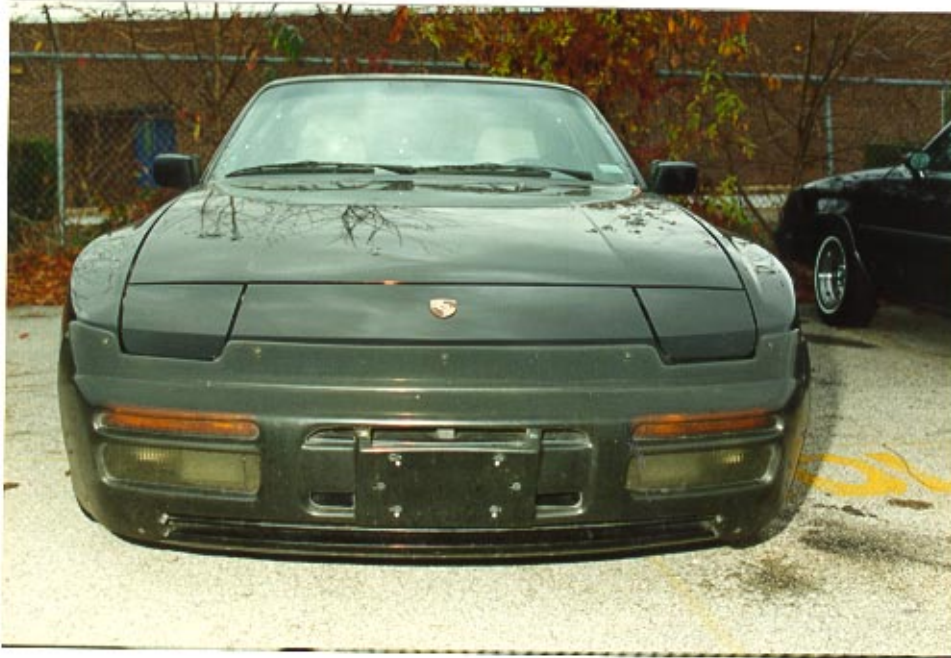
1. Frontal view of the 1987 Porsche 944 Turbo.

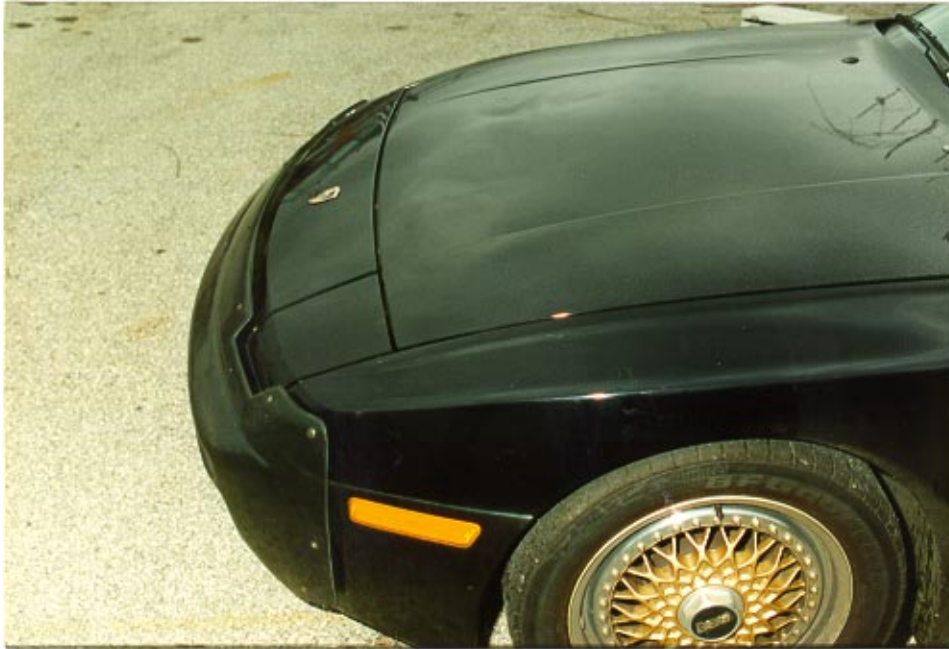
3. Left profile view of the frontal structure and *Lexan* shield.

The driver/owner purchased the 1987 Porsche 944 Turbo as a used vehicle in 1988. At the time of purchase, he stated that the vehicle had an odometer reading of approximately 8K km (5K miles). The driver has maintained the vehicle in excellent condition and has performed all the required maintenance himself. In addition to routine maintenance, the driver had made several modifications to improve the handling and braking of the vehicle for race track events. These modifications included the replacement of the original equipment wheels and tires with (41 cm) 16" alloy wheels with wide, low profile performance tires, the addition of Porsche 968 front and rear sway bars, a truss bar bolted across the top of the front shock towers to minimize lateral movement, high performance front and rear disc brake pads, and a cool air kit for the front brakes which consists of a vent duct to the leading edge of the brake calipers. The vehicle was originally equipped with a cellular telephone by the previous owner, however, the system was removed prior to this driver's purchase. The antenna remained attached to the left rear quarter window. The driver stated that he installed a citizens band (CB) radio in the center console of the vehicle directly below the radio/cassette player. He further stated that there were no engine, electrical, or interior modifications to the Porsche. The driver installed a translucent Lexan cover to the front bumper fascia to protect the frontal area from insects and road debris.

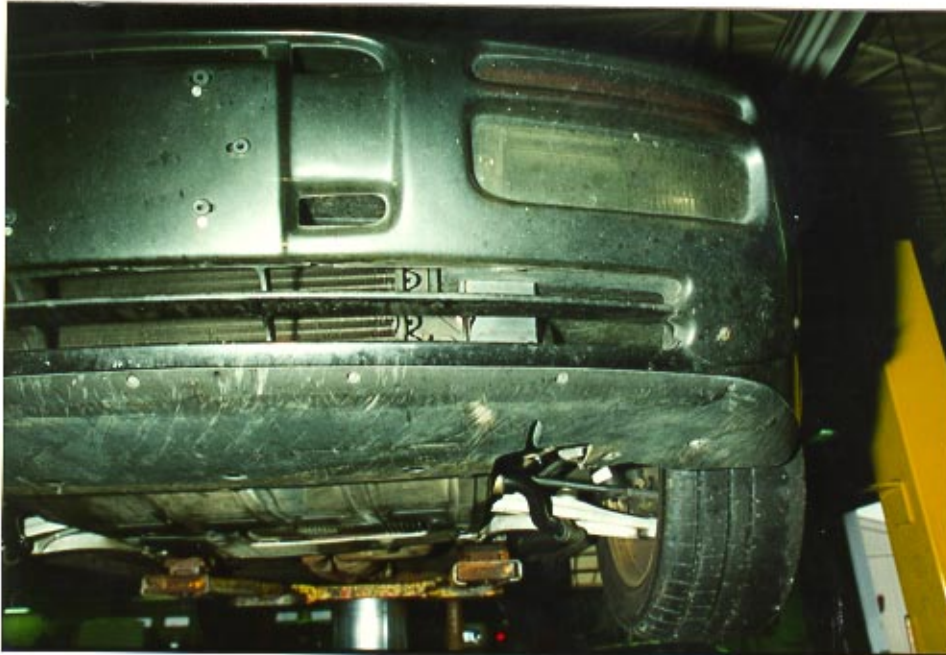
8. Underside of the left front bumper fascia and valance.

The Porsche was driven into the service facility of the dealership and raised on a hydraulic floor lift to inspect the undercarriage of the vehicle for possible damage. There was no damage or direct contact evidence to the undercarriage. All components were intact and none appeared to have been replaced or removed prior to this inspection.

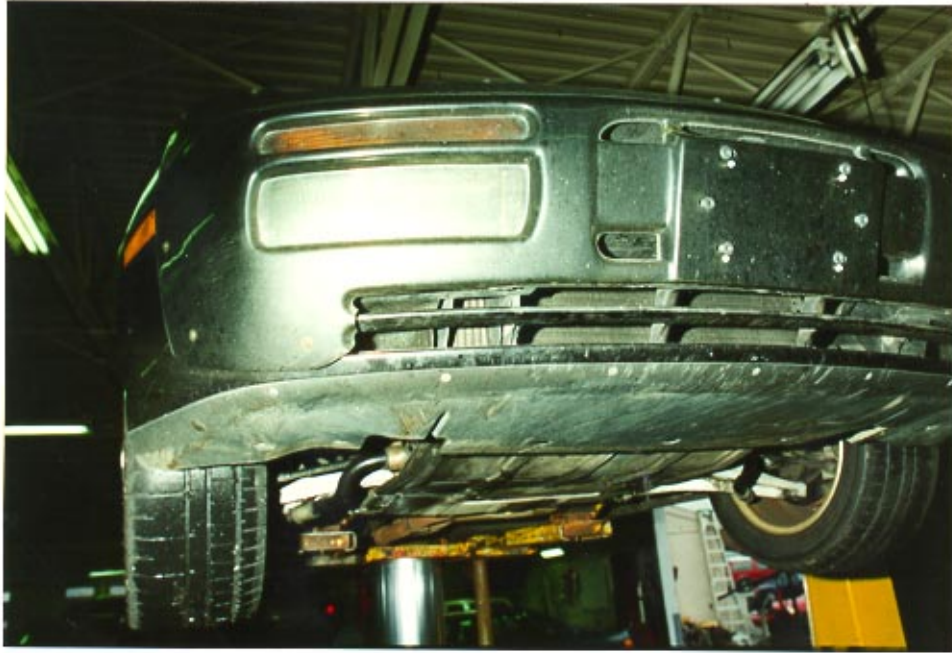
9. Underside view of the right bumper fascia and valance.

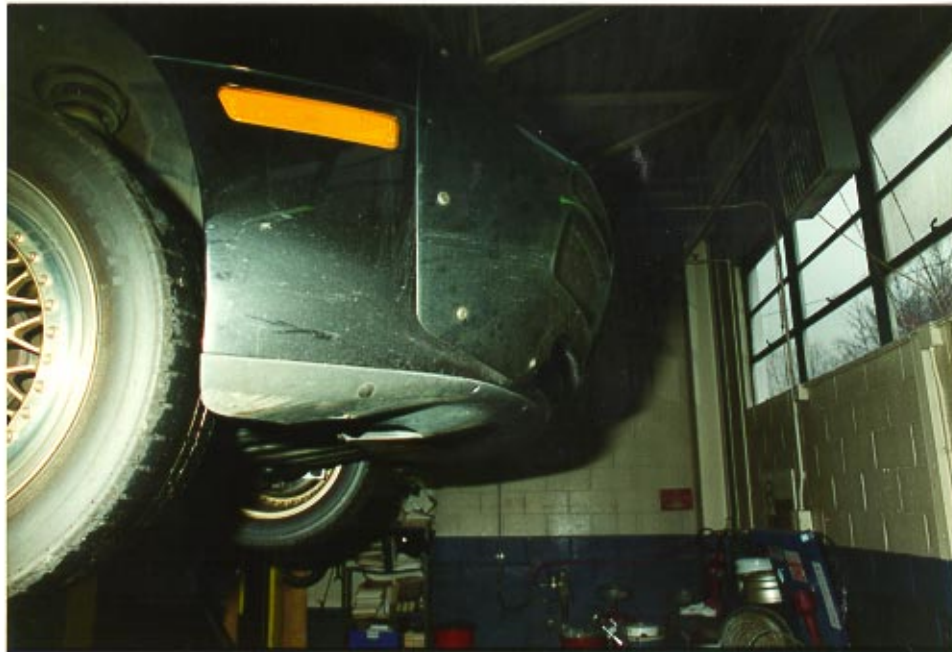
10. Profile view of the right side bumper fascia and valance panel.

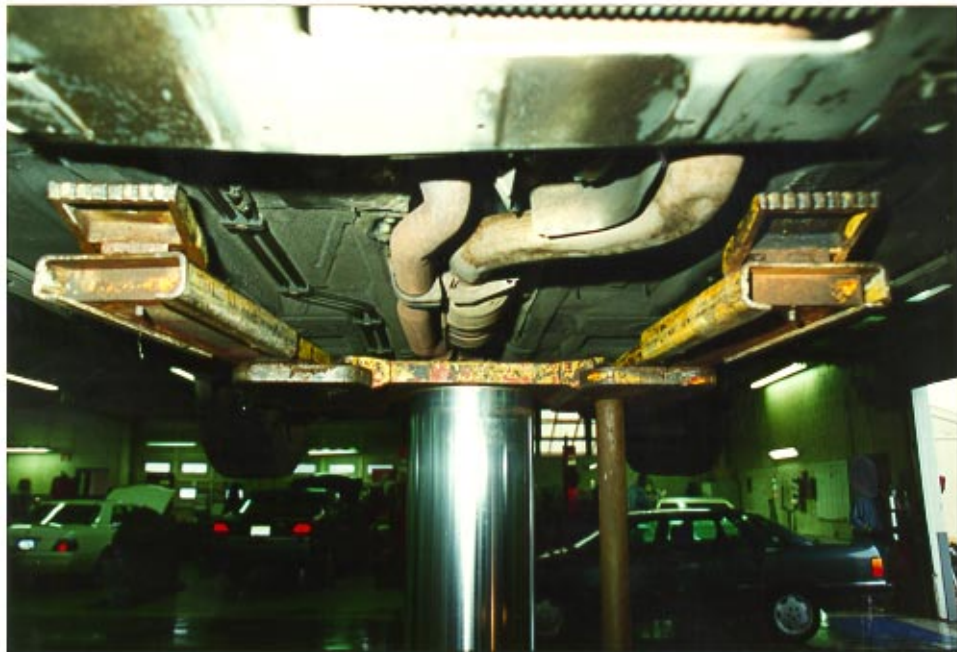
12. Mid undercarriage and exhaust system of the 944.

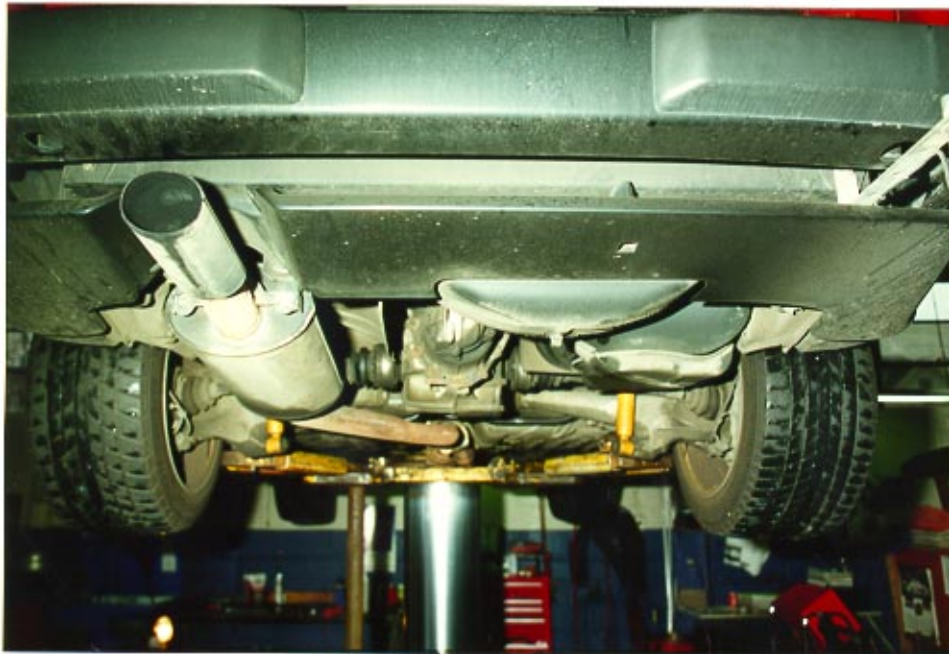
13. Rear undercarriage components viewed from the rear of the vehicle.

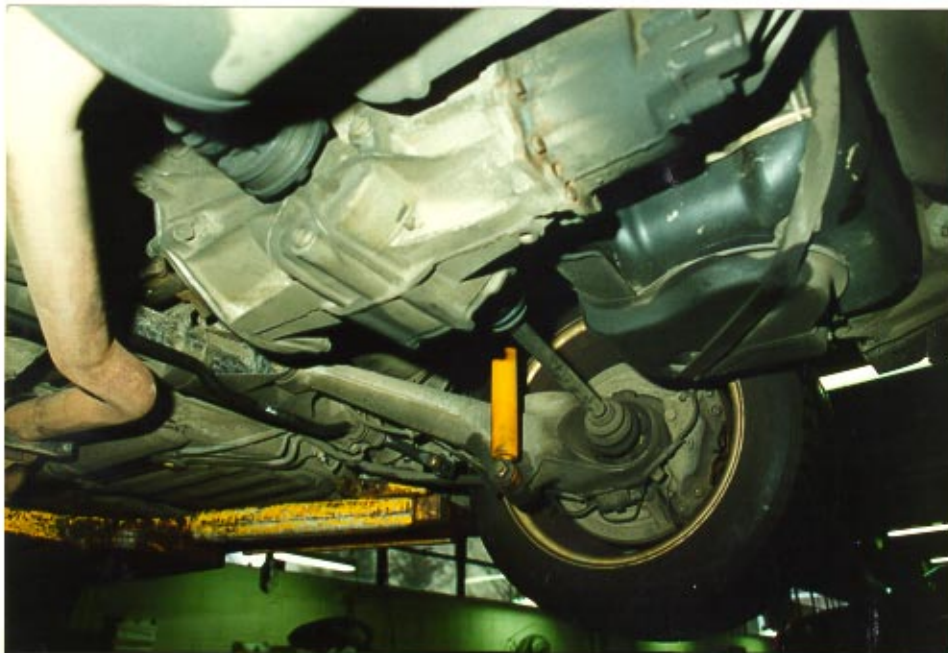
14. Transaxle, rear suspension components, and the retrofitted OEM rear anti-sway bar.

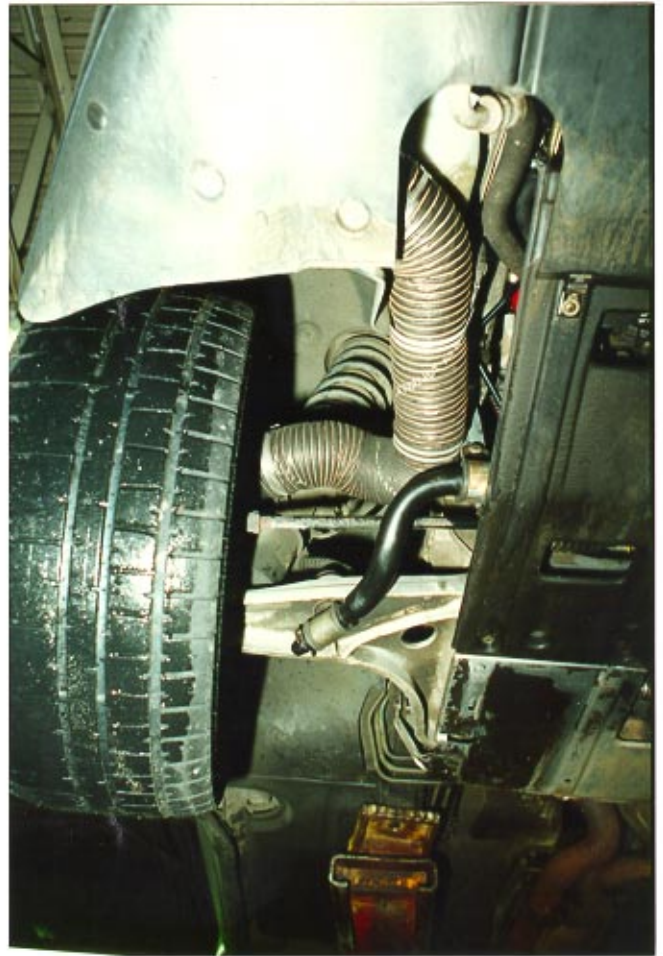
15. & 16. Aftermarket left and right front disc brake cooling ducts.

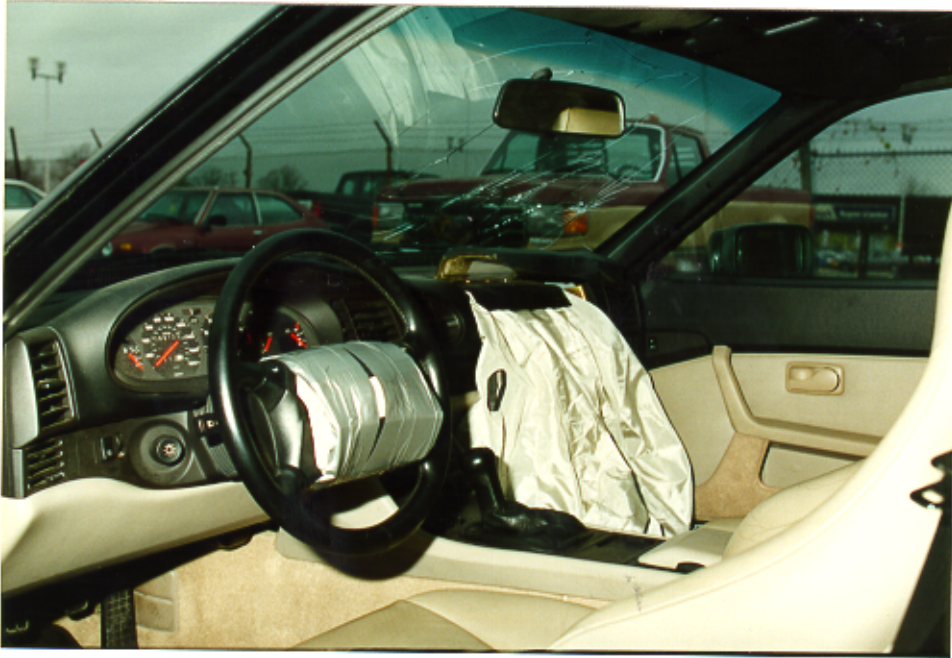
17. Overall view of the inadvertently deployed driver and passenger side air bags.

The interior of the vehicle was in excellent original condition with no evidence of alterations or damage, except for the deployed driver and passenger air bags. The driver's side module was contained within the four-spoke steering wheel. The module opened at the designated tear points in an H-configuration with an 4.0 x 16.8.cm (2.5 x 6.6") upper flap and a 7.6 x 16.8 cm (3.0 x 6.6") lower cover flap. The air bag remained folded with the module cover flaps taped in a partially closed position. There was no damage to the knee bolster or to the manual 3-point lap and shoulder belt system.

Based on the statements from the driver regarding the sequence of events that preceded the deployment and the lack of impact damage to the vehicle, it was apparent that the supplemental driver and passenger air bag system deployed inadvertently in this 1987 Porsche 944 Turbo. The driver was fortunate that he was traveling on a straight segment of the race track with no others vehicles in his immediate area and that he was able to maintain control of the vehicle and stop safely off the track without causing an injury producing event to himself or to track personnel.

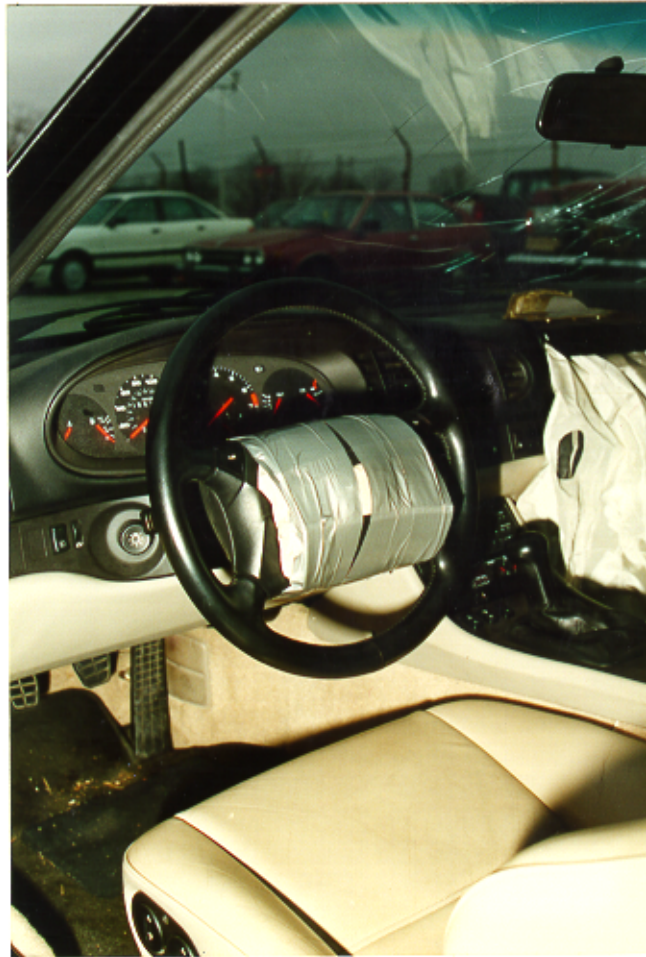
18. Driver/owner taped driver's side air bag module closed.

The driver folded the driver's side air bag back into the module assembly and taped the cover flaps in a closed position and drove the vehicle back to his residence in [REDACTED]. He reported the inadvertent deployment to the Porsche regional representative. Porsche initially declined to repair the vehicle citing the warranty had expired and the driver neglected to return the vehicle to a Porsche dealership for a required inspection of the air bag system at the four year interval in 1991. The driver subsequently returned the vehicle to the dealership to allow a Porsche representative to inspect the vehicle.

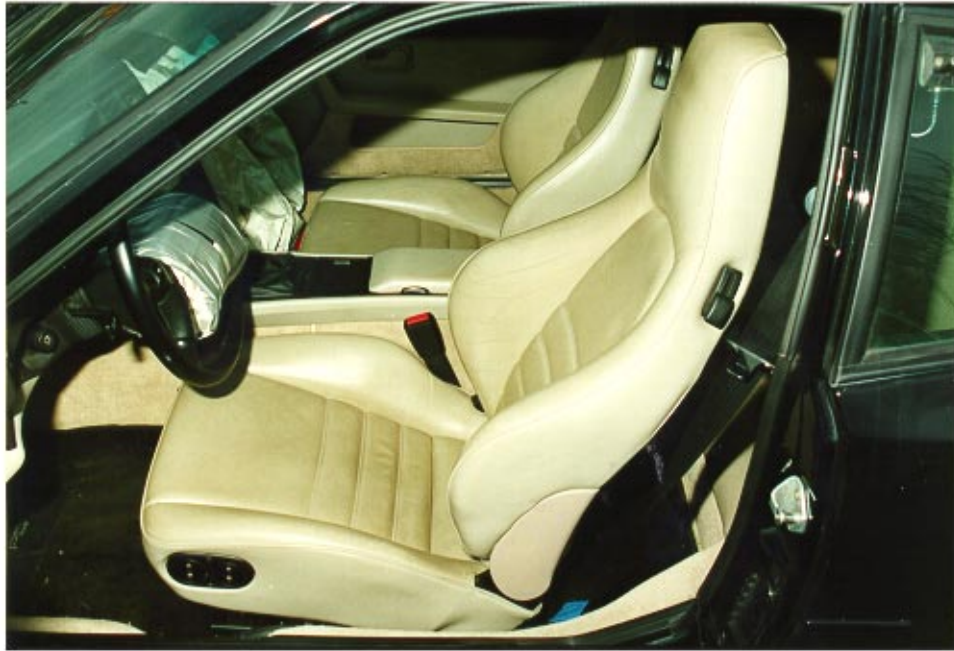
19. Driver's seat mid track adjustment relative to the steering assembly.

The driver was a 52 year old male with a height of 180 cm (71") and weight of 63 kg (140 lbs). He stated that he was in a normal upright seated position with the seat adjusted to a mid track position when the SRS inadvertently deployed. He had the seat back reclined to a position that allowed him to drive the vehicle with his arms fully extended onto the steering wheel. The driver stated that his hands were positioned on the steering wheel between the spokes at the 3 and 9 o'clock positions, with his thumbs wrapped over the top of the upper spokes. He was properly restrained by the vehicle's 3-point lap and shoulder belt system. In addition to the manual belt system, the driver was wearing a full face helmet with a face shield. The left front door window was in the full open position with all remaining windows and sunroof in the closed positions.

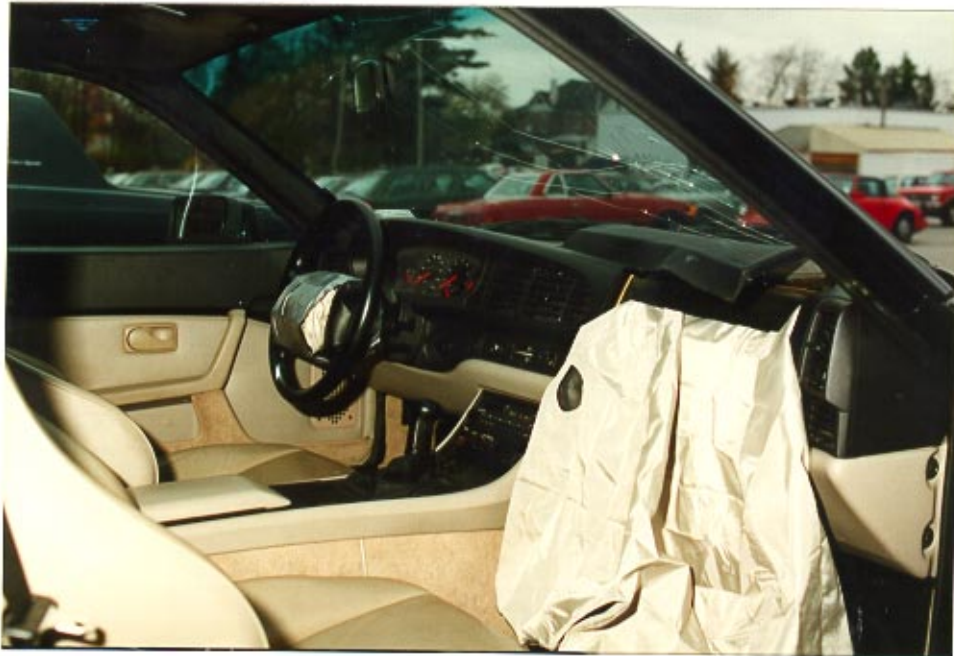
20. Inadvertently deployed passenger's side air bag.

The passenger side air bag was fully extended from the module. The module was located at the juncture of the upper and mid instrument panel. The passenger side module cover door was hinged at the top surface which allowed the door to open in an upward direction. The door was 37.5 cm (14.75") in width and had a vertical profile of 10.8 cm (4.25") and a horizontal depth of 6.4 cm (2.5"). The outboard edges of the door contacted and cracked the laminated windshield. The contact points on the windshield were located 19.0 & 53 cm (7.5 & 21") right of center. This contact and resultant windshield damage was typical of a Porsche 944 SRS deployment. In addition to the door contact, the deployed passenger side air bag contacted the windshield above the mid point of the module. A woven nylon fabric transfer evidenced the contact point. The passenger side air bag was vented by two 5.7 cm (2.25") diameter ports located on the side surfaces of the bag. There was black generant residue around the inboard vent port of the bag and additional residue scattered about the interior of the vehicle.

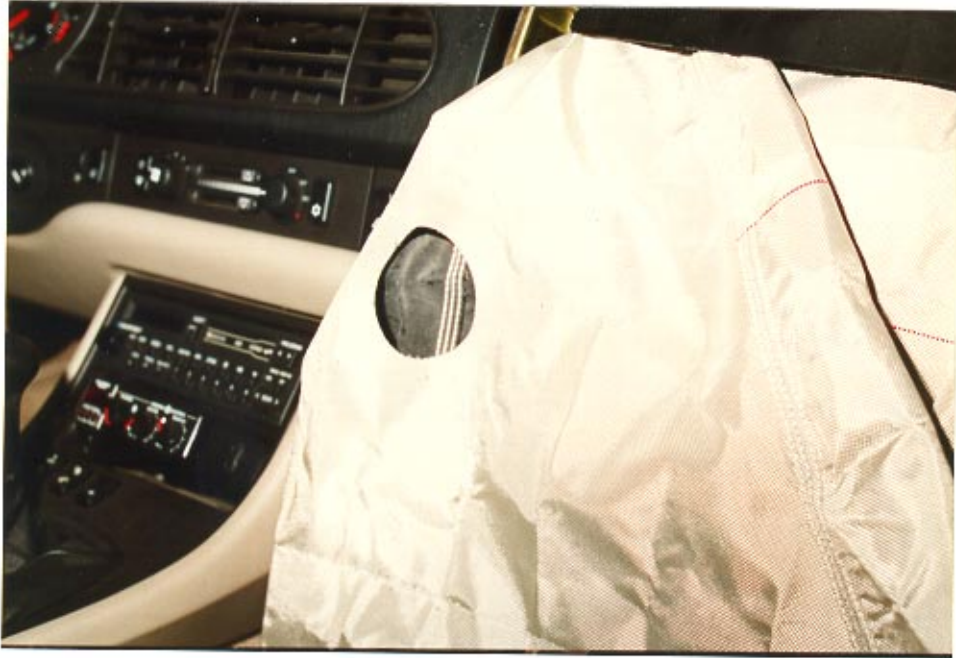
21. Inboard 6.4 cm (2.5") vent port of the passenger air bag.

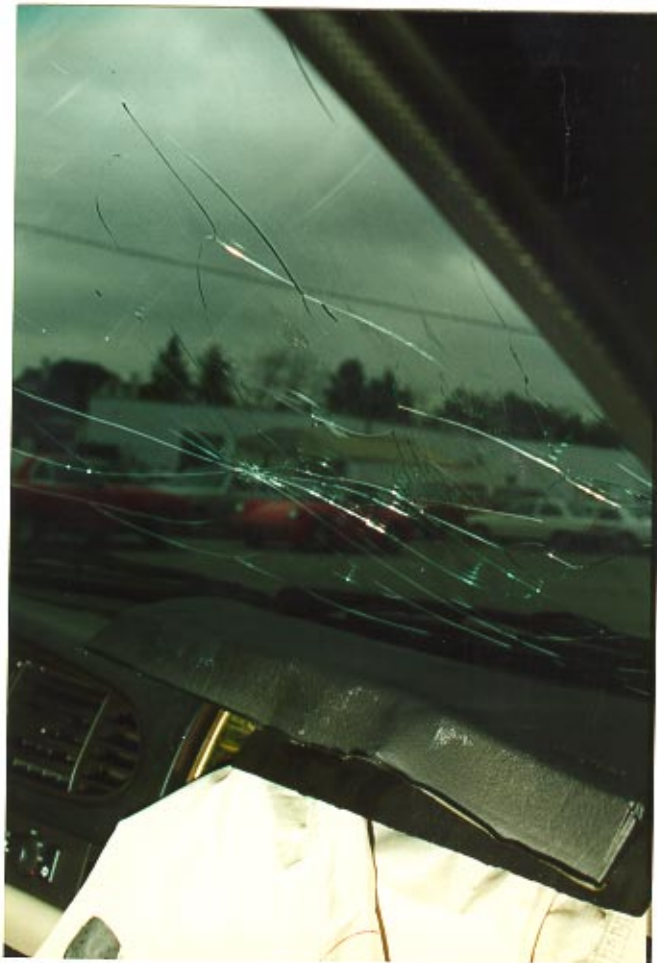
22. Passenger side module cover flap contact damage to the right windshield.
