**Information Dynamics, Inc. Remote Air Bag Deployment Investigation**

**Information Dynamics, Inc. Case Number 95-01 (ID9501)**

**Vehicle Number 1 - 1995 Toyota Camry LE 4 Door**

**Vehicle Number 2 - 1989 Chrysler LeBaron 2 Door**

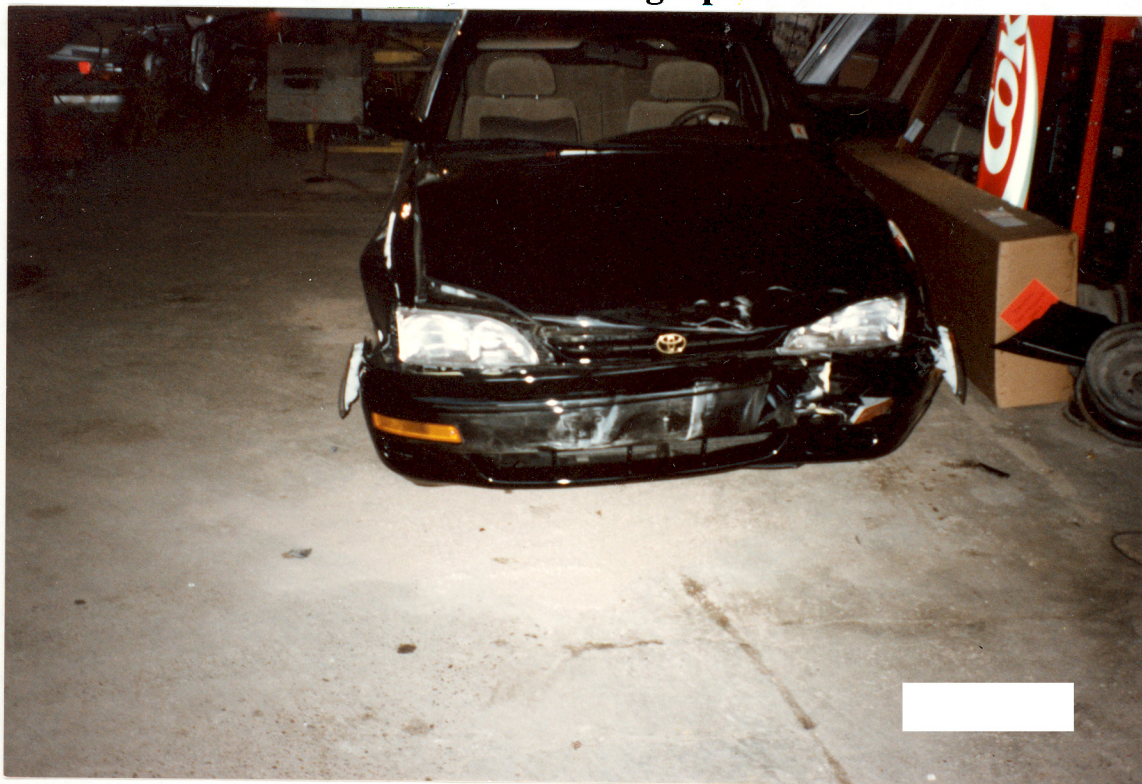
Photo #1 1995 Toyota Avalon Front Damage (11FDEW1)

There is minor crush to the entire front bumper and grill area of the Toyota with lateral shift from left to right consistent with the angled impact configuration. The delta V is low, visually estimated at approximately 10 mph. The CDC estimated from the photos is 11FDEW1.

The front of the Toyota struck the right side of the Chrysler. The entire front plane of the Toyota had minor crush damage with lateral shift from left to right (11 o'clock PDOF) consistent with the angled impact configuration. The delta V is low, visually estimated at approximately 10 MPH. The Chrysler was struck on the right side with an estimated 2 o'clock principle direction of force, predominantly behind the center of gravity, based on the 180 degrees of rotation indicated between impact and final rest.

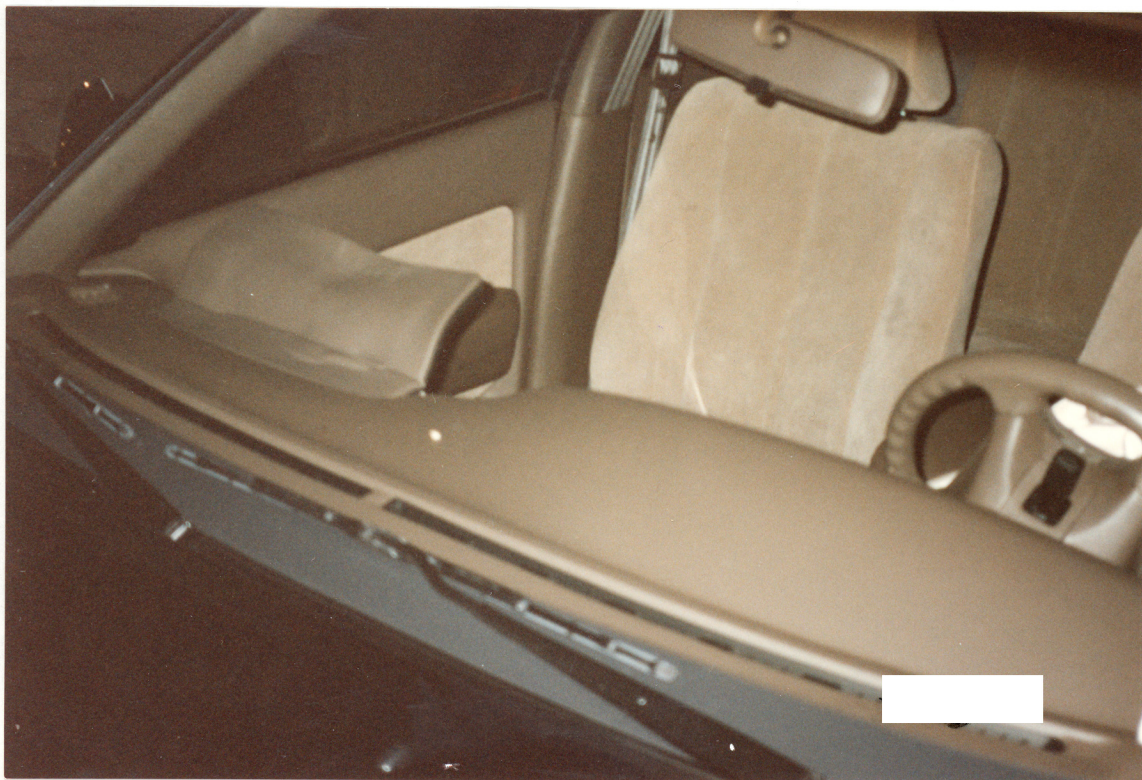
Photo #2 1995 Toyota Avalon interior through windshield  
Note: Head contact to the passenger side air bag module cover

The 1995 Toyota Camry LE was equipped with a driver and passenger side air bag system which deployed at impact. The driver of the Toyota was a 38 year old female. The only passenger was a 6 year old female seated in the front right position. The police accident report noted that neither of the occupants of the 1995 Toyota Camry LE were restrained with the available lap and shoulder belts. The front right occupant slid forward off the seat during the braking evasive maneuver and contacted the passenger side air bag module cover as the air bag began to deploy. The air bag module cover flap contacted her face resulting in severe closed head injuries (see photo #2).

There is a distinct indentation to the upper cover flap of the passenger side air bag system visible in the photos. The air bag cover flap contacted the girls face resulting in a fatal closed head injury.

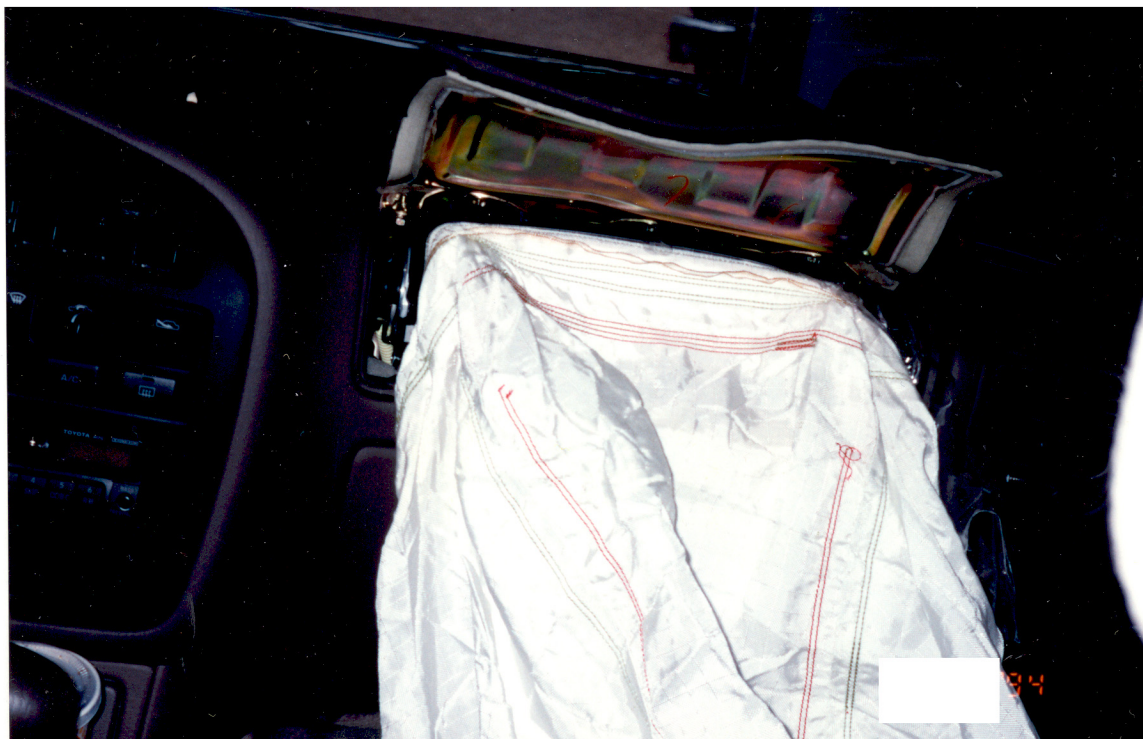
Photo #3 Toyota Avalon interior passenger side air bag module cover.

Note: Dent in air bag module cover to head/face direct contact

The 6 year old child's injuries are from an impact between her face/ head and the passenger side air bag cover flap. The unrestrained right front occupant was seated. During the severe braking evasive maneuver she slid forward off the seat contacting the passenger side air bag module cover with her face as the air bag began to deploy. The air bag module cover flap contacted her face resulting in the face and closed head injuries. The 6 year old child expired six hours later at a local hospital.

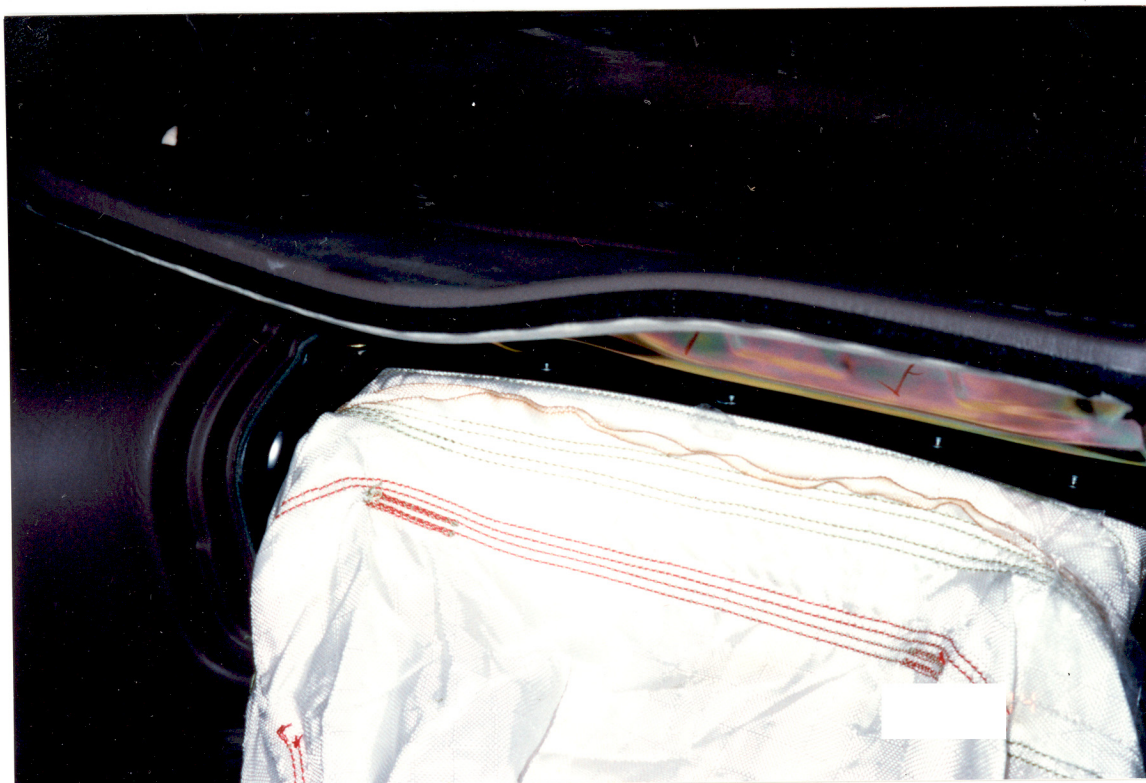
Photo #4 1995 Toyota Avalon interior passenger side air bag module cover close-up.

Note: Dent in air bag module cover to head/face direct contact
