DYNAMIC SCIENCE, INC.
In-Depth Accident Investigation

Case Number DSI-95-AB-014

1. Report No. DSI-95-AB-14		2. Government Accession No.		3. Recipient Catalog No.	
4. Title and Subtitle In-Depth Accident Investigation [REDACTED]				5. Report Date [REDACTED] 1996

TECHNICAL SUMMARY

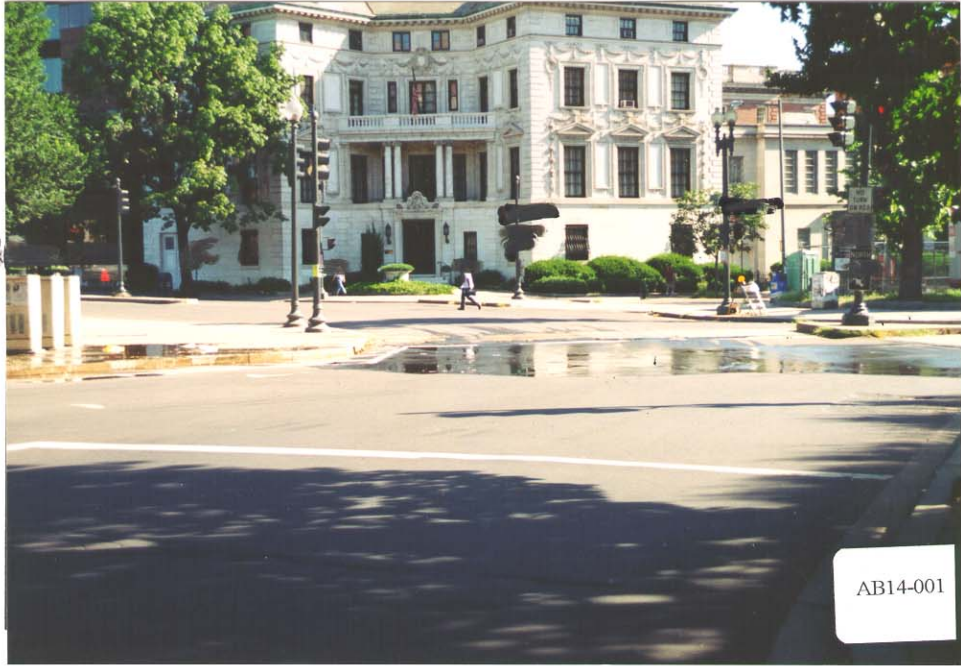
AB14-001

PHOTO NO.	VEHICLE NO.	DIRECTION OF PICTURE	SUBJECT MATTER
1-12	Vehicle 1	North	Travel path of Vehicle 1
13	Vehicle 1	East	Direction of travel to final rest
14-23	Vehicle 1	Clockwise	Exterior Views, Vehicle 1
24-39	Vehicle 1	---	Undercarriage views of Vehicle 1
40-51	Vehicle 1	---	Interior views, Vehicle 1
