**SAFETY COMPLIANCE TESTING FOR FMVSS 201  
OCCUPANT PROTECTION IN INTERIOR IMPACT**

**FORD MOTOR CORPORATION  
2003 FORD RANGER XLT SUPERCAB**

NHTSA NUMBER: C30205

**FINAL REPORT**

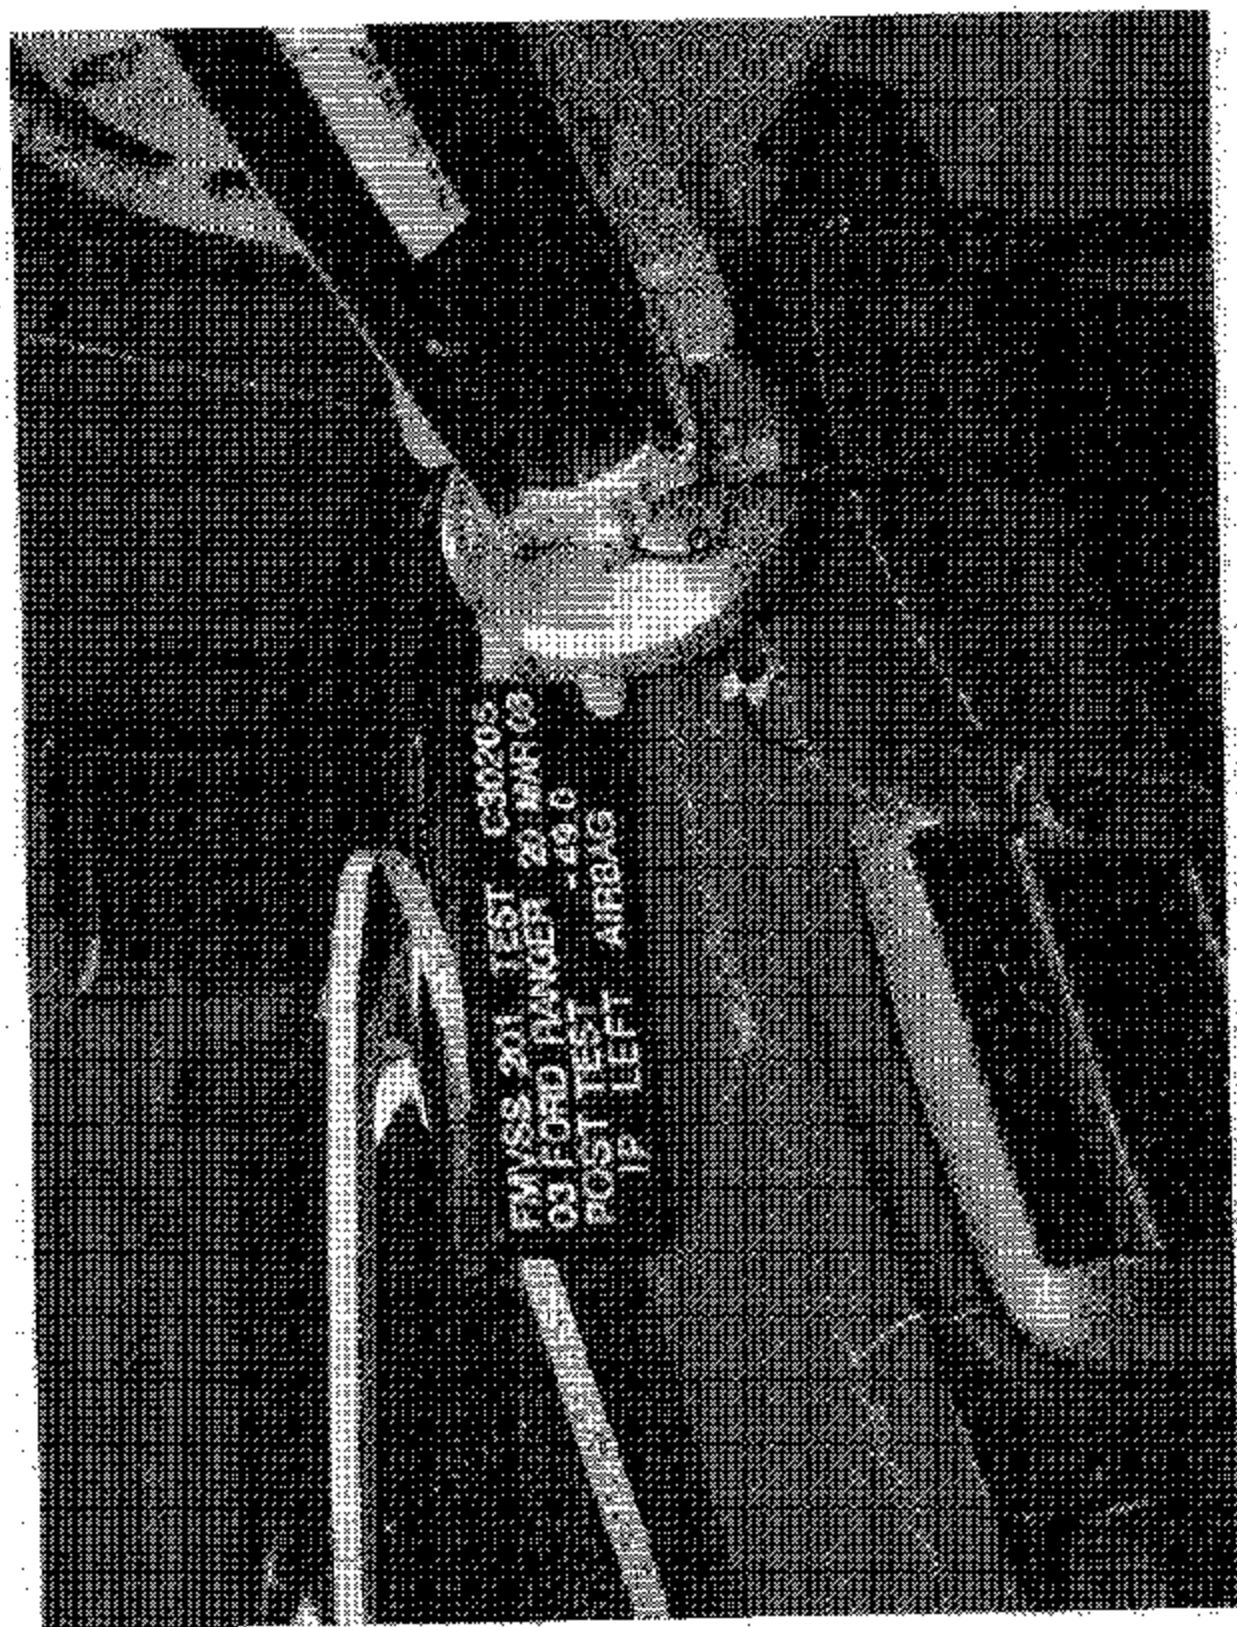
Figure A-14: INSTRUMENT PANEL AIRBAG UPPER LEFT IMPACT POST-TEST

| IMPACT LOCATION AND NUMBER | | | | VELOCITY<br>(mph) | PEAK<br>ACCELERATION<br>(3 ms Clip) Gs |
|---|---|---|---|---|---|
| 2 - Left Airbag | 26.5 | 9.9 | -49.0 | 11.46 | 53.32 |

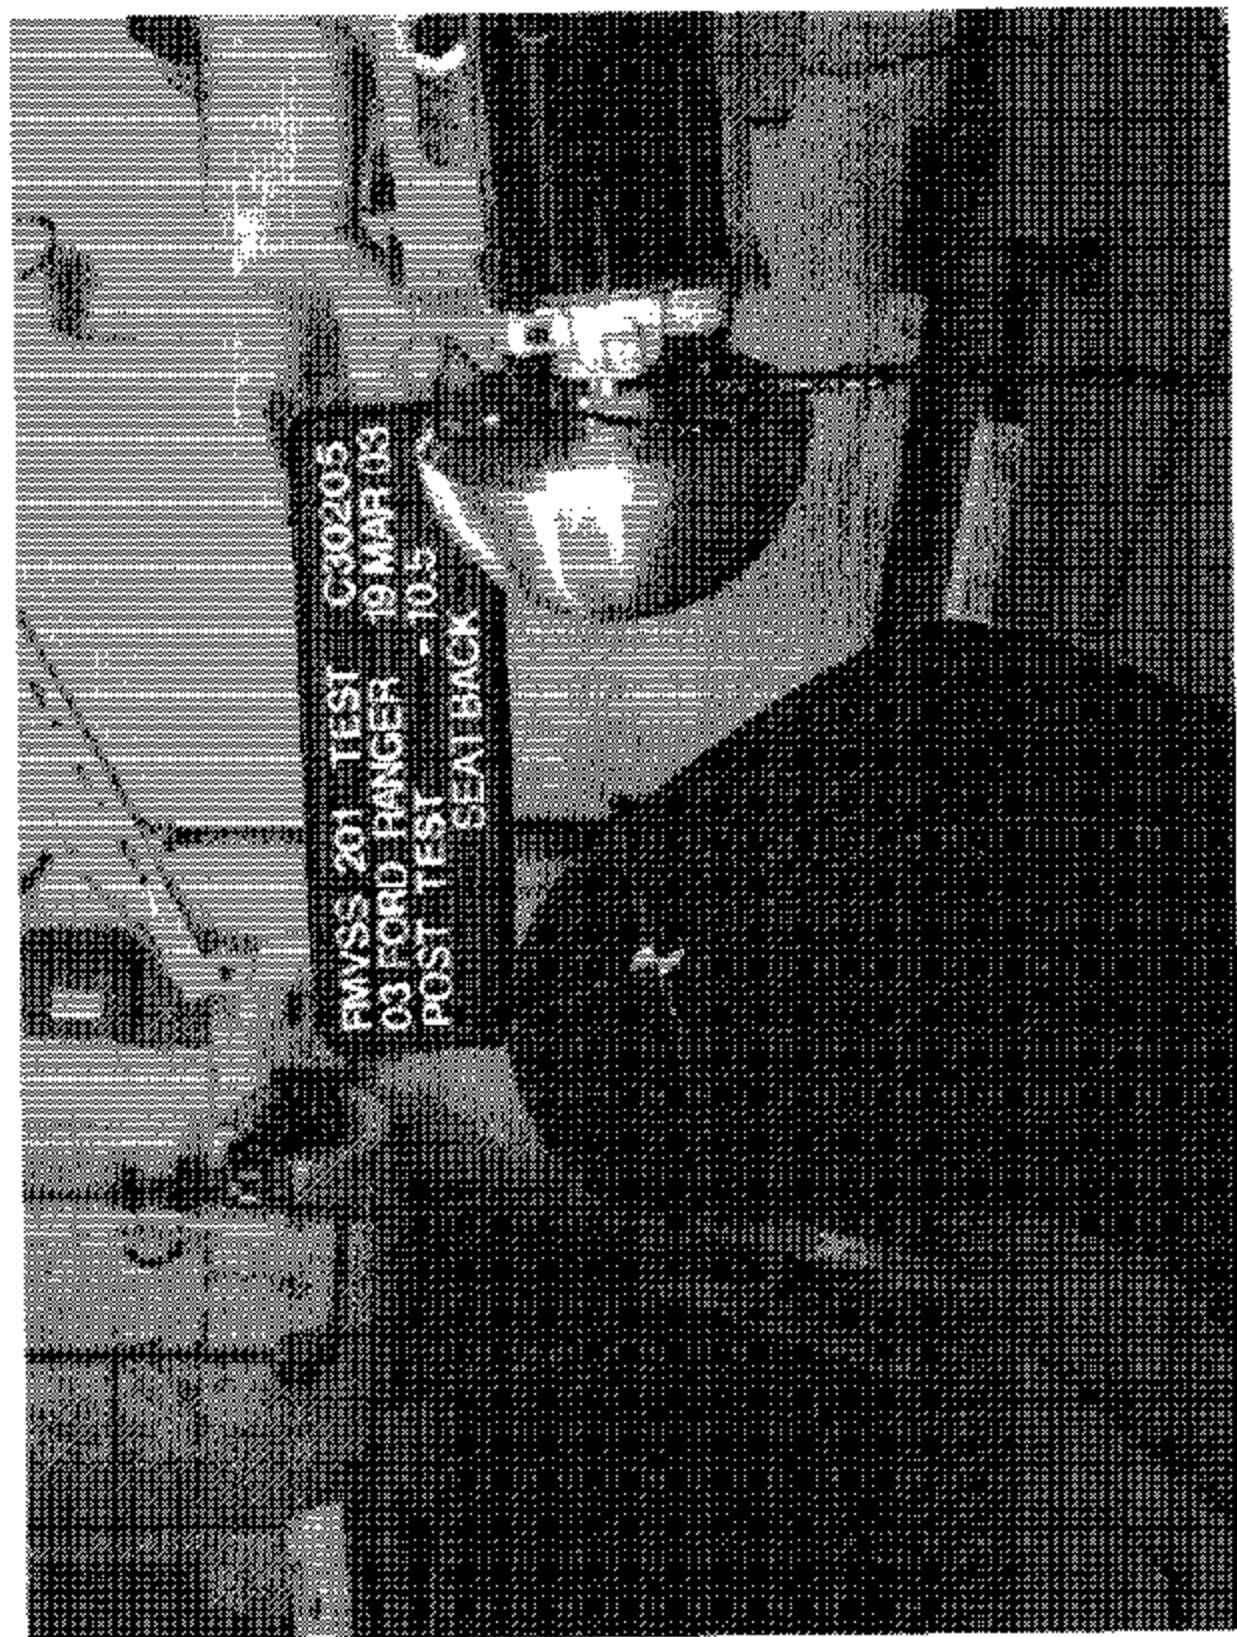
Figure A-21 : HEAD RESTRAINT IMPACT AREA POST-TEST

| | NUMBER OF IMPACTS | PASS/FAIL |
|---|---|---|
| SEAT BACK | 1 Indicant test only | Pass |
