# SAFETY COMPLIANCE TESTING FOR FMVSS 124L ACCELERATOR CONTROL SYSTEMS

DAIMLERCHRYSLER CORPORATION  
2004 CHRYSLER PACIFICA, MPV  
NHTSA NO. C40301

1. Report No. 124L-GTL-04-002	2. Government Accession No.	3. Recipient's Catalog No.
4. Title and Subtitle Final Report of FMVSS 124 Compliance Testing of 2004 CHRYSLER PACIFICA, MPV NHTSA No. C40301	5. Report Date May 14, 2004	6. Performing Organ. Code GTL

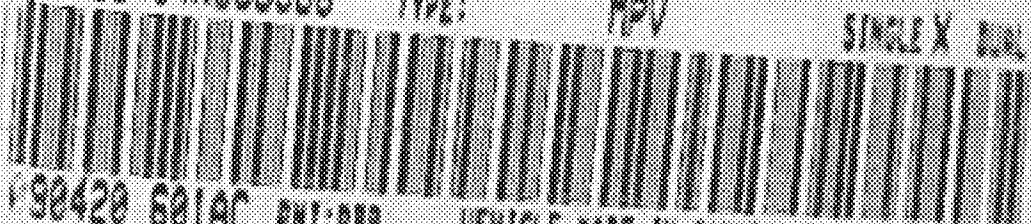
THIS VEHICLE CONFORMS TO ALL APPLICABLE FEDERAL MOTOR VEHICLE SAFETY AND THEFT PREVENTION STANDARDS IN EFFECT ON THE DATE OF MANUFACTURE SHOWN ABOVE.

VIN: 2C4GM68404R539386 TYPE: MPV SINGLE X BURL

KCH: 690420 601AC PNT: PDB VEHICLE MADE IN CANADA TRM: PBDU 4646525

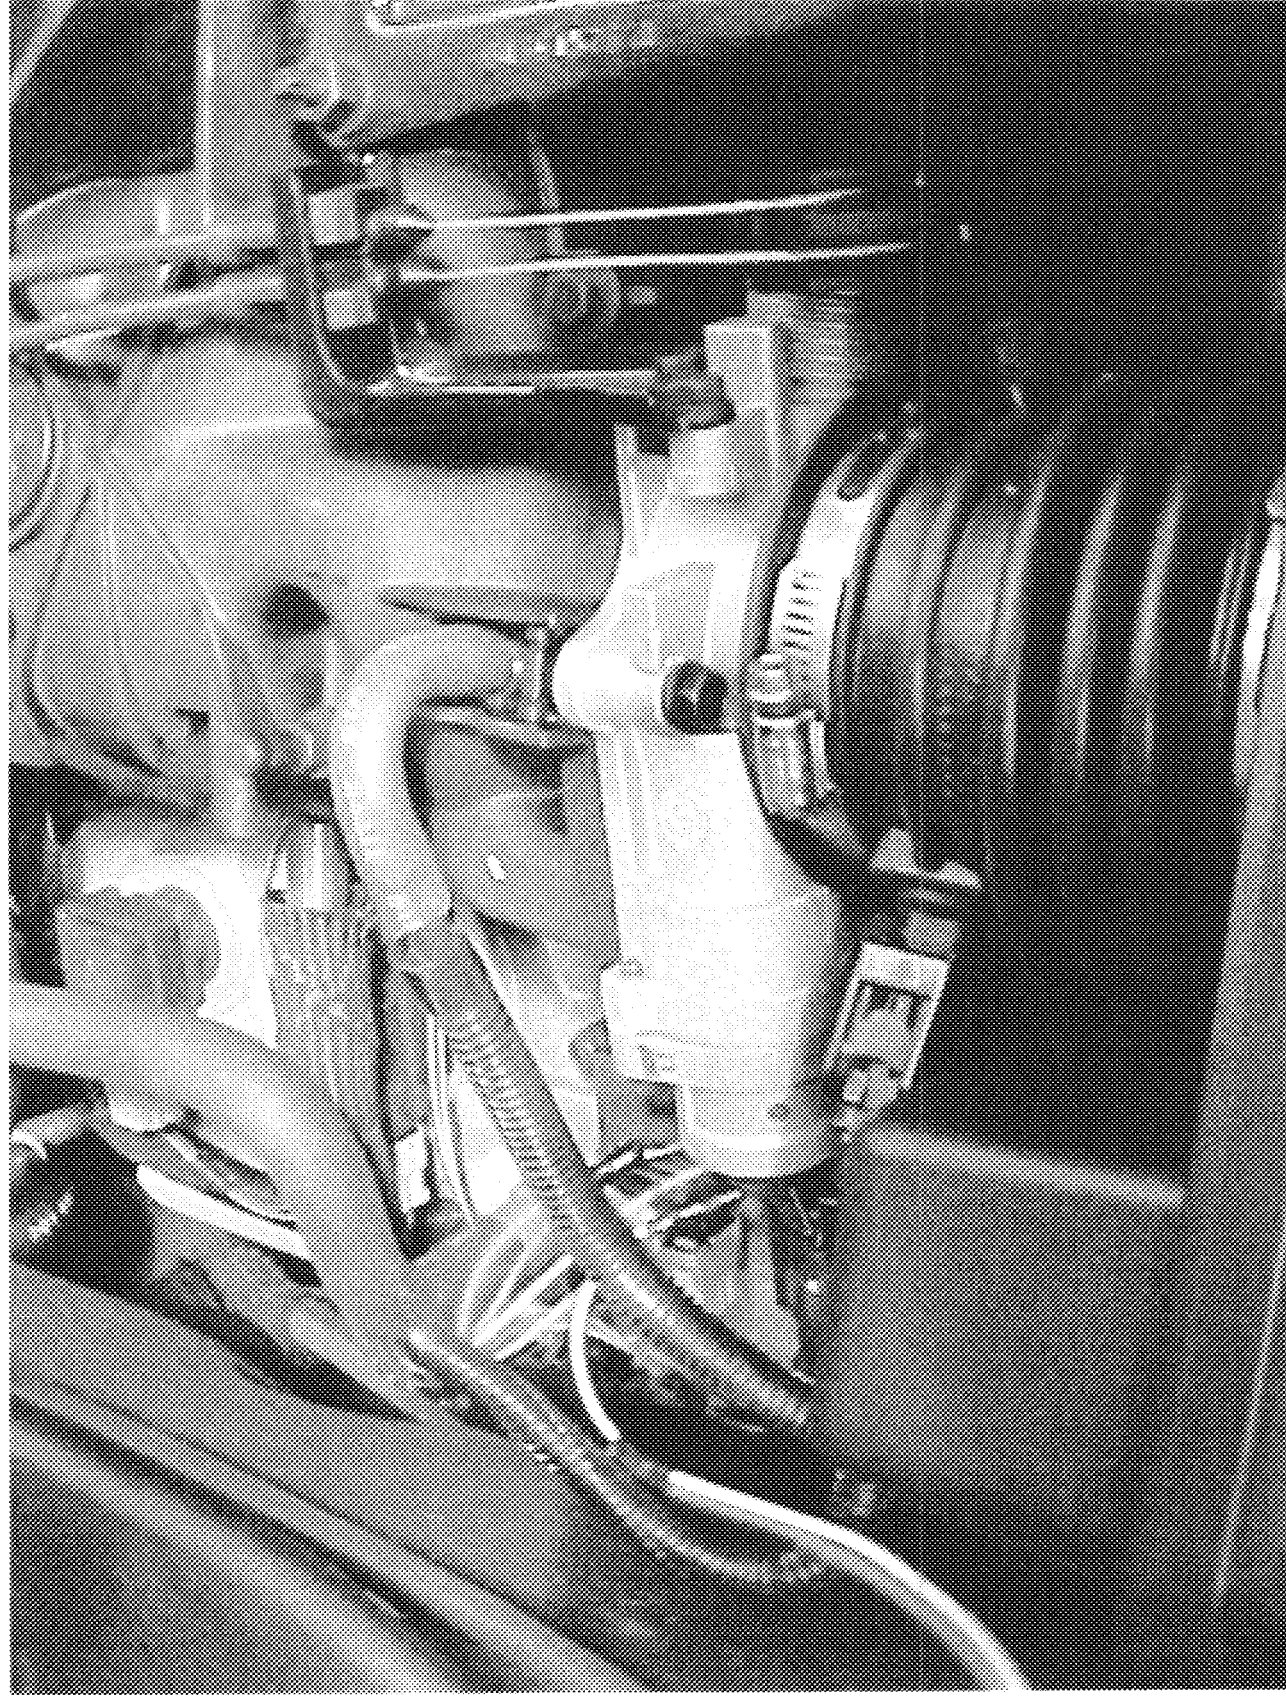
2004 CHRYSLER PACIFICA  
NHTSA NO. C40301  
FMVSS NO. 124L

FIGURE 5.5  
VIEW OF THROTTLE BODY

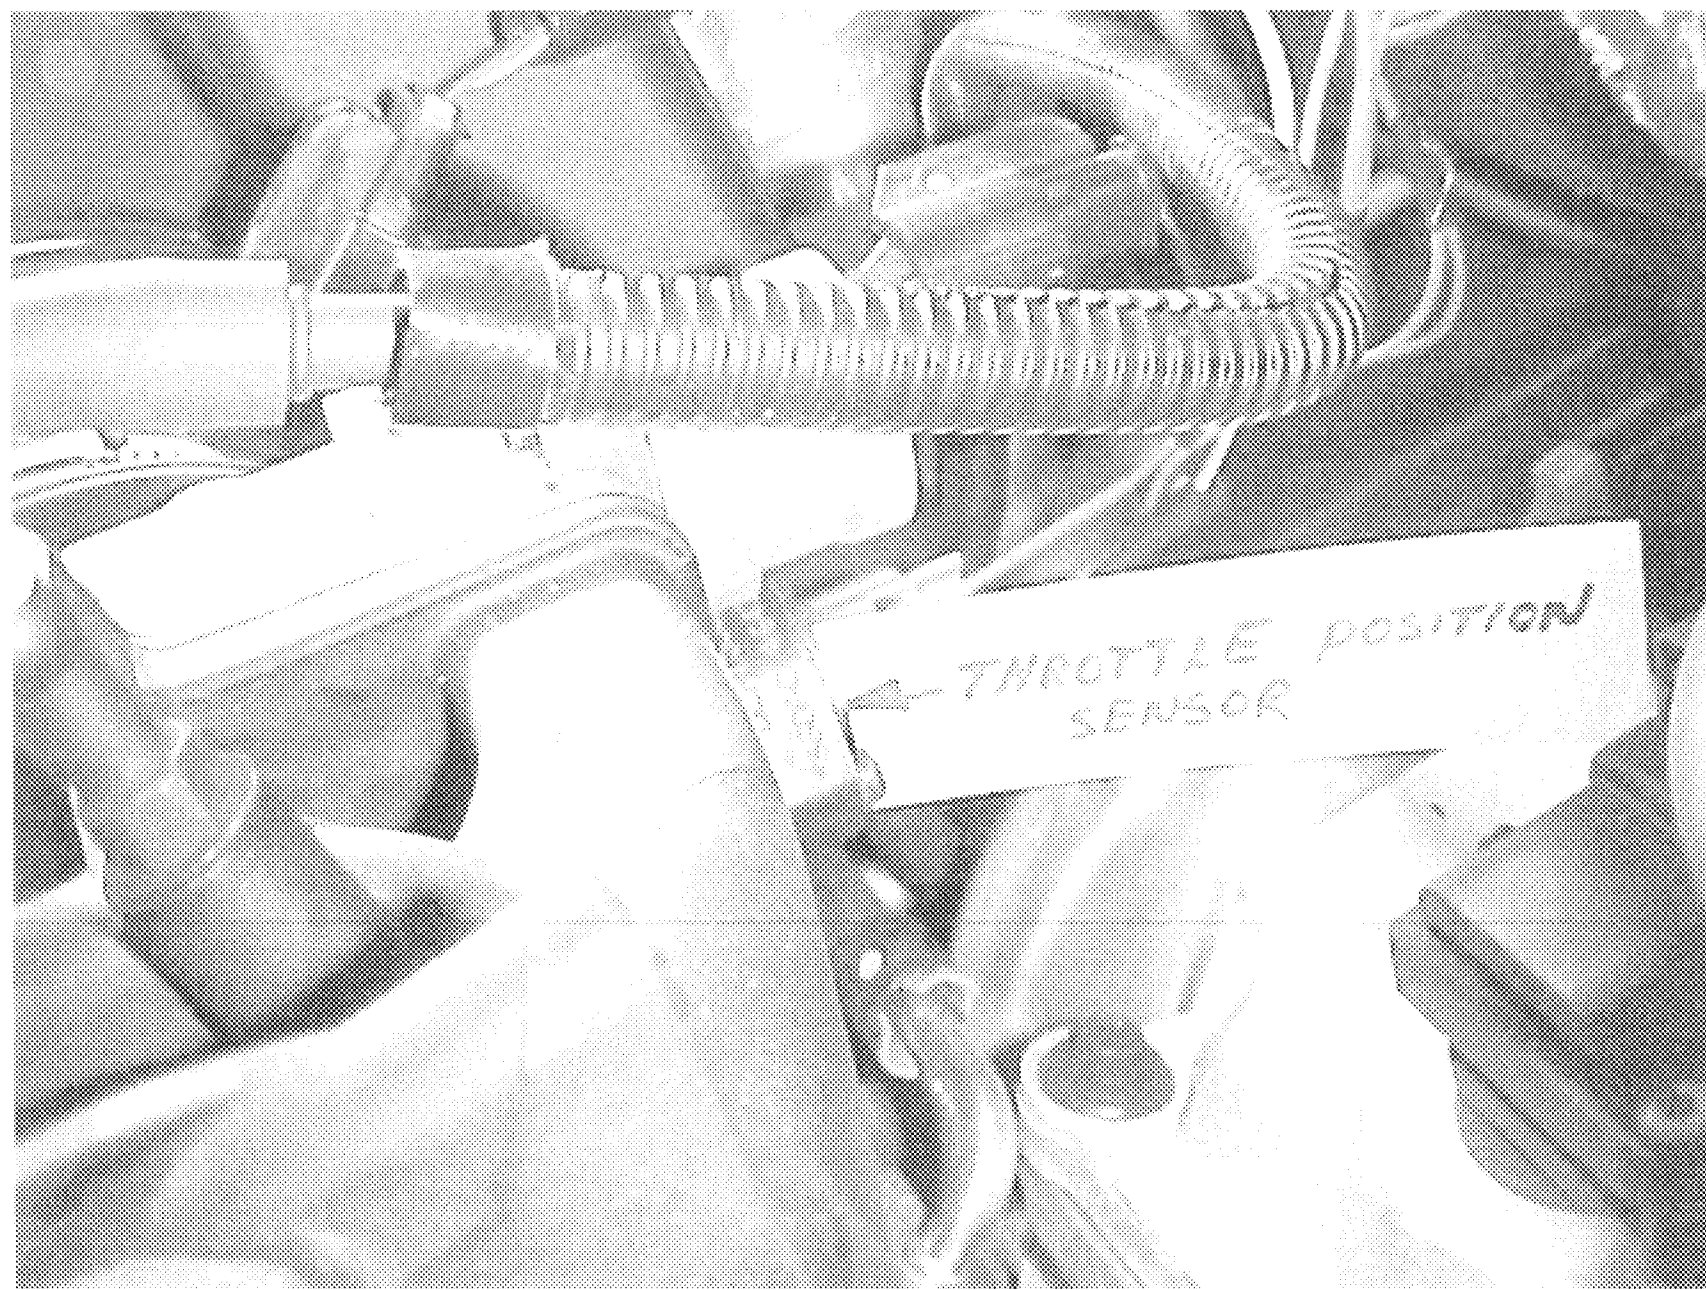
2004 CHRYSLER PACIFICA  
NHTSA NO. C40301  
FMVSS NO. 124L

FIGURE 5.6  
THROTTLE POSITION SENSOR CLOSE-UP

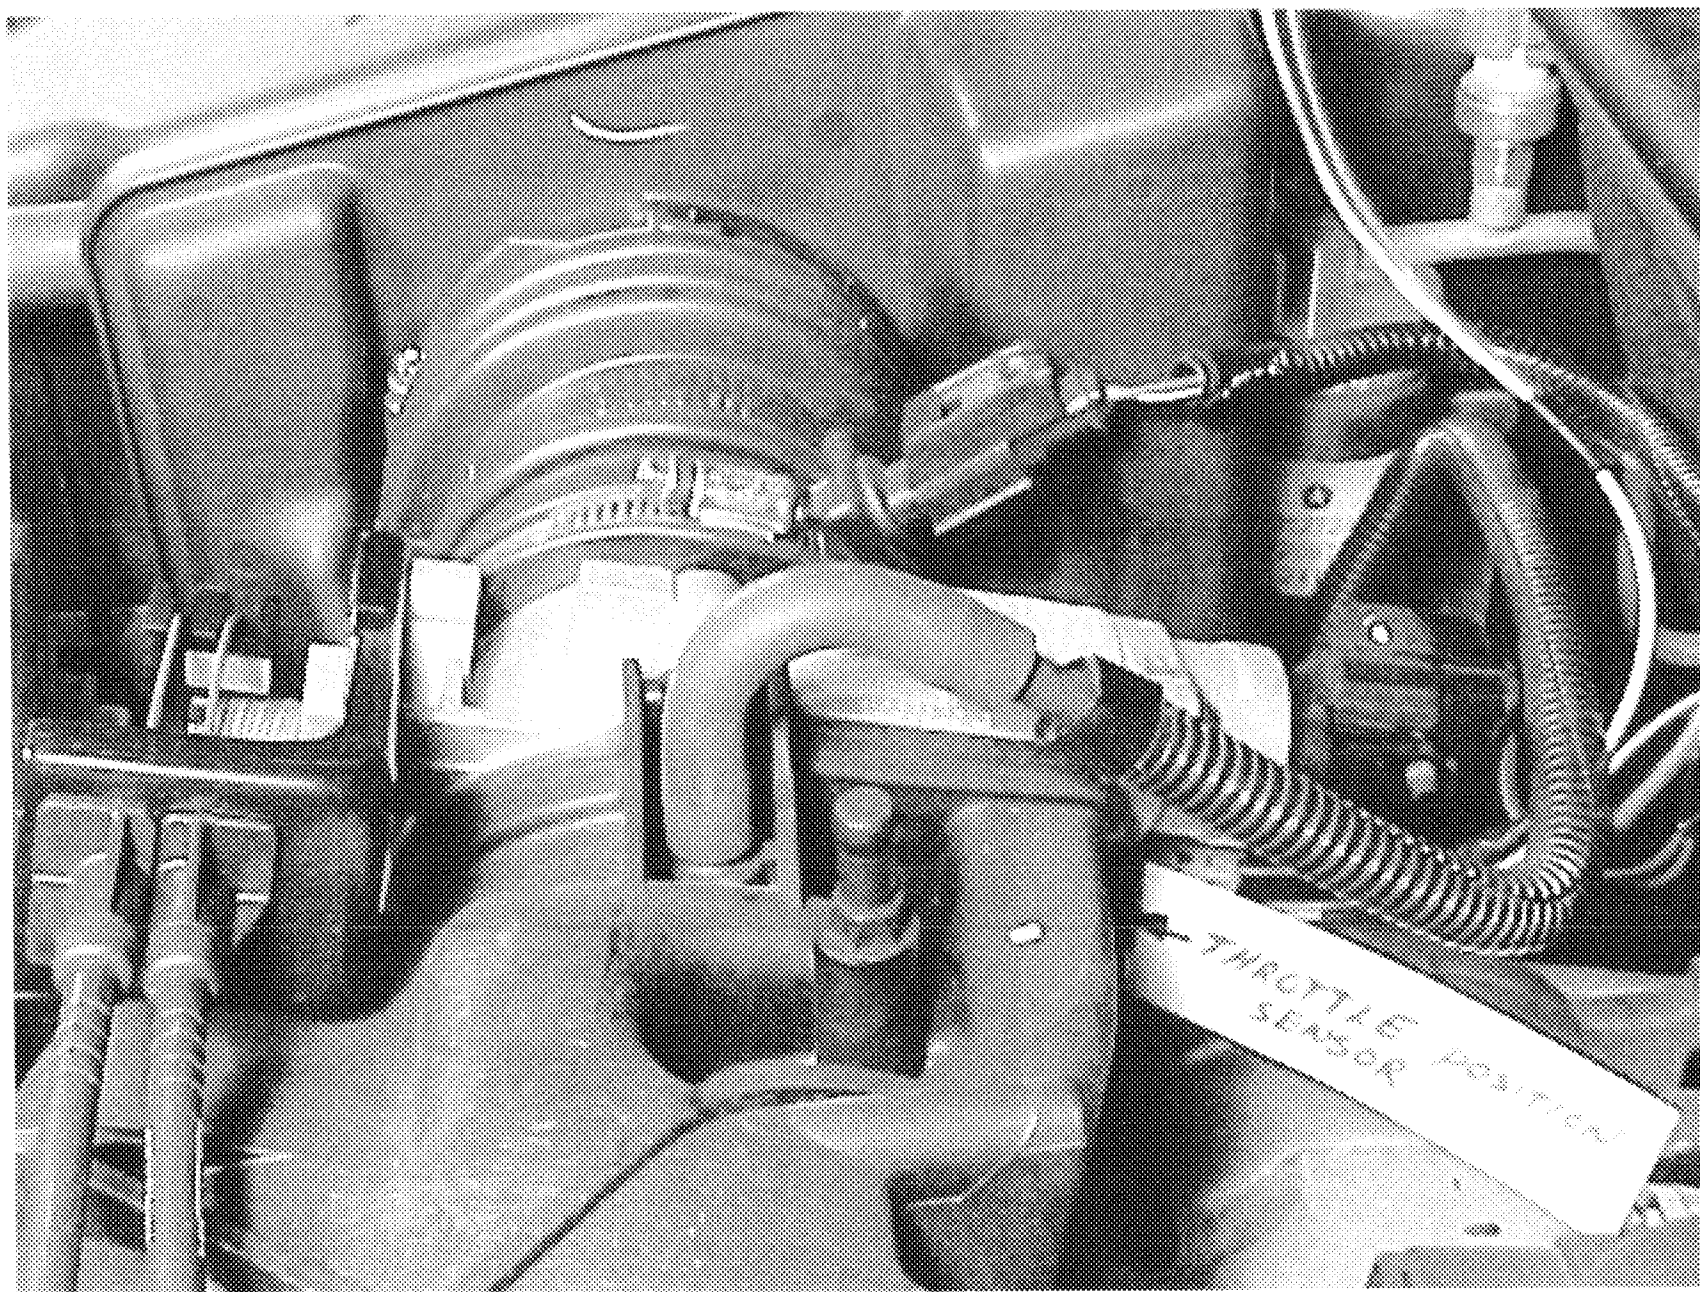
2004 CHRYSLER PACIFICA  
NHTSA NO. C40301  
FMVSS NO. 124L

FIGURE 5.7  
THROTTLE POSITION SENSOR LOCATION

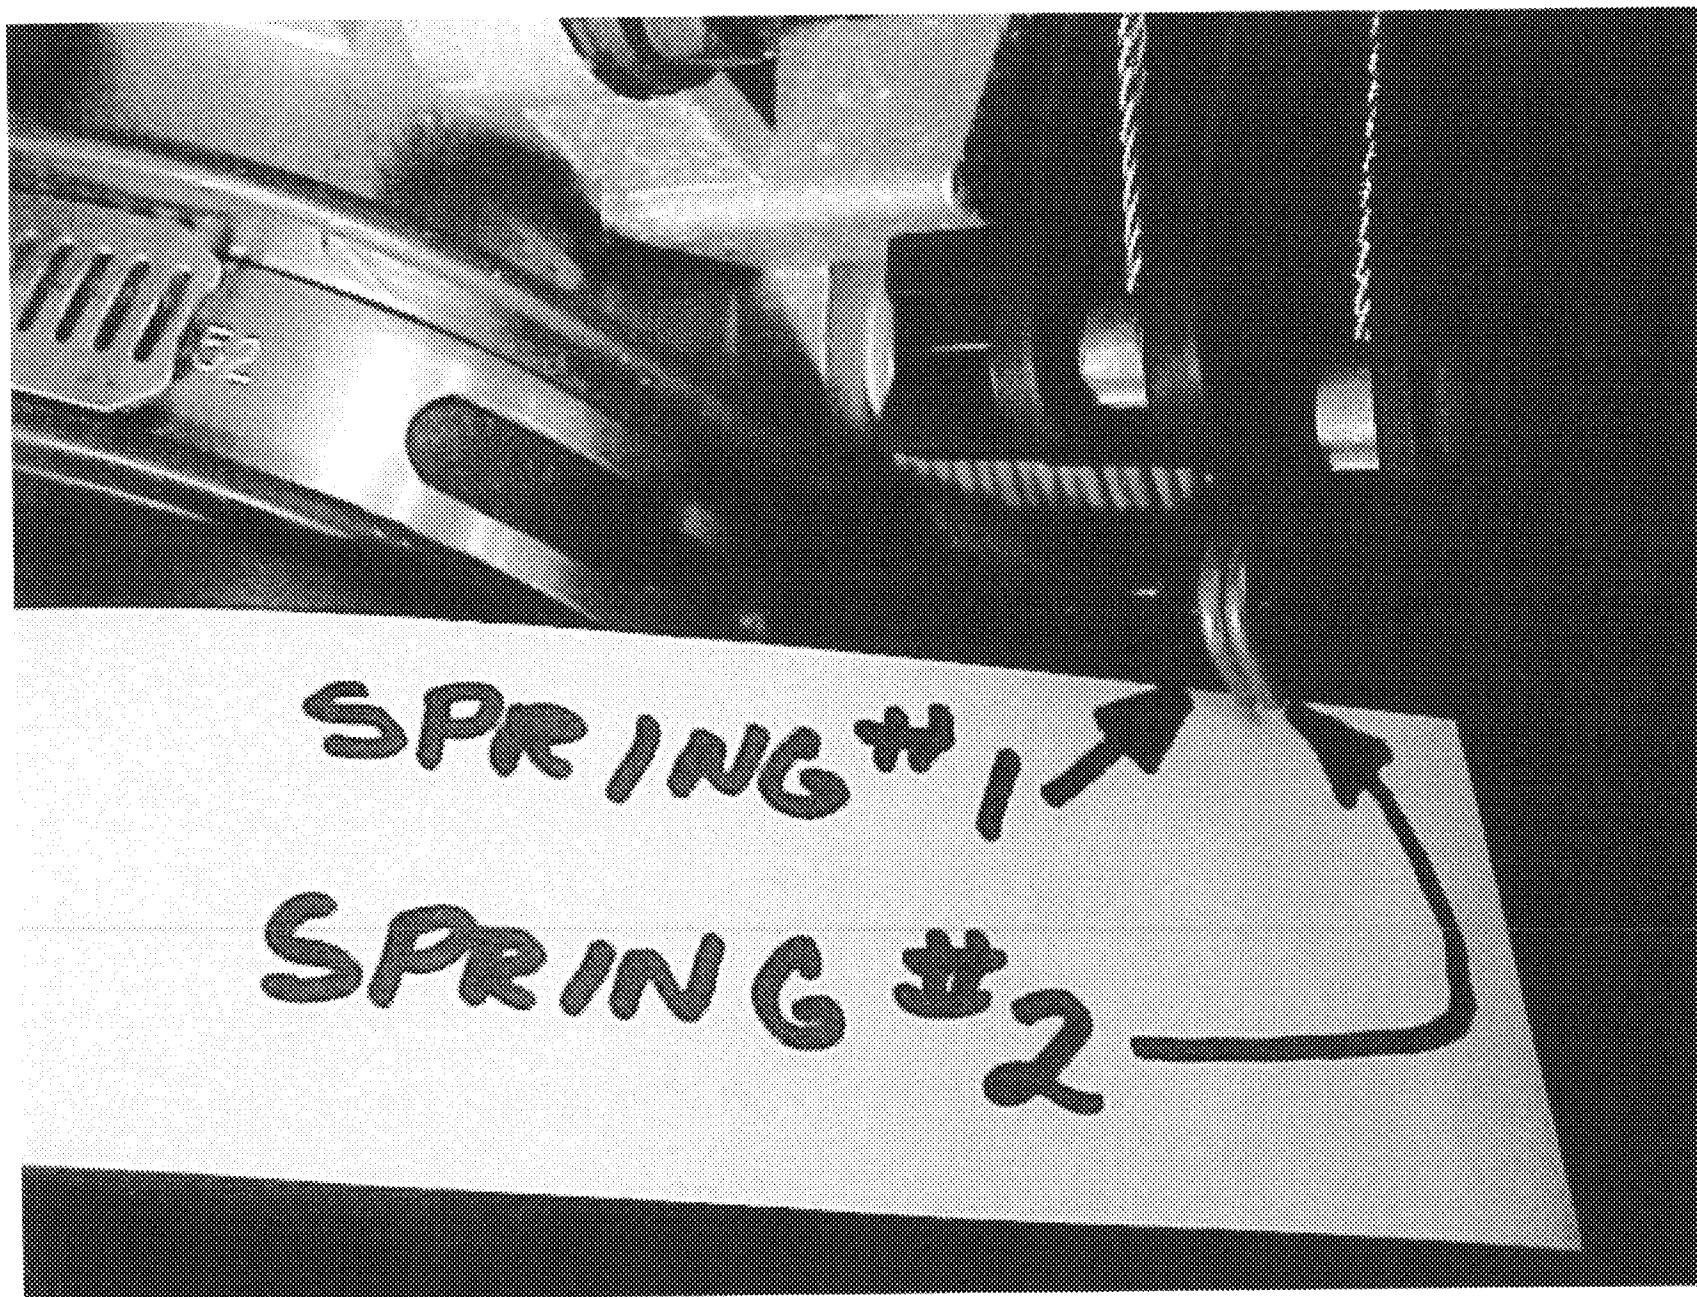
2004 CHRYSLER PACIFICA  
NHTSA NO. C40301  
FMVSS NO. 124L

FIGURE 5.8  
THROTTLE RETURN SPRINGS #1 & #2 CLOSE-UP

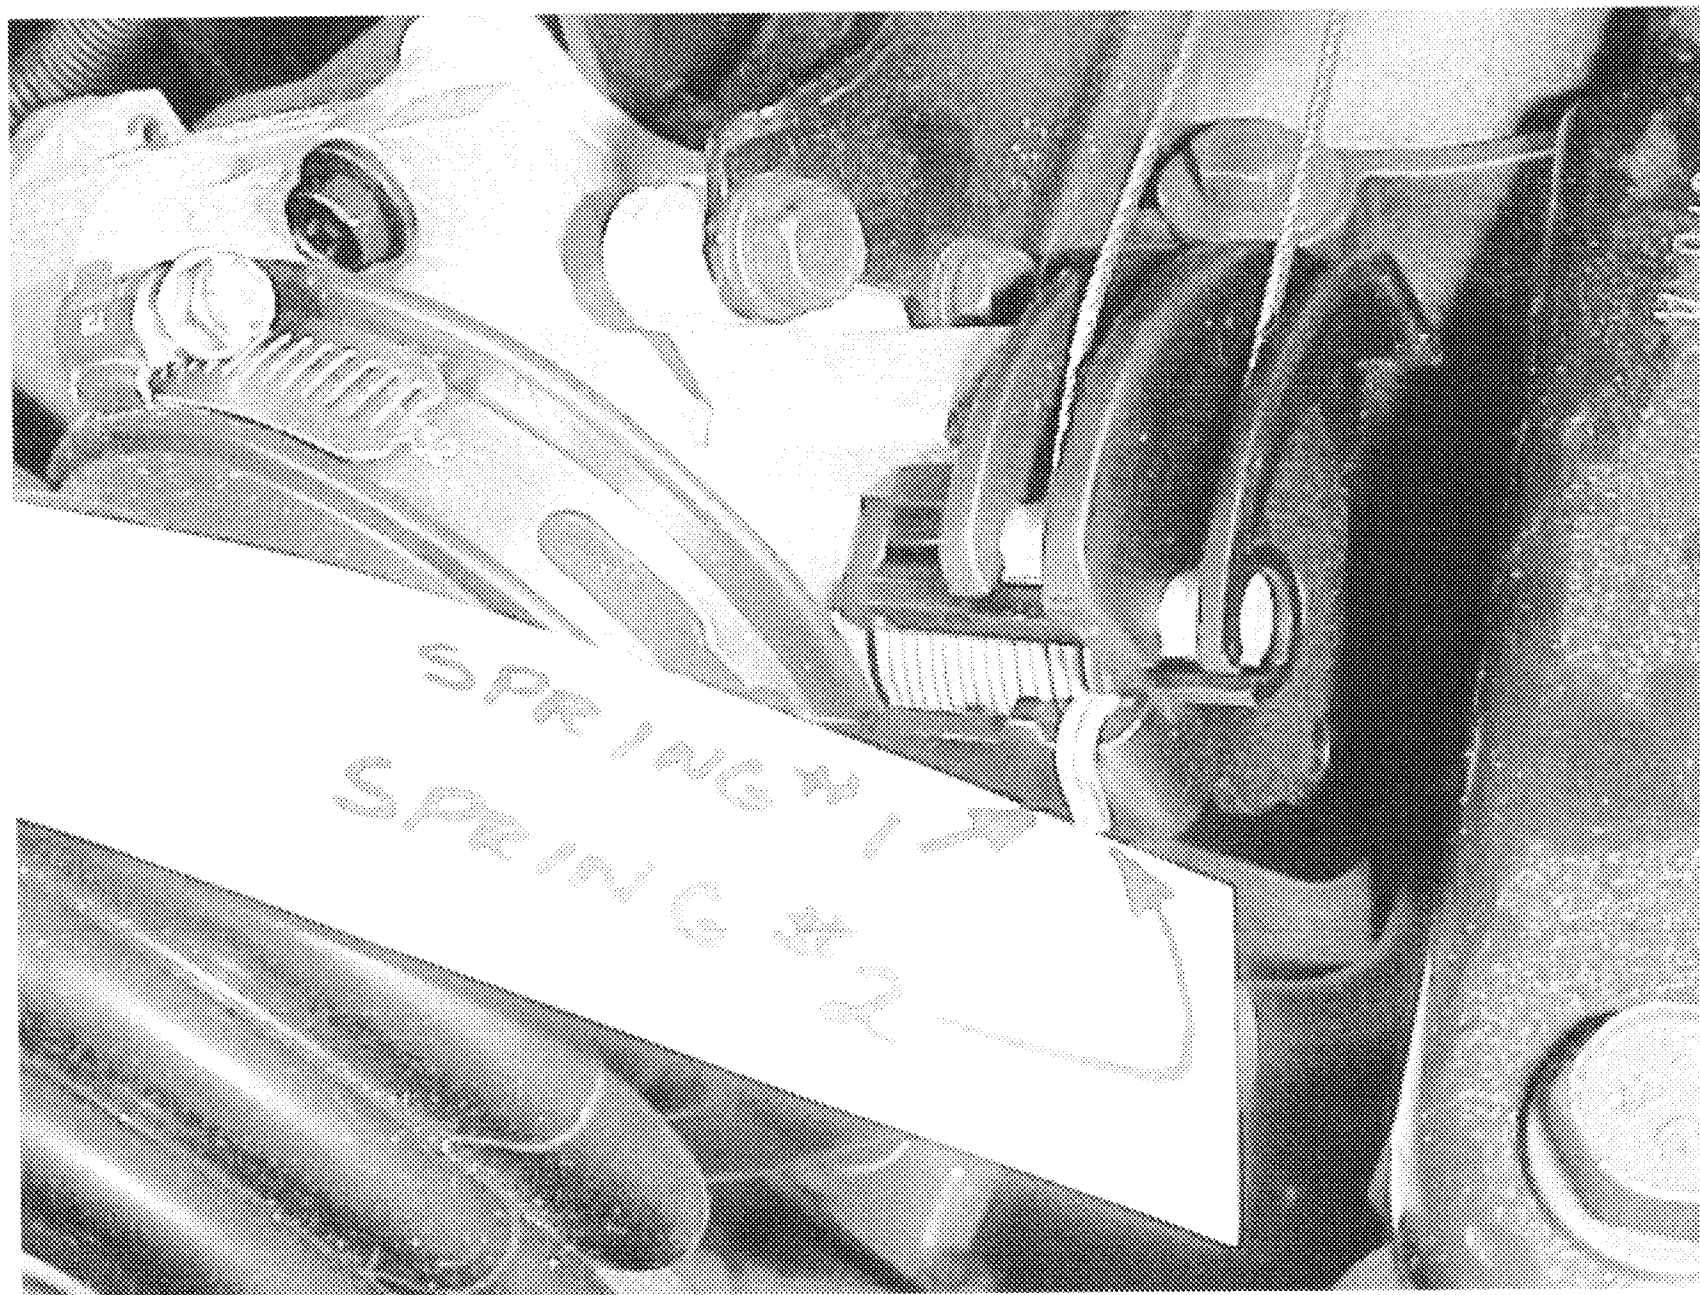
2004 CHRYSLER PACIFICA  
NHTSA NO. C40301  
FMVSS NO. 124L

FIGURE 5.9  
THROTTLE RETURN SPRINGS #1 & #2  
LOCATION

- The point chosen to show compliance with FMVSS 124 for single point disconnects was in the throttle body. One of the two throttle return springs was completely disconnected to demonstrate a worst case condition.

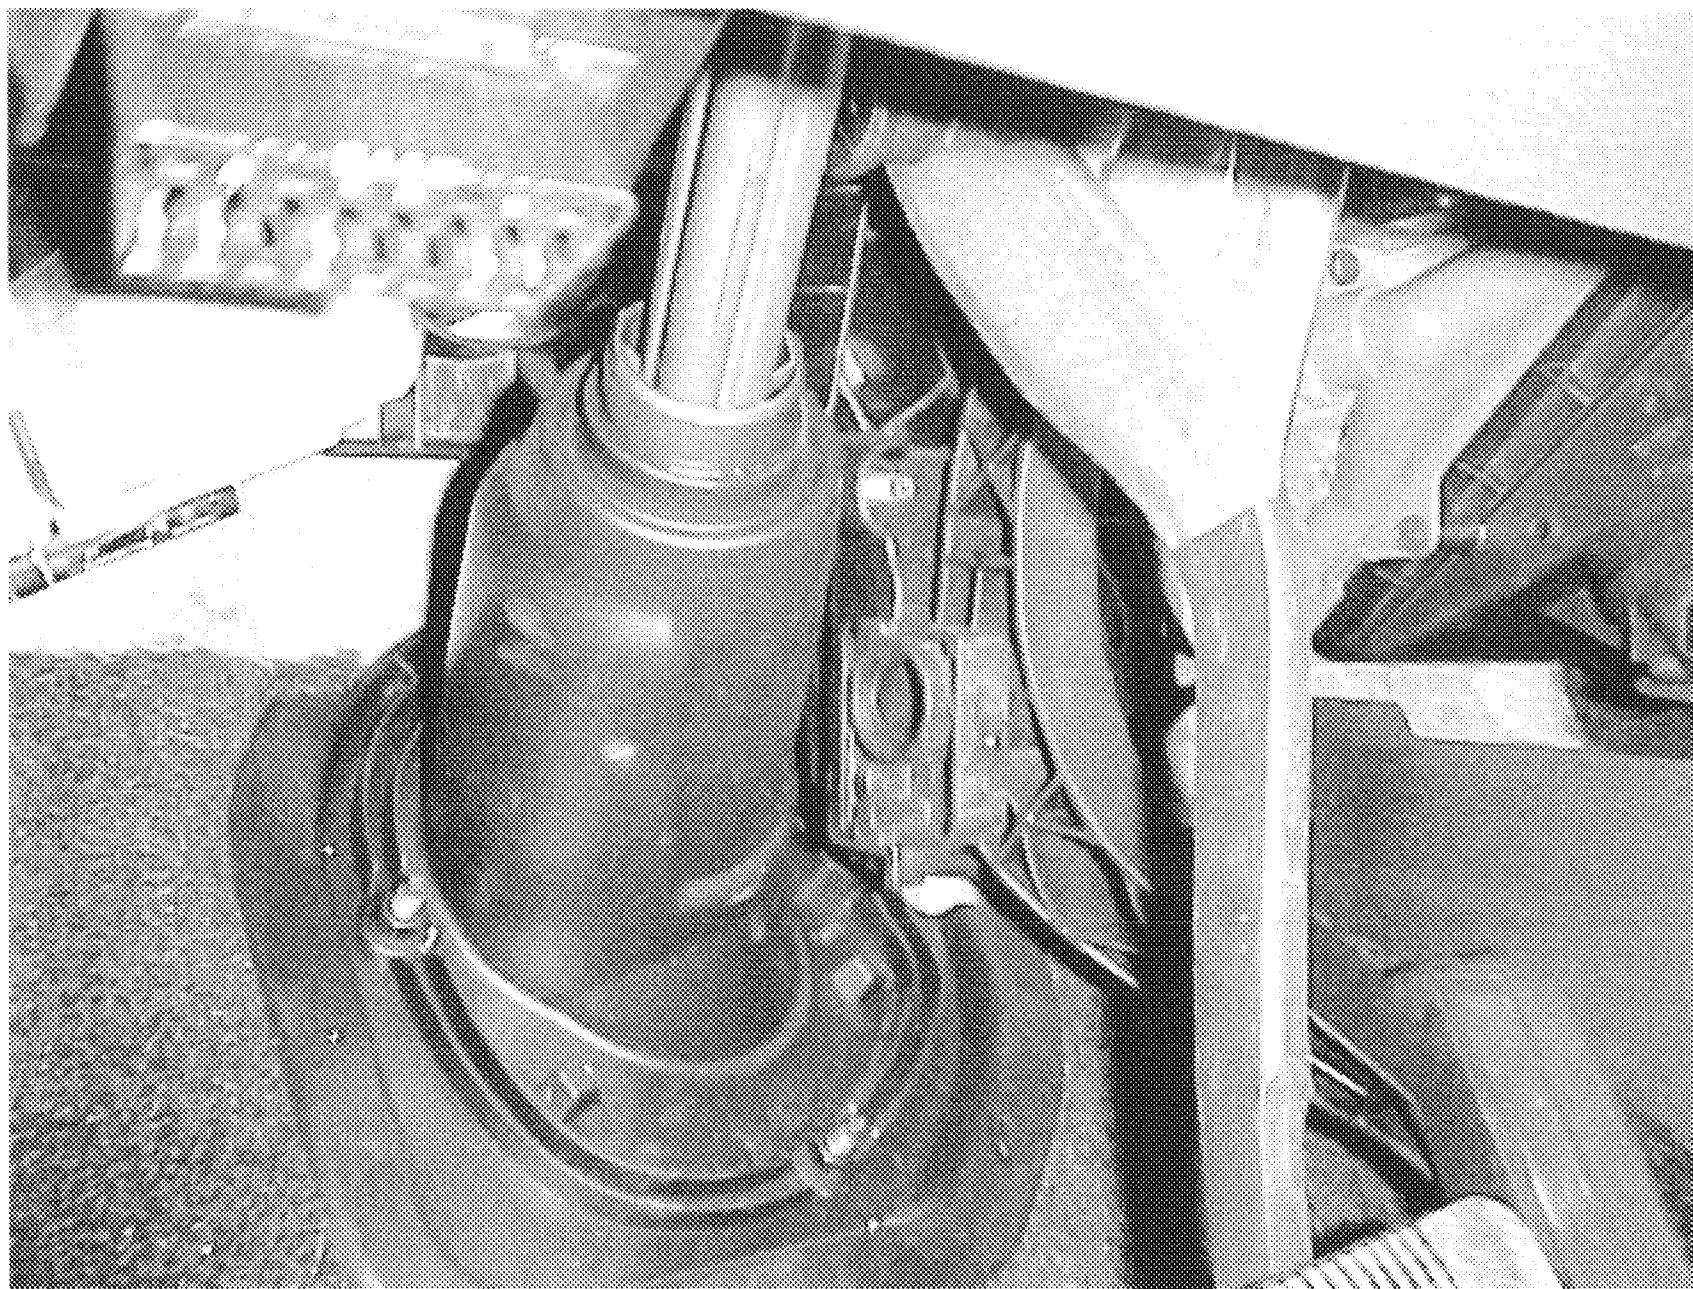
2004 CHRYSLER PACIFICA  
NHTSA NO. C40301  
FMVSS NO. 124L

FIGURE 5.10  
ACCELERATOR PEDAL

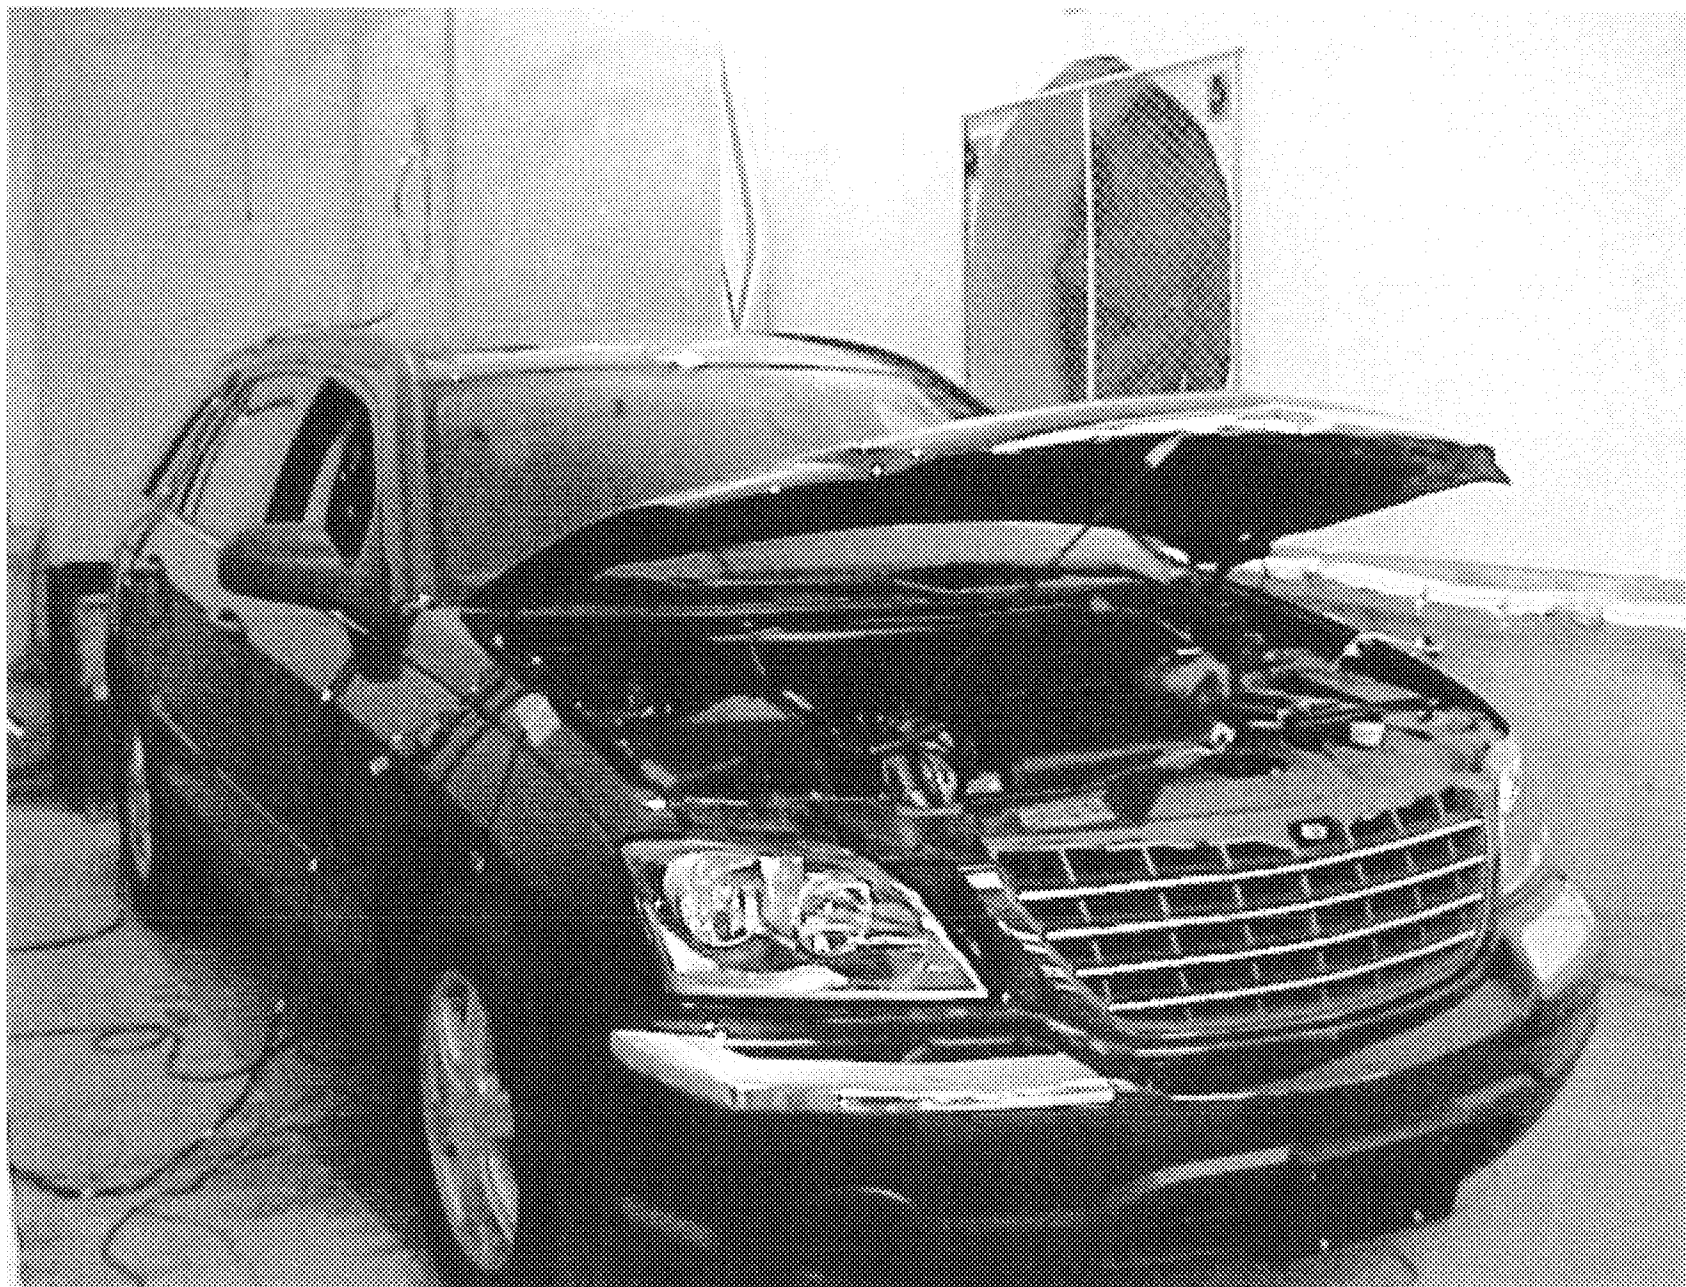
2004 CHRYSLER PACIFICA  
NHTSA NO. C40301  
FMVSS NO. 124L

FIGURE 5.11  
VEHICLE IN TEST CHAMBER

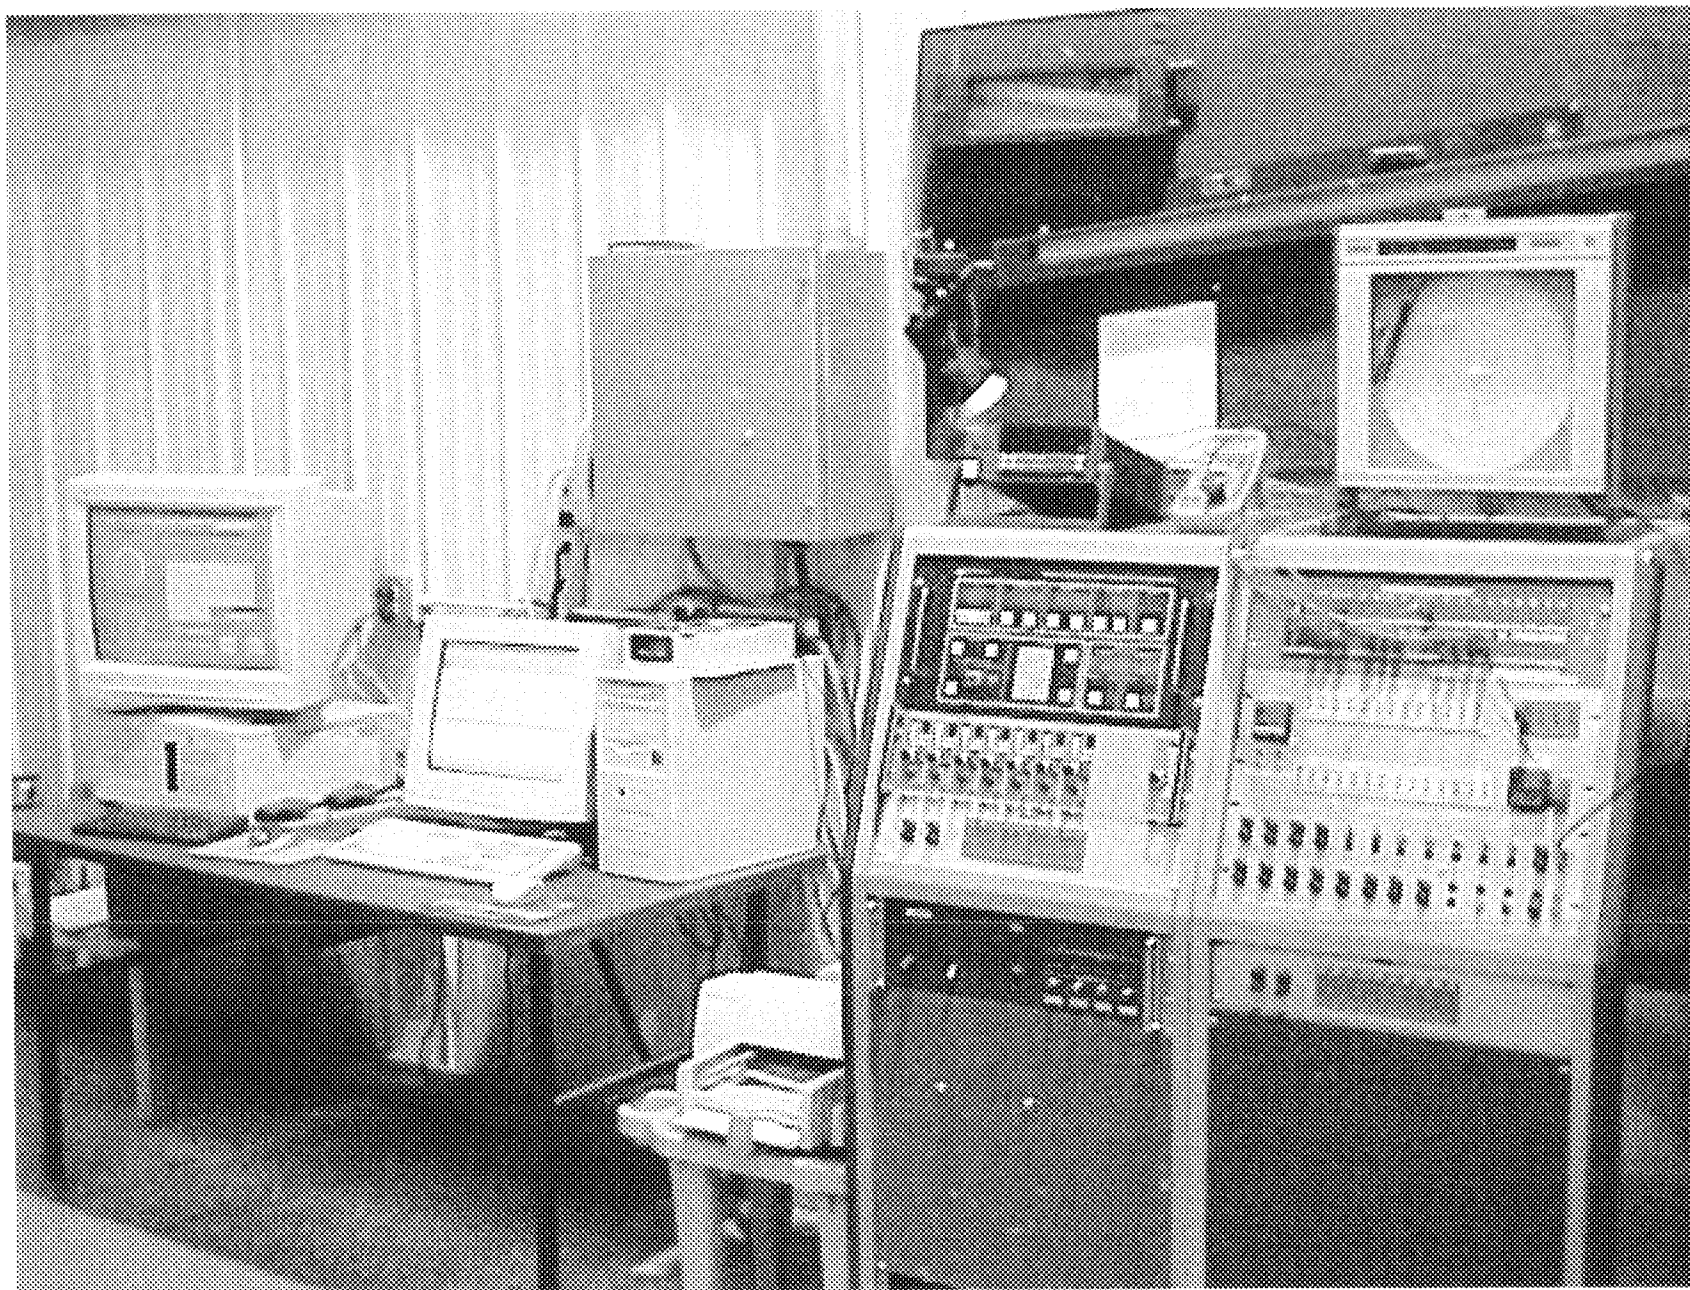
2004 CHRYSLER PACIFICA  
NHTSA NO. C40301  
FMVSS NO. 124L

Output from the vehicle throttle position sensor on the air throttle plate shaft was used to measure throttle position and data was recorded at 1000 HZ with GTL's data acquisition system. Testing was conducted to simulate the normal removal of the driver's foot from the accelerator pedal. Testing was performed with the vehicle in park and the engine running. Return to idle times were determined for four throttle plate positions with the accelerator control system complete and with each of the two throttle return springs on the throttle plate shaft independently disconnected. The severed linkage test was also performed by disconnecting the throttle cable from the throttle body. As the air throttle plate was mechanically linked to the accelerator pedal, no electrical disconnections were required.

FIGURE 5.12  
124 TEST INSTRUMENTATION SET-UP

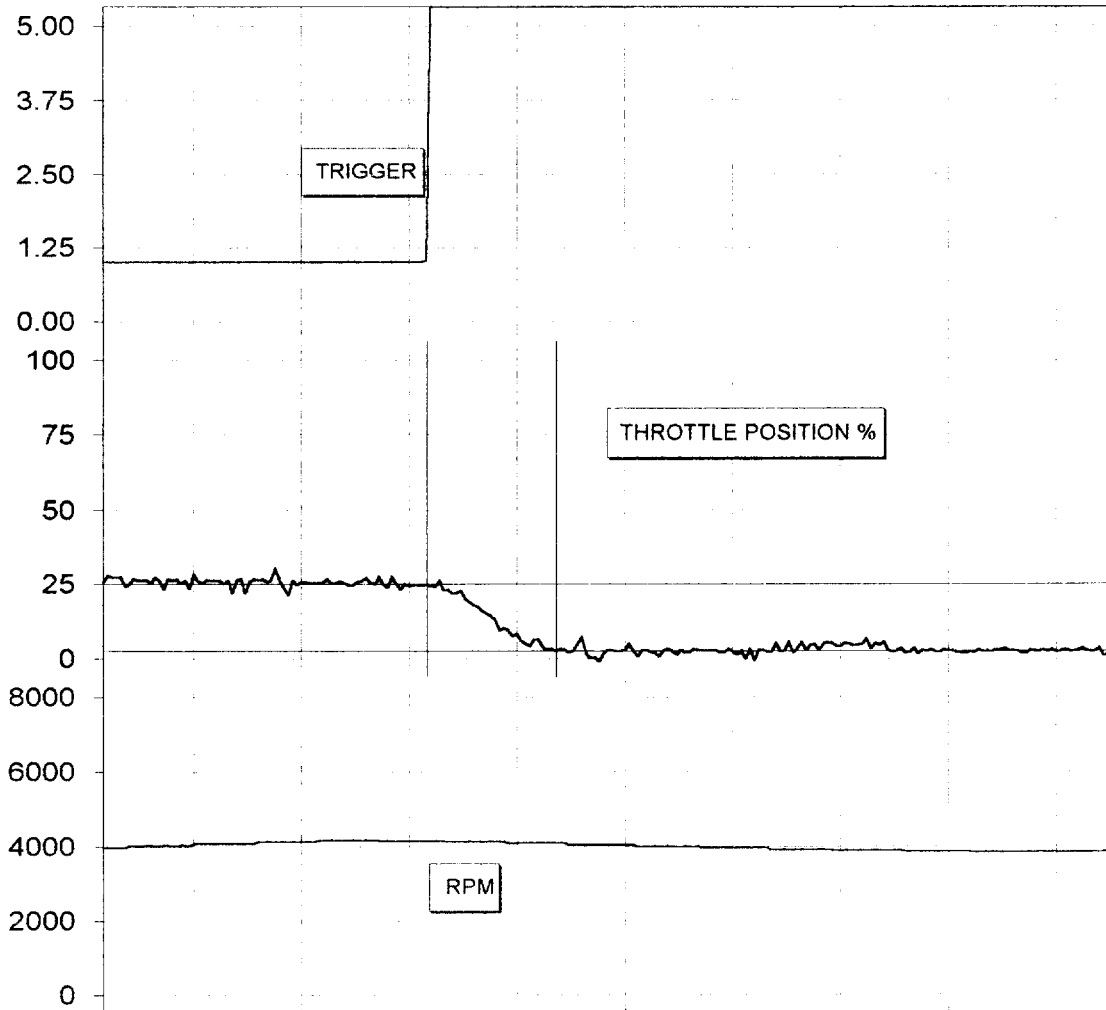
124 COLD/ NORMAL/ 25% WOT

Y1: 25.005 %	Y2: 2.546 %
t1: -32820.317 ms	t2: -32790.317 ms
dt: 0.030 s	f: 33.333 Hz

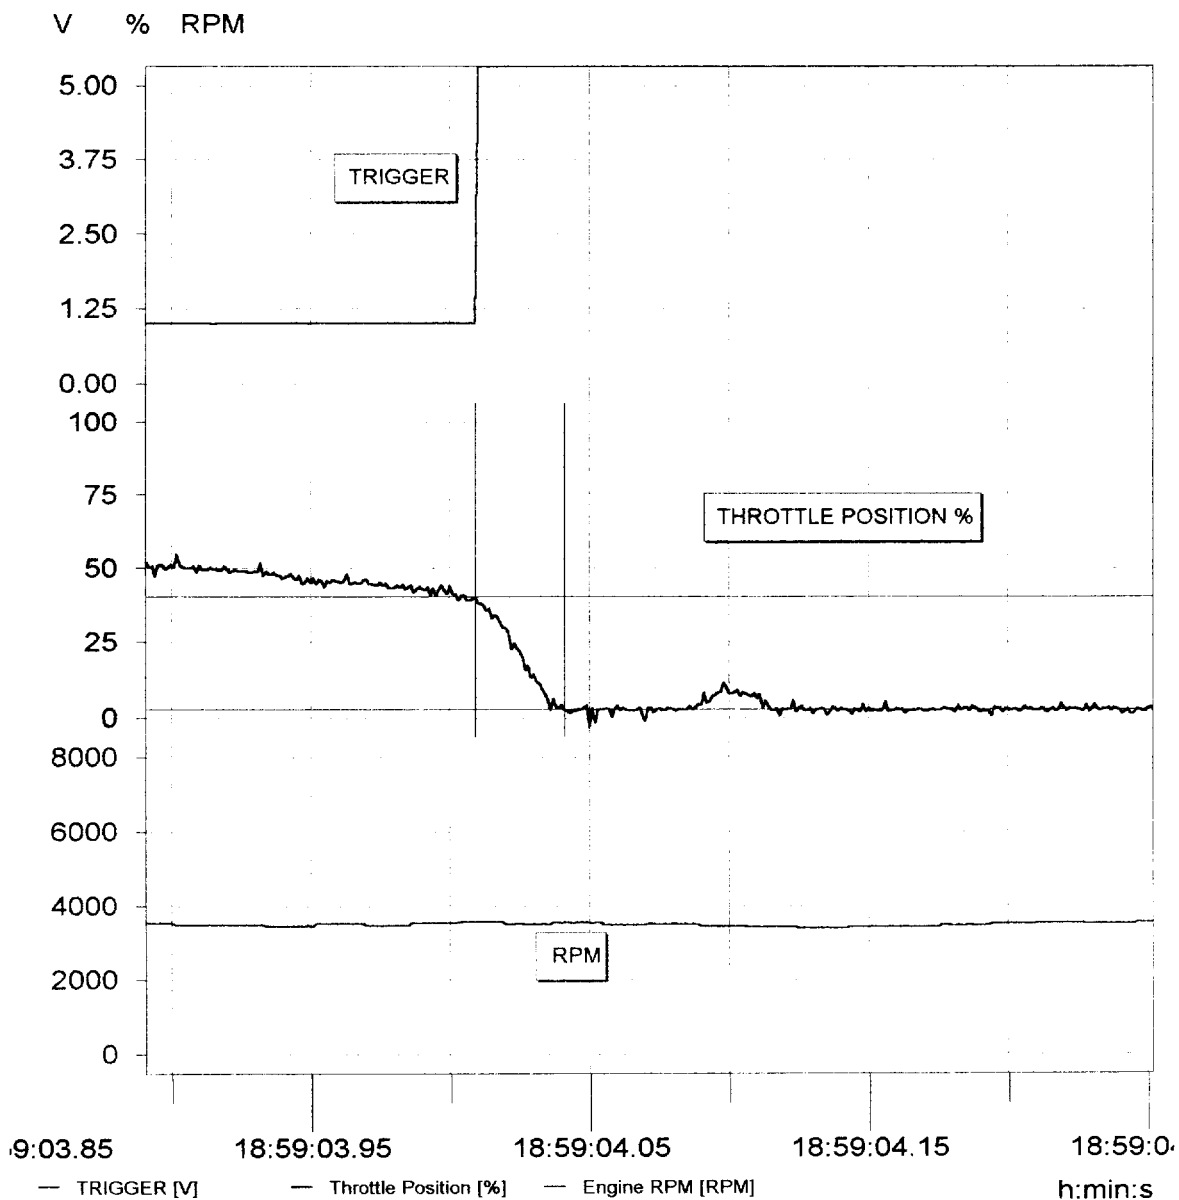
# FMVSS 124 THROTTLE RETURN TEST 124 COLD/ NORMAL/ 50% WOT 7:04:19 PM 5/4/04

Y1: 40.259 %	Y2: 2.704 %
t1: -24990.317 ms	t2: -24958.317 ms
dt: 0.032 s	f: 31.250 Hz

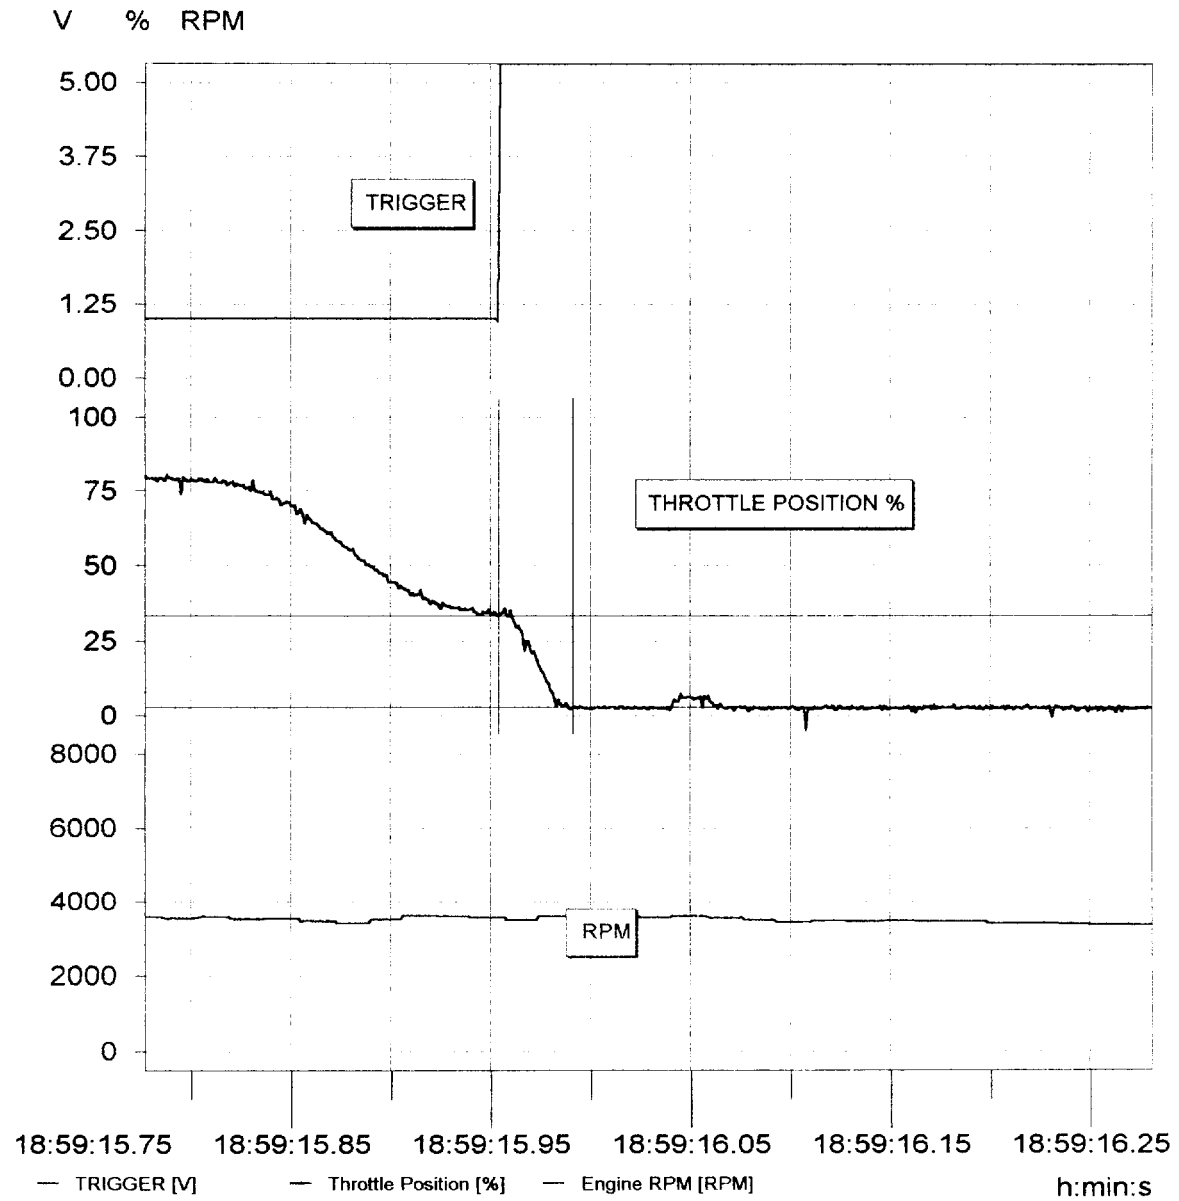
124 COLD/ NORMAL/ 75% WOT

Y1: 33.538 %  
t1: -13045.317 ms  
dt: 0.037 s

Y2: 2.823 %  
t2: -13008.317 ms  
f: 27.027 Hz
