# SAFETY COMPLIANCE TESTING FOR FMVSS 124L ACCELERATOR CONTROL SYSTEMS

DAIMLERCHRYSLER CORPORATION  
2004 CHRYSLER PACIFICA, MPV  
NHTSA NO. C40301

1. Report No. 124L-GTL-04-002	2. Government Accession No.	3. Recipient's Catalog No.
4. Title and Subtitle Final Report of FMVSS 124 Compliance Testing of 2004 CHRYSLER PACIFICA, MPV NHTSA No. C40301	5. Report Date May 14, 2004	6. Performing Organ. Code GTL

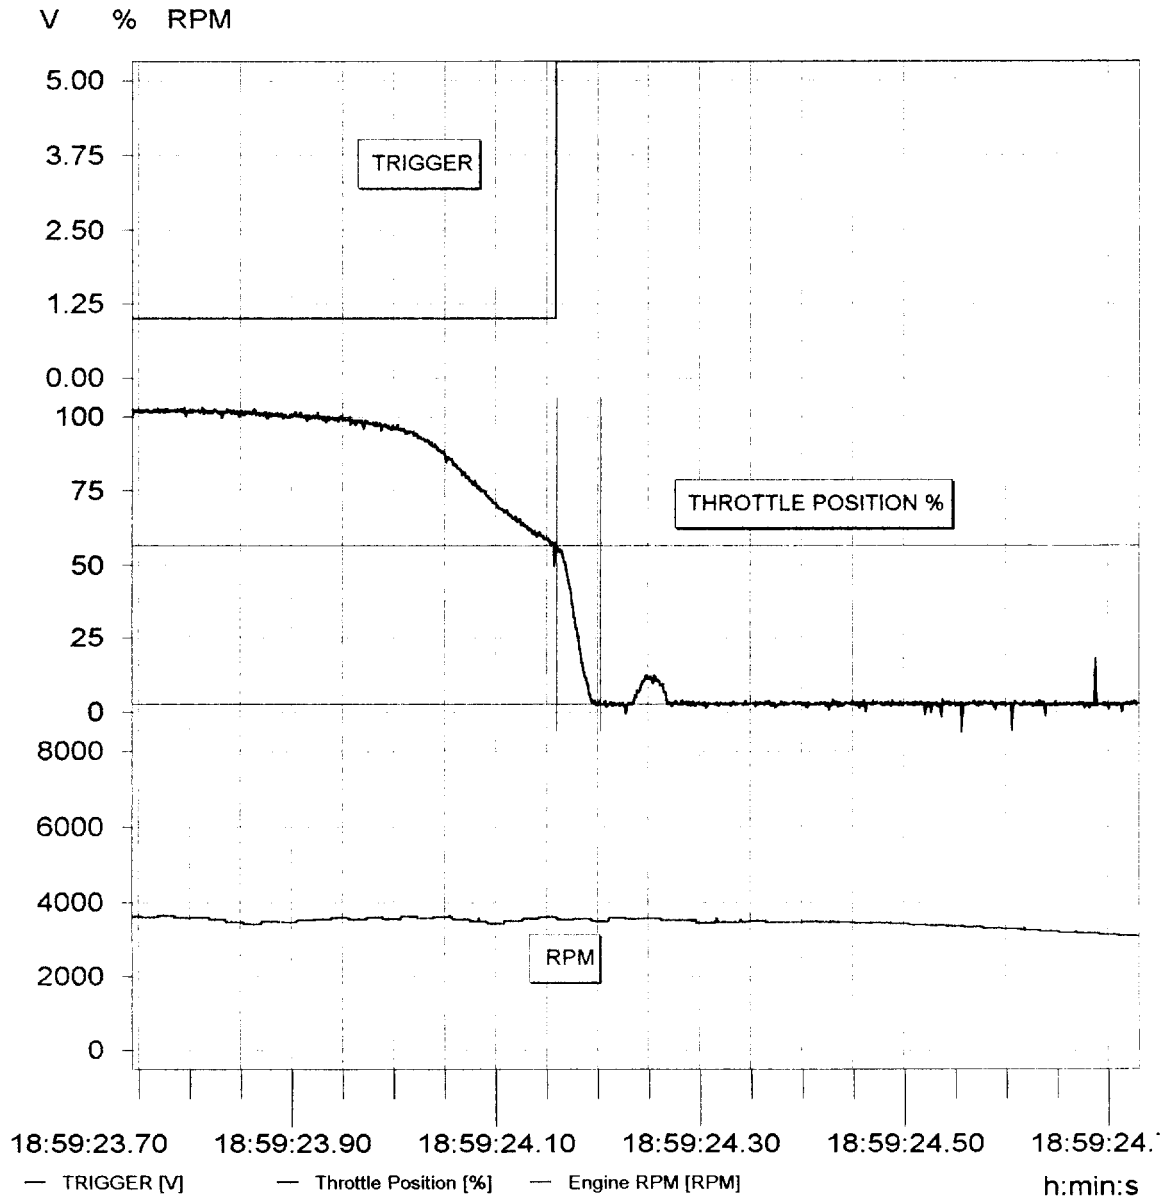
124 COLD/ NORMAL/ 100% WOT

Y1: 56.495 %  
t1: -4839.317 ms  
dt: 0.043 s

Y2: 2.546 %  
t2: -4796.317 ms  
f: 23.256 Hz

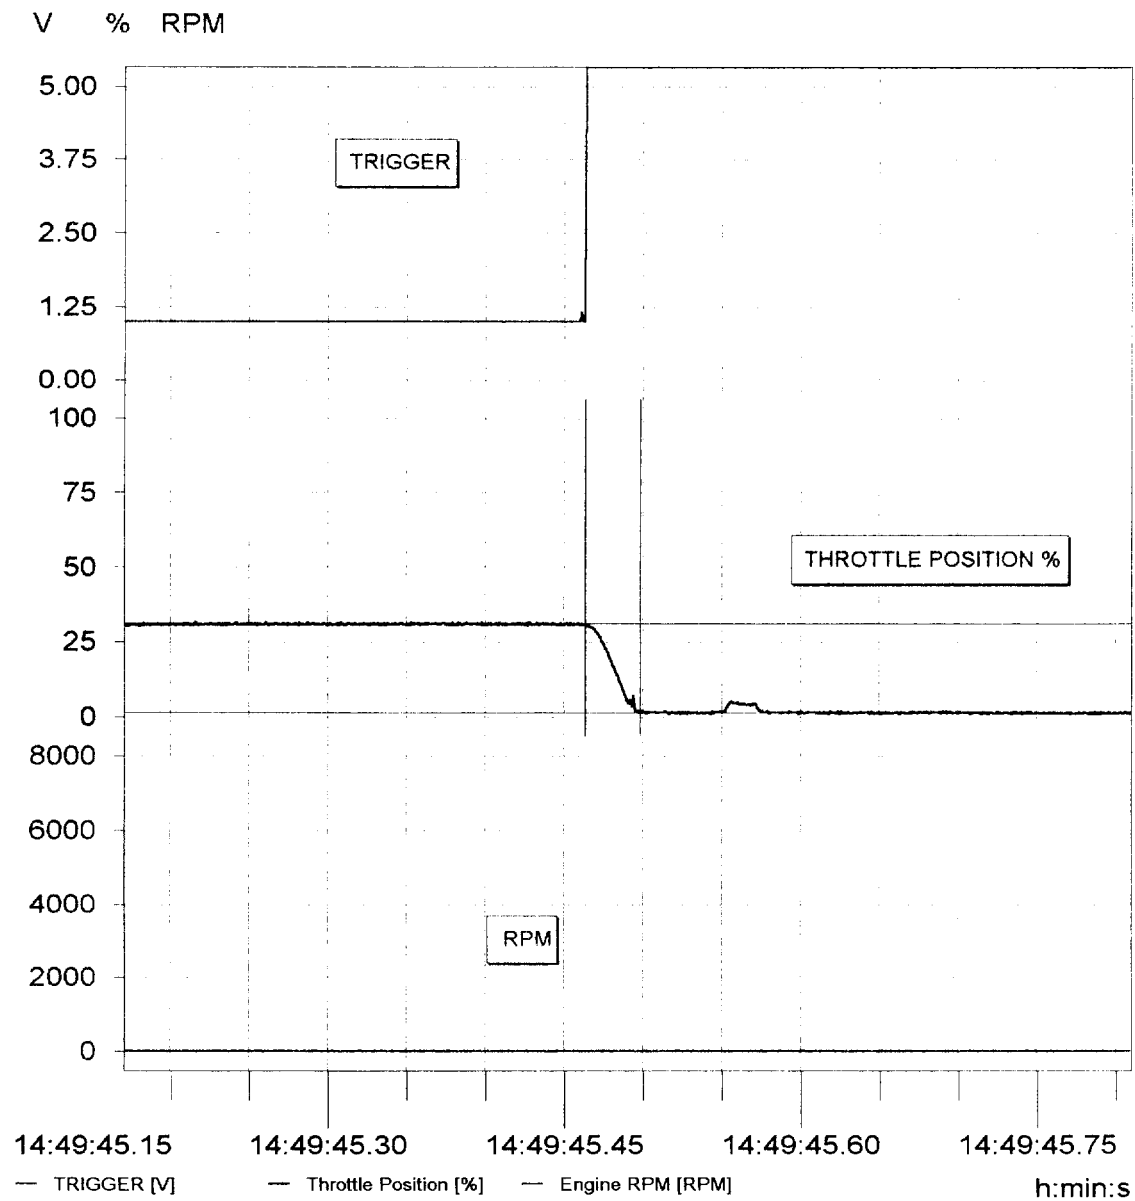
124 COLD/ ENGINE OFF/ 25% WOT

Y1: 31.128 %  
t1: -35584.874 ms  
dt: 0.035 s

Y2: 1.499 %  
t2: -35549.874 ms  
f: 28.571 Hz

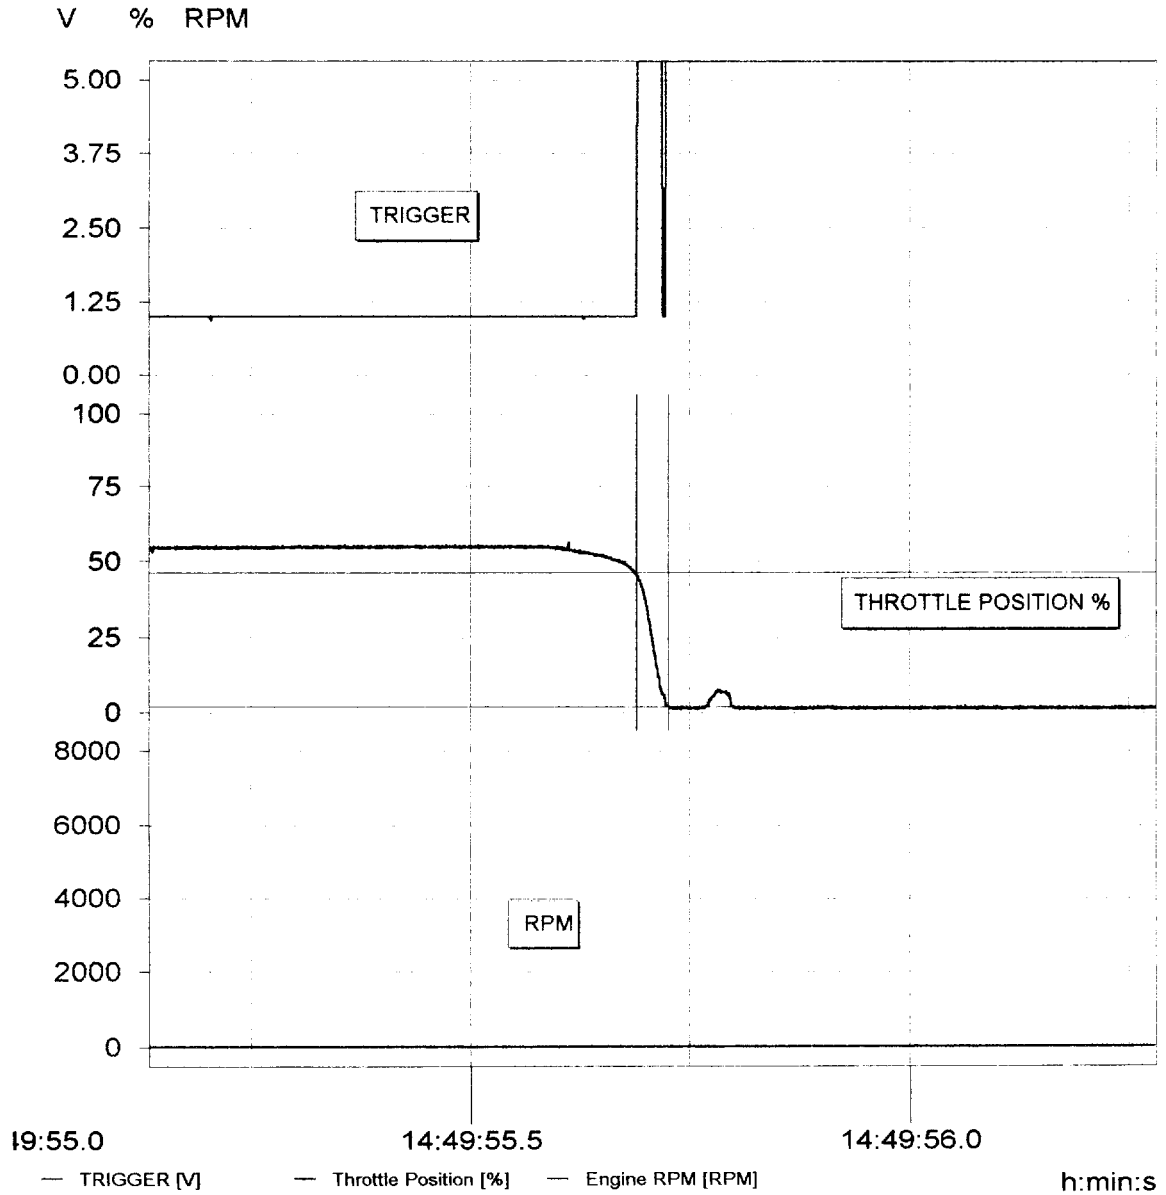
FMVSS 124 THROTTLE RETURN TEST  
124 COLD/ ENGINE OFF/ 50% WOT 3:05:23 PM 5/4/04

Y1:	46.016 %	Y2:	1.894 %
t1:	-25358.874 ms	t2:	-25322.874 ms
dt:	0.036 s	f:	27.778 Hz

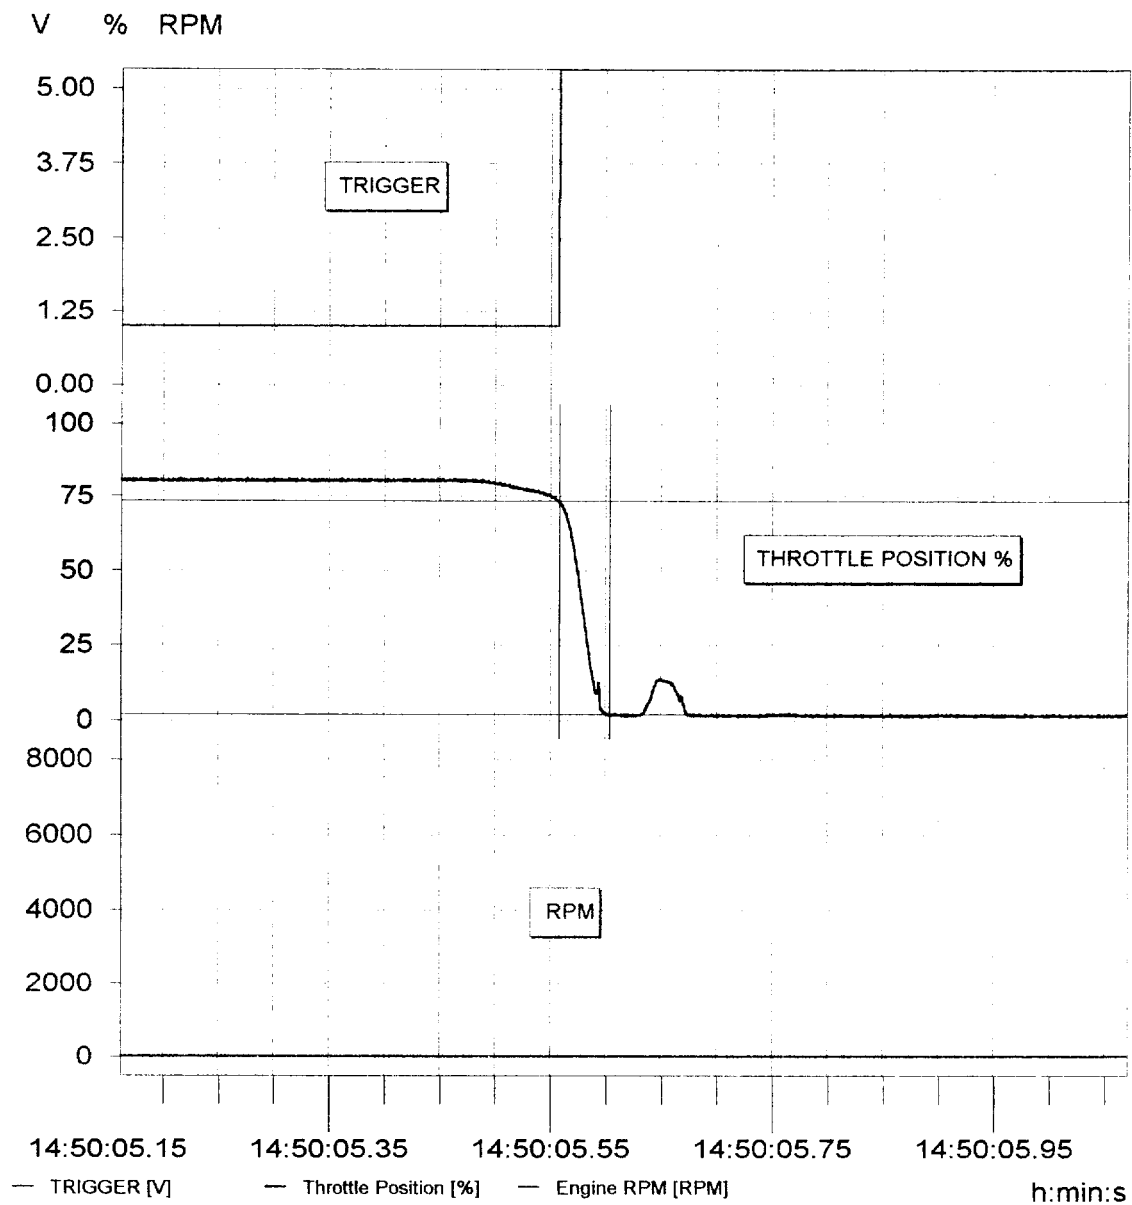
124 COLD/ ENGINE OFF/ 75% WOT

Y1: 73.206 %  
t1: -15489.874 ms  
dt: 0.045 s

Y2: 1.771 %  
t2: -15444.874 ms  
f: 22.222 Hz

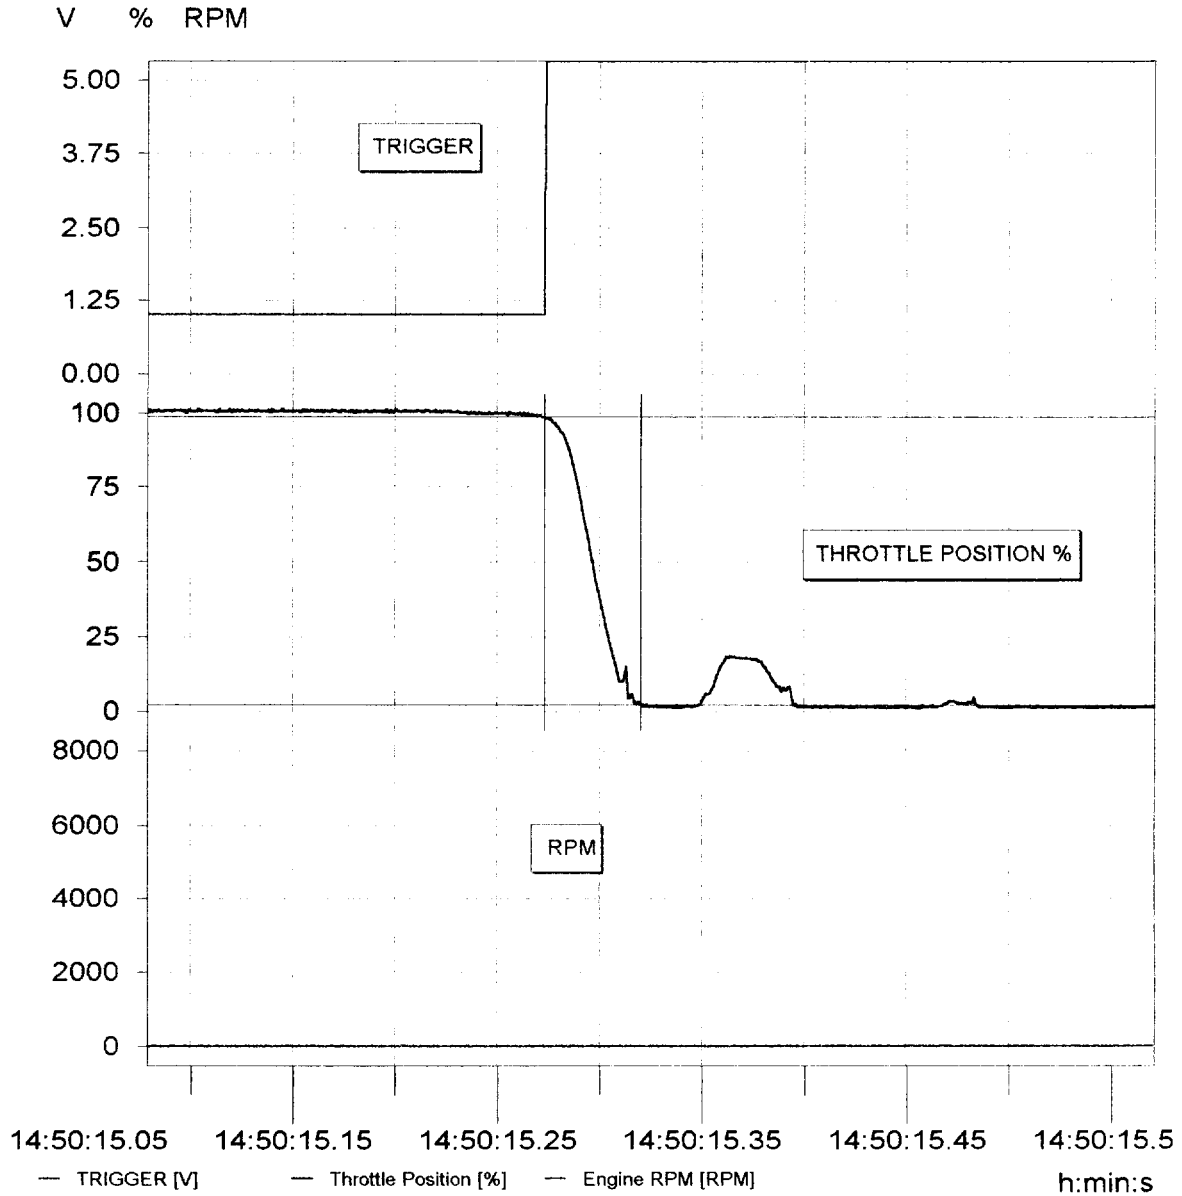
124 COLD/ ENGINE OFF/ 100% WOT

Y1: 98.731 %  
t1: -5774.874 ms  
dt: 0.047 s

Y2: 2.112 %  
t2: -5727.874 ms  
f: 21.277 Hz

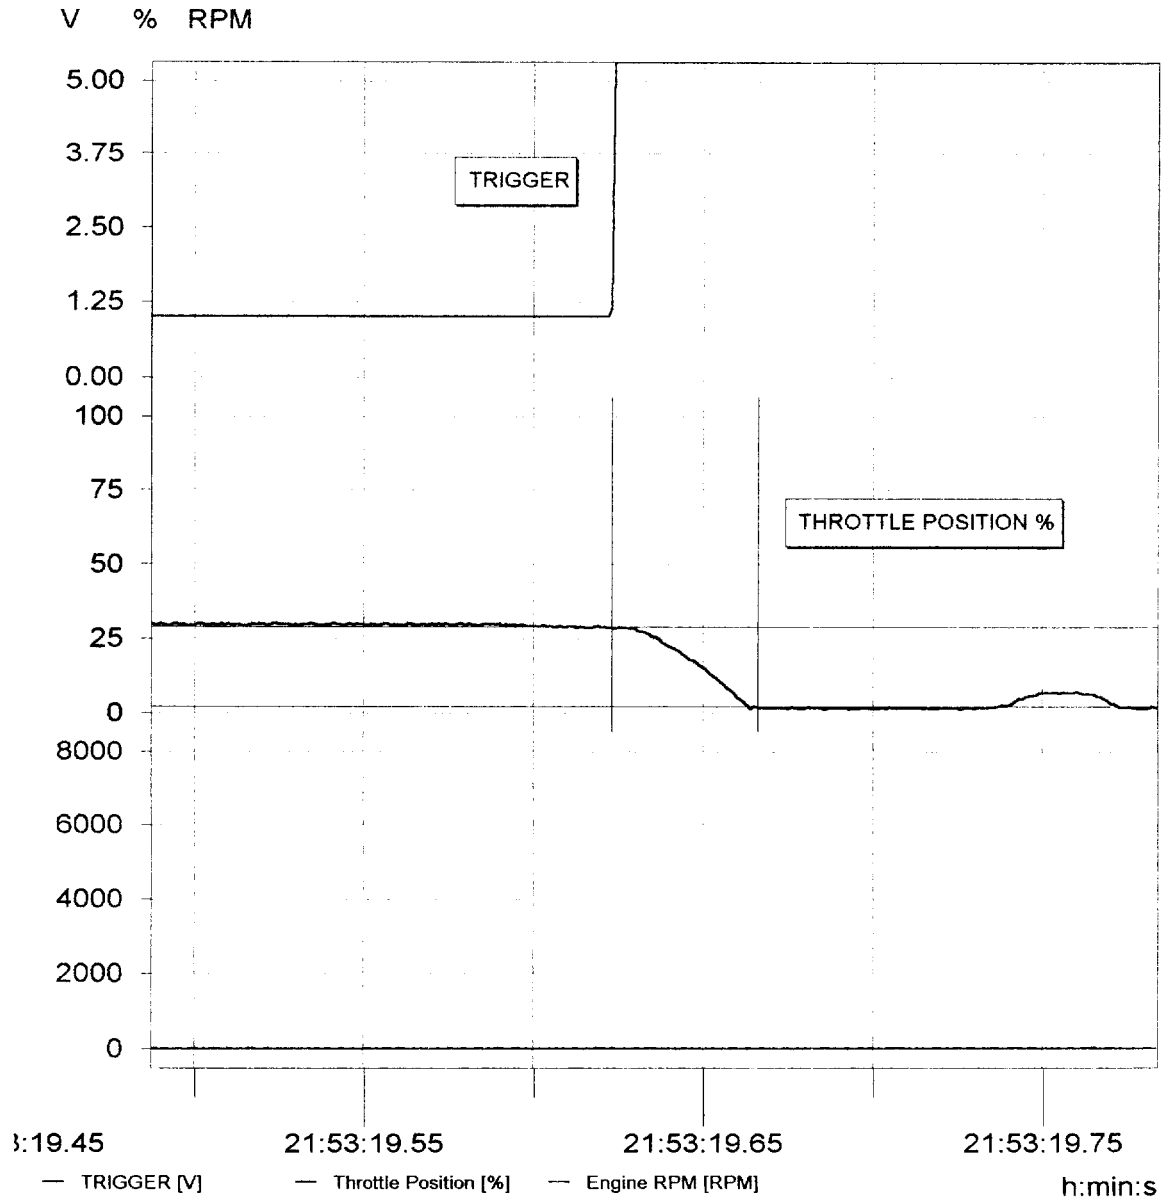
124 COLD/ SPRING 1/ 25% WOT

Y1: 28.763 %  
t1: -35381.658 ms  
dt: 0.043 s

Y2: 2.018 %  
t2: -35338.658 ms  
f: 23.256 Hz

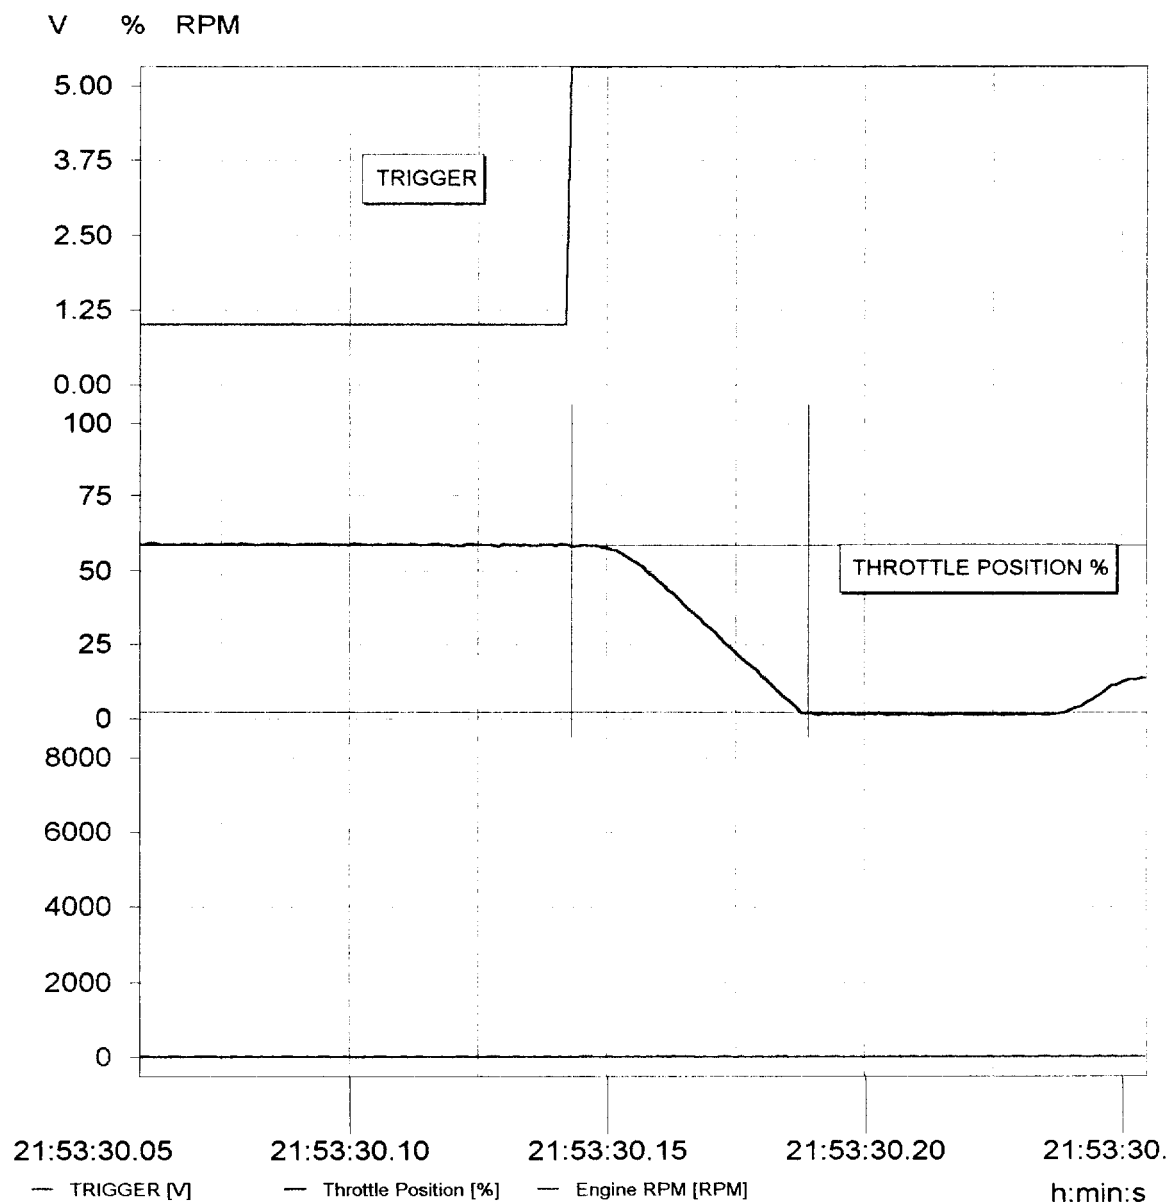
FMVSS 124 THROTTLE RETURN TEST  
124 COLD/ SPRING 1/ 50% WOT 9:57:48 PM 5/4/04

Y1: 58.540 %  
t1: -24861.658 ms  
dt: 0.046 s

Y2: 2.062 %  
t2: -24815.658 ms  
f: 21.739 Hz

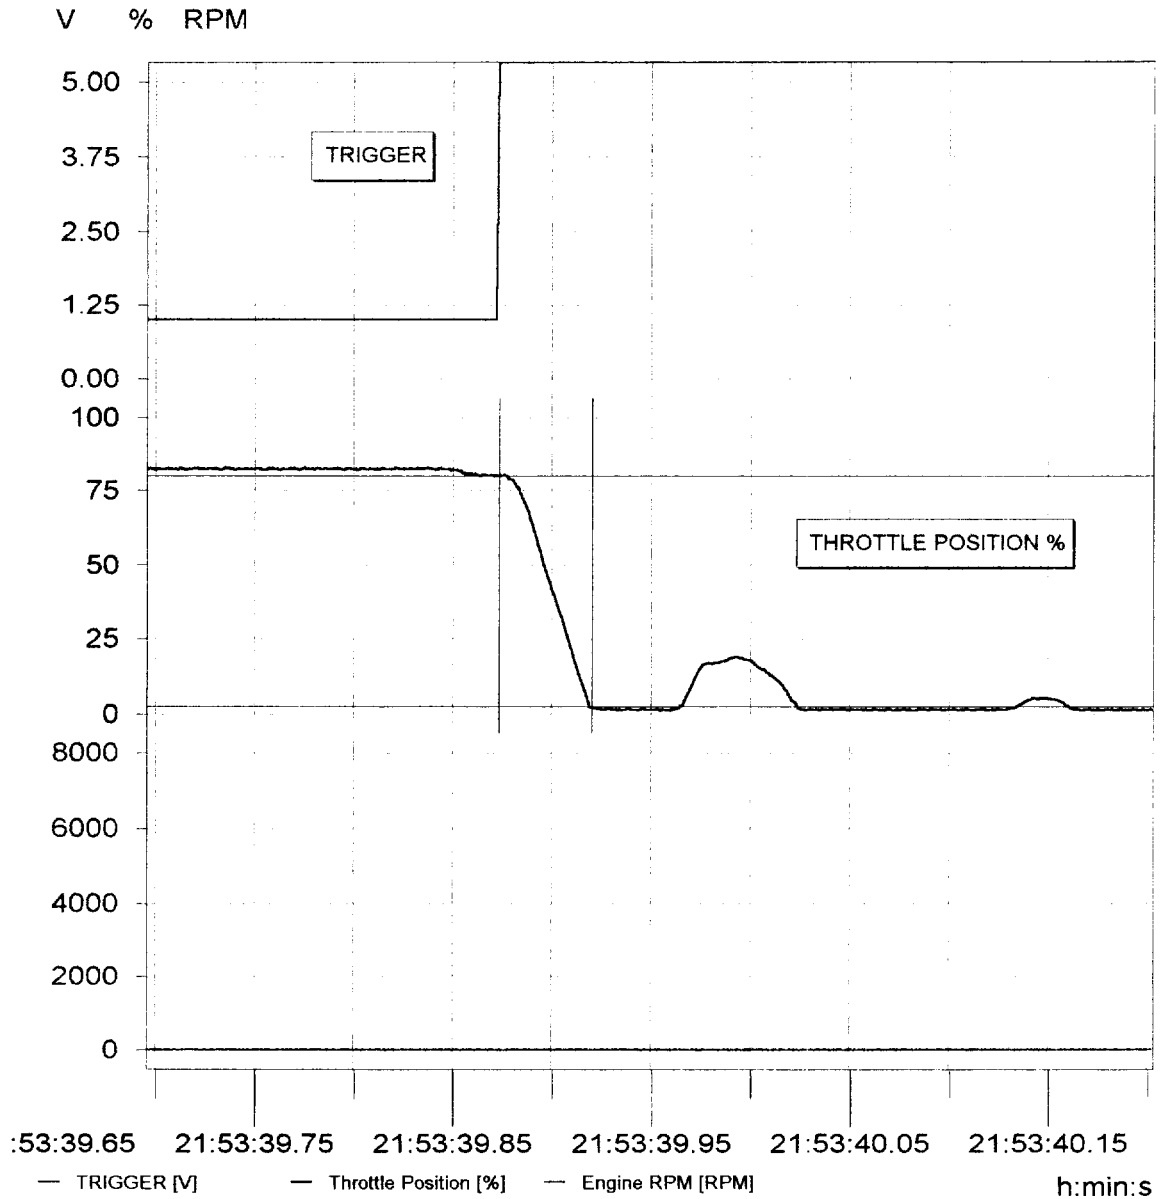
124 COLD/ SPRING 1/ 75% WOT

Y1: 79.931 %  
t1: -15131.658 ms  
dt: 0.047 s

Y2: 2.522 %  
t2: -15084.658 ms  
f: 21.277 Hz

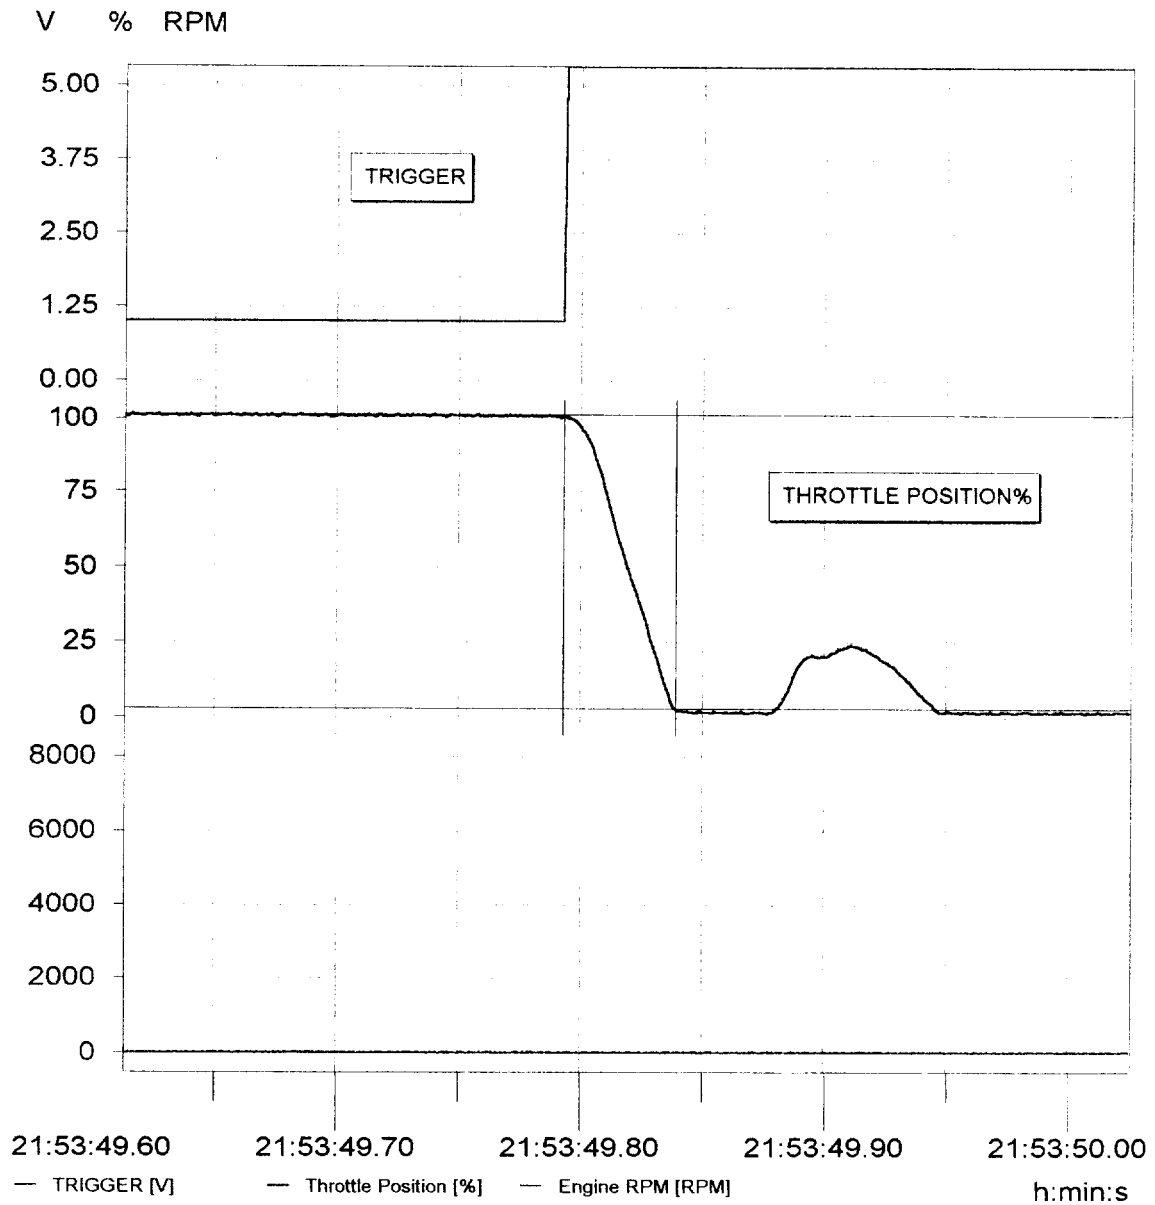
124 COLD/ SPRING 1/ 100% WOT

Y1: 101.427 %  
t1: -5211.658 ms  
dt: 0.046 s

Y2: 2.670 %  
t2: -5165.658 ms  
f: 21.739 Hz

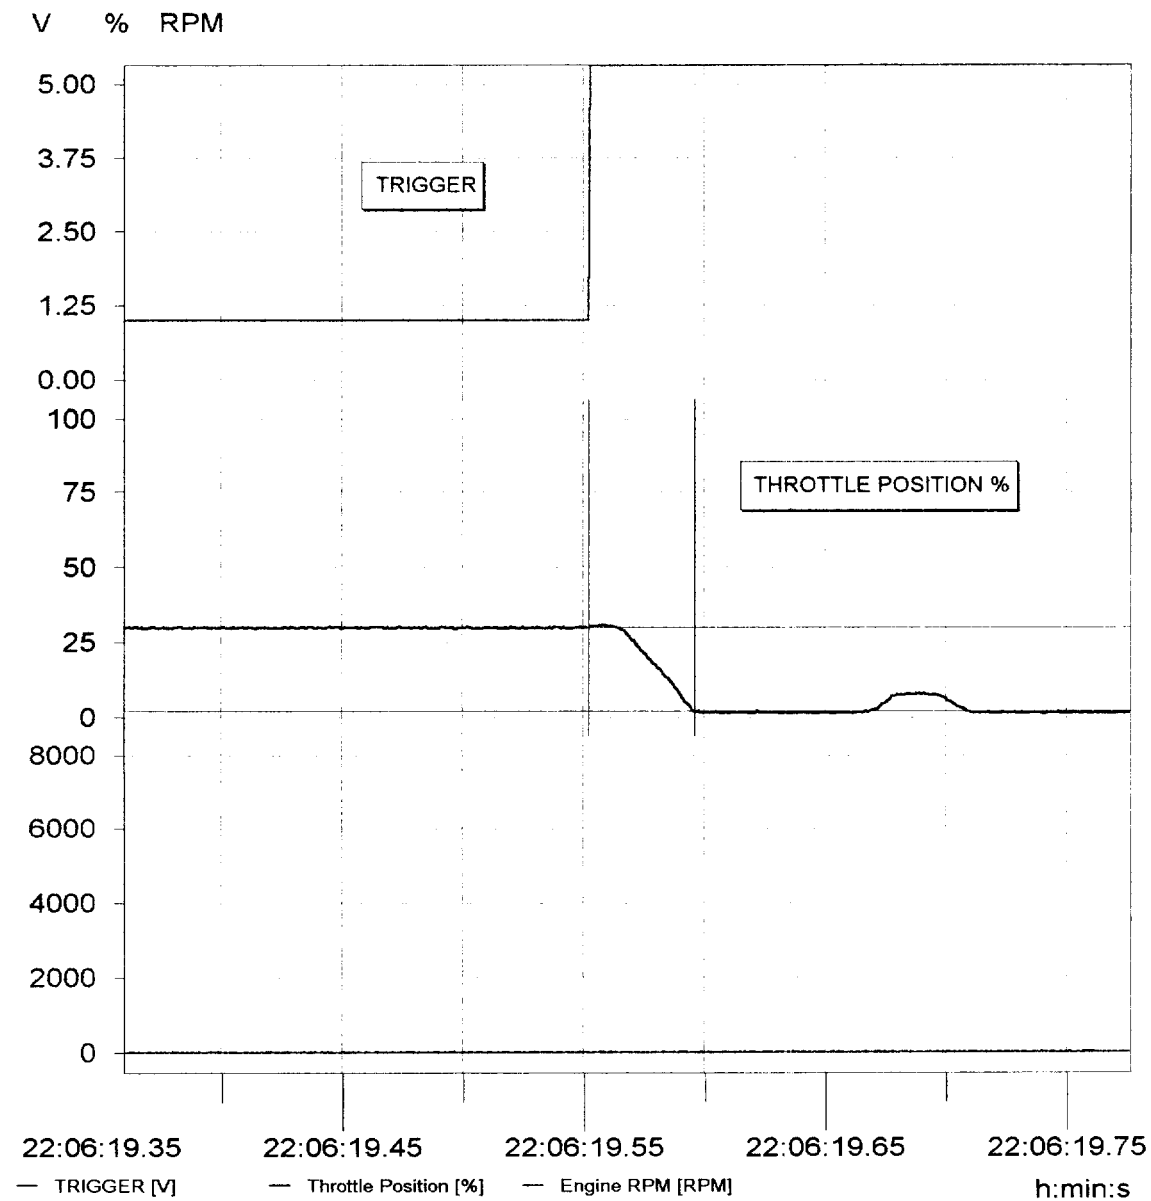
FMVSS 124 THROTTLE RETURN TEST  
124 COLD/ SPRING 2/ 25% WOT 10:08:43 PM 5/4/04

Y1:	30.056 %	Y2:	2.107 %
t1:	-34448.510 ms	t2:	-34404.510 ms
dt:	0.044 s	f:	22.727 Hz

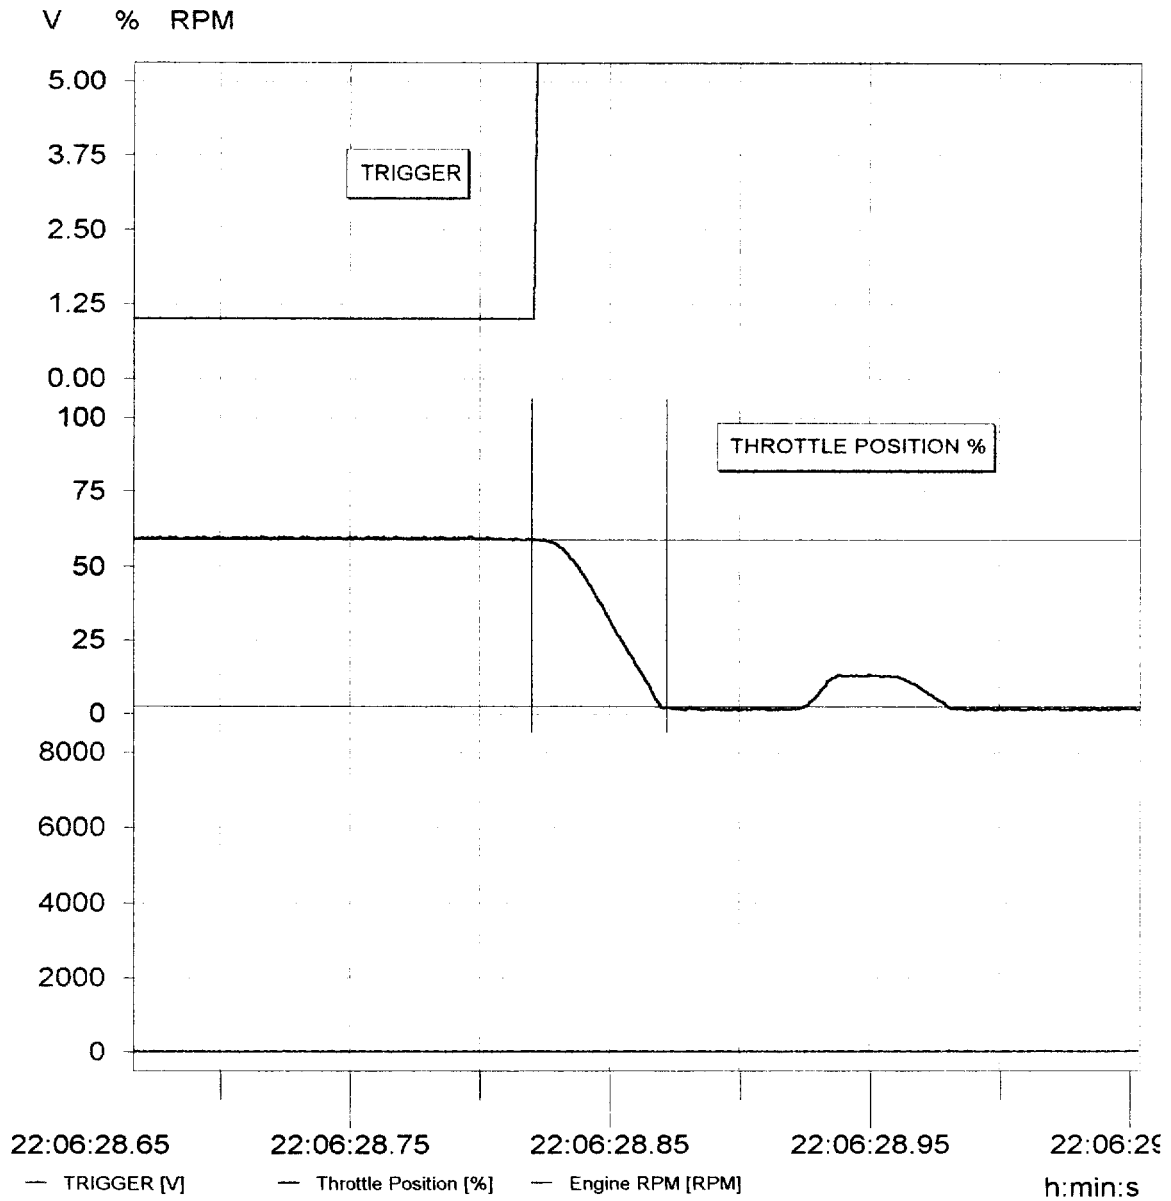
124 COLD/ SPRING 2/ 50% WOT

Y1: 58.875 %  
t1: -25180.510 ms  
dt: 0.052 s

Y2: 2.304 %  
t2: -25128.510 ms  
f: 19.231 Hz

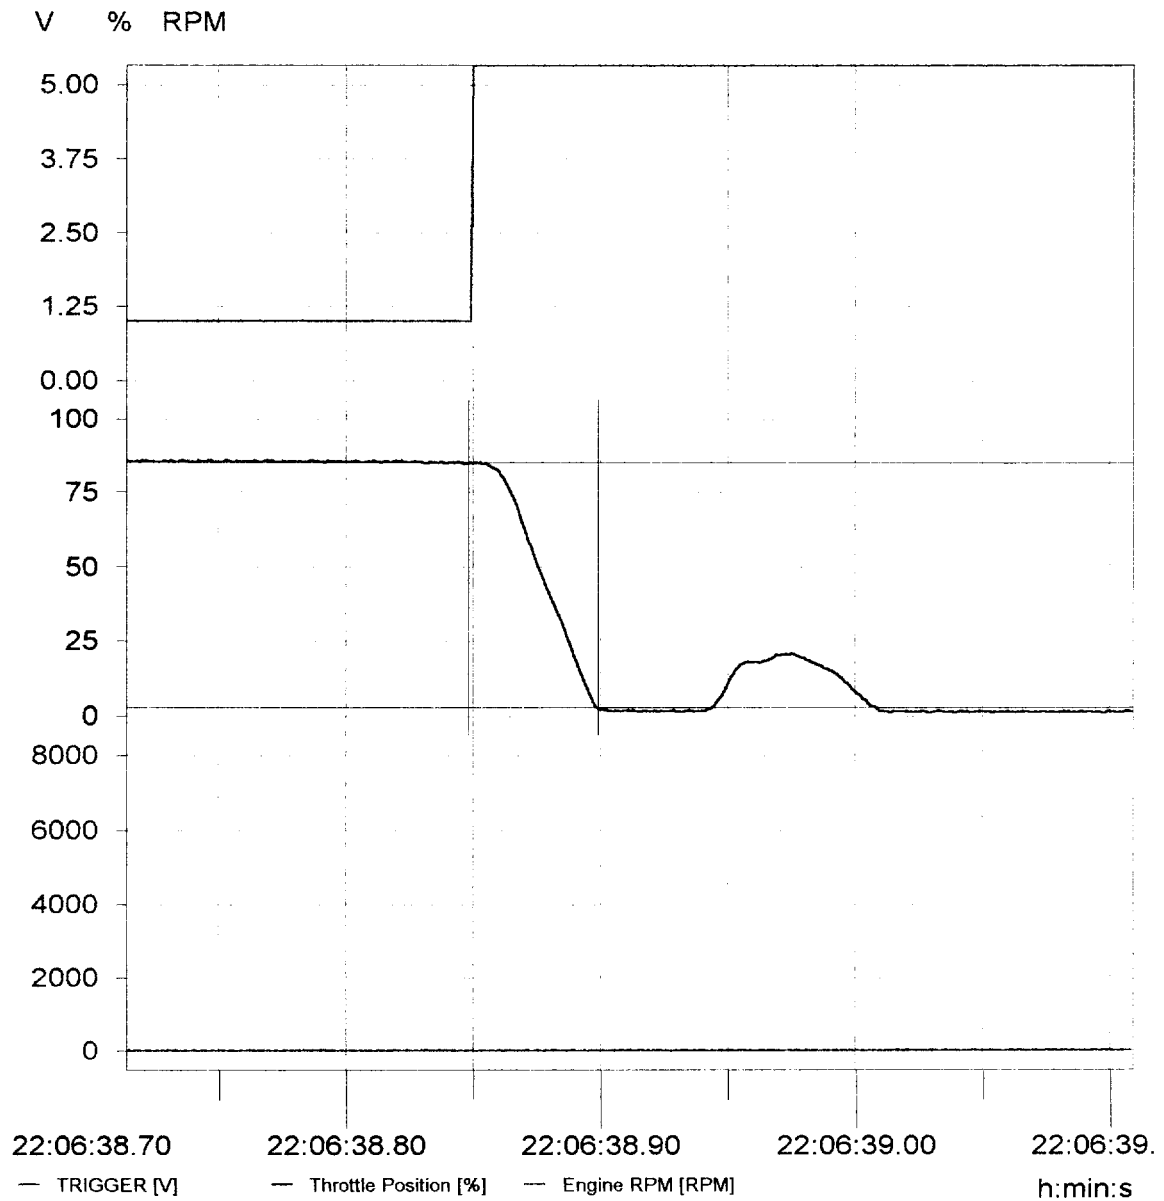
124 COLD/ SPRING 2/ 75% WOT

Y1: 84.840 %  
t1: -15152.510 ms  
dt: 0.051 s

Y2: 2.620 %  
t2: -15101.510 ms  
f: 19.608 Hz

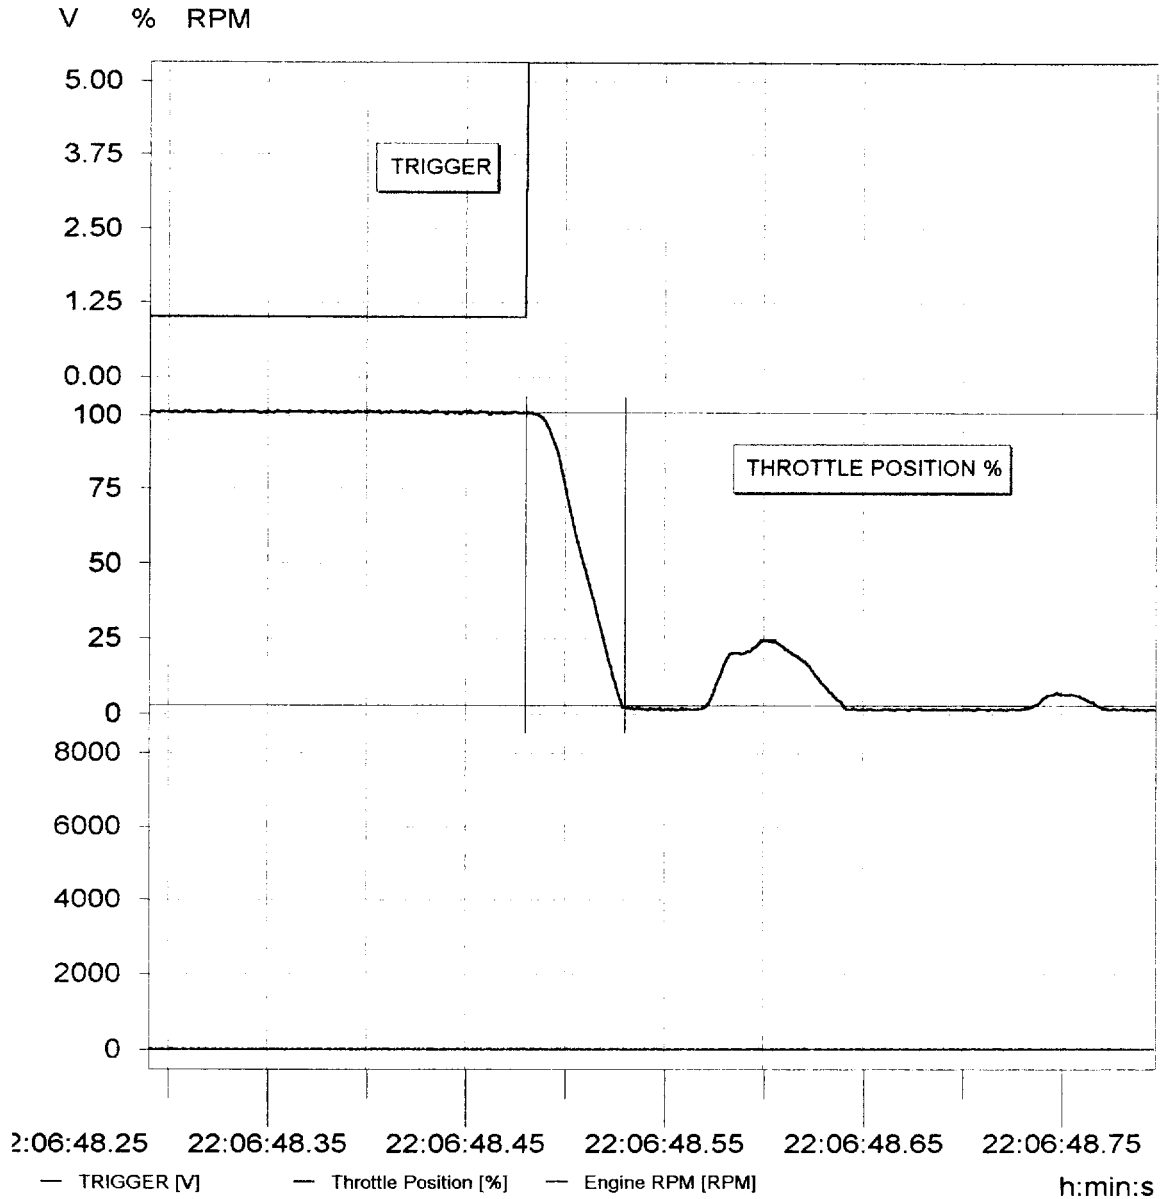
124 COLD/ SPRING 2/ 100% WOT

Y1: 100.953 %  
t1: -5520.510 ms  
dt: 0.050 s

Y2: 2.719 %  
t2: -5470.510 ms  
f: 20.000 Hz

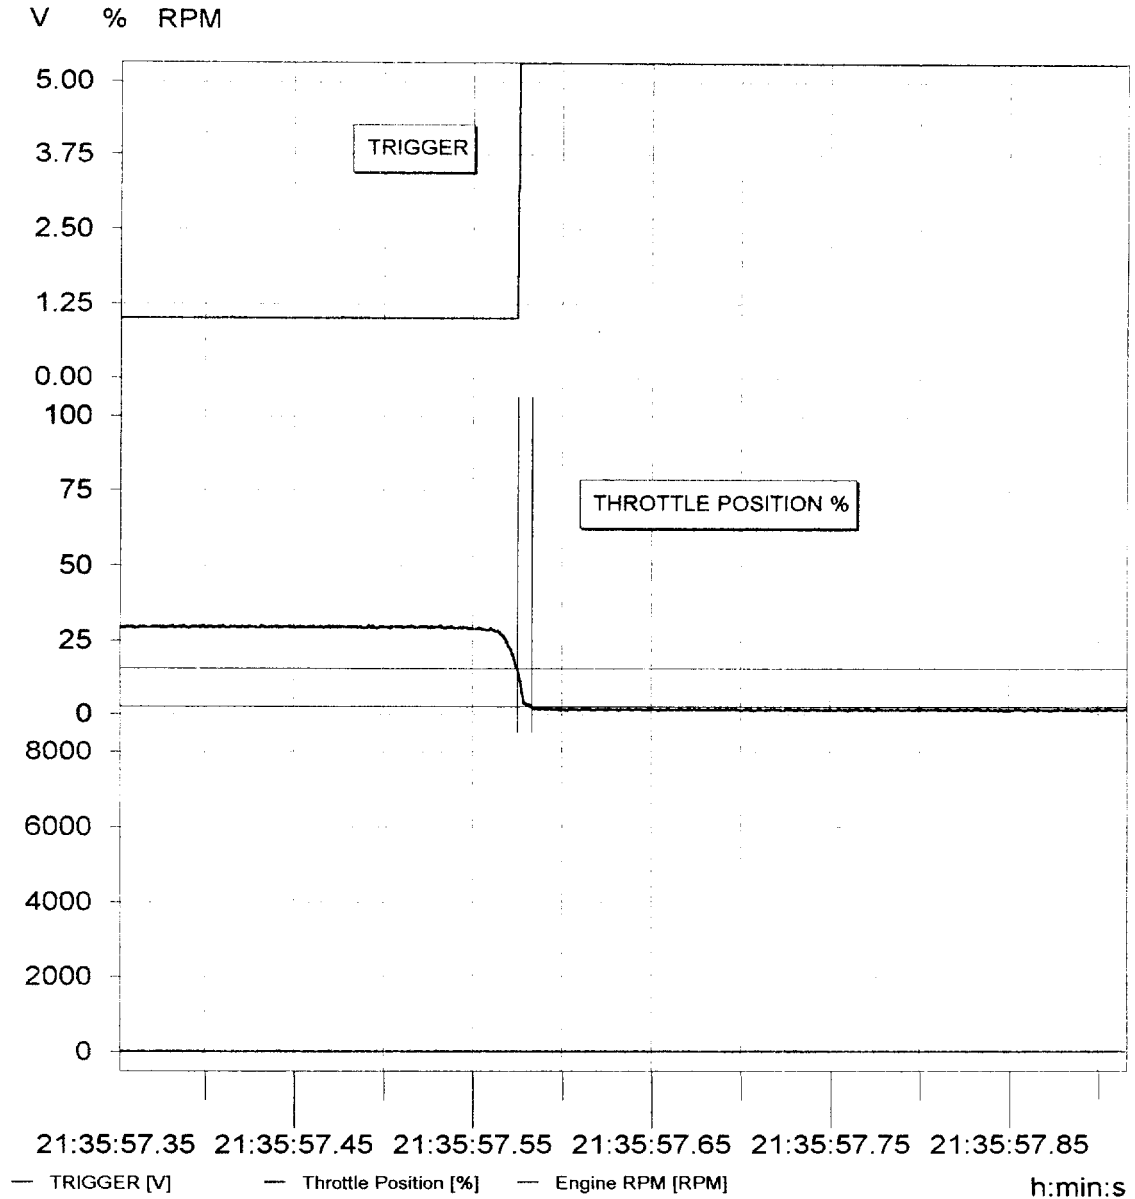
124 COLD/ SEVERED/ 25% WOT

Y1: 15.489 %  
t1: -55431.679 ms  
dt: 0.008 s

Y2: 2.492 %  
t2: -55423.679 ms  
f: 125.000 Hz

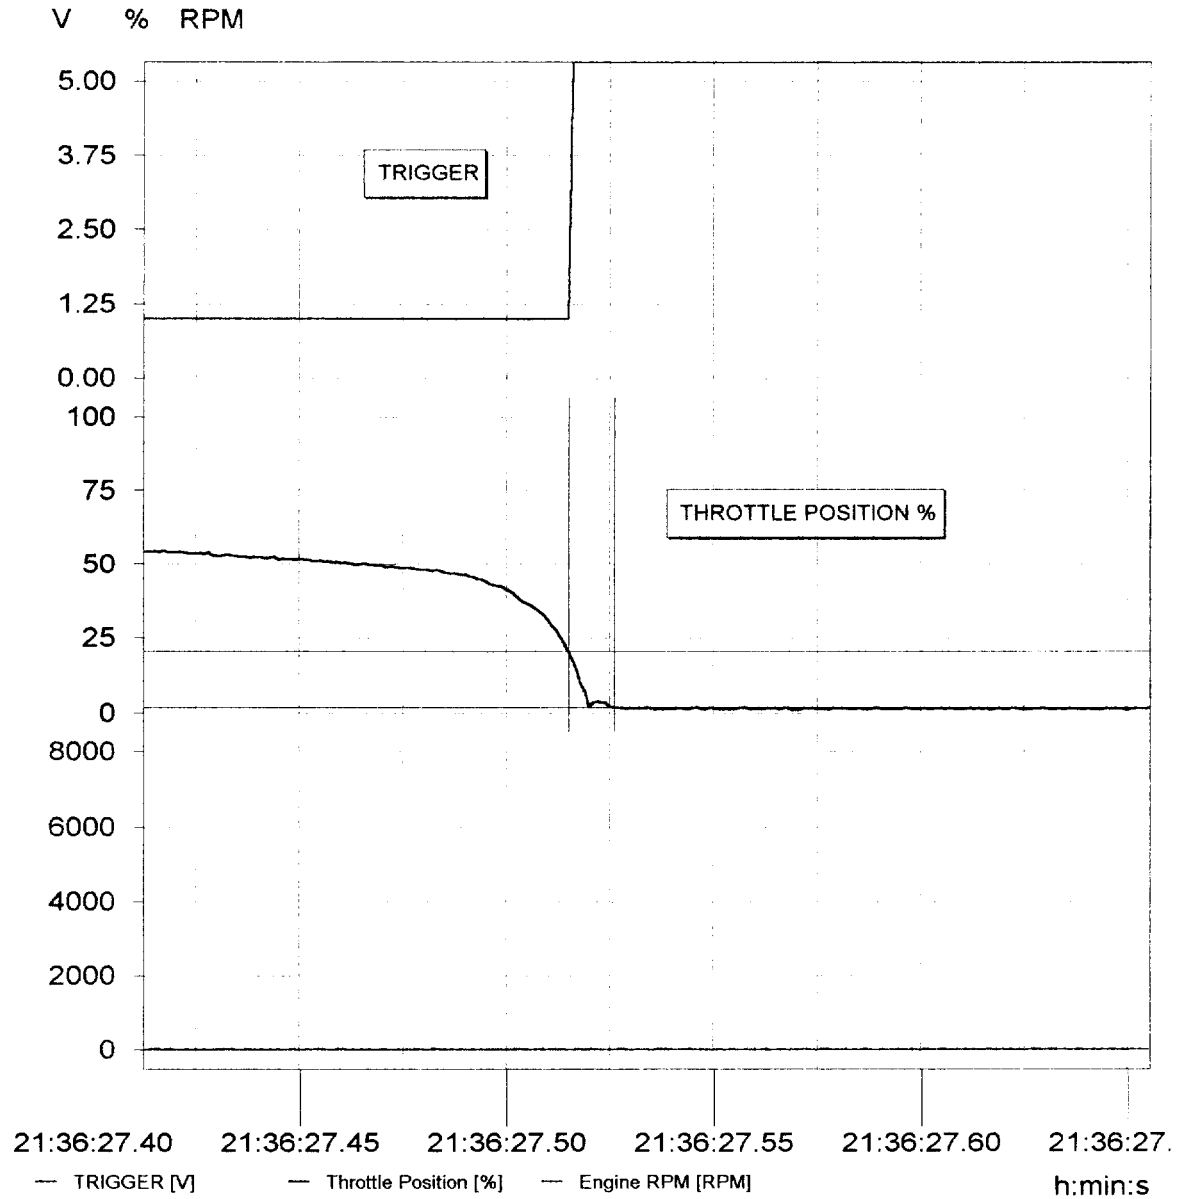
124 COLD/ SEVERED/ 50% WOT

Y1: 20.402 %  
t1: -25491.679 ms  
dt: 0.011 s

Y2: 1.830 %  
t2: -25480.679 ms  
f: 90.909 Hz

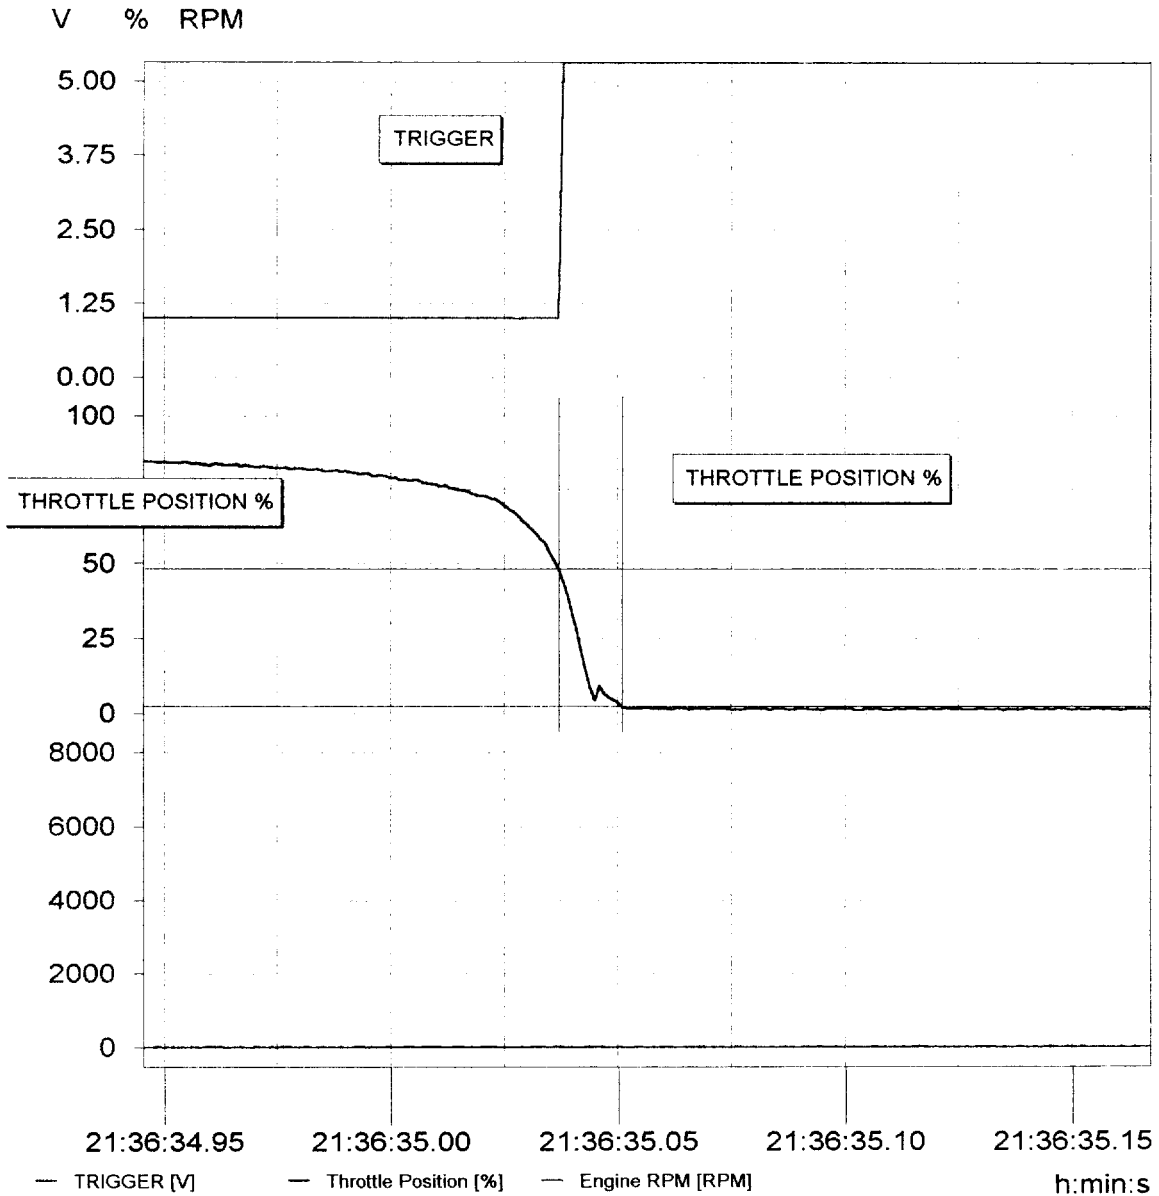
124 COLD/ SEVERED/ 75% WOT

Y1: 47.942 %  
t1: -17969.679 ms  
dt: 0.014 s

Y2: 2.196 %  
t2: -17955.679 ms  
f: 71.429 Hz
