# SAFETY COMPLIANCE TESTING FOR FMVSS 124L ACCELERATOR CONTROL SYSTEMS

DAIMLERCHRYSLER CORPORATION  
2004 CHRYSLER PACIFICA, MPV  
NHTSA NO. C40301

1. Report No. 124L-GTL-04-002	2. Government Accession No.	3. Recipient's Catalog No.
4. Title and Subtitle Final Report of FMVSS 124 Compliance Testing of 2004 CHRYSLER PACIFICA, MPV NHTSA No. C40301	5. Report Date May 14, 2004	6. Performing Organ. Code GTL

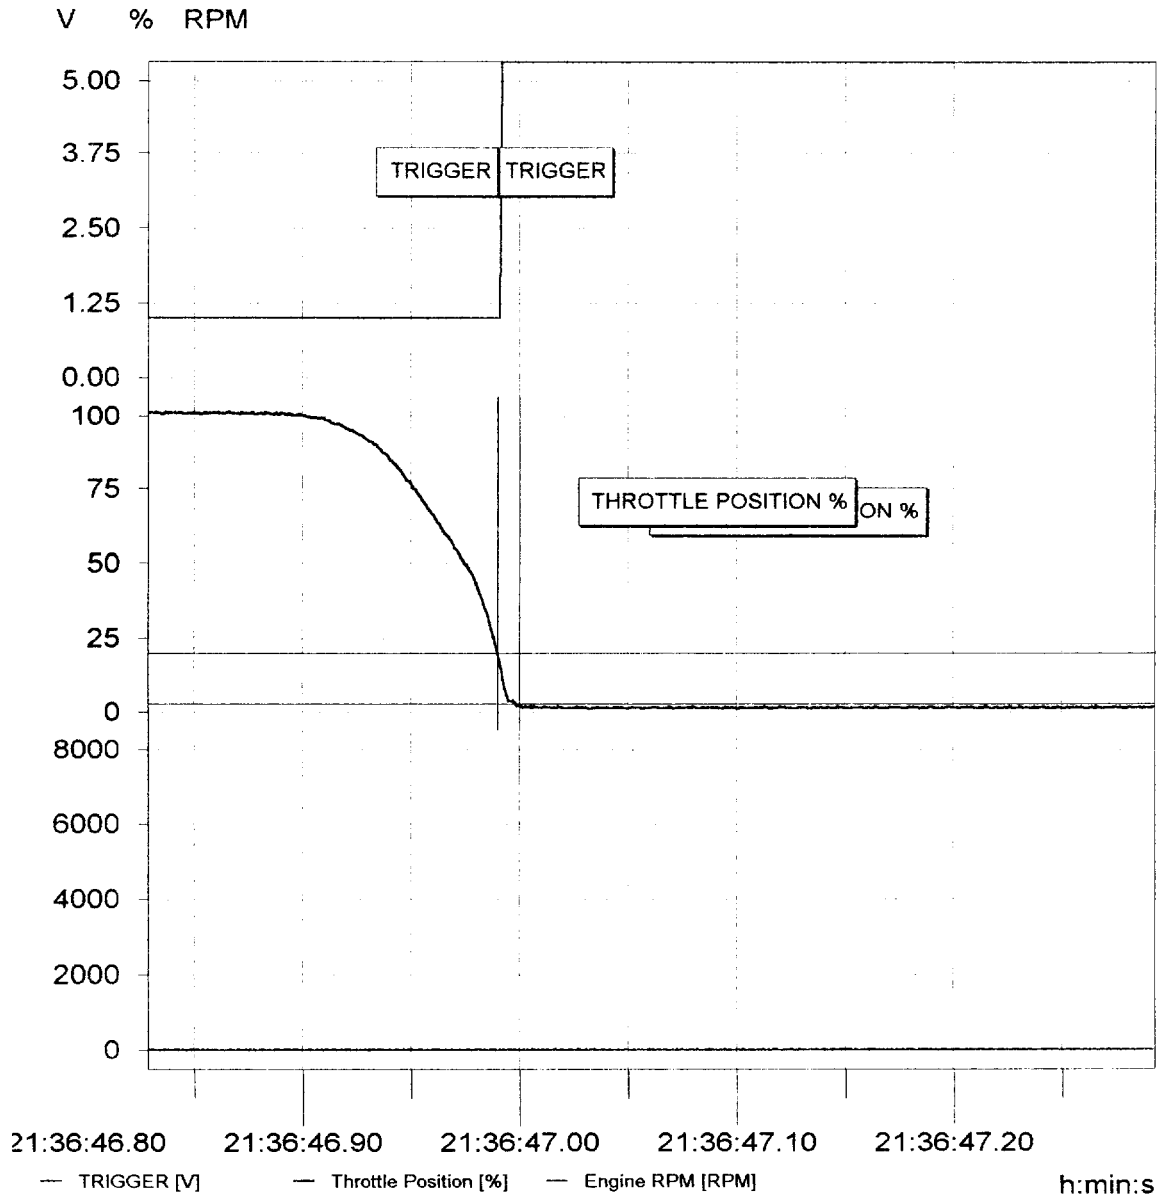
124 COLD/ SEVERED/ 100% WOT

Y1: 19.884 %  
t1: -6016.679 ms  
dt: 0.010 s

Y2: 2.660 %  
t2: -6006.679 ms  
f: 100.000 Hz
