REPORT NUMBER: 114-CAL-04-04

**SAFETY COMPLIANCE TESTING FOR  
FMVSS No. 114  
THEFT PROTECTION**

**MITSUBISHI MOTORS NORTH AMERICA, INC.  
2004 MITSUBISHI ENDEAVOR 4-DOOR MPV**

**FINAL REPORT**

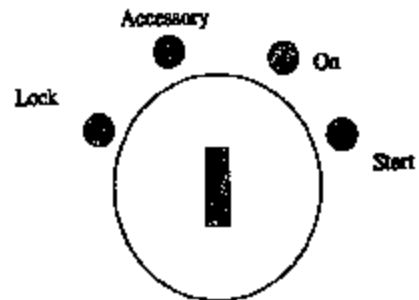
Ignition Switch Positions: (refer to page 6-2 of this report for a description of the switch positions provided in the vehicle owner's manual).
