Report No. 217-NVS-04-04

FMVSS No. 217 "BUS EMERGENCY EXITS AND WINDOW RETENTION AND RELEASE"

Compliance Test Report for a 2004 NABI, 61 Passenger Transit Bus NHTSA No. C40803

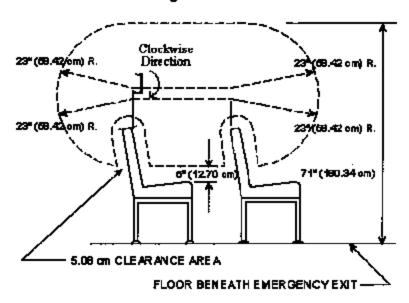
Access Regions for Low Force

The forces were measured using a Shimpo MF handheld force gauge. The force gauge has a hook at one end that allows for the attachment of the gauge onto the release mechanism. After the gauge is attached an engineer applies a force to the gauge which is transferred to the release mechanism. The engineer applies increasingly greater force until the release mechanism is released. The force measured is recorded and the gauge is zeroed for the next test.

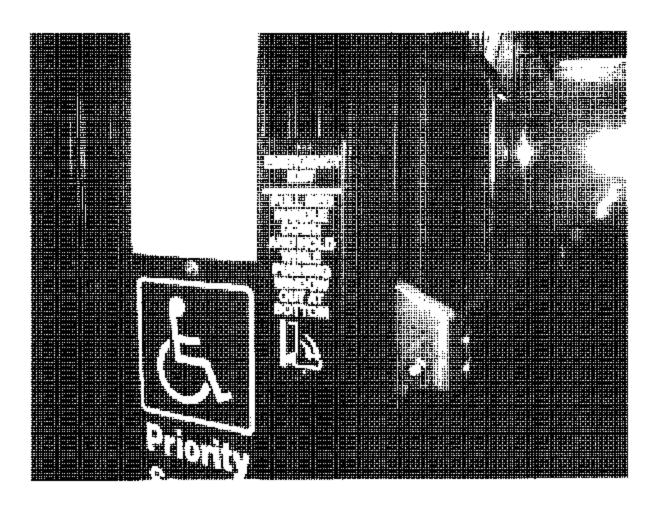
Photo 4 - Emergency Exit Label and Rolesso Mochanism

- Each emergency exit has a permanently affixed, legible label or placard with the designation "Emergency Door" or "Emergency Exit."

PASS
- 2. Each emergency exit has a permanently affixed, legible label or placard describing the motion necessary to release (unlatch) and open the exit.

PASS
- The label is within 16 cm of the nearest release mechanism. PASS

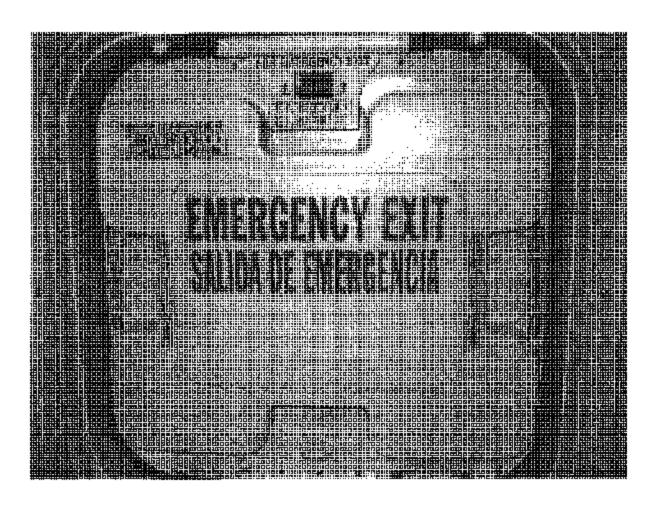
Photo 5 Roof Emergency Exit

The bus has a rear roof exit and the configuration of the bus appears to preclude the installation of an accessible rear exit.
