REPORT NO. 111-KAR-04-003

**SAFETY COMPLIANCE TESTING
FOR FMVSS 111**

**REARVIEW MIRRORS
(Other Than School Buses)**

2004 NISSAN MAXIMA
4 DOOR SEDAN

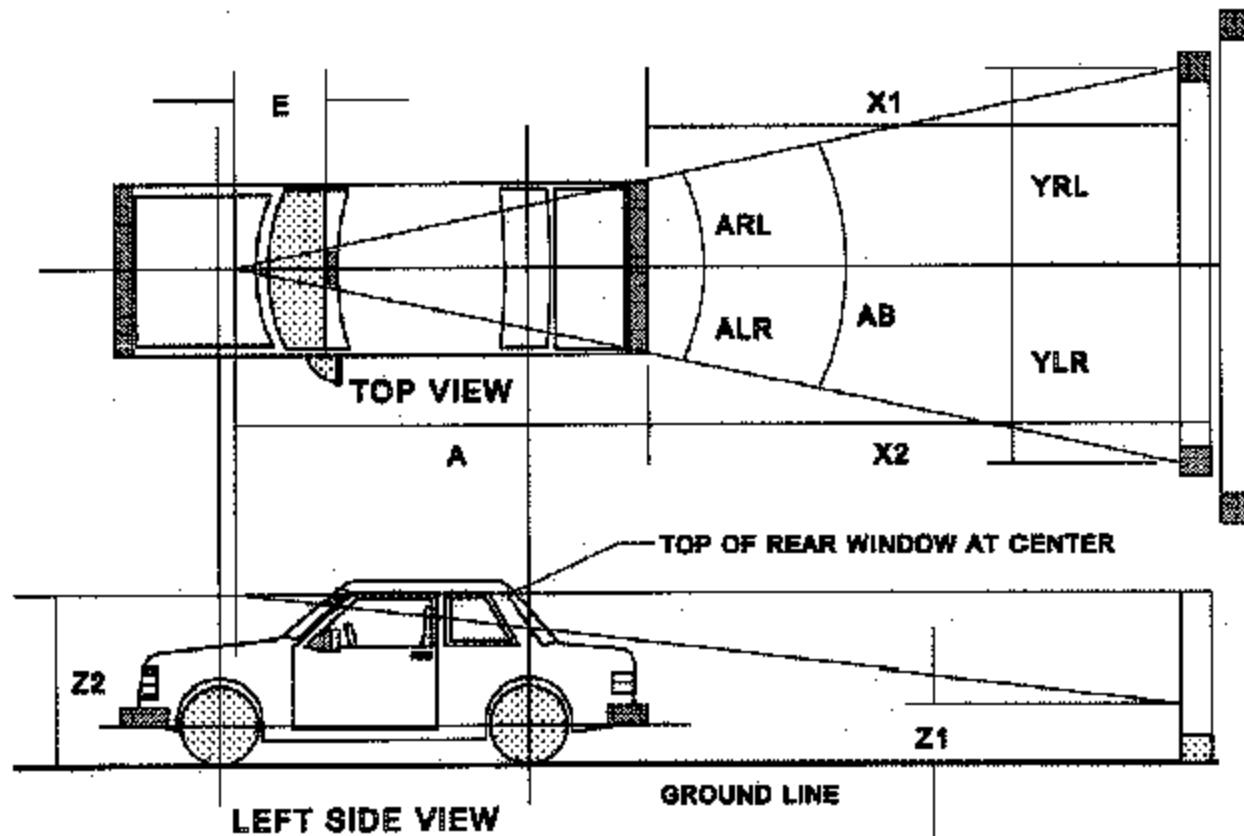
DATA SHEET NO. 3... (Continued)

E Distance from center of mirror to projected eye point location = 550.0 mm

A Distance from rear of vehicle to projected eye point location = 3490.0 mm

X1 Distance from rear of vehicle to field of view grid = 8211.0 mm

Z1 Vertical distance to lowest point of field of view at distance X1 627.0 mm

Z2 Height of center of mirror = 1249.0 mm

$$\text{ANGLE AB} = \underline{\underline{25.0^\circ}} \quad (\text{S111 REQUIREMENT} = 20 \text{ degrees minimum})$$

INSIDE REARVIEW MIRROR FIELD OF VIEW
TEST GRID AND MARKER SETUP

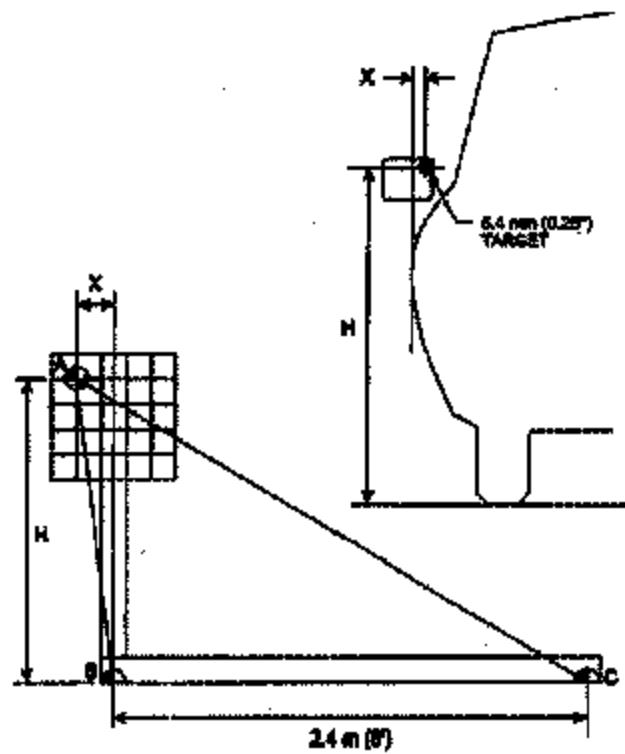
HEIGHT OF TARGET DISC ON MIRROR 1045 mm

DISTANCE OF TARGET DISC ON MIRROR FROM VEHICLE
TANGENT PLANE 55 mm

TARGET DISC LOCATION RELATIVE TO VEHICLE TANGENT PLANE INBOARD
(Inboard or Outboard)

DRIVER SIDE OUTSIDE MIRROR TARGET DISC LOCATION WITH X AND H DIMENSIONS

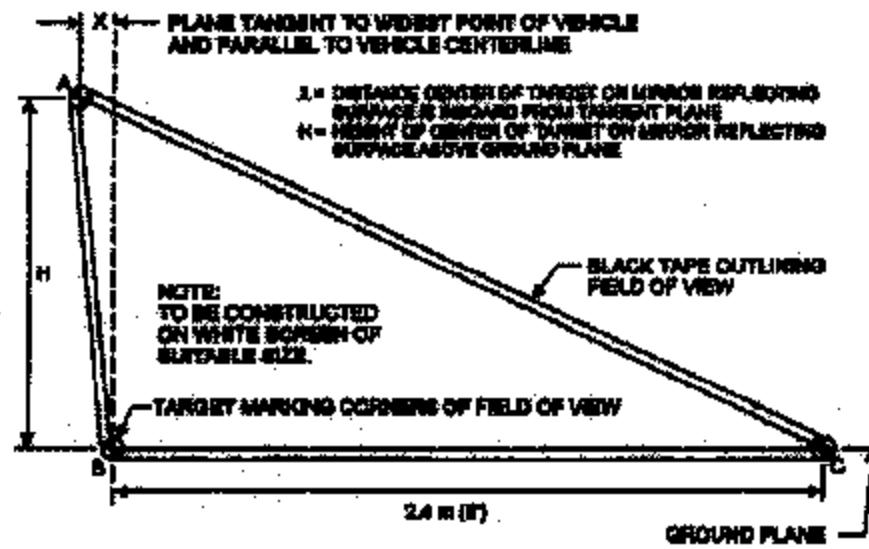
ENTIRE TRIANGULAR TEST TARGET AREA ON SCREEN VISIBLE YES X NO

DRIVER SIDE OUTSIDE MIRROR REQUIRED FIELD OF VIEW TRIANGLE

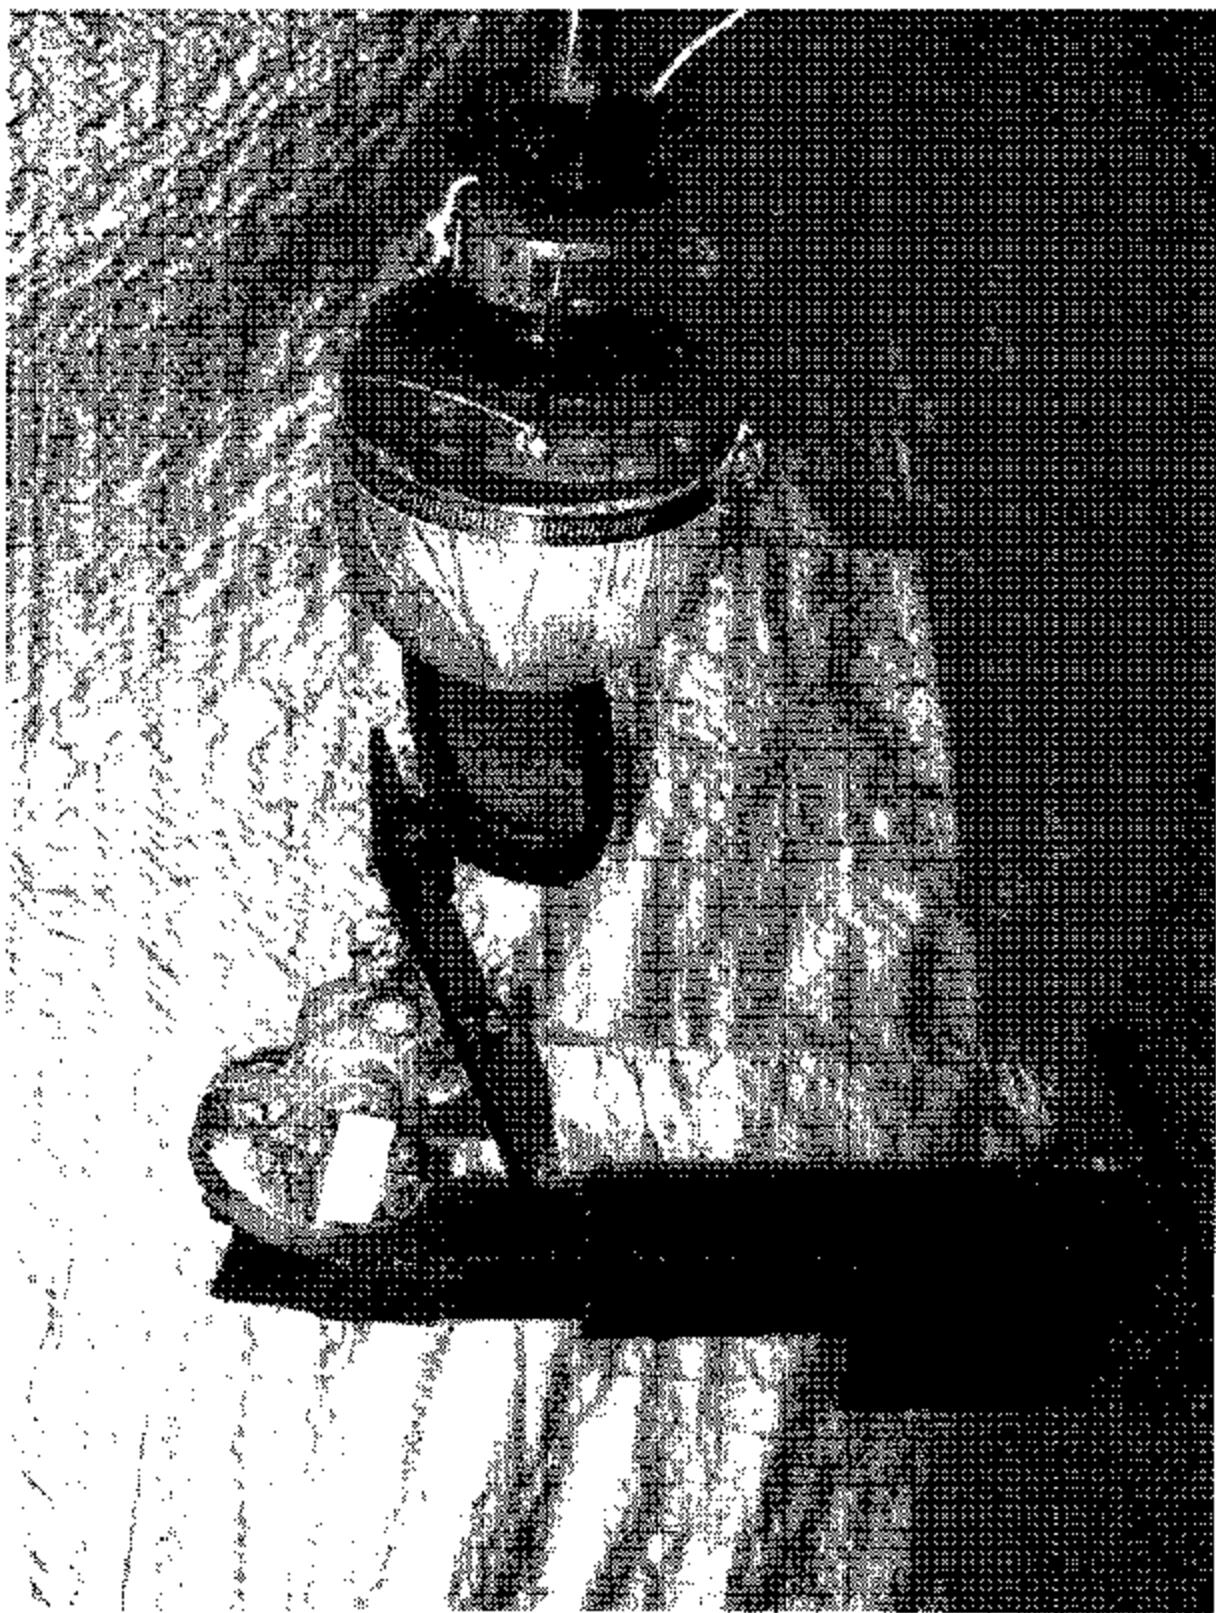
FIGURE 13: CLOSE-UP OF MIRROR BREAK AWAY TEST

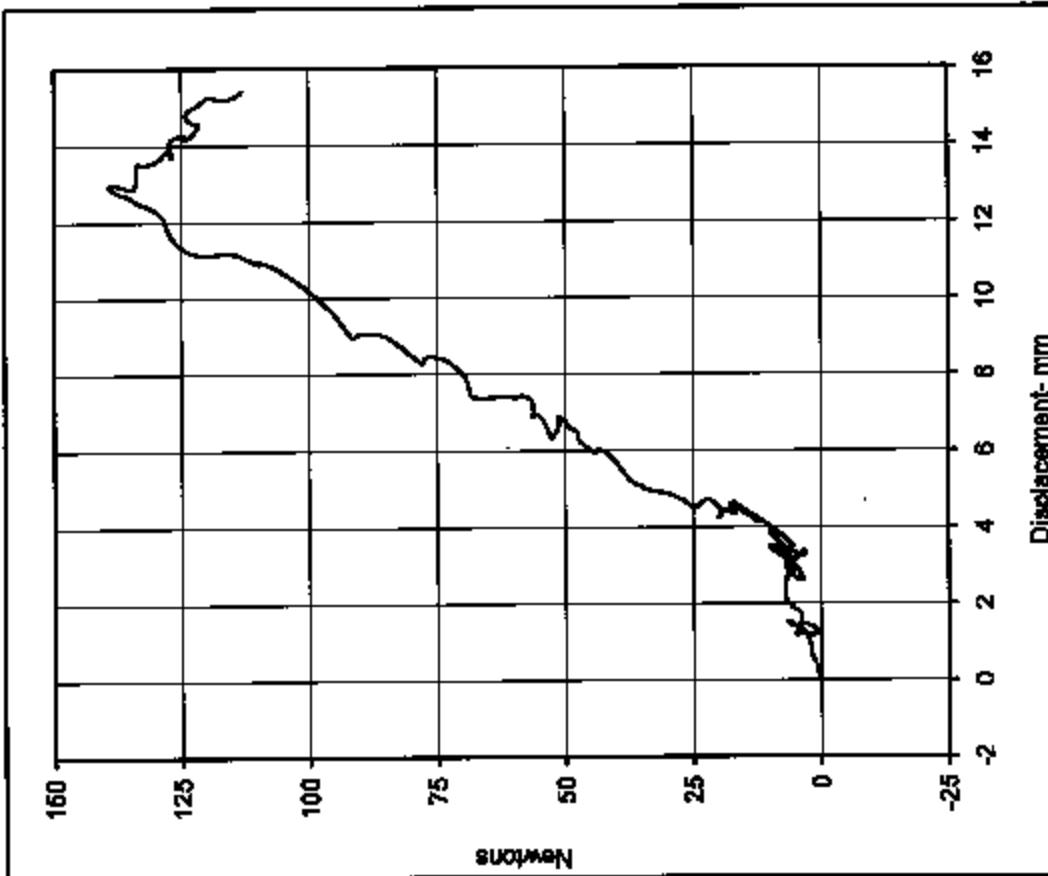
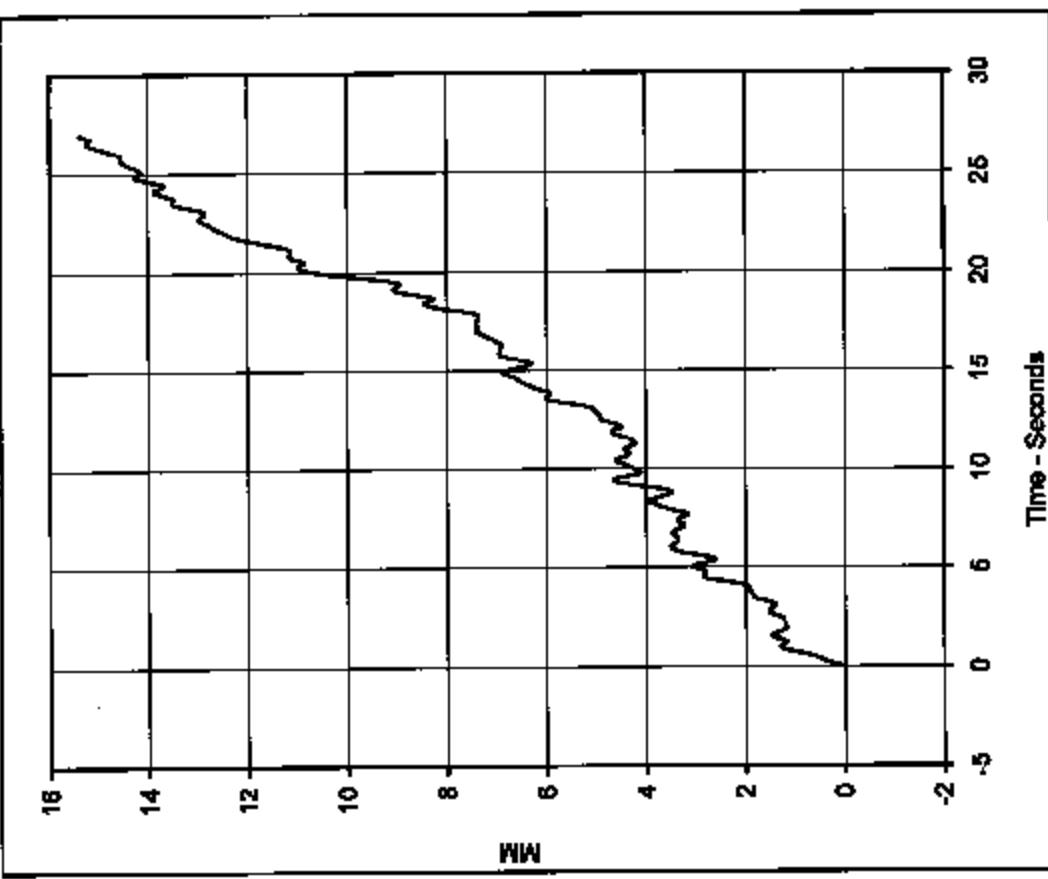
Load Direction: 0 / 90
Test Date: 5/25/04

Curve Description	CURNO	Type	
Force vs. Displacement	001	FIL	
Units	Peak Force	Displacement	Filter (Hz)
Newton	139.1	12.9	1

TEST NO.	LOAD DIRECTION VERTICAL/HORIZONTAL	MAXIMUM FORCE (N)	DISPLACEMENT (MM)	PASS	FAIL
1	0-90 DEGREES	139.1	15.4	X	
2	+45/90 DEGREES	261.3	6.6	X	
3	-45/90 DEGREES	129.7	14.9	X	
4	-45/+45 DEGREES	102.7	32.2	X	
5	+45/+45 DEGREES	221.9	50.7	X	
6	+45/-45 DEGREES	208.8	18.4	X	
7	-45/-45 DEGREES	120.8	38.0	X

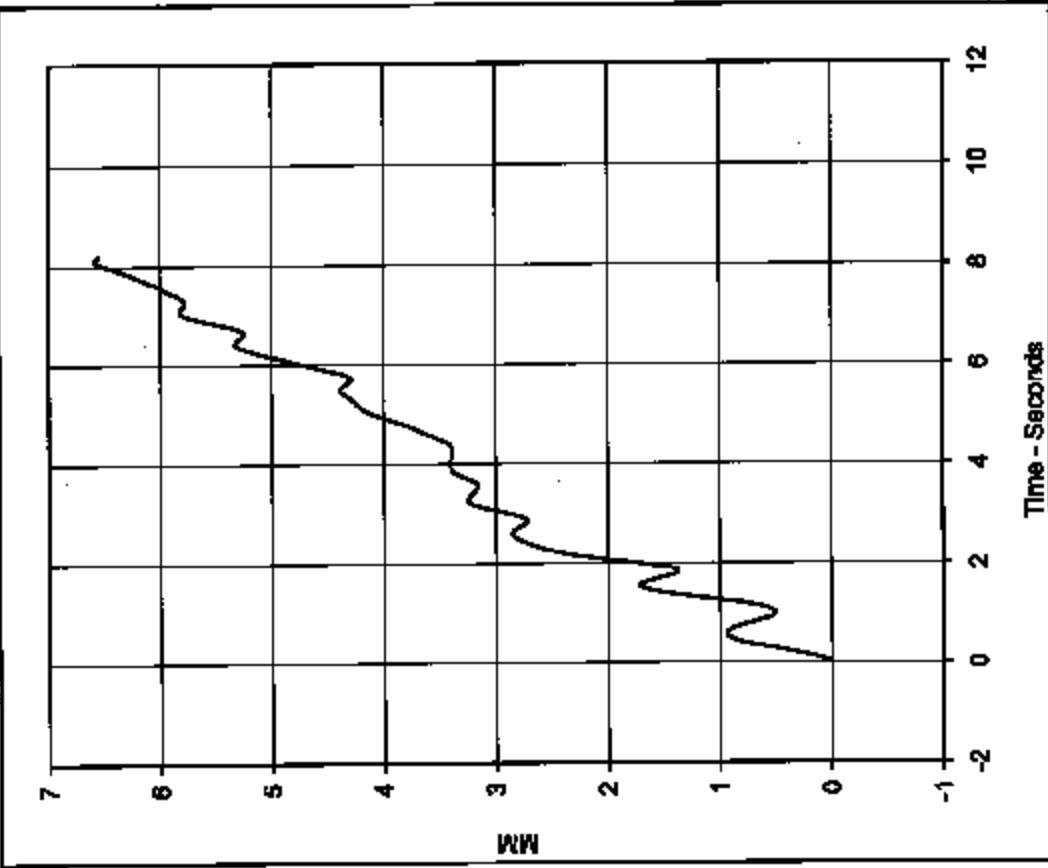
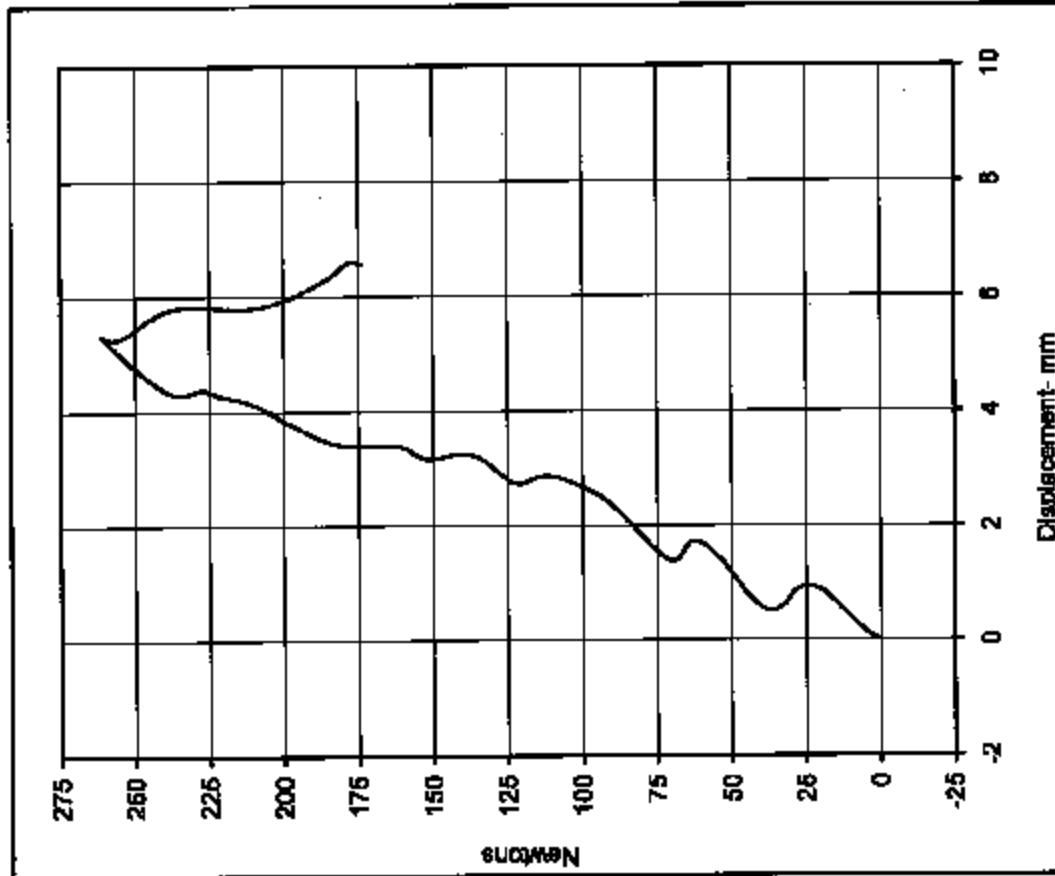
Test Program: 2004 FMVSS 111 Rearview Mirrors Test No.: 2
 Test Vehicle: 2004 Nissan Maxima No.: C45204

Curve Description	CURNO	Type	CURNO		Type
Force vs. Displacement	001	FIL	002	FIL	
Units	Peak Force	Displacement	Filter (Hz)	Disp. Rate (mm/min.)	Filter (Hz)
Newton	261.3	5.3	1	47.7	1

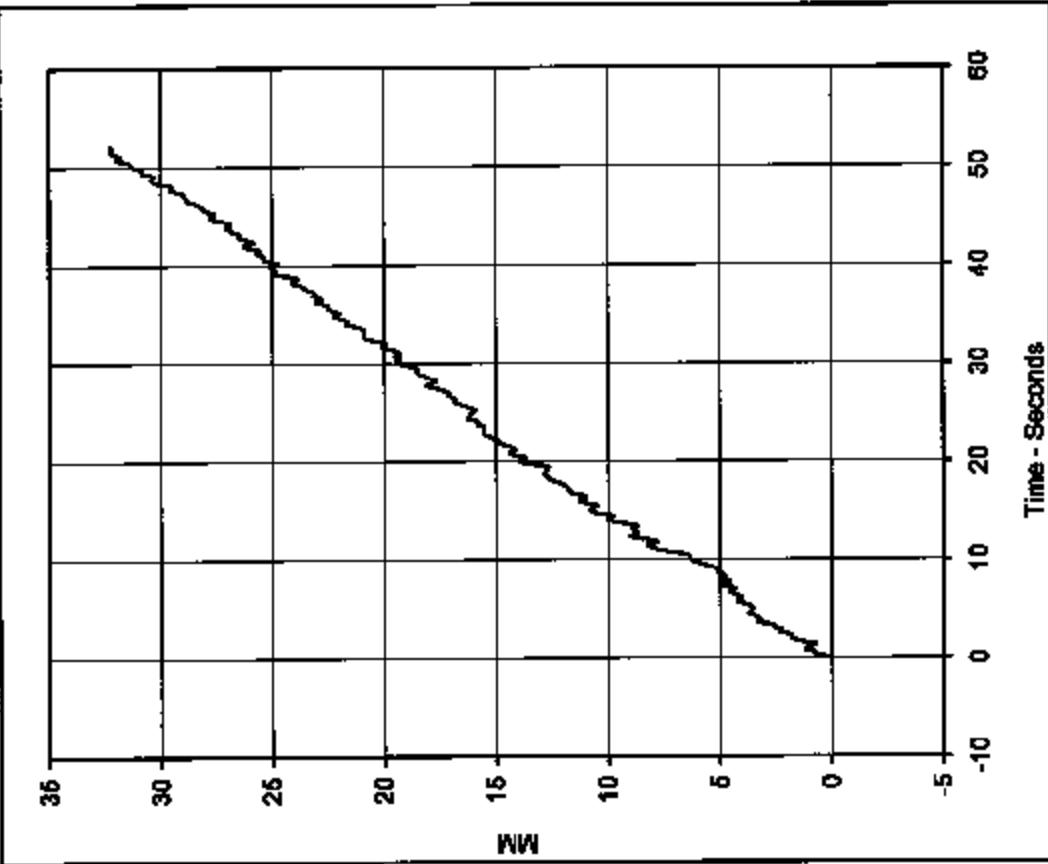
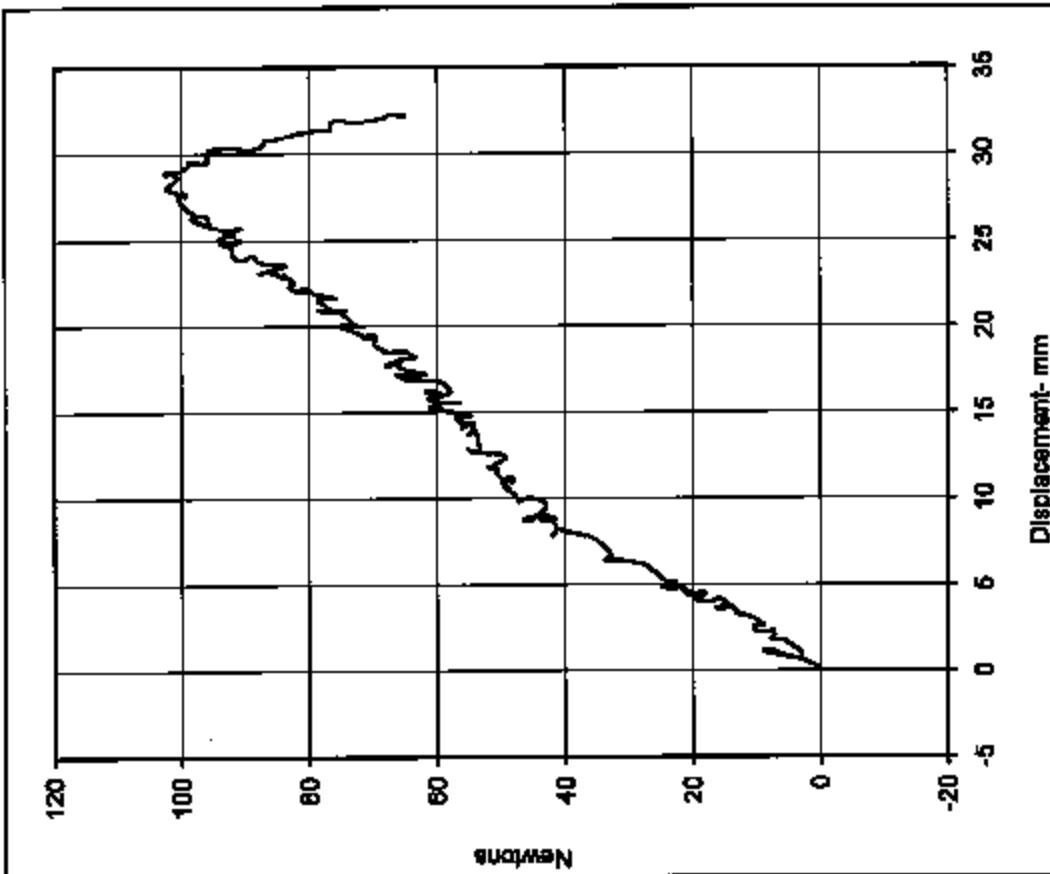
Test Program: 2004 FMVSS 111 Rearview Mirror Test No.: 4
 Test Vehicle: 2004 Nissan Maxima No.: C46204

Curve Description	CURNO	Type
Displacement vs. Time	002	FIL
Units	Max	Time
MM	32.2	51.7

Curve Description	CURNO	Type
Force vs. Displacement	001	FIL
Units	Peak Force	Displacement
Newton	102.7	28.9

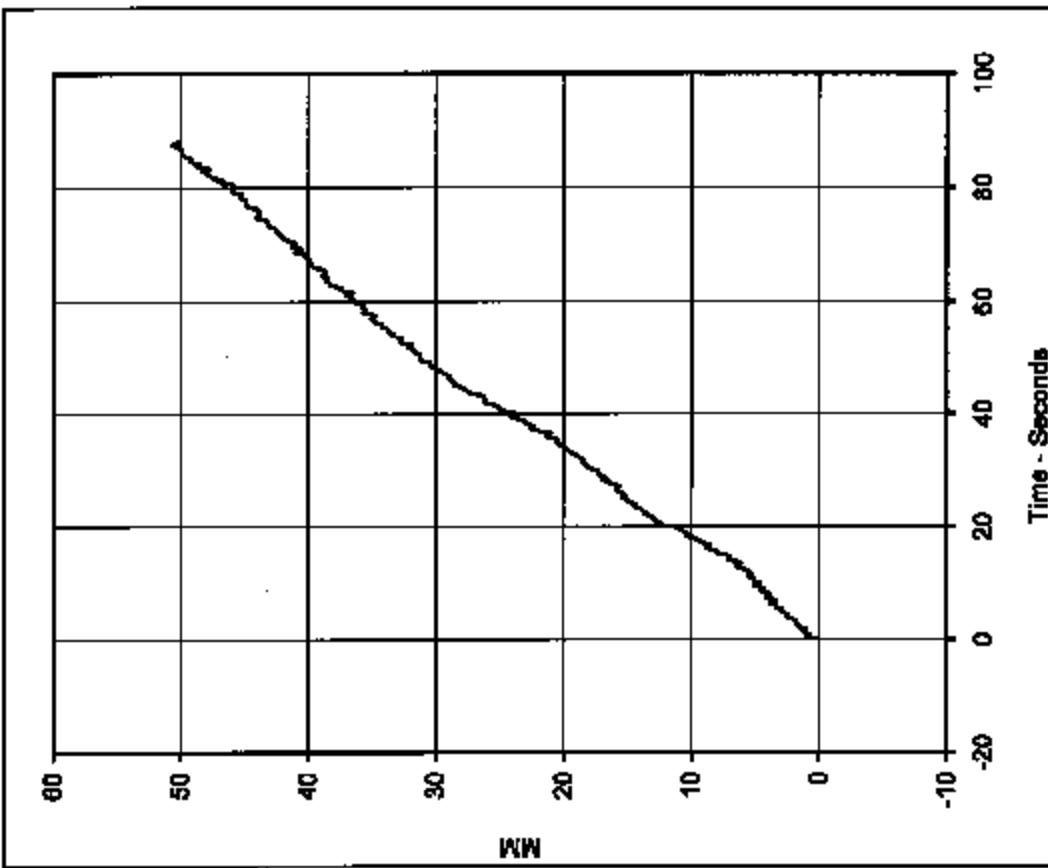
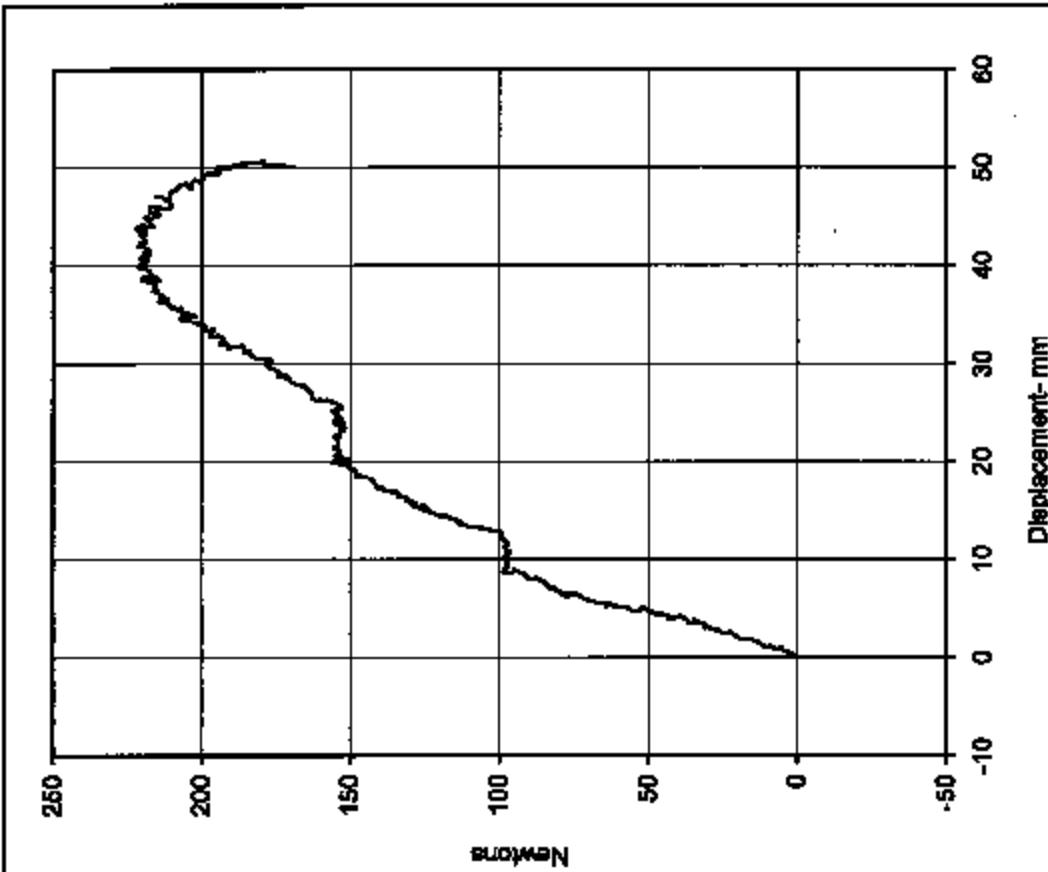
Test Program: 2004 FMVSS 111 Review Mirror Test No.: 5
 Test Vehicle: 2004 Nissan Maxima No.: C45204

Curve Description	CURNO	Type		
Displacement vs. Time	002	FIL		
Curve Description	CURNO	Type		
Displacement vs. Time	002	FIL		
Units	Max	Time	Disp. Rate (mm/min.)	Filter (Hz)
MM	50.7	67.5	34.6	1

Curve Description	CURNO	Type		
Force vs. Displacement	001	FIL		
Units	Peak Force	Displacement	Filter (Hz)	
Newton	221.9	43.8	1	
Units	Peak Force	Displacement	Filter (Hz)	
Newton	221.9	43.8	1

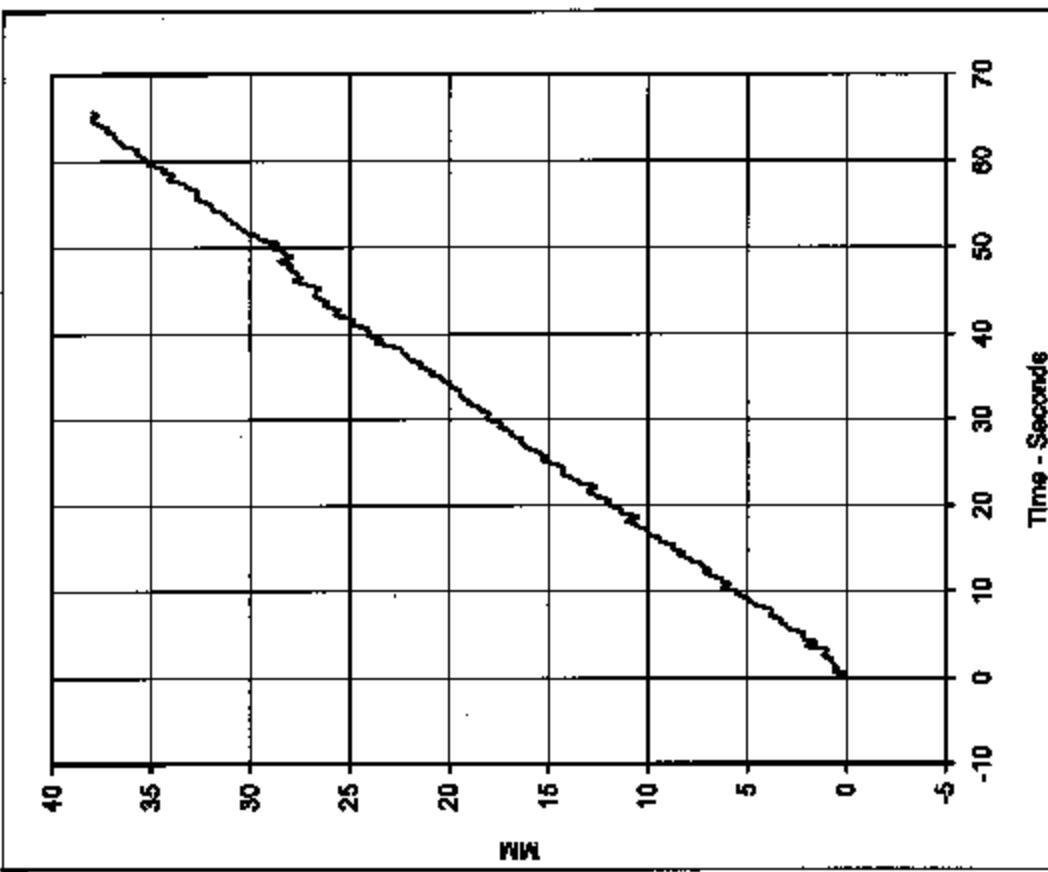
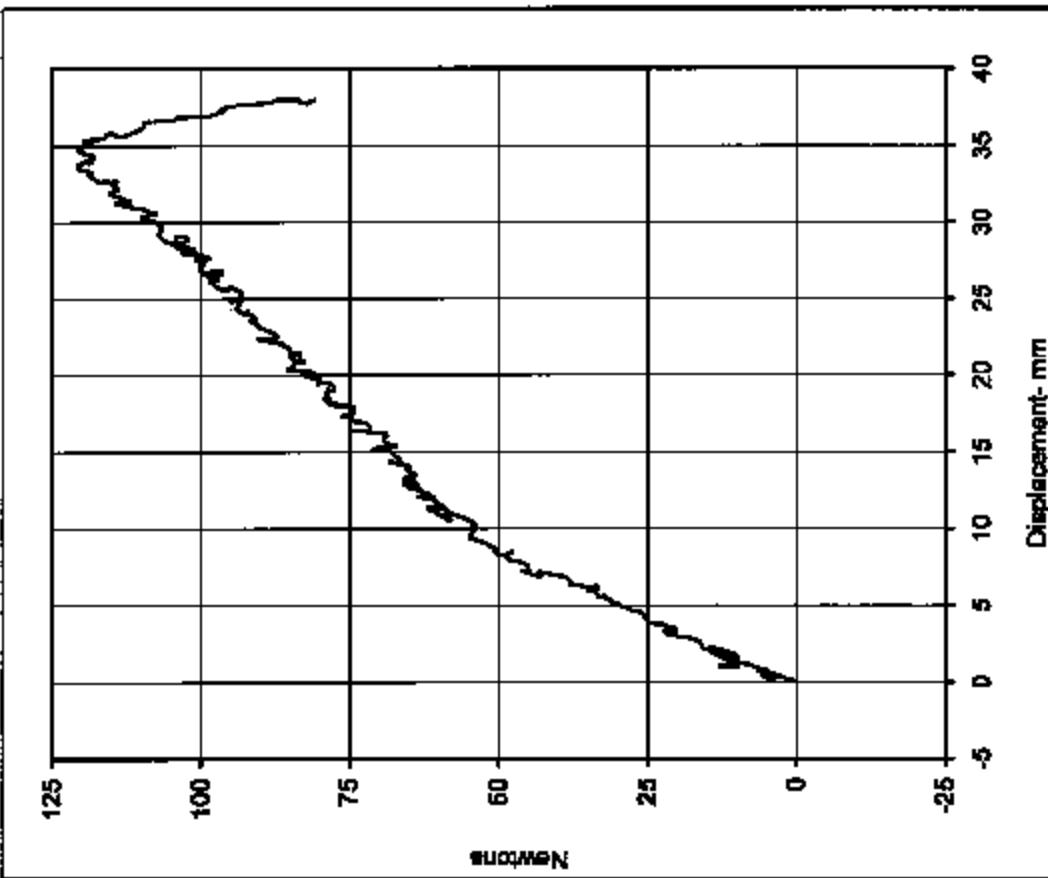
Test Program: 2004 FMVSS 111 Review Minima Test No.: 7
 Test Vehicle: 2004 Nissan Maxima No.: C45204

Curve Description	CURNO	Type		
Force vs. Displacement	001	FIL		
Units	Max	Time	Displ. Rate (mm/min.)	Filter (Hz)
MM	38.0	34.9	34.7	1

Curve Description	CURNO	Type	
Force vs. Displacement	001	FIL	
Units	Peak Force	Displacement	Filter (Hz)
Newton	120.8	33.7	1
