REPORT NUMBER: 214-CAL-04-07

**SAFETY COMPLIANCE TESTING FOR FMVSS 214  
SIDE IMPACT PROTECTION  
INDICANT**

**DAIMLERCHRYSLER CORPORATION  
2004 CHRYSLER CROSSFIRE  
THREE-DOOR HATCHBACK**

**FINAL REPORT**

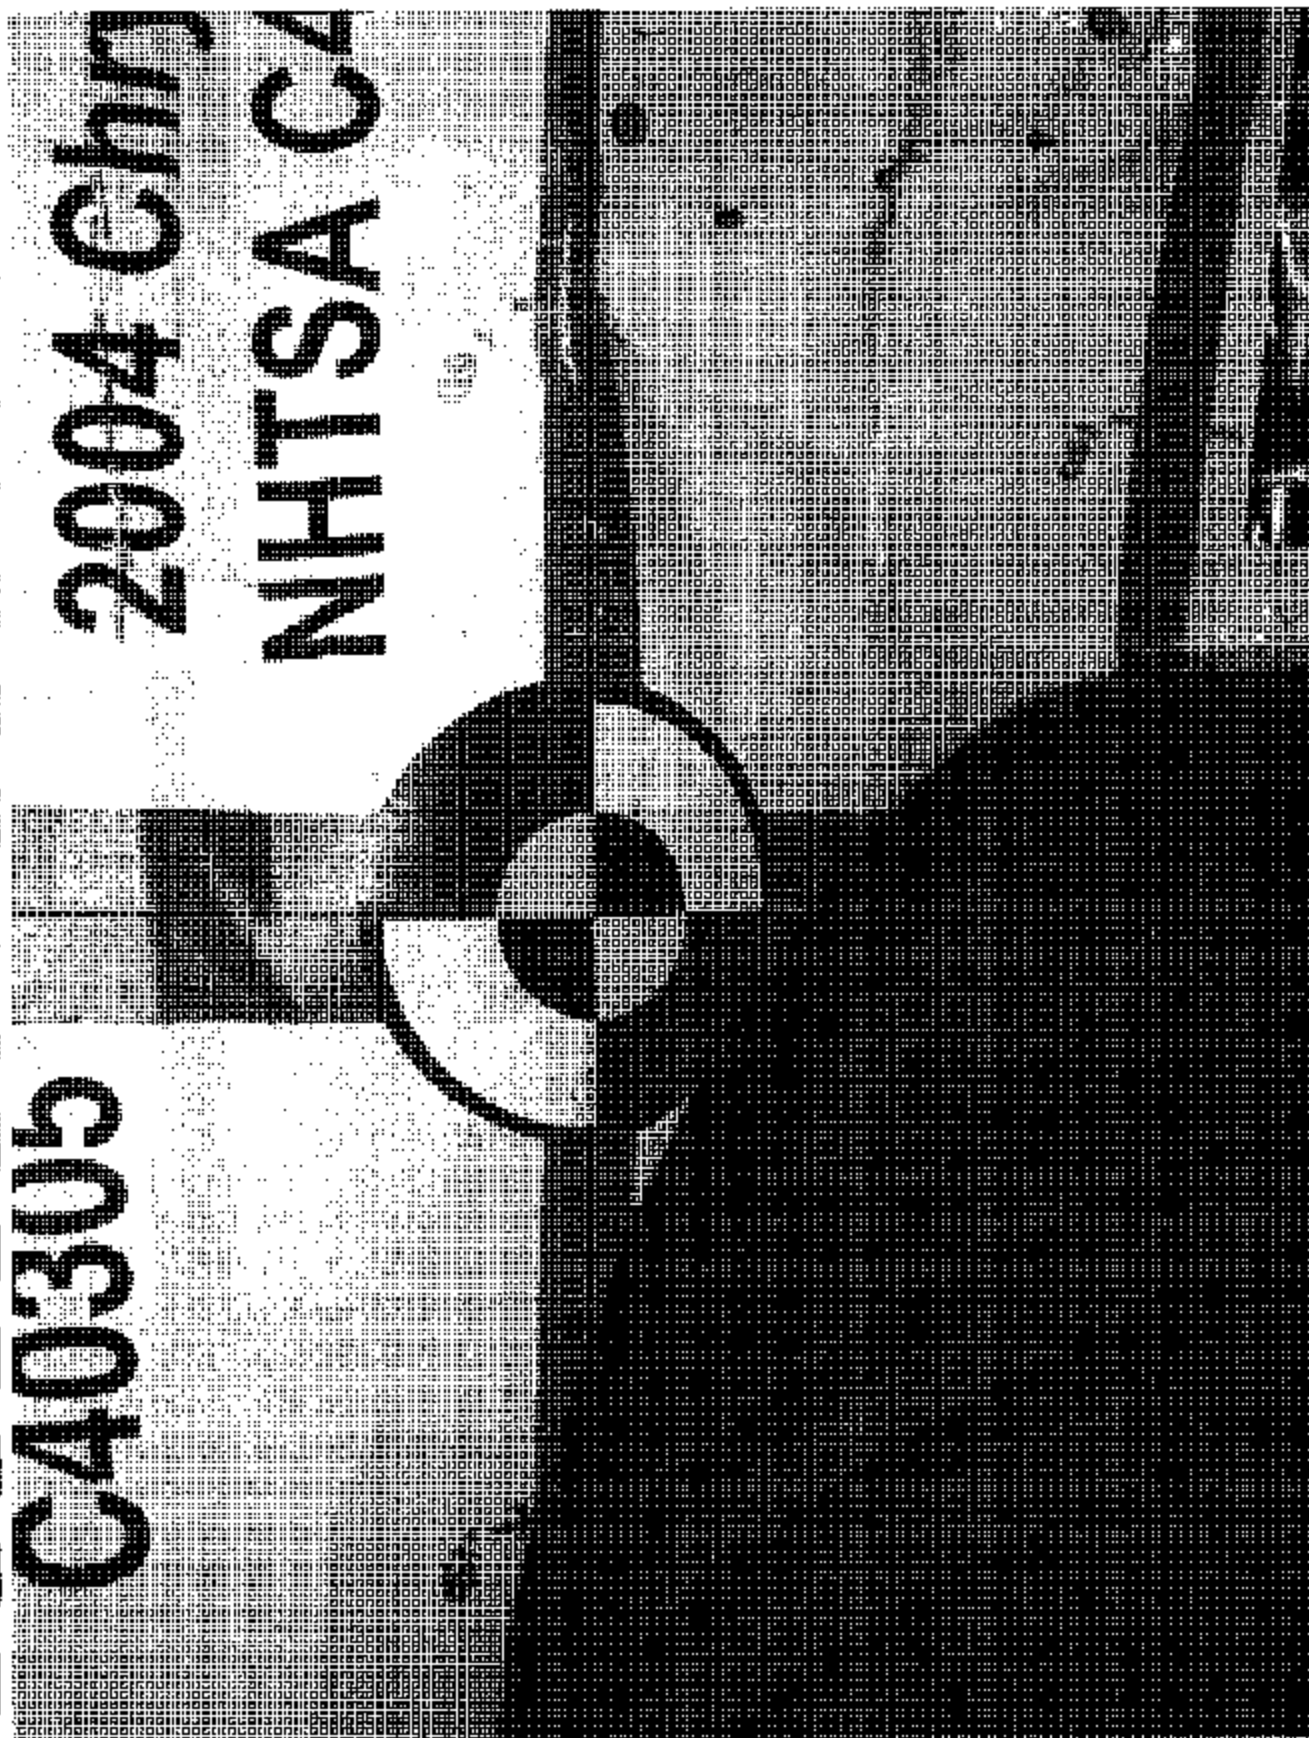
Figure A-33 POST-TEST CLOSE-UP VIEW OF IMPACT POINT TARGET

Actual Impact Point is 254 millimeters rearward of front axle centerline
