REPORT NUMBER 104-GTL-04-005

**SAFETY COMPLIANCE TESTING FOR
FMVSS NO. 104
WINDSHIELD WIPING AND WASHING SYSTEMS**

**TOYOTA MOTOR CORPORATION
2004 TOYOTA PRIUS, PASSENGER CAR
NHTSA NO. C45107**

FINAL REPORT

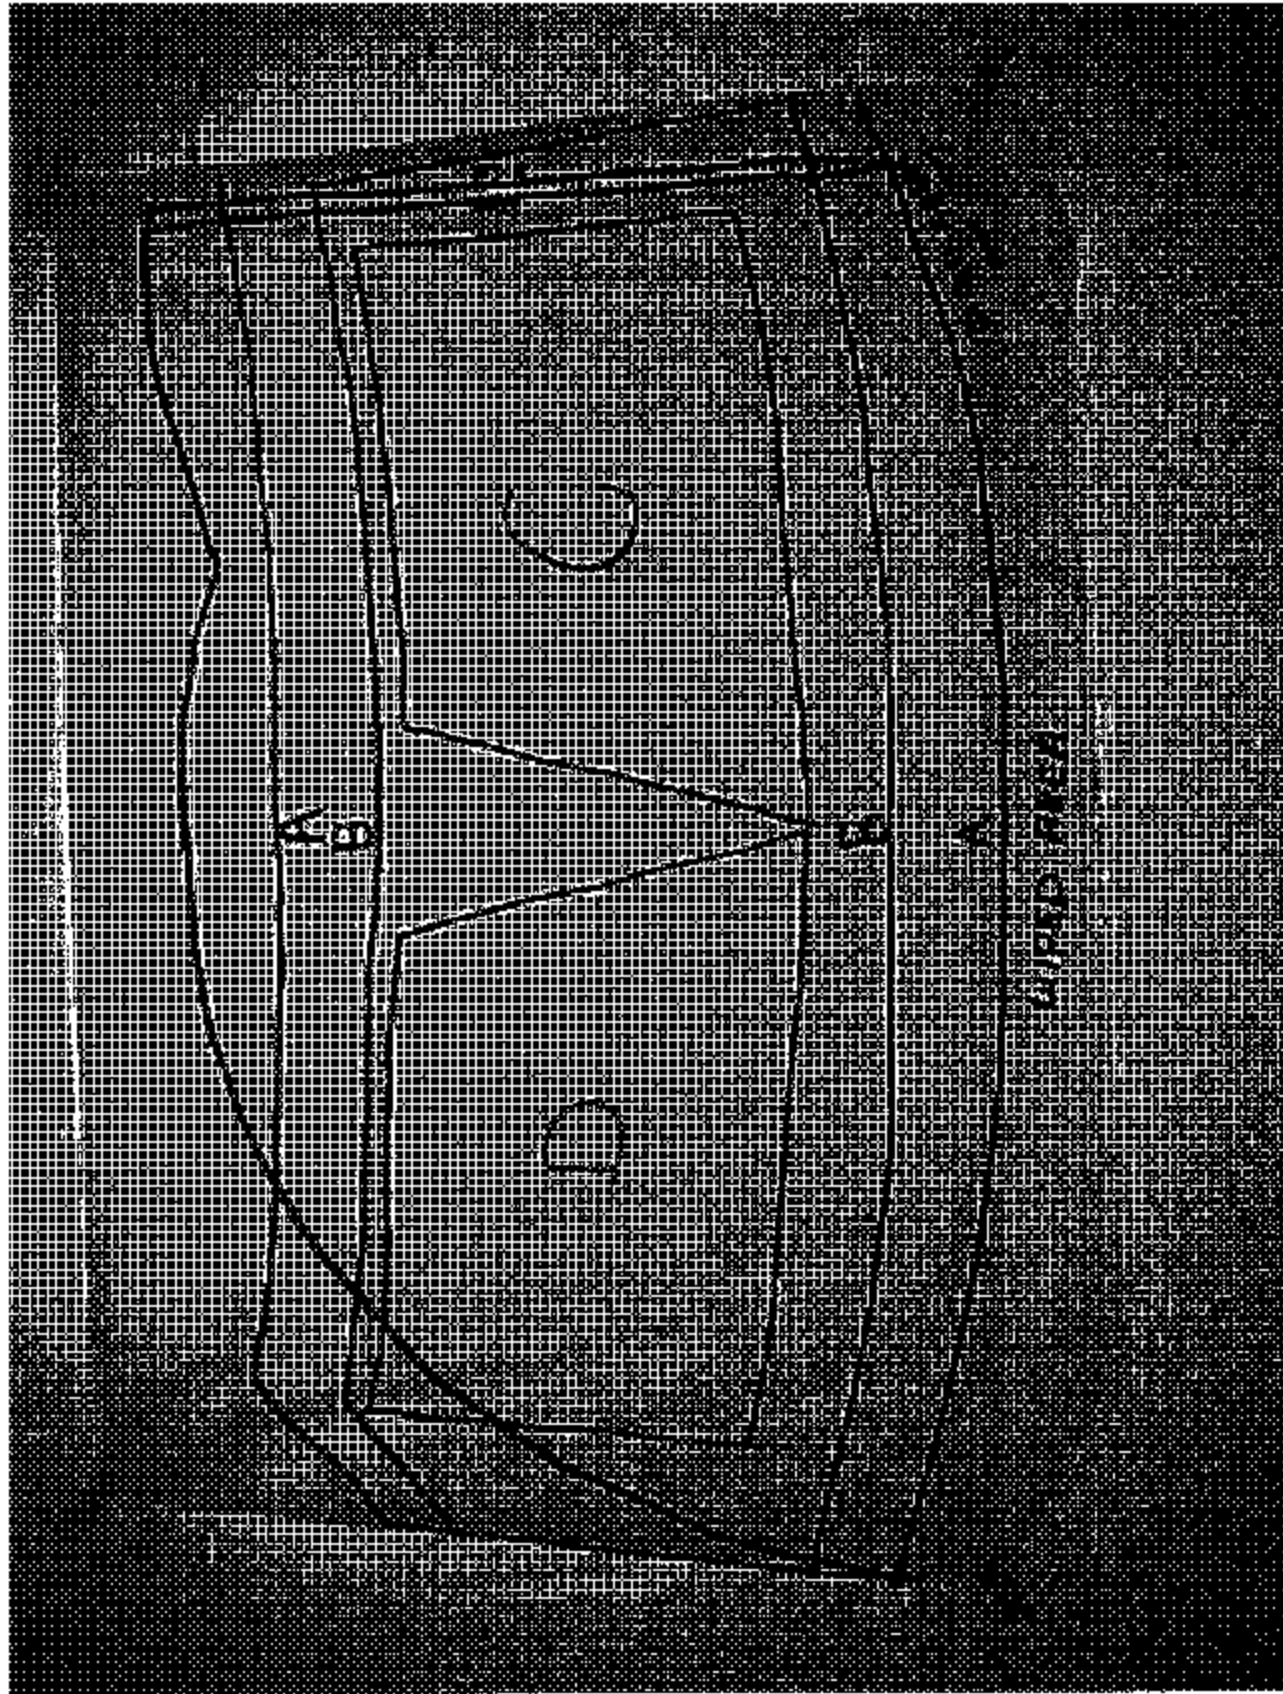
FIGURE 5.10
WIPED AREA TEST PATTERN

The test was conducted with the windshield wiper system operating at the high speed setting, engine at idle RPM and the spray nozzles spraying water at a minimum of 50 cubic inches per minute. The wiper blade wipe pattern was outlined on the glazing surface and then transferred to a windshield pattern. The wiped area was determined for areas A, B and C from the windshield pattern.

PERCENT WIPED				
WINDSHIELD AREA	ACTUAL	REQUIRED	PASS	FAIL
A	89.5%	80%	X	
B	94.1%	94%	X	
C	100%	99%	X
