REPORT NUMBER 301L-GTL-04-005

**SAFETY COMPLIANCE TESTING FOR
FMVSS NO. 301L
FUEL SYSTEM INTEGRITY**

**LANDROVER IN THE UK
2004 LANDROVER FREELANDER, MPV
NHTSA NO. C40602**

**GENERAL TESTING LABORATORIES, INC.
1623 LEEDSTOWN ROAD
COLONIAL BEACH, VIRGINIA 22443**

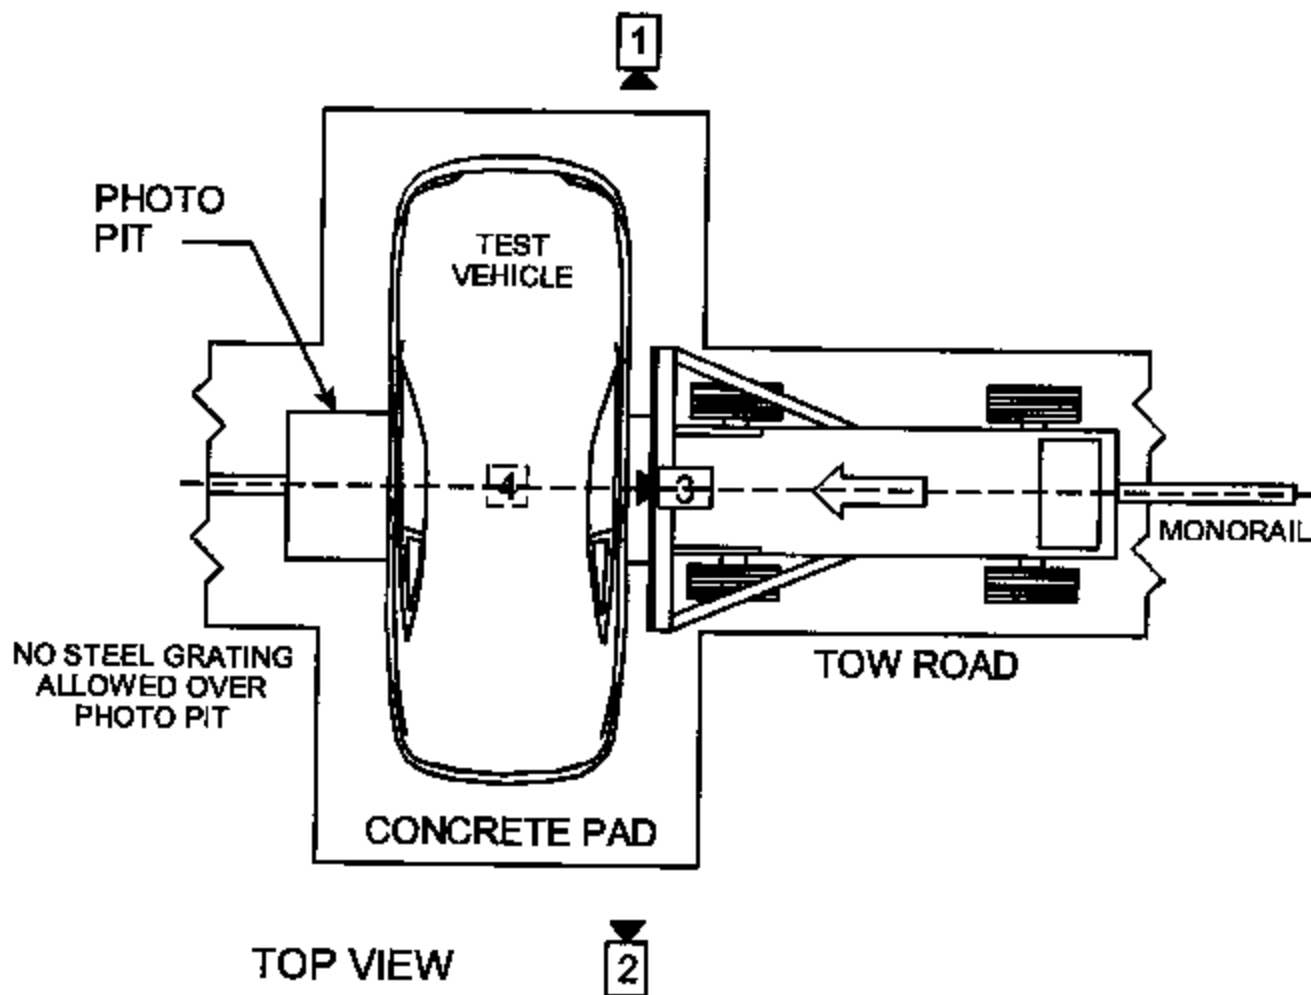
DATA SHEET 6 CAMERA LOCATION

- CAMERA 1 – FRONT SIDE VIEW OF VEHICLE DURING CRASH
- CAMERA 2 – REAR SIDE VIEW OF VEHICLE DURING CRASH
- CAMERA 3 – OVERHEAD VIEW OF ENTIRE IMPACT
- CAMERA 4 – UNDERBODY VIEW OF FUEL TANK LOCATED IN PIT

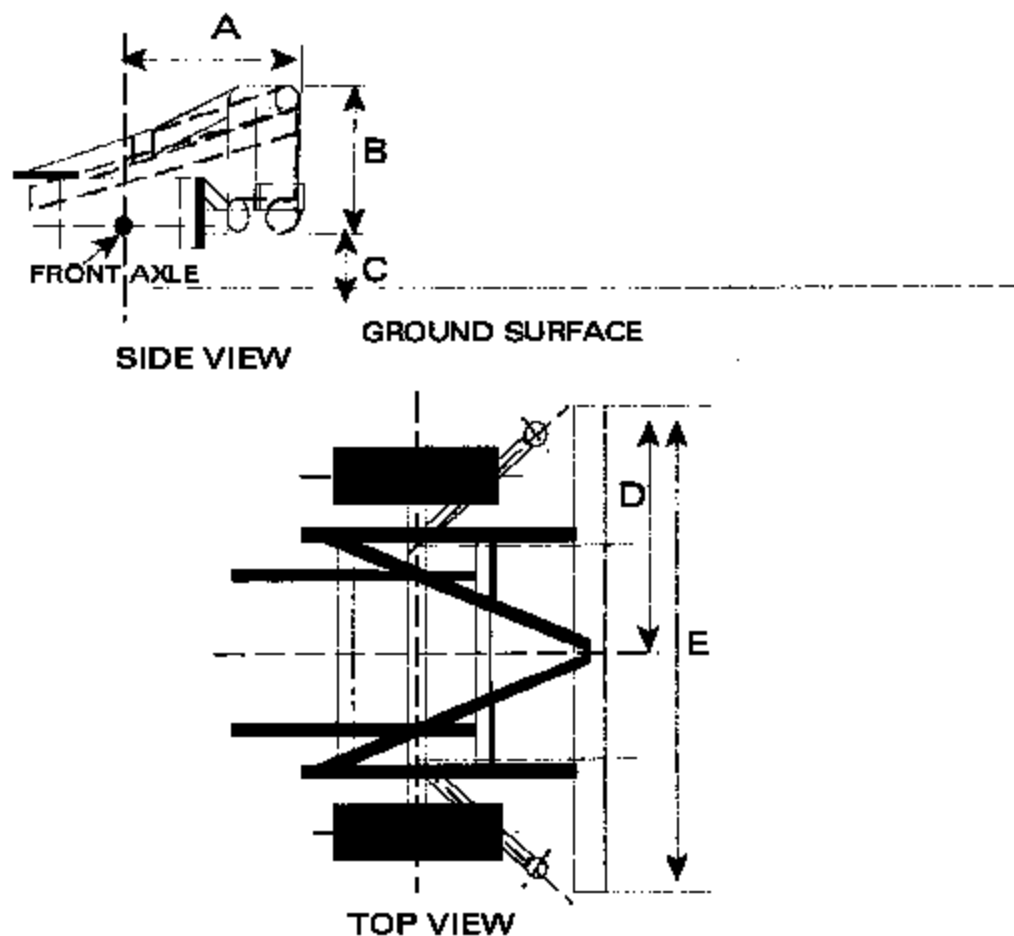
SECTION 6
BARRIER INFORMATION

1. Face Plate 0.50 in. (19mm) thick cold rolled steel
2. All Inner Reinforcements 4.0 x 2.0 x 0.19 in. (102 x 51 x 5mm) Steel Tubing
3. Impact Surface above shown without .75 x 48 x 96 in. Plywood Face attached

TEST SET-UP OF COMMON CARRIAGE WITH 60" x 78" FLAT FACE IMPACT SURFACE INSTALLED:

DIMENSIONS FOR GTL 60" x 78" FLAT FACE IMPACT SURFACE
