**Report Number: 214-TRC-04-004**

**Safety Compliance Testing For FMVSS 214**

**Side Impact Protection**

**2005 Scion TC 2-door**

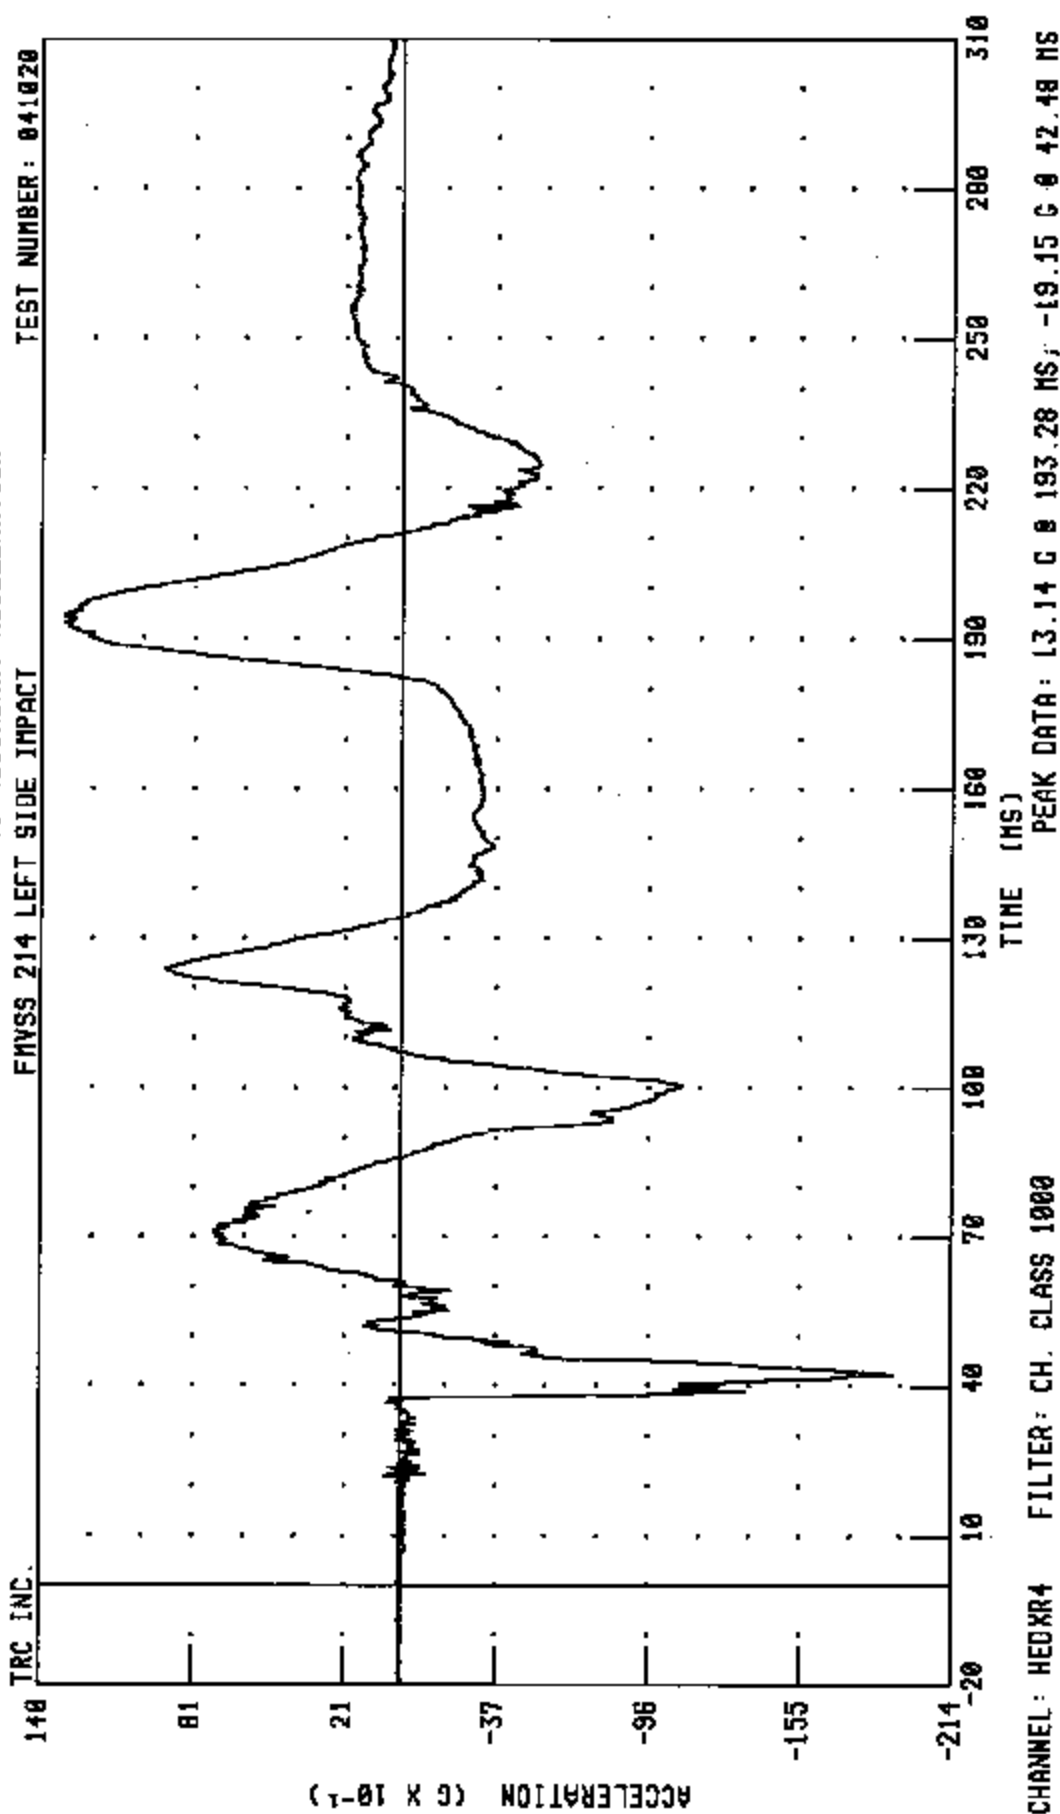
PEAK DATA: 34.85 KM/H @ 47.28 MS; 0.00 KM/H @ 0.00 MS

55/28 KPH 90 DEGREE SIDE IMPACT (MOVING DEFORMABLE BARRIER) INTO LEFT SIDE OF 2005 SCION TC  
LEFT REAR PASSENGER HEAD X-AXIS REDUNDANT ACCELERATION
