REPORT NUMBER 207-GTL-05-001

**FMVSS NO. 207  
INDICANT TEST**

**TOYOTA MOTOR MANUFACTURING,  
KENTUCKY, INC.  
2005 TOYOTA AVALON, PASSENGER CAR  
NHTSA NO. C55104**

**GENERAL TESTING LABORATORIES, INC.  
1623 LEEDSTOWN ROAD  
COLONIAL BEACH, VIRGINIA 22443**

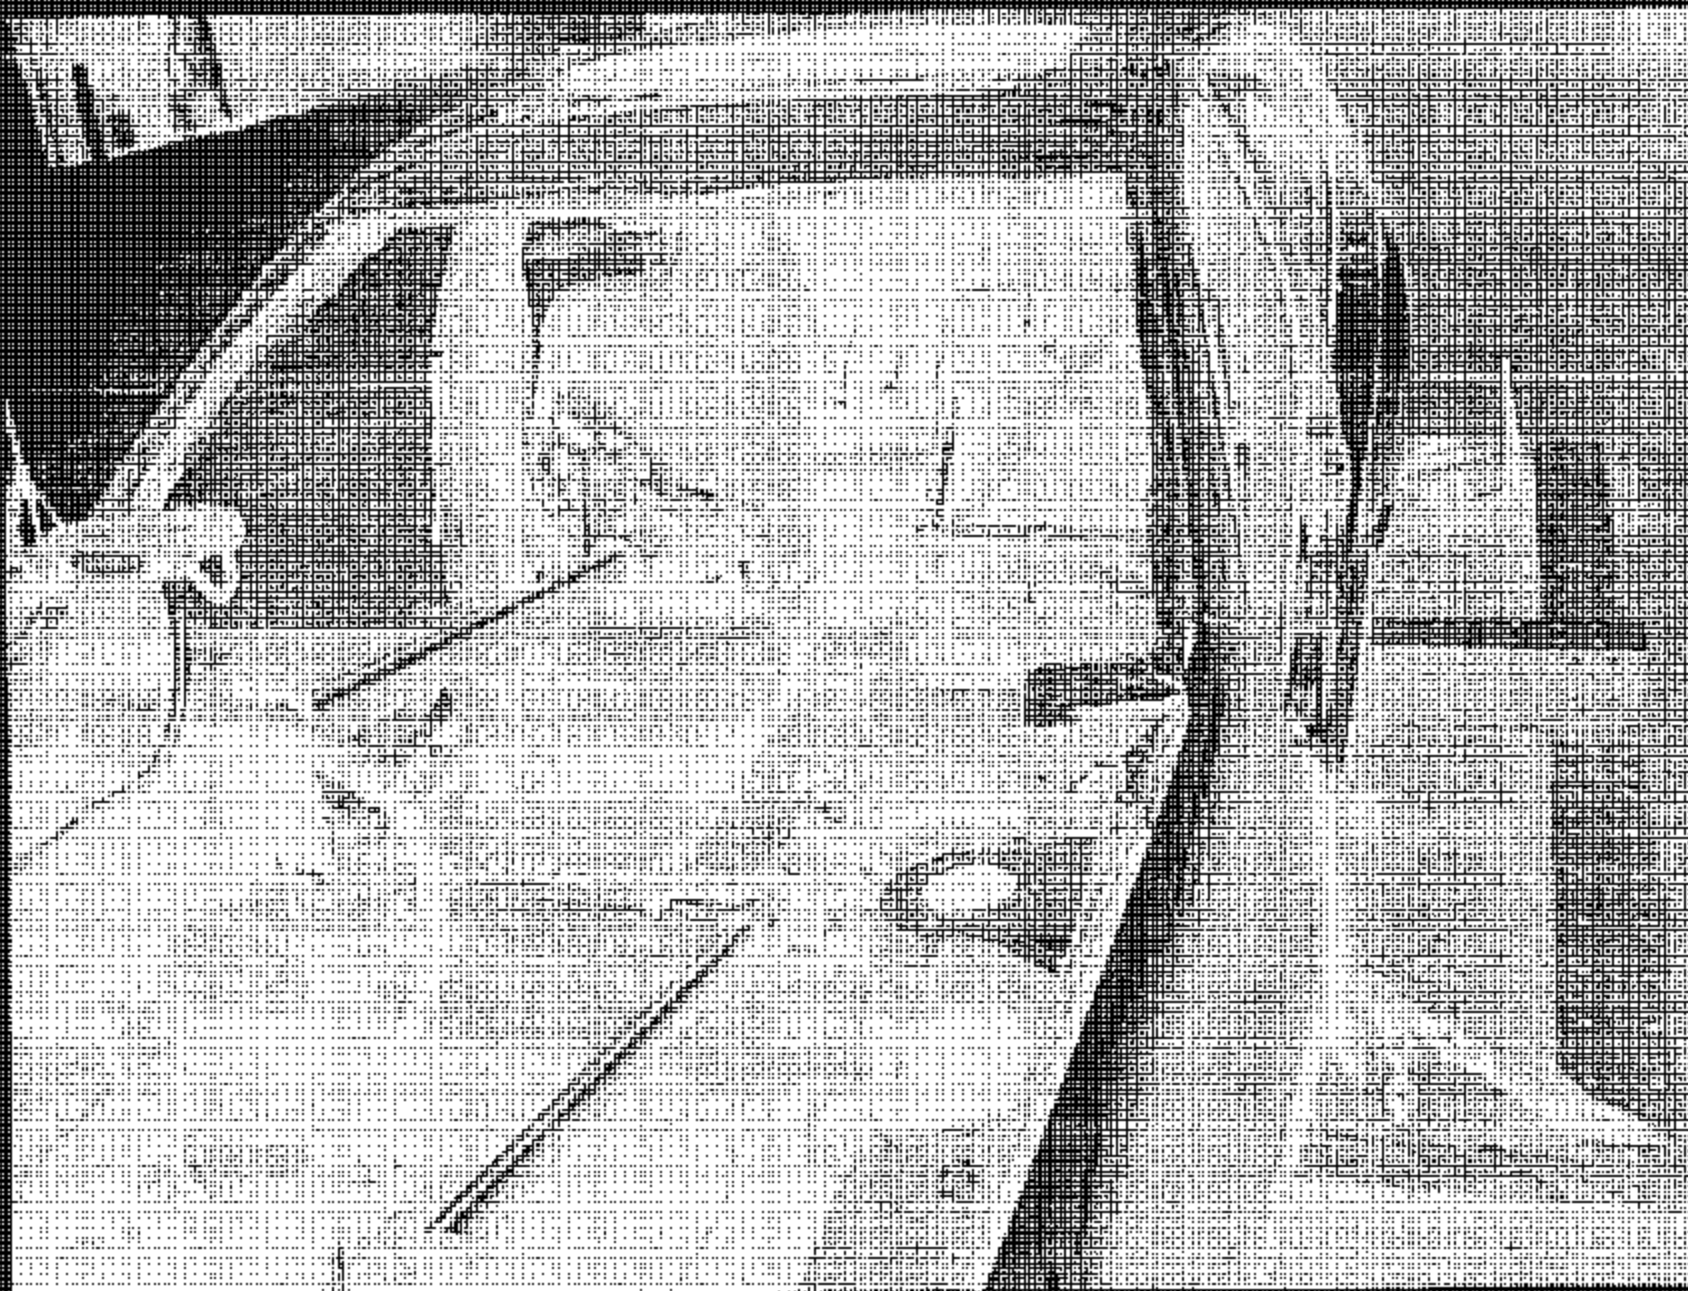
FIGURE 58  
3/4 LEFT FRONT VIEW OF VEHICLE IN TEST RIG

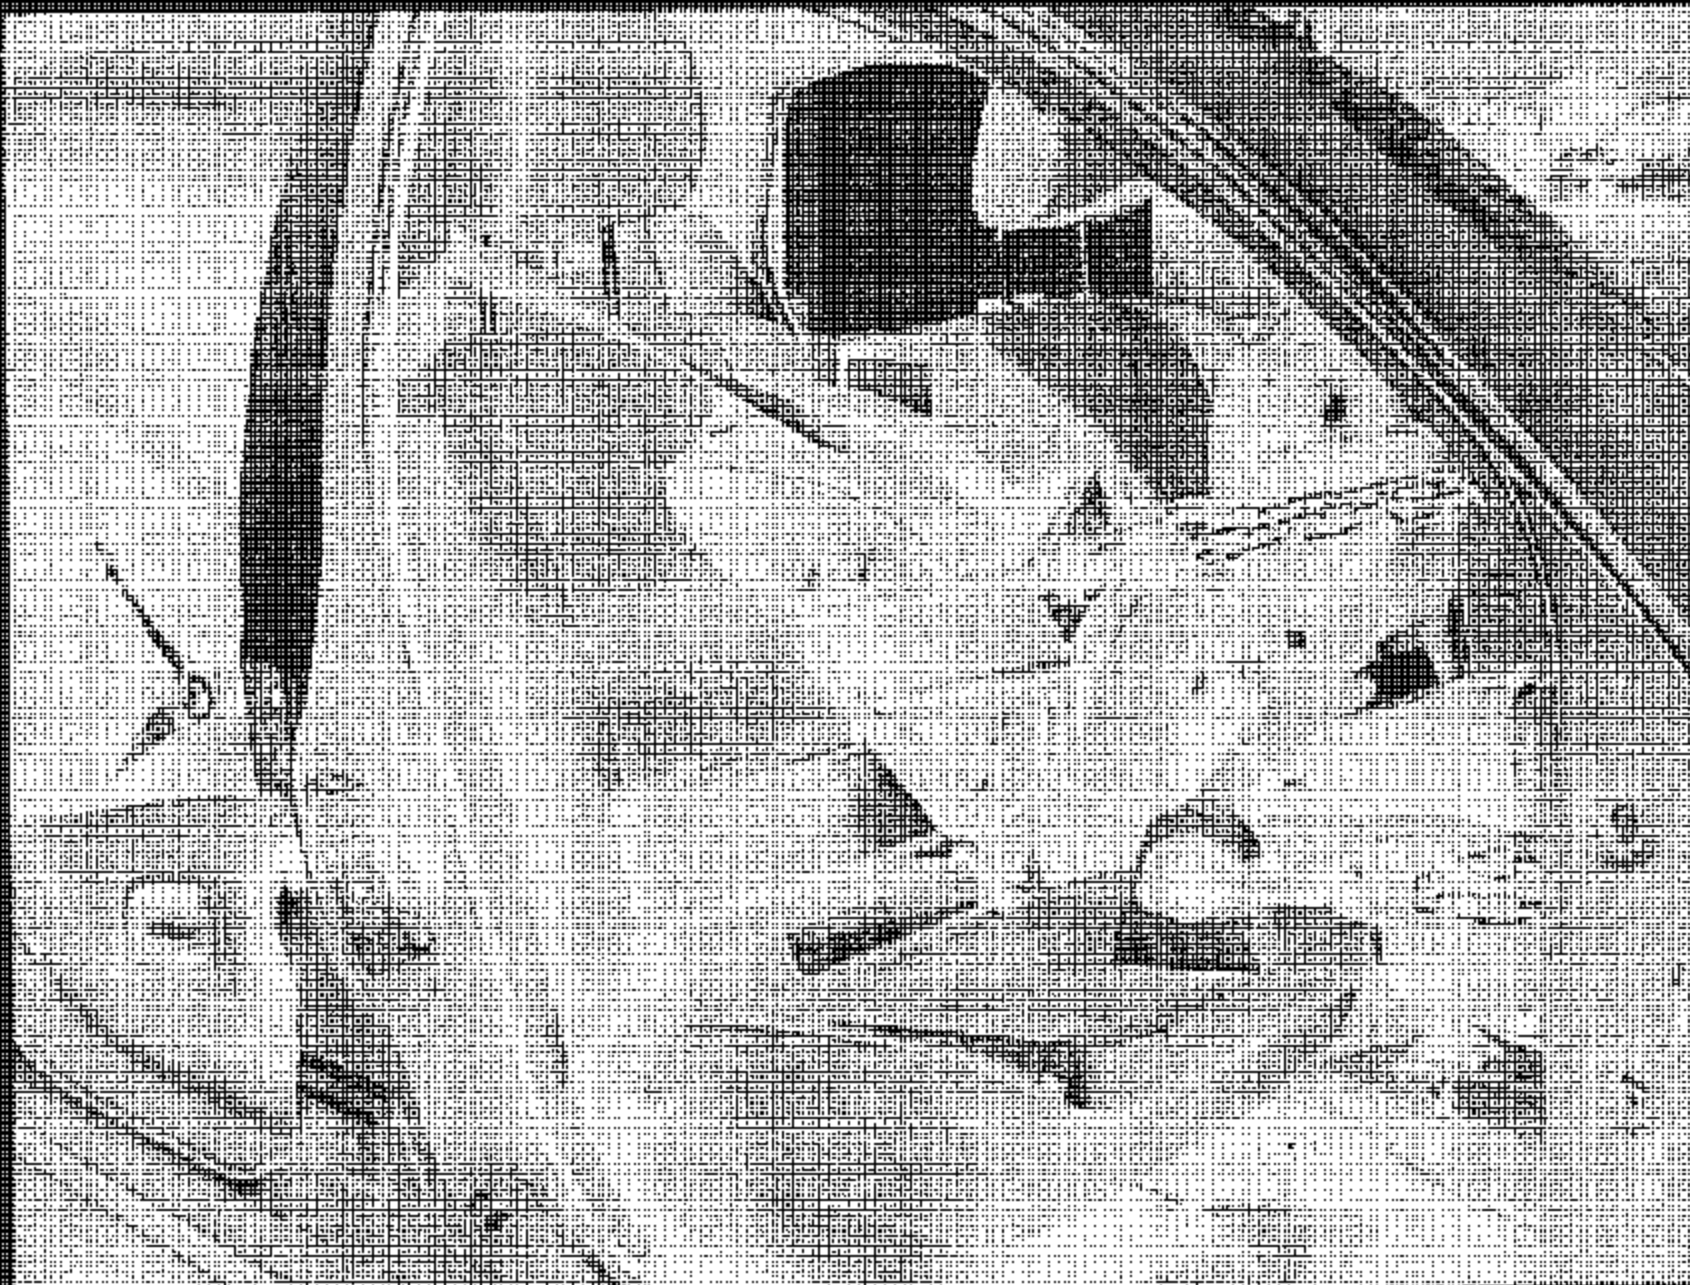
FIGURE 5.11  
PRE-TEST ROW 1, ¼ RIGHT FRONT VIEW

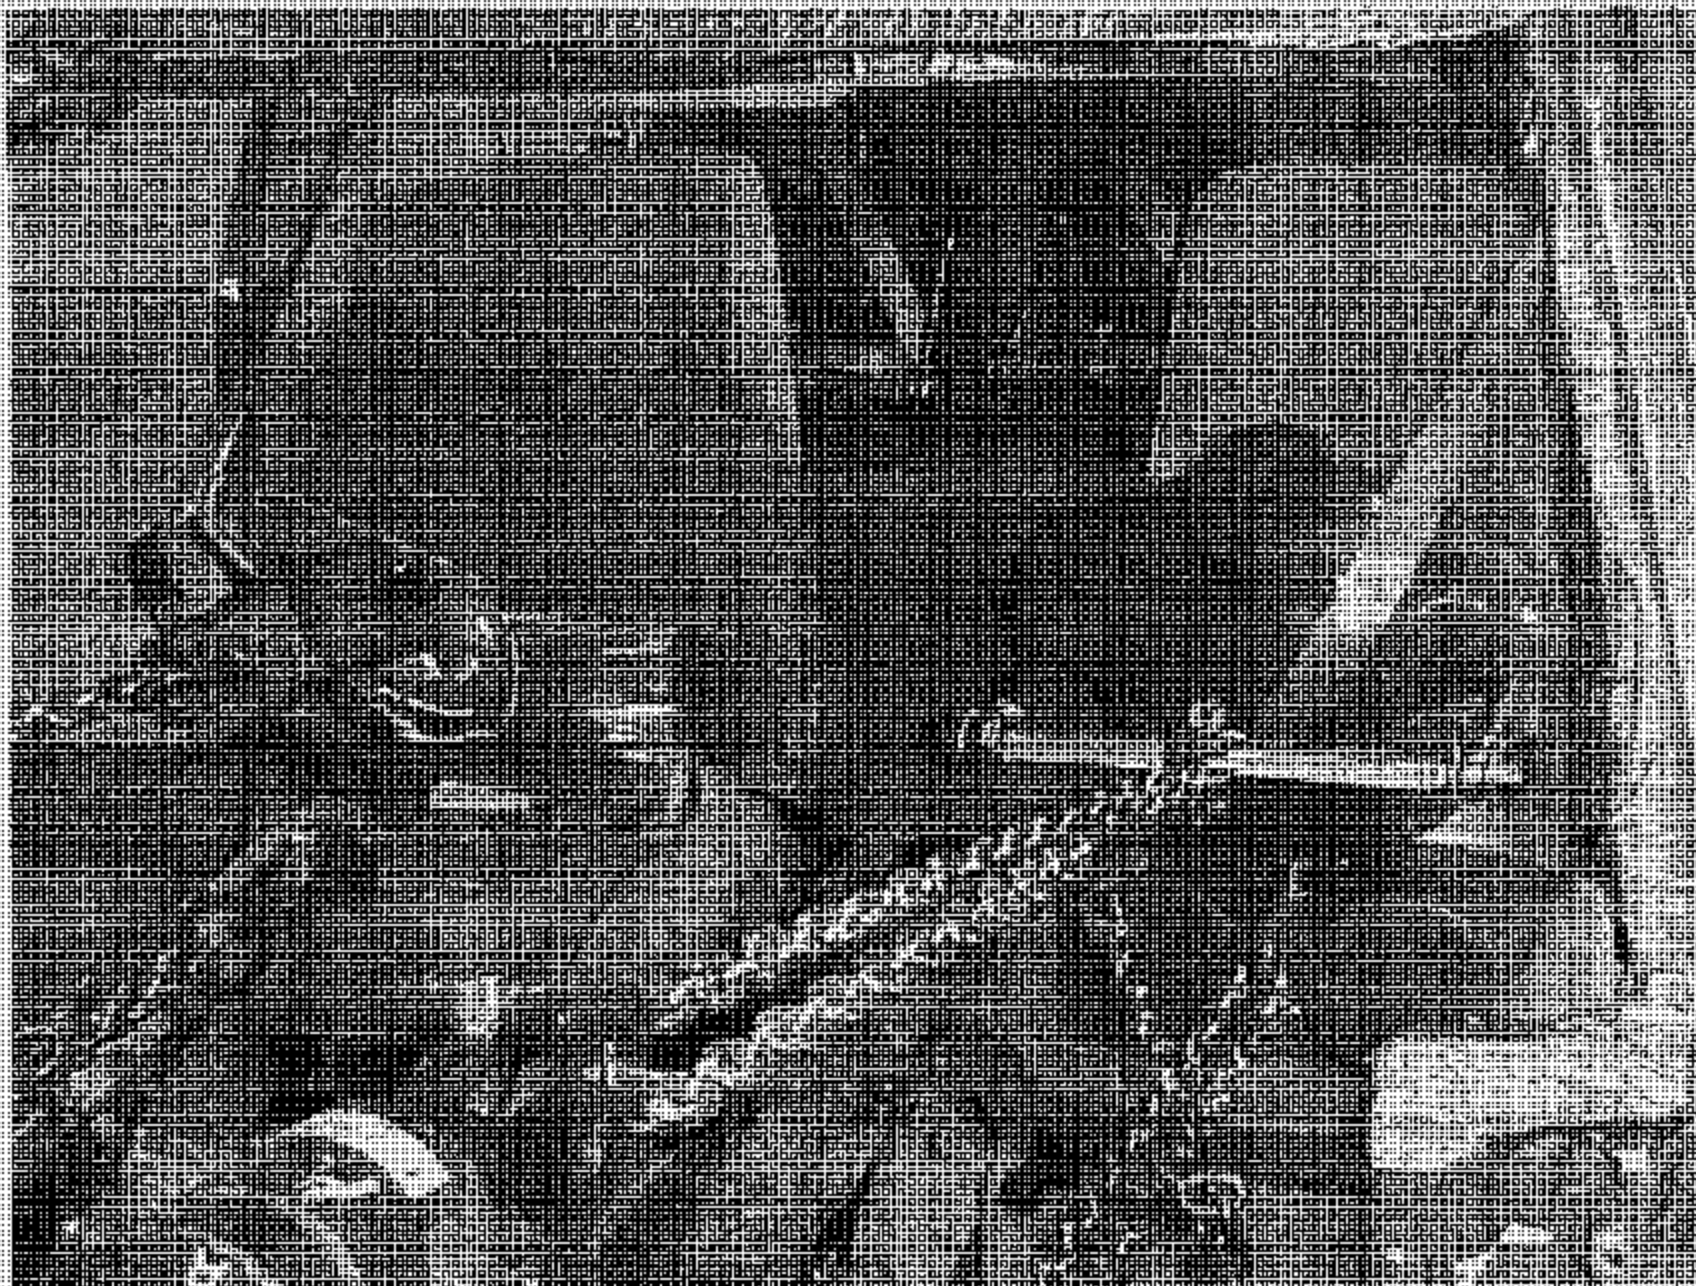
FIGURE 5.16  
FULL LOAD ROW 1, ¼ LEFT FRONT VIEW

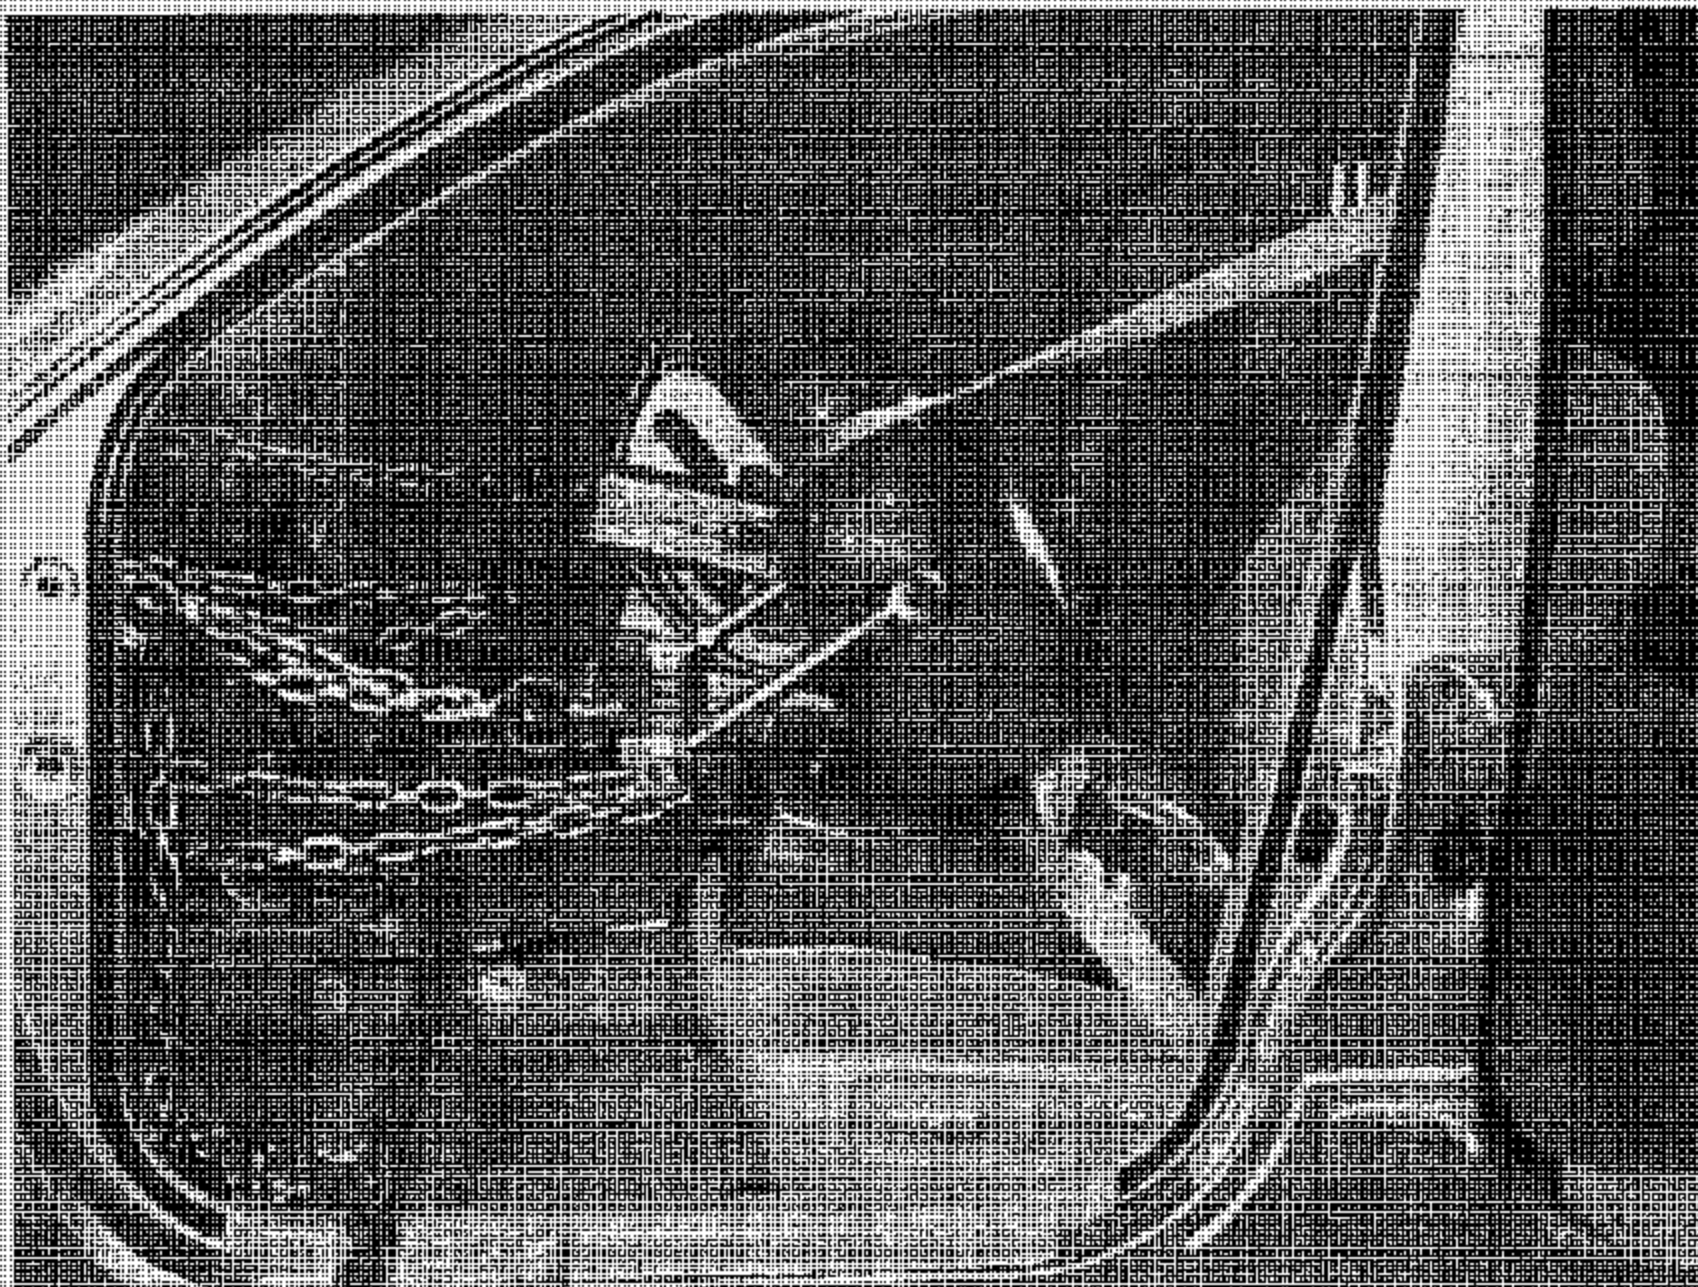
FIGURE 3.17  
POST TEST ROW 1, LEFT SIDE VIEW

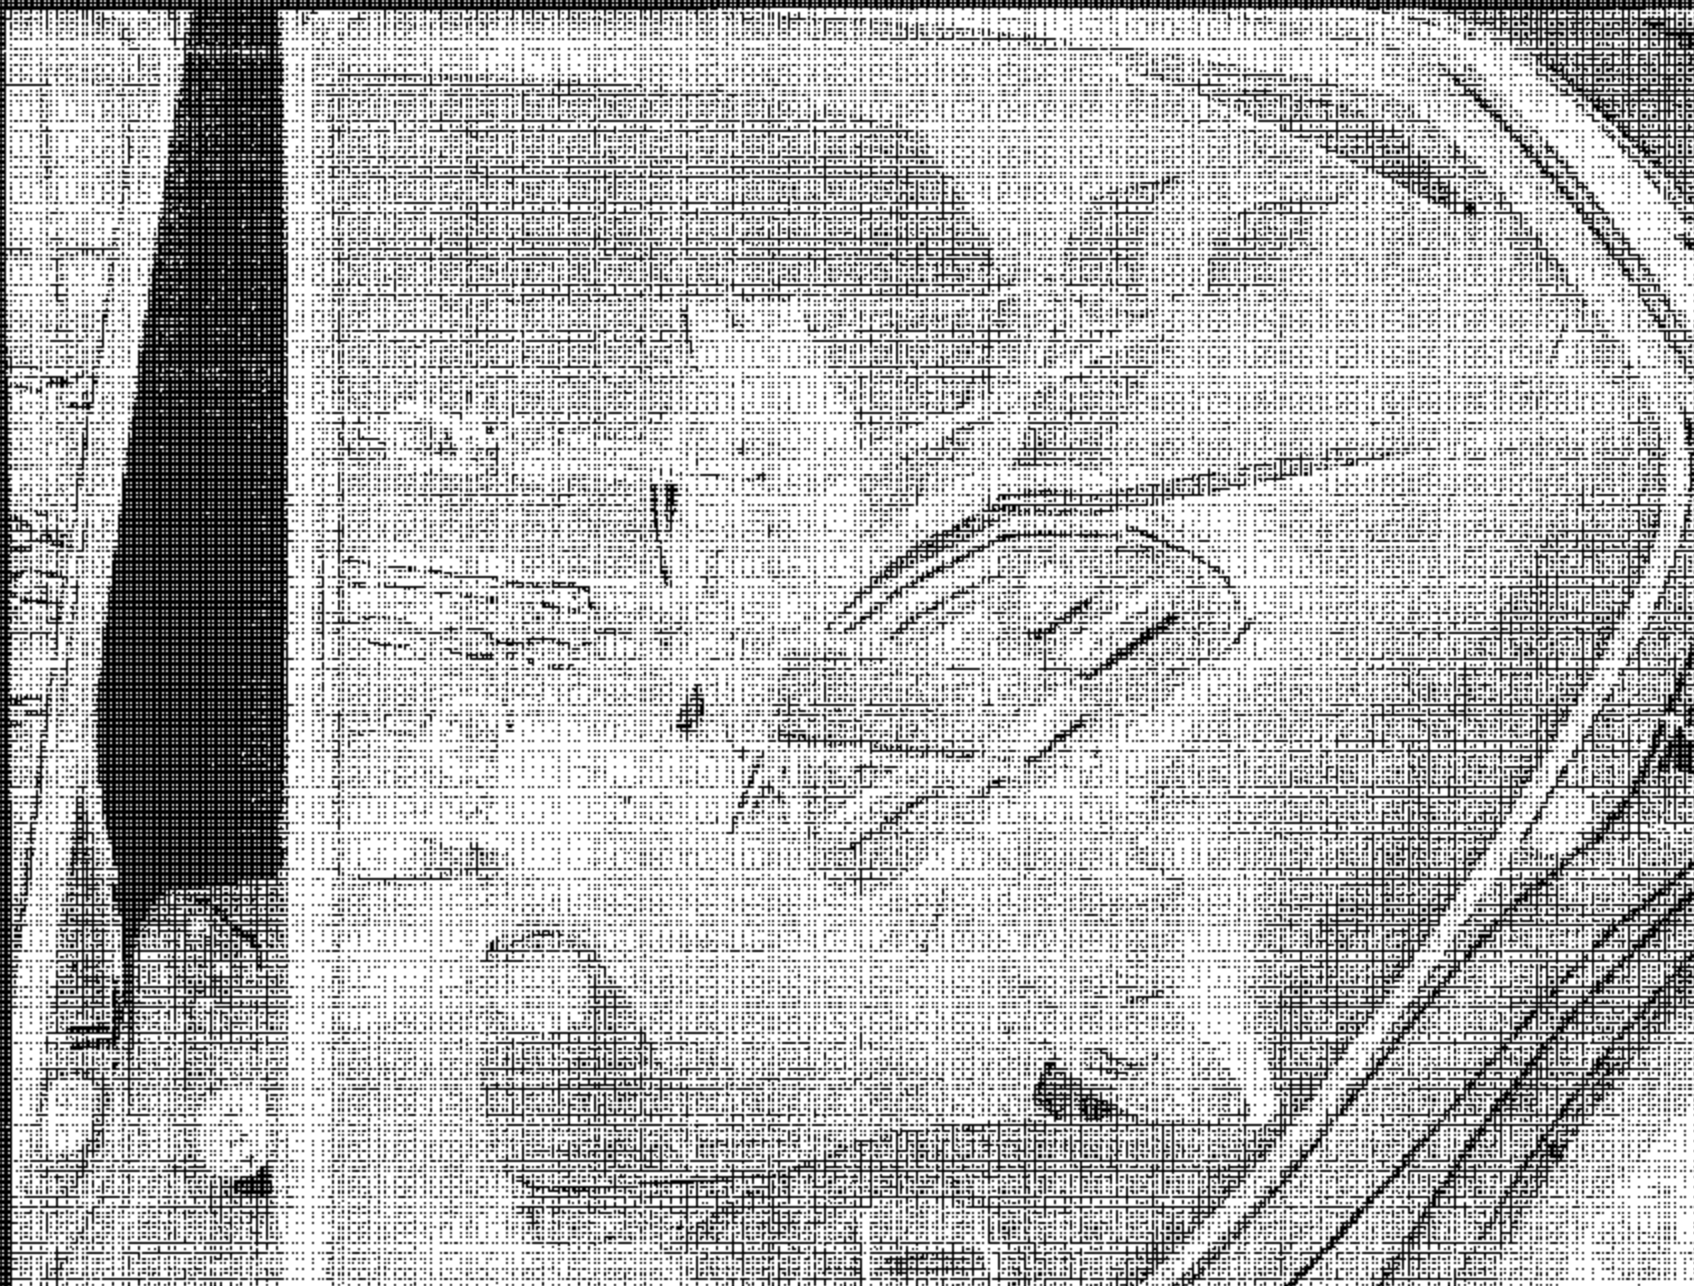
FIGURE 3.24  
FULL LOAD ROW 2, LEFT SIDE VIEW

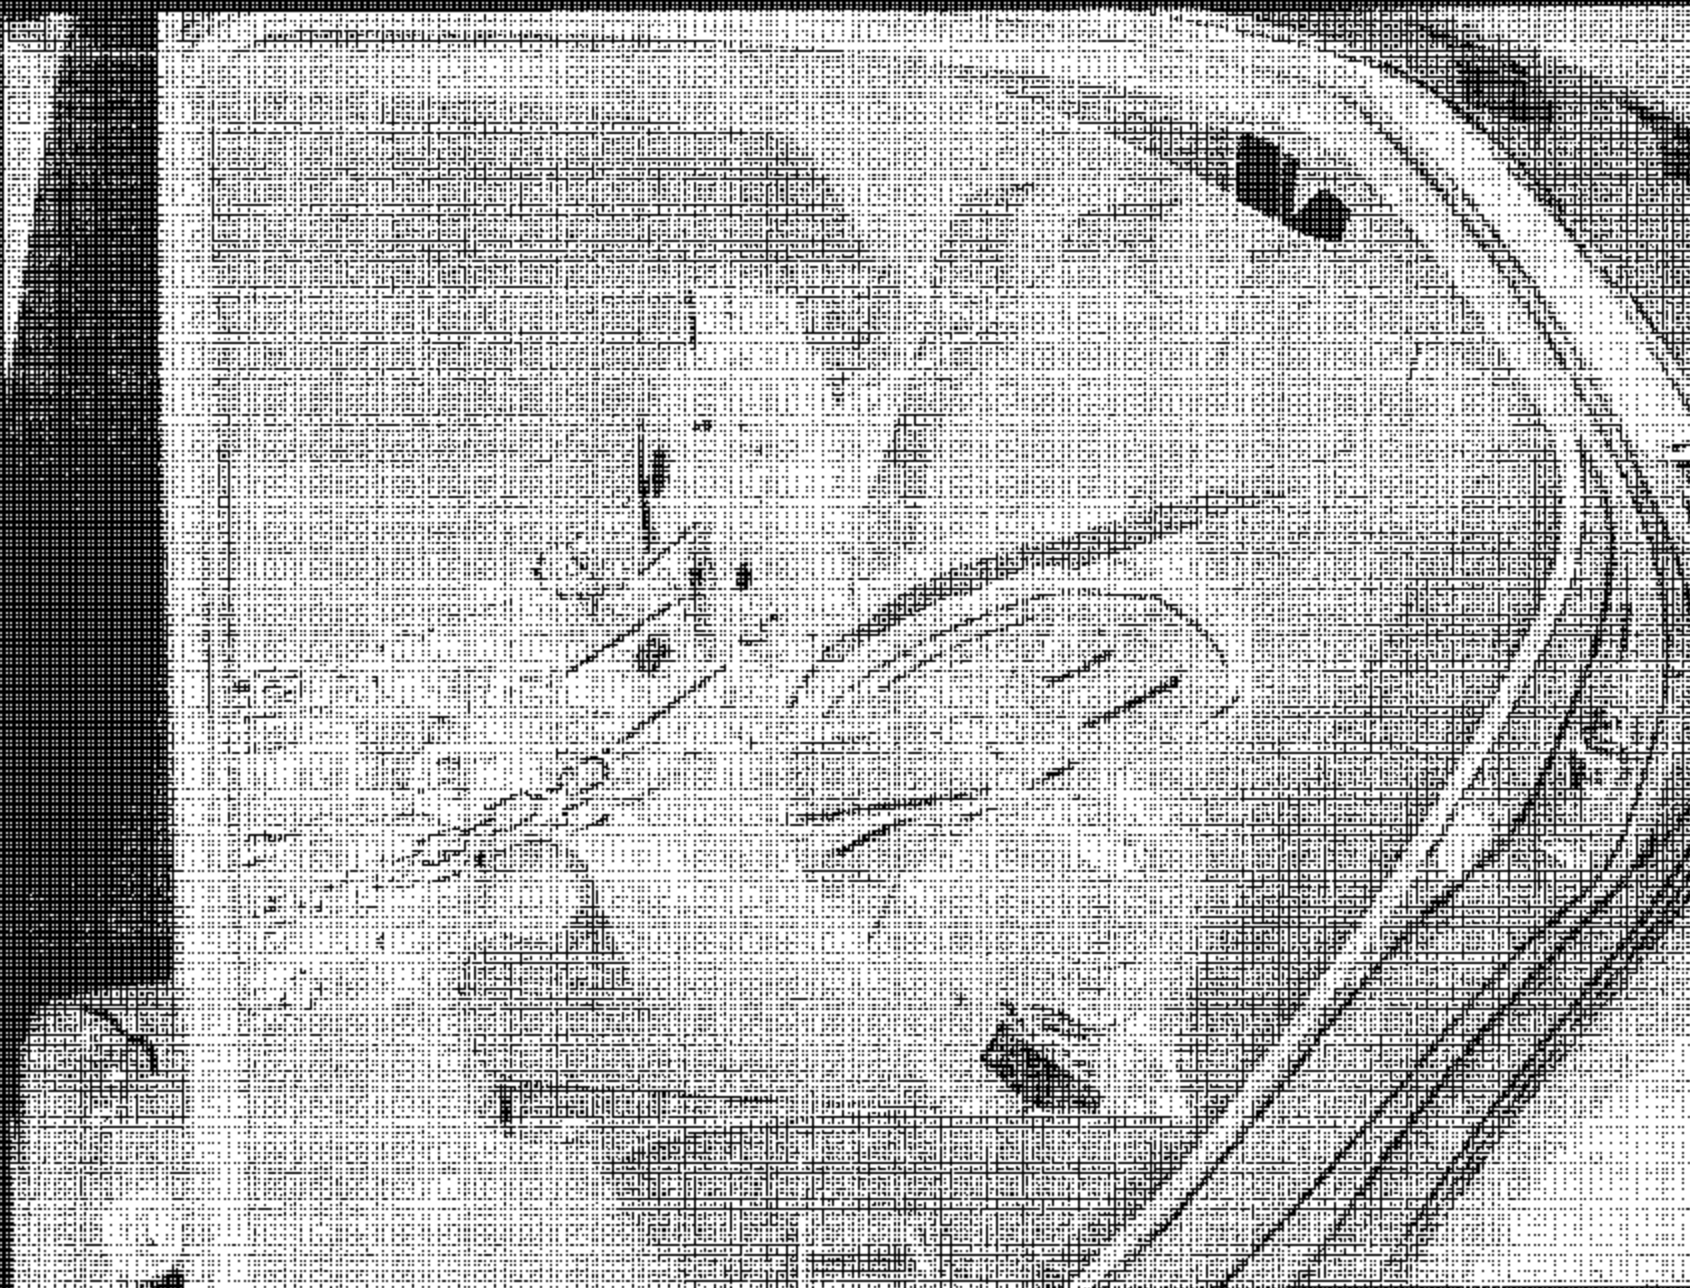
FIGURE 5.26  
POST TEST ROW 2, LEFT SIDE VIEW

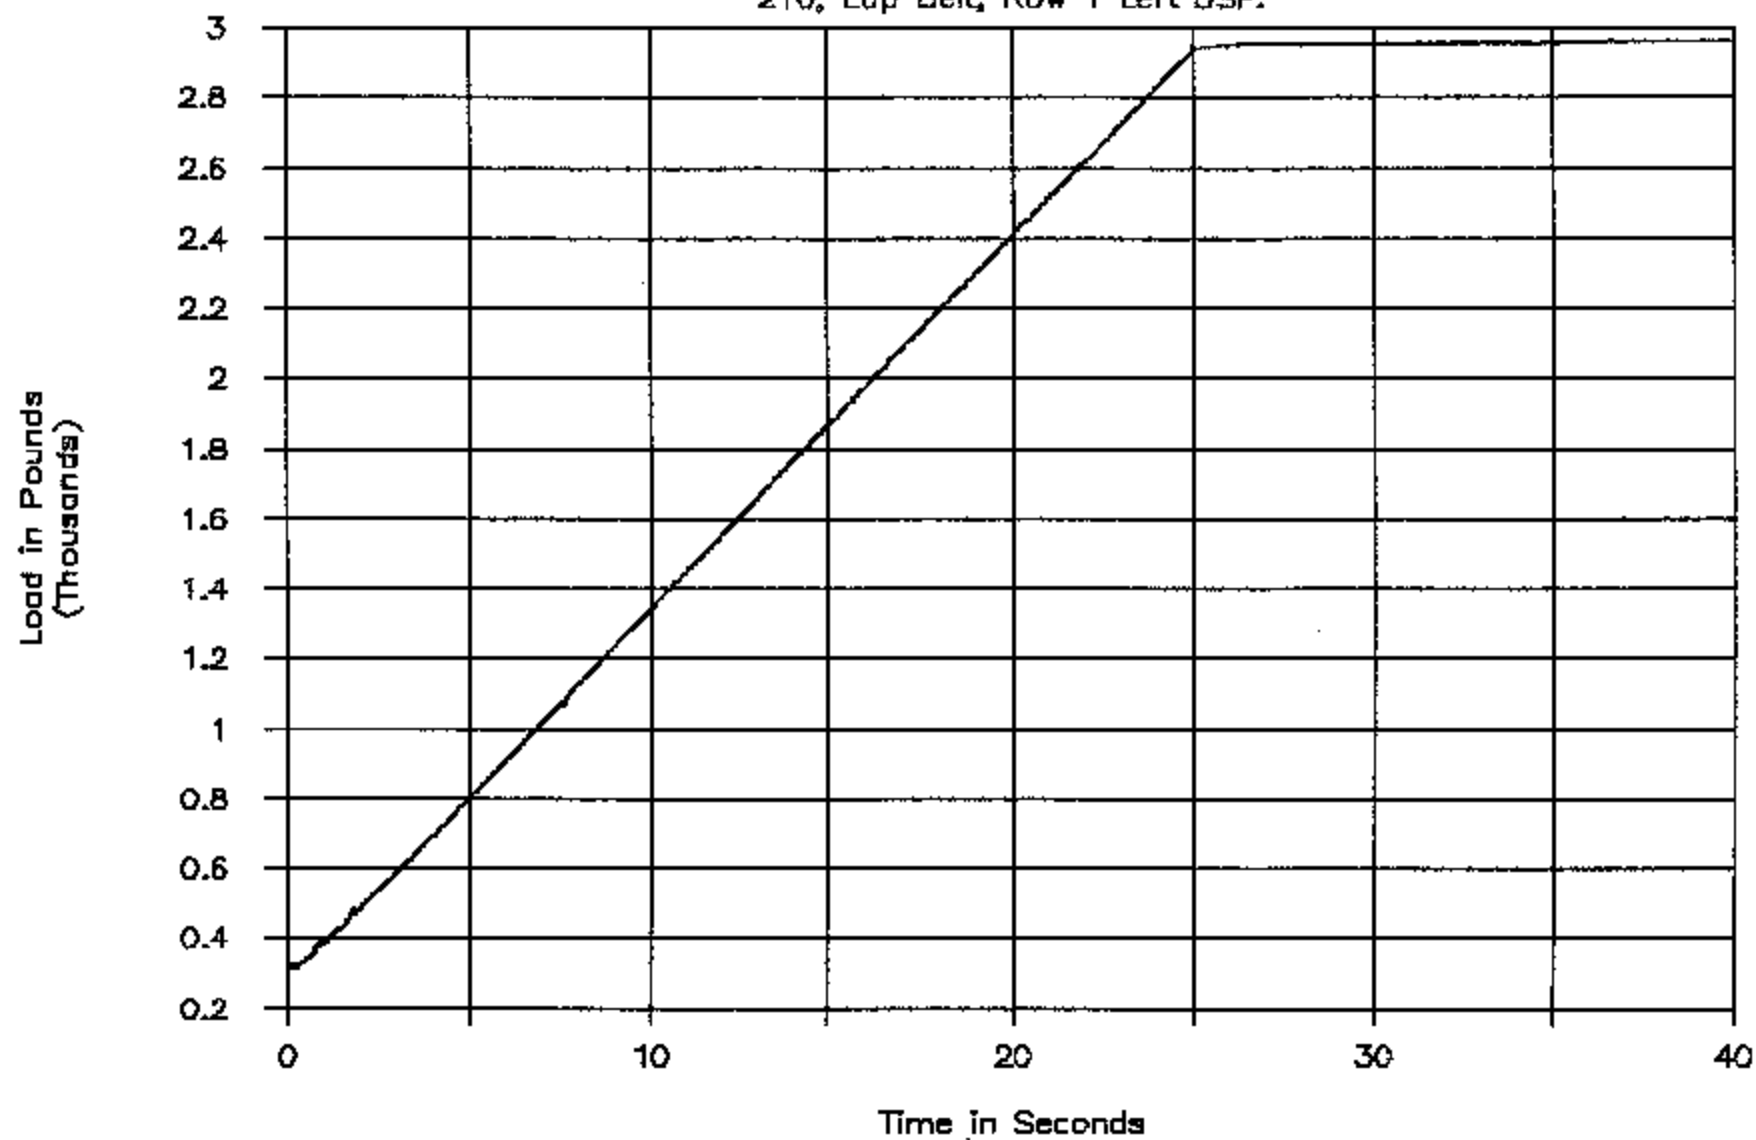
GTL 5305, NHTSA C55104

210, Lap Belt, Row 1 Left DSP.

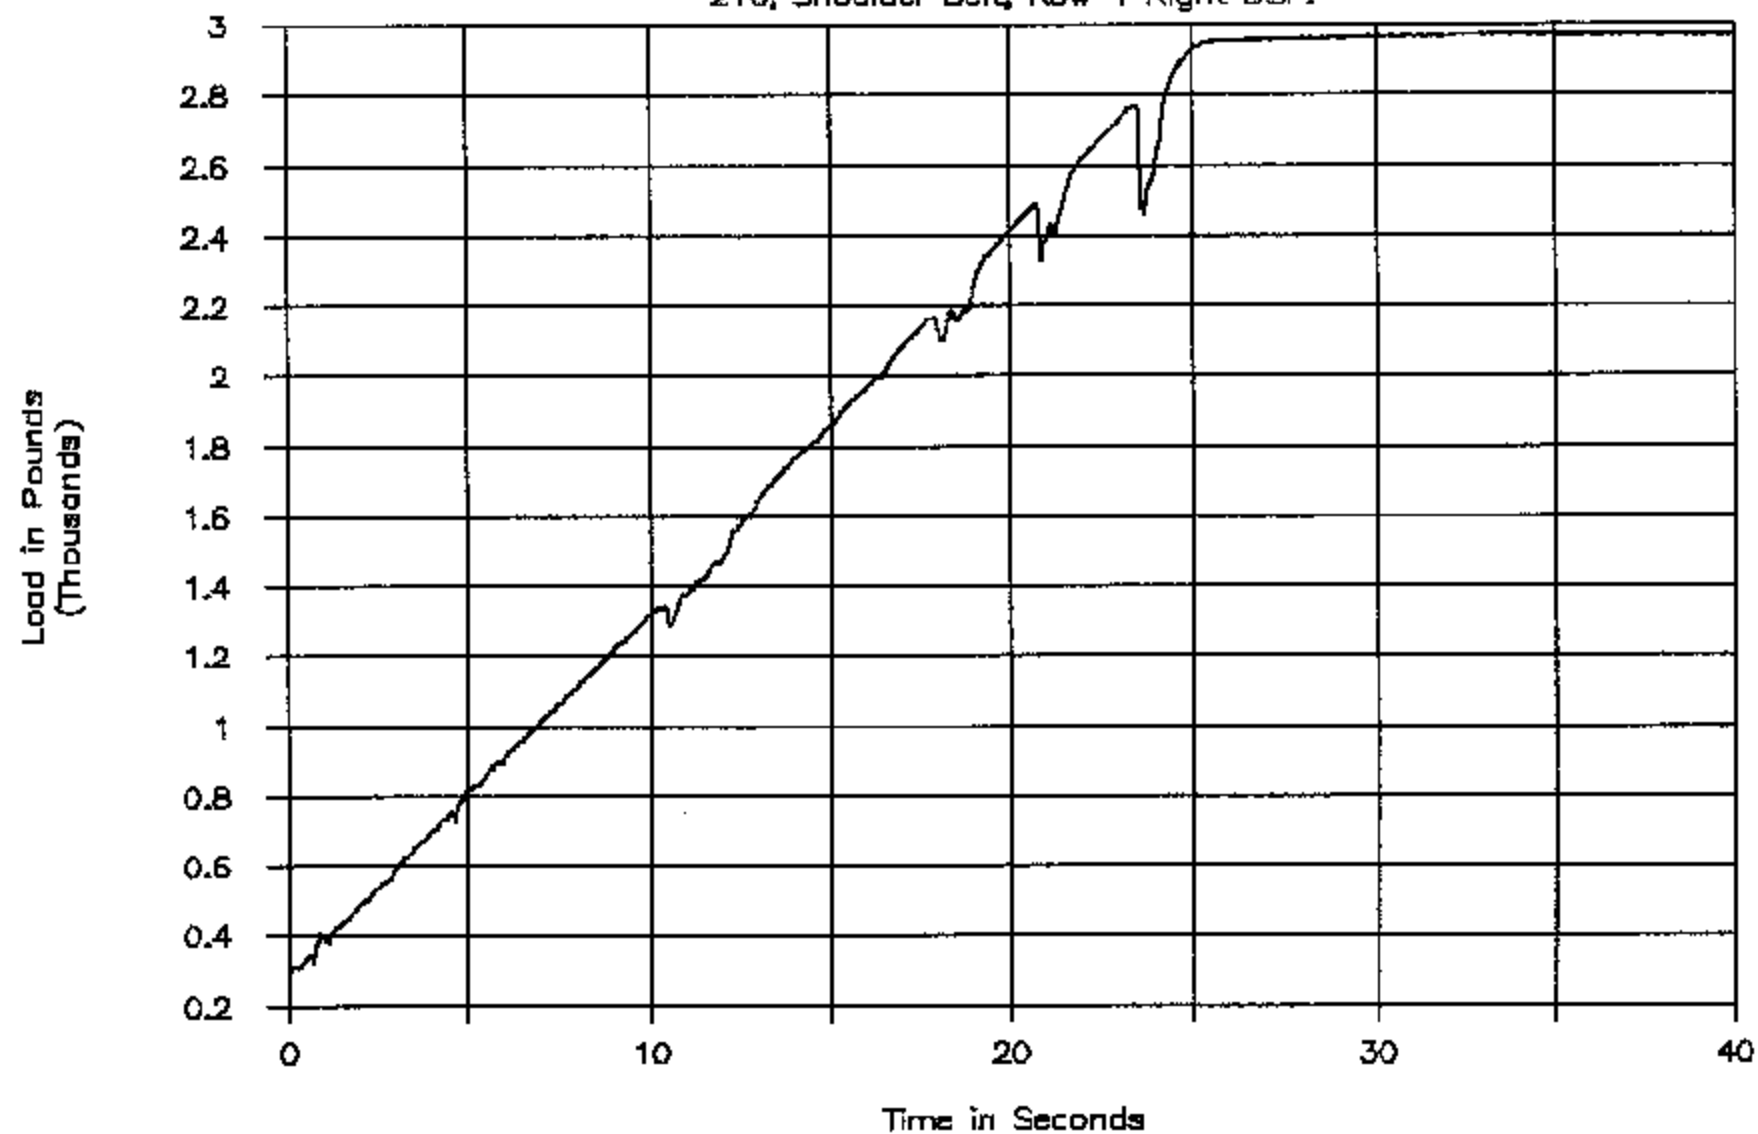
GTL 5305, NHTSA C55104

210, Shoulder Belt, Row 1 Right DSP.

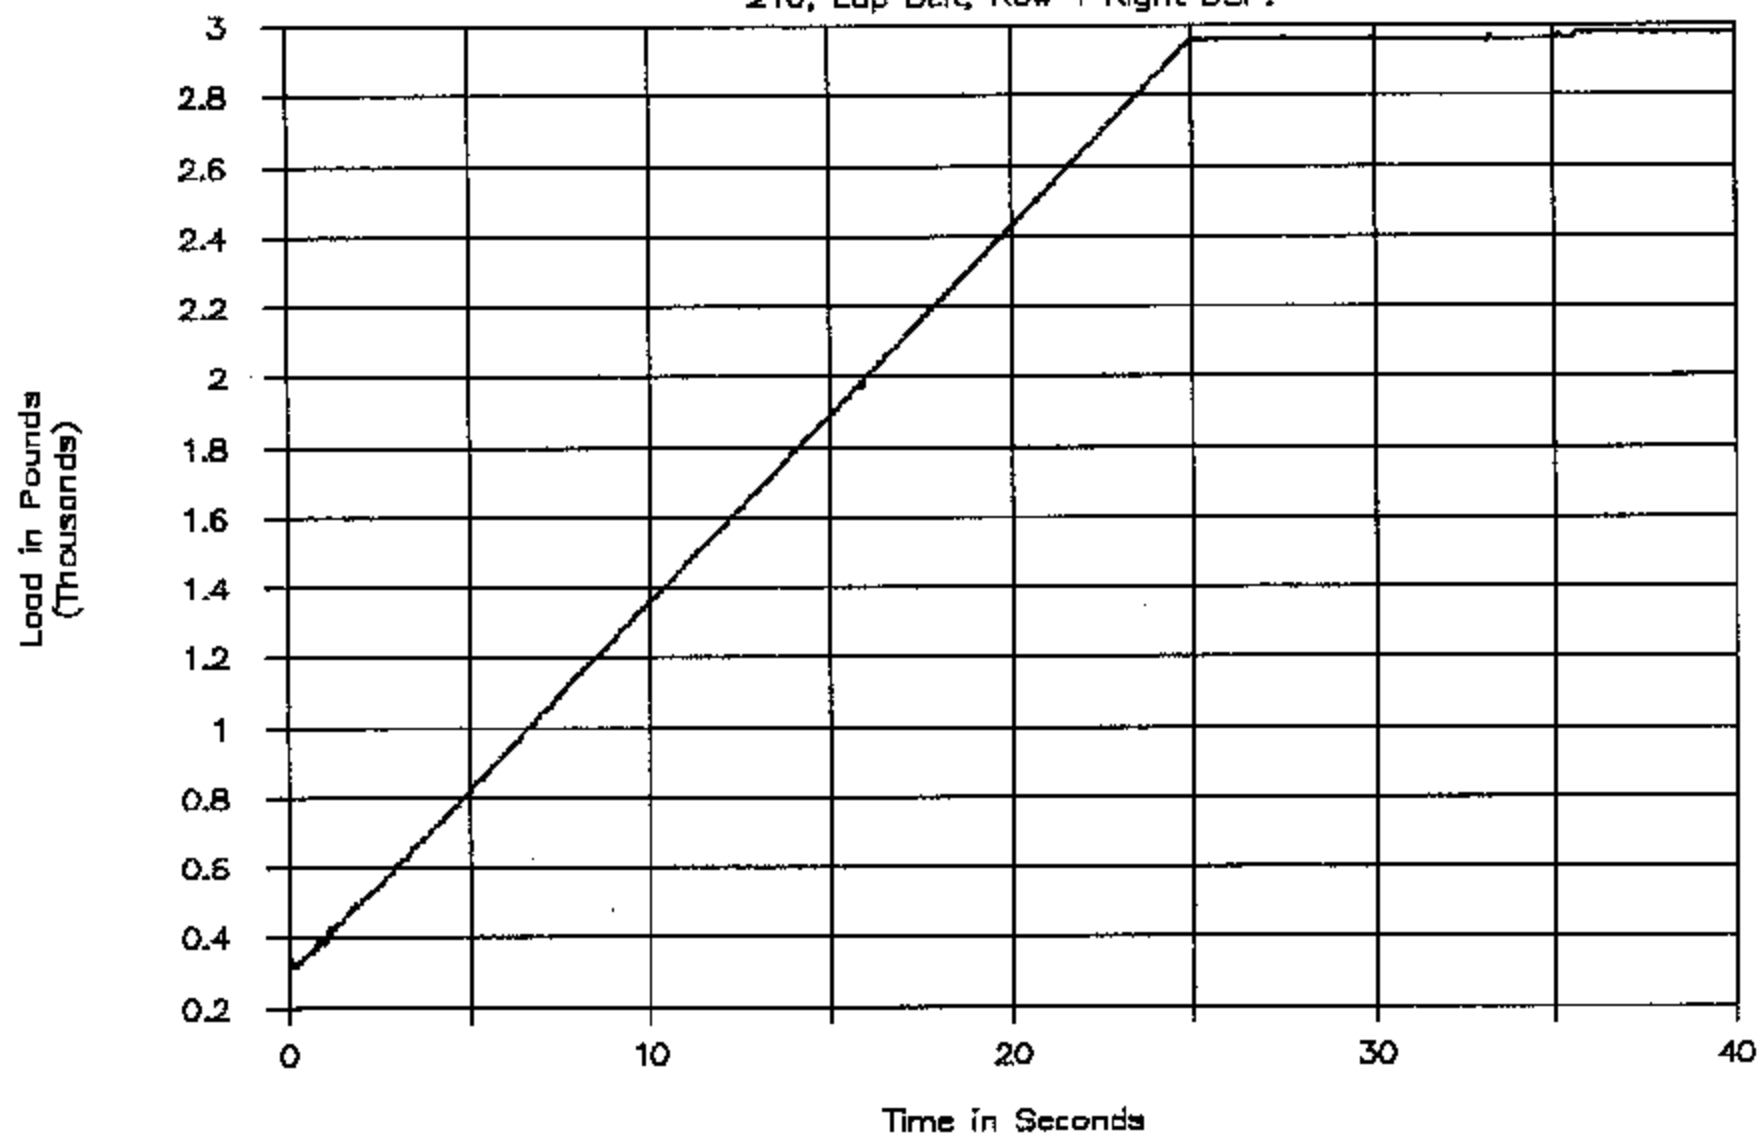
GTL 5305, NHTSA C55104

210, Lap Belt, Row 1 Right DSP.

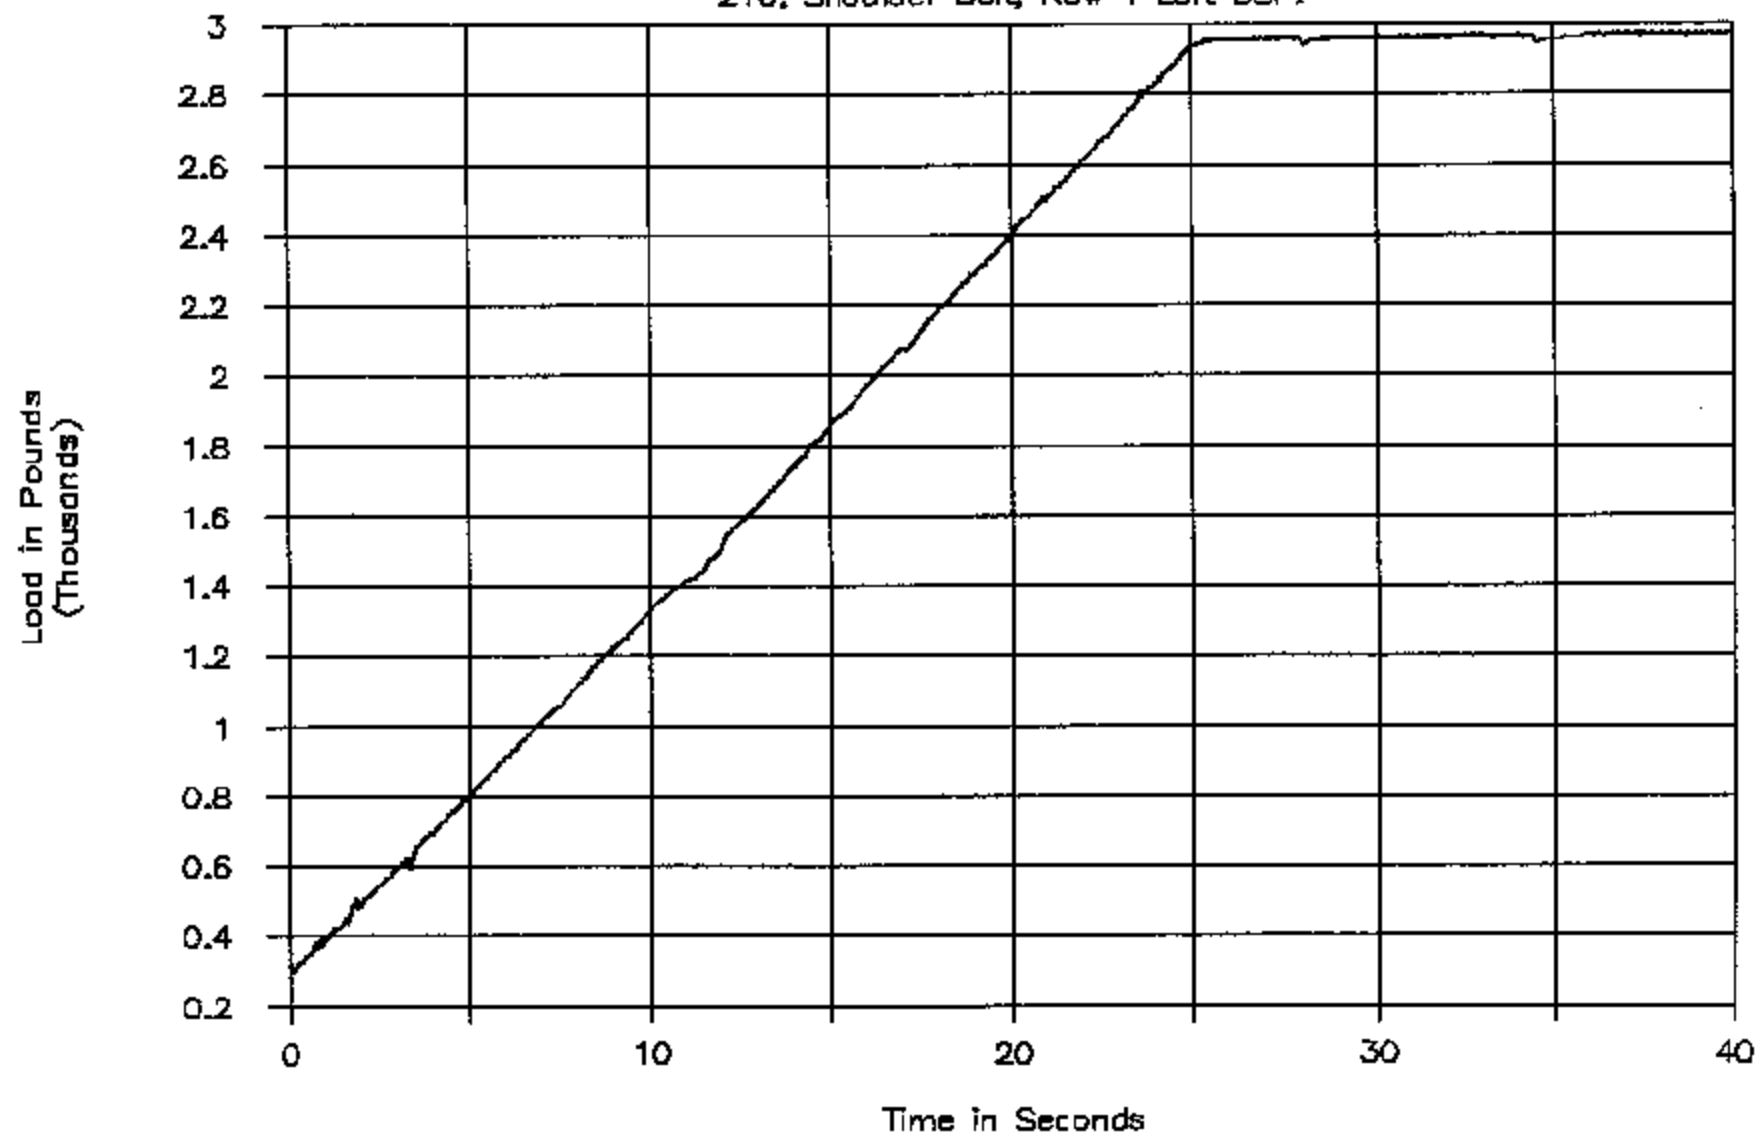
GTL 5305, NHTSA C55104

210, Shoulder Belt, Row 1 Left DSP.

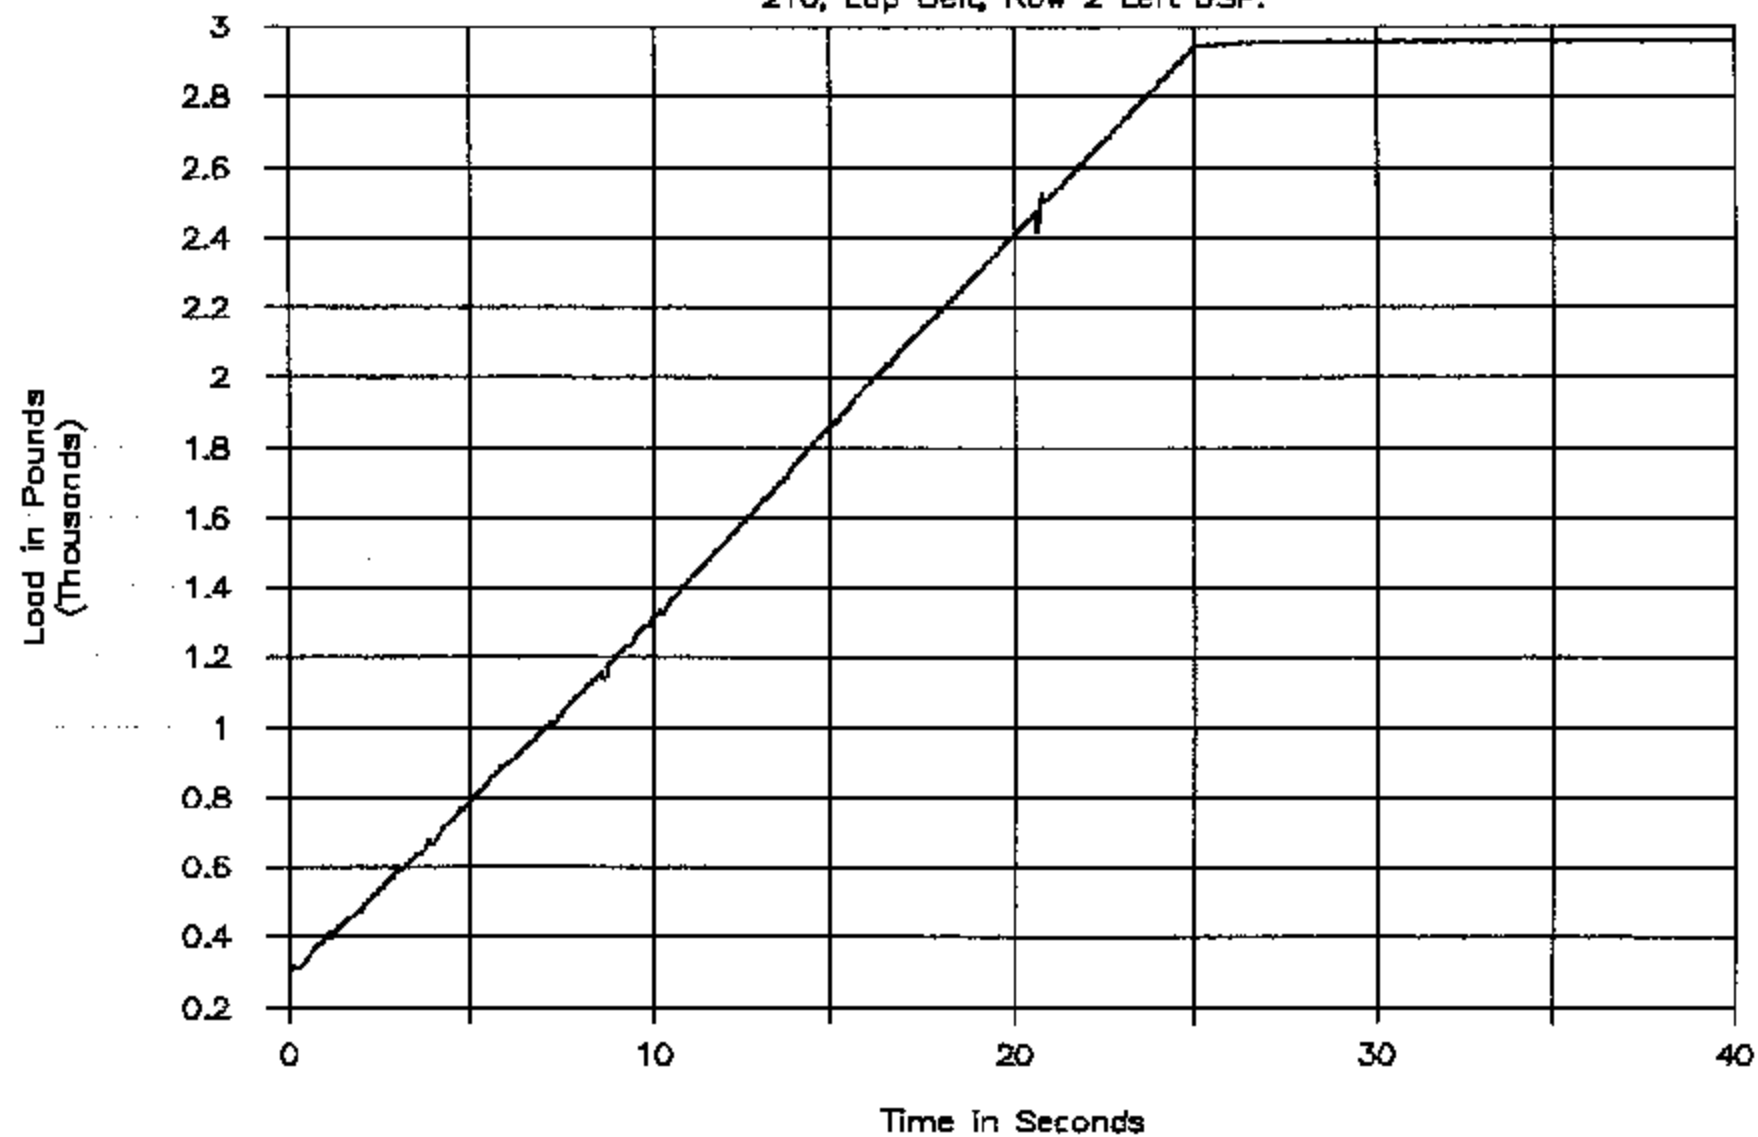
GTL 5306, NHTSA C55104

210, Lap Belt, Row 2 Left DSP.
