REPORT NUMBER 207-GTL-05-001

**FMVSS NO. 207  
INDICANT TEST**

**TOYOTA MOTOR MANUFACTURING,  
KENTUCKY, INC.  
2005 TOYOTA AVALON, PASSENGER CAR  
NHTSA NO. C55104**

**GENERAL TESTING LABORATORIES, INC.  
1623 LEEDSTOWN ROAD  
COLONIAL BEACH, VIRGINIA 22443**

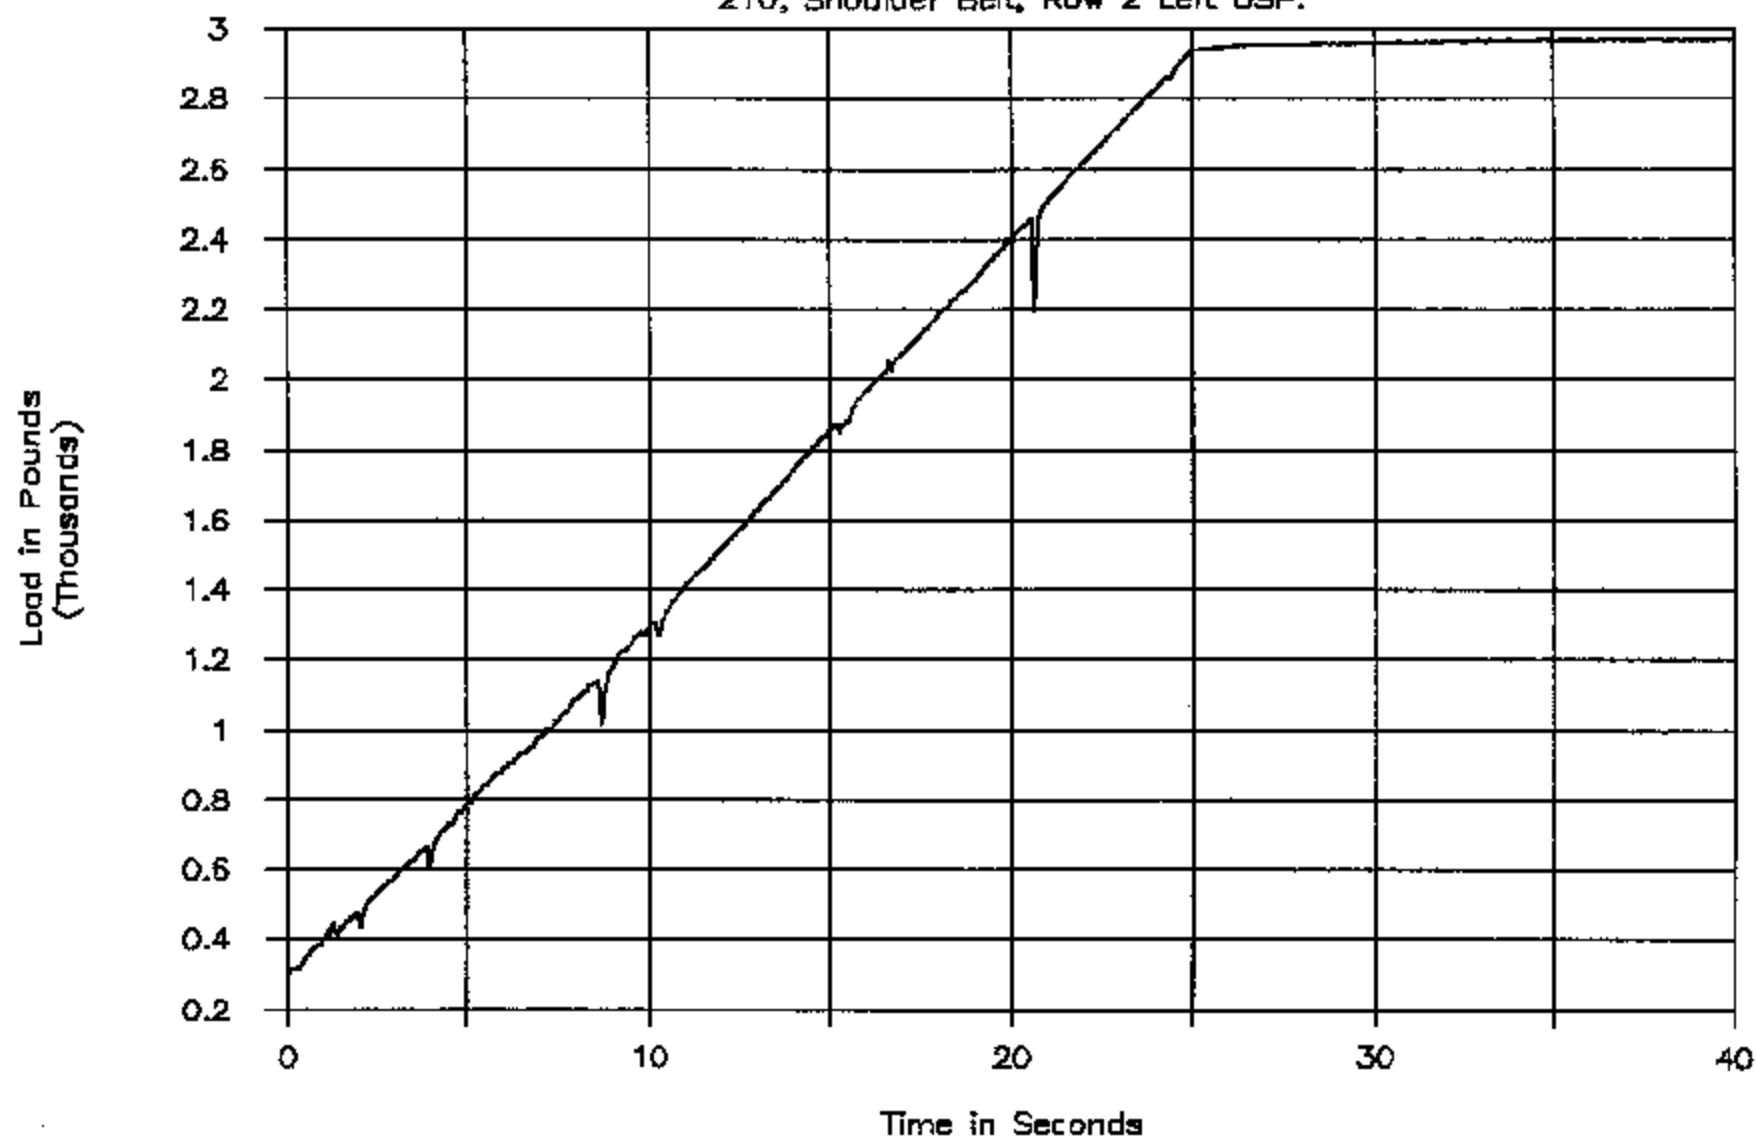
GTL 5306, NHTSA C55104

210, Shoulder Belt, Row 2 Left DSP.

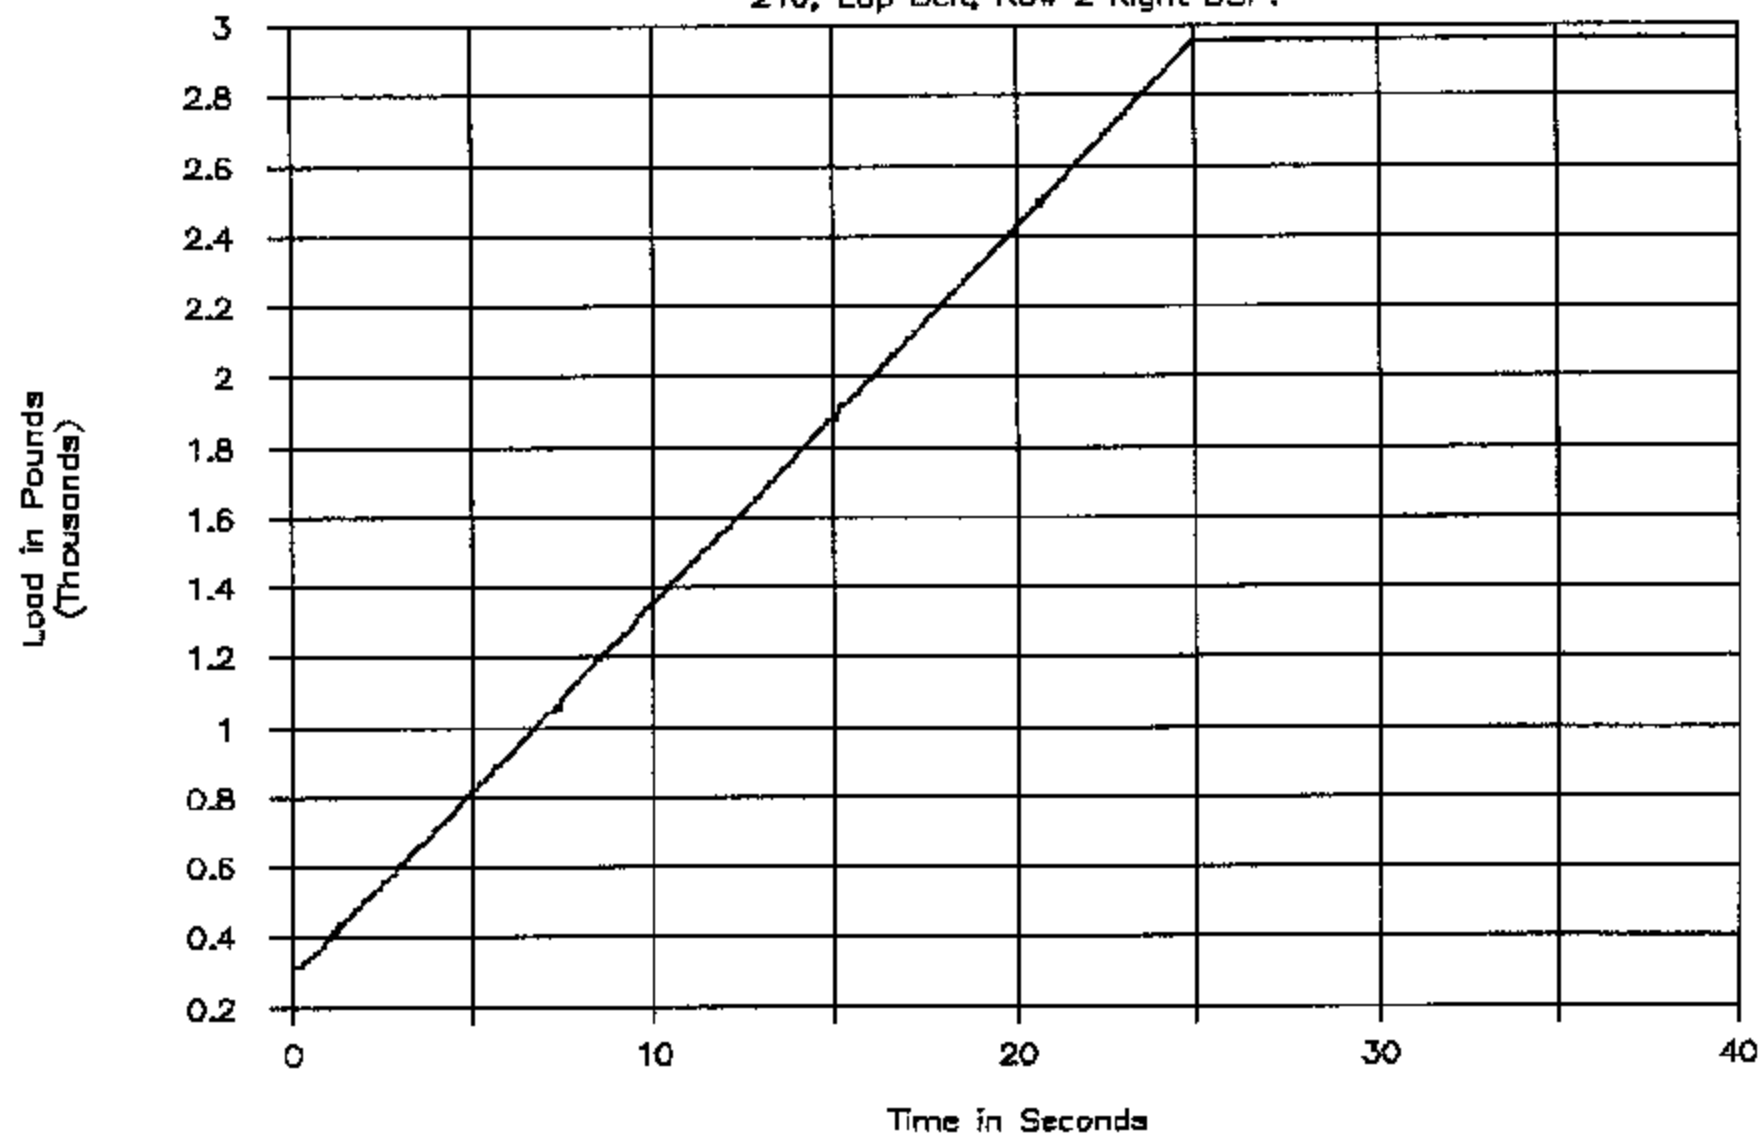
GTL 5306, NHTSA C55104

210, Lap Belt, Row 2 Right DSP.

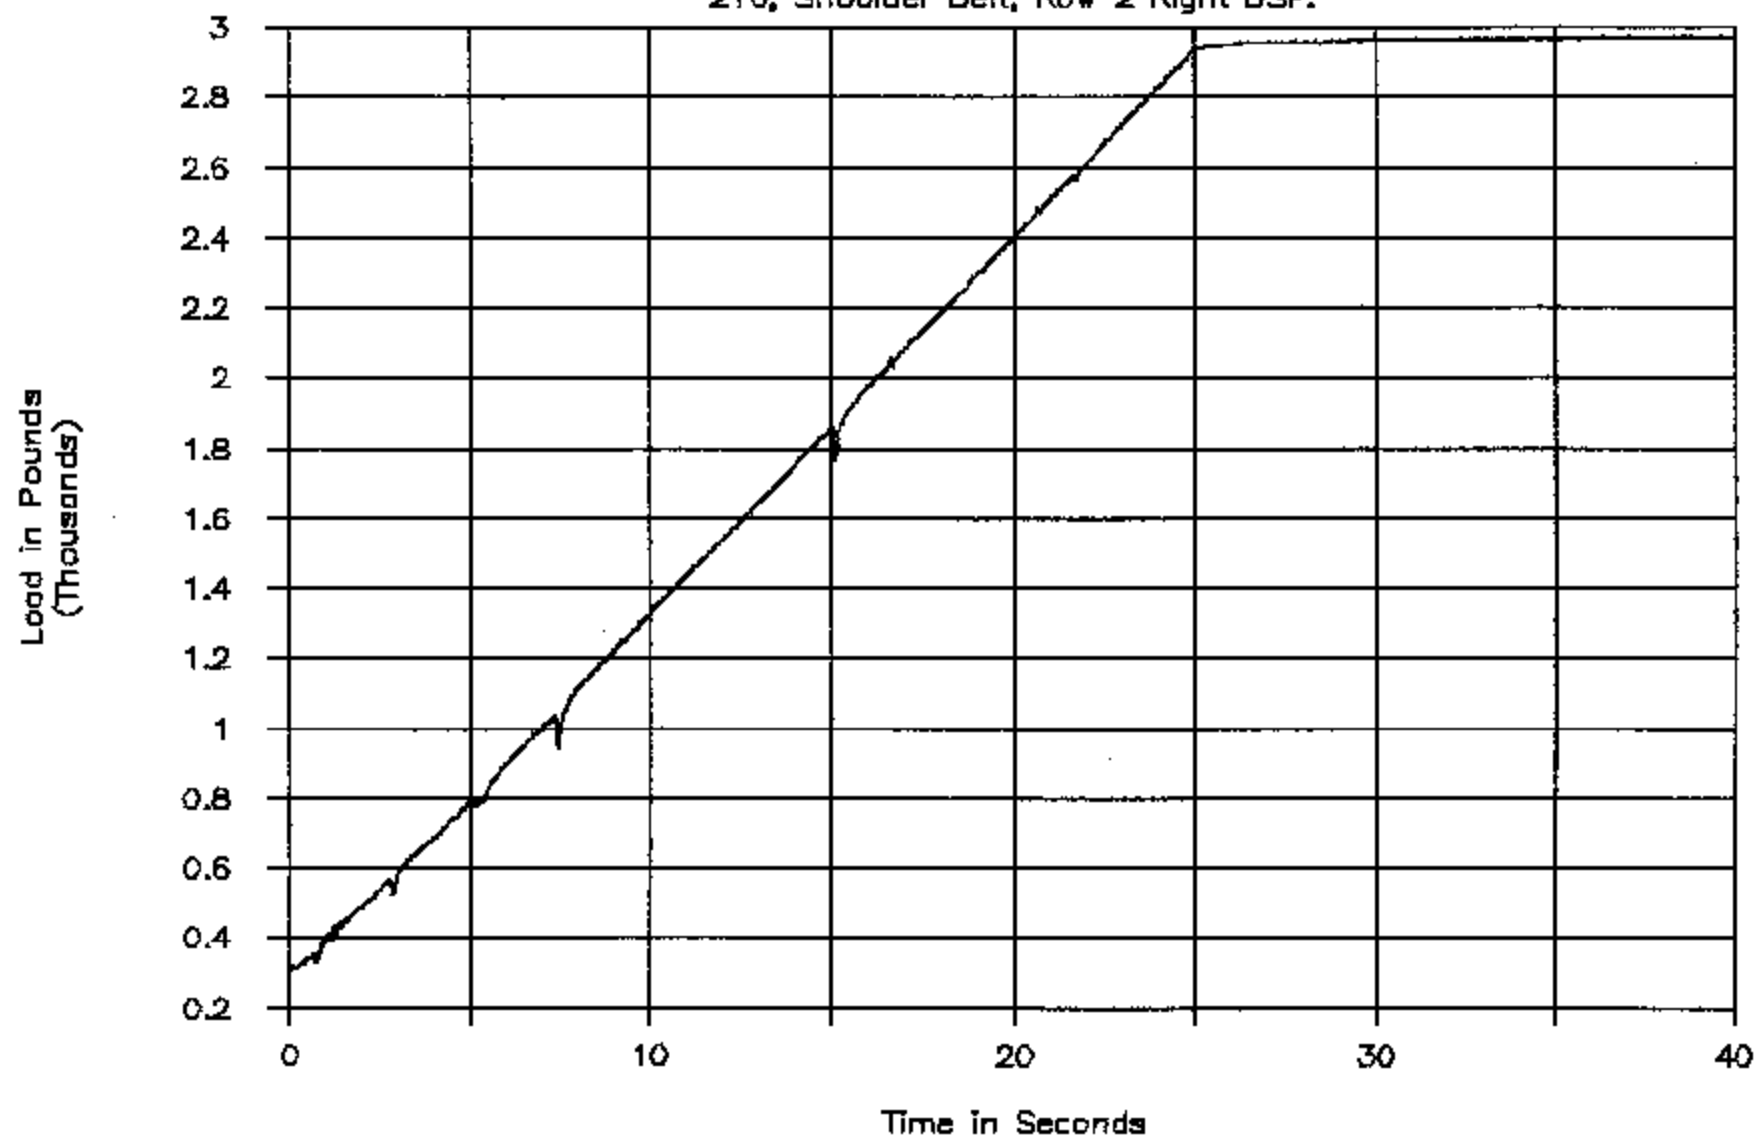
GTL 5306, NHTSA C55104

210, Shoulder Belt, Row 2 Right DSP.

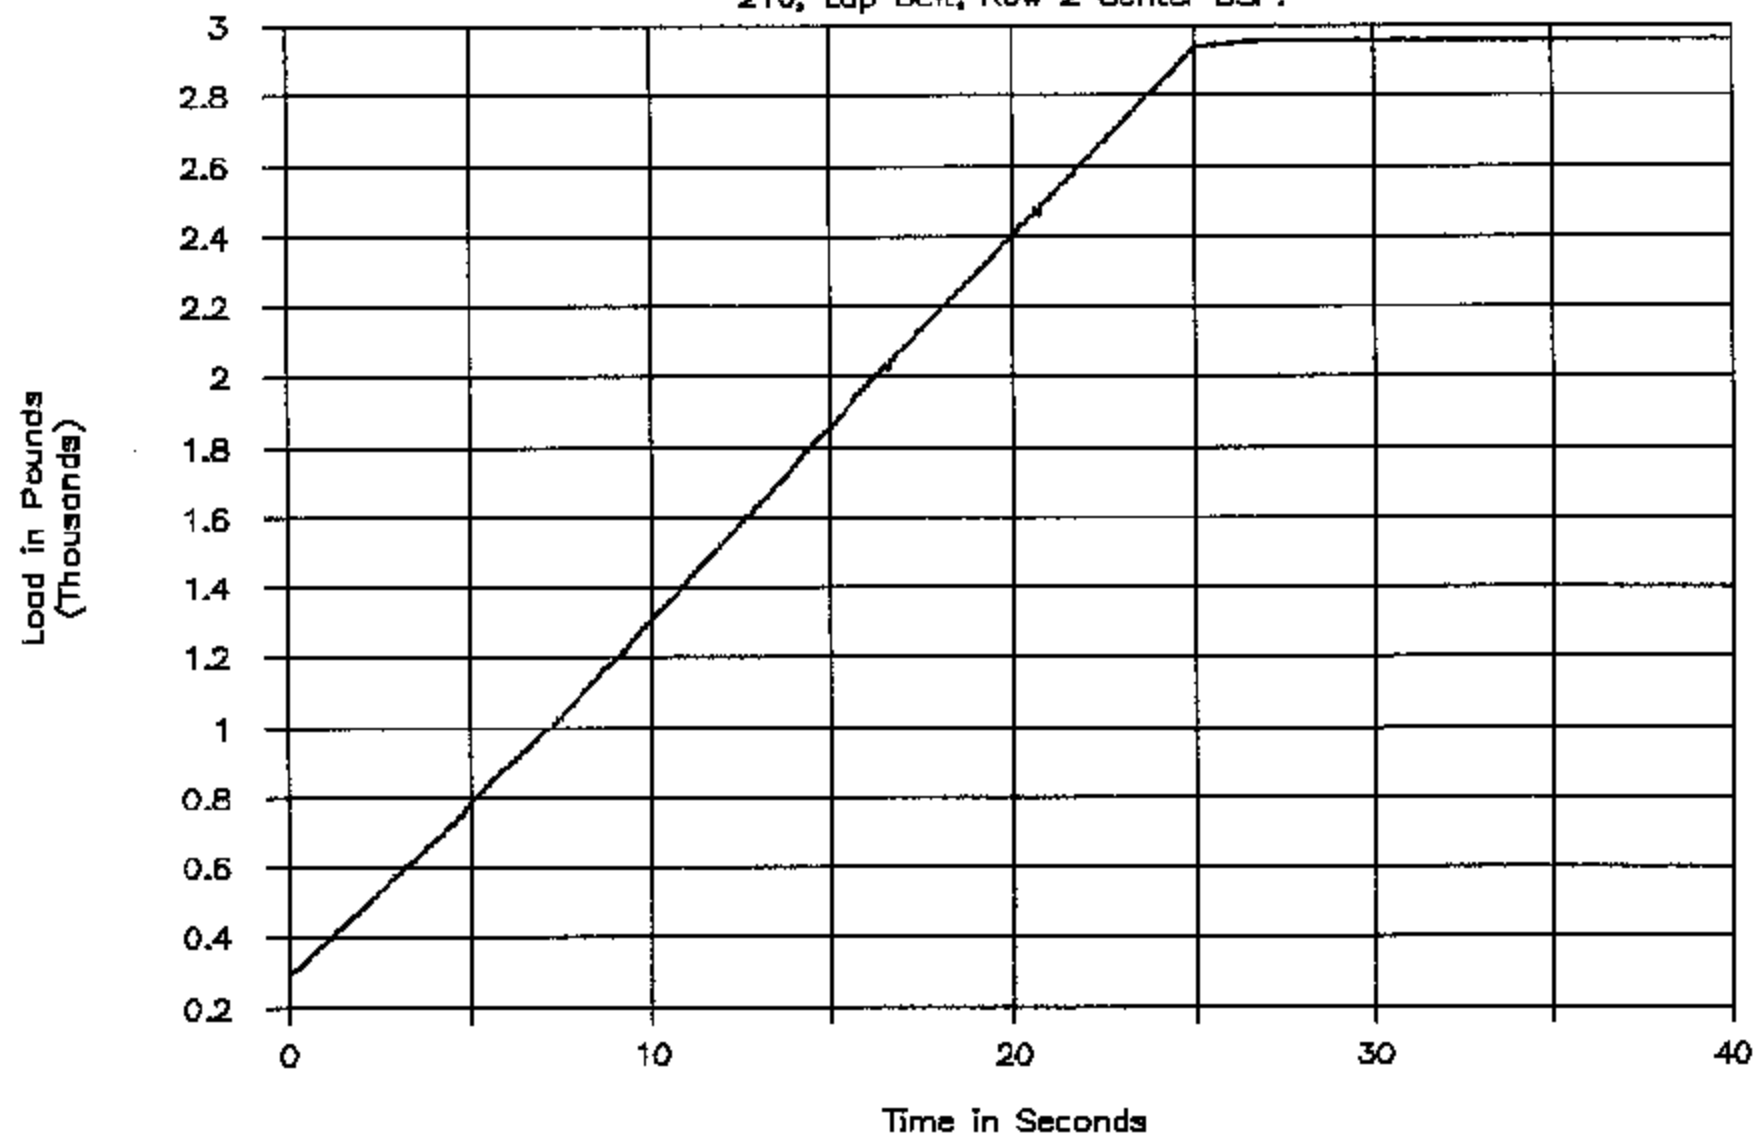
GTL 5306, NHTSA C55104

210, Lap Belt, Row 2 Center DSP.

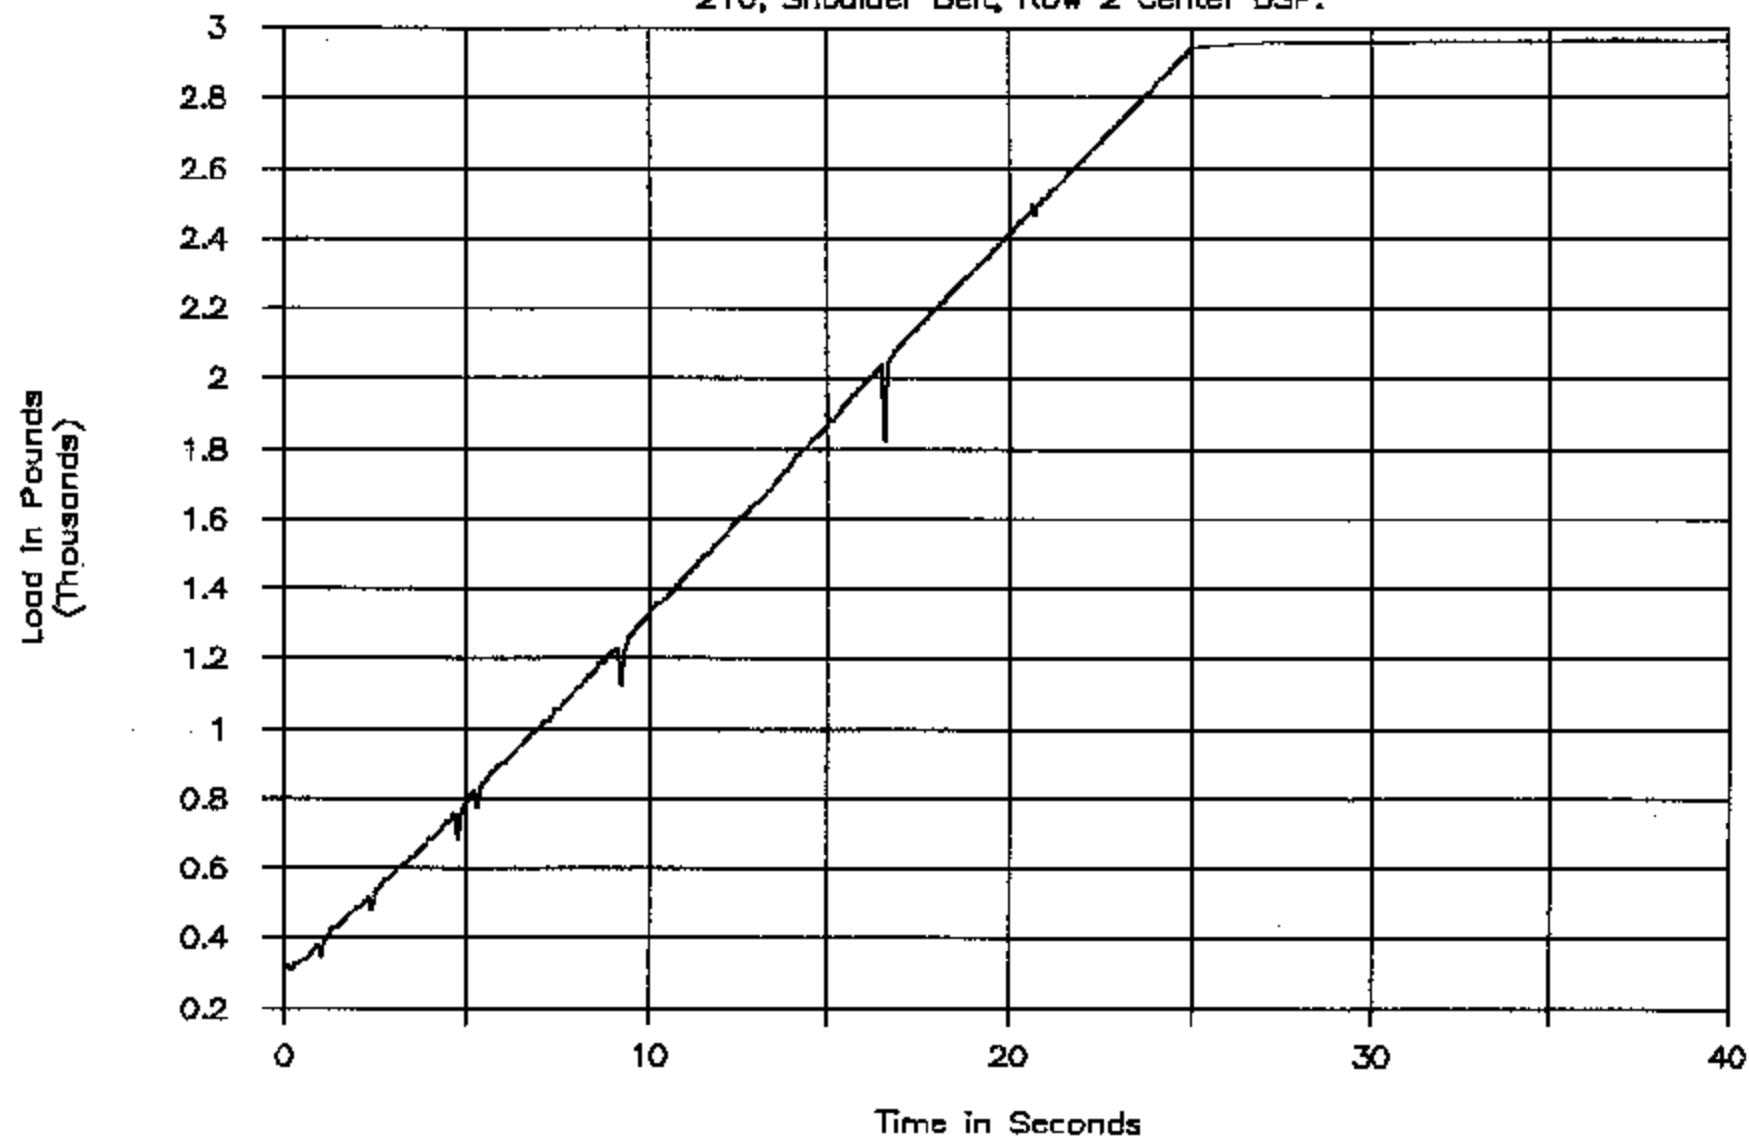
GTL 5306, NHTSA C55104

210, Shoulder Belt, Row 2 Center DSP.
