REPORT NUMBER 207-GTL-05-002

**FMVSS NO. 207
INDICANT TEST**

**VOLKSWAGEN AG GERMANY
2005 VOLKSWAGEN PASSAT, PASSENGER CAR
NHTSA NO. C55800**

**GENERAL TESTING LABORATORIES, INC.
1623 LEEDSTOWN ROAD
COLONIAL BEACH, VIRGINIA 22443**

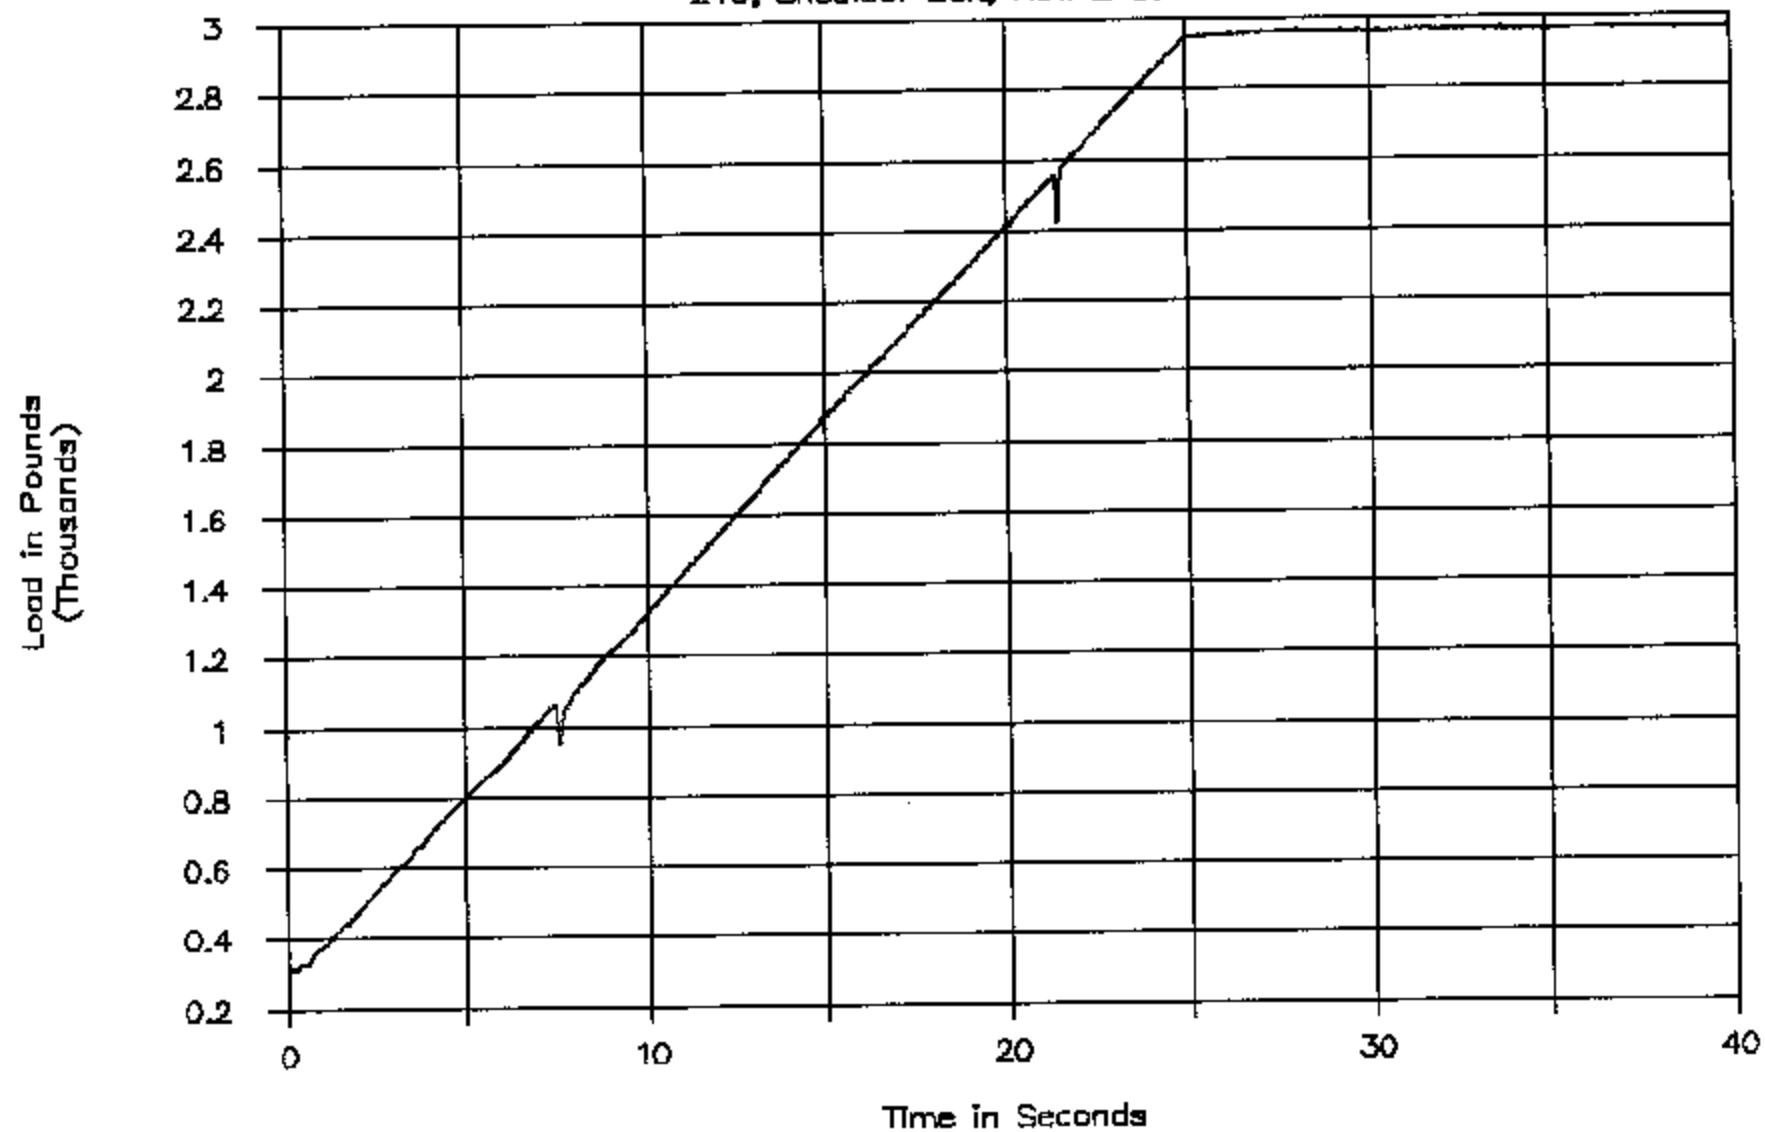
GTL 5309, NHTSA C55800.

210, Shoulder Belt, Row 2 Center DSP.

SEAT	BELT ASSEMBLY TESTED	MAXIMUM LOAD REQUIREMENT	APPLIED LOAD
FRONT GTL TEST #5307*	Left Lap	3000 lbs, -10, -50	2968
	Left Shoulder	3000 lbs, -10, -50	2990
	Right Lap	3000 lbs, -10, -50	2965
	Right Shoulder	3000 lbs, -10, -50	2846
FRONT GTL TEST #5308 RETEST OF 5307	Left Lap	3000 lbs, -10, -50	2975
	Left Shoulder	3000 lbs, -10, -50	2967
	Right Lap	3000 lbs, -10, -50	2981
	Right Shoulder	3000 lbs, -10, -50	2972
REAR GTL TEST #5309	Left Lap	3000 lbs, -10, -50	2975
	Left Shoulder	3000 lbs, -10, -50	3022
	Right Lap	3000 lbs, -10, -50	2979
	Right Shoulder	3000 lbs, -10, -50	2972
	Center Lap	3000 lbs, -10, -50	2960
	Center Shoulder	3000 lbs, -10, -50	2983
