**SAFETY COMPLIANCE TESTING FOR
FMVSS NO. 110
TIRE SELECTION AND RIMS**

**DAIMLERCHRYSLER CORPORATION
2005 CHRYSLER 300, 4-DOOR PASSENGER CAR
NHTSA NO. C50306**

FINAL REPORT

1. Report No. 110-GTL-05-004	2. Government Accession No. N/A	3. Recipient's Catalog No. N/A
4. Title and Subtitle Final Report of FMVSS 110 Compliance Testing of 2005 CHRYSLER 300 PASSENGER CAR NHTSA No. C50308		5. Report Date July 5, 2005

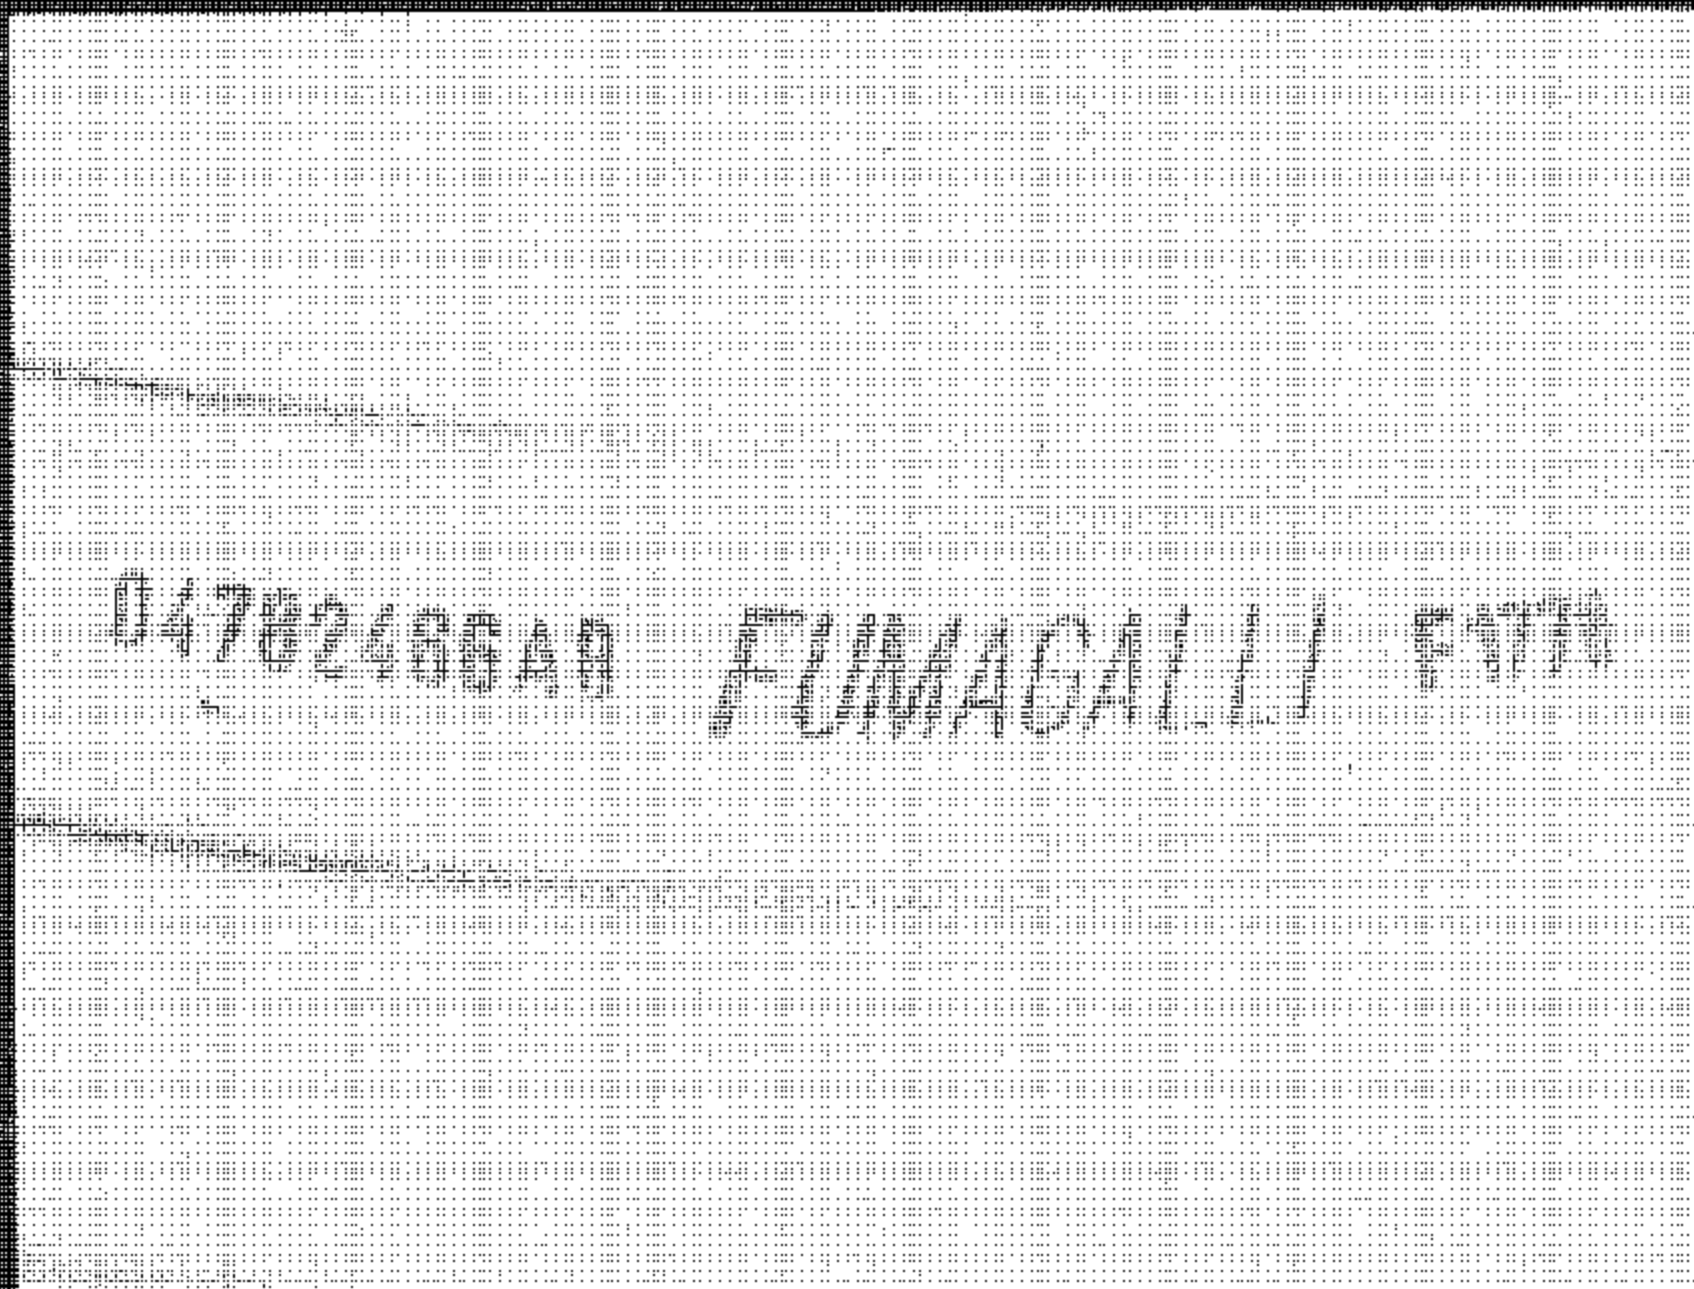
FIGURE 5.18
OTHER RIM MARKINGS

Rim Manufacturer's Name or Label: FUMAGALLI

Other Rim/Wheel Marking: 04782486AB, F1, 08 26 04
