**SAFETY COMPLIANCE TESTING FOR FMVSS 201U**  
**Occupant Protection In Interior Impact**  
**Upper Interior Head Impact Protection**

**HYUNDAI MOTOR COMPANY**  
**2005 Hyundai Tucson 4-Door MPV**  
**NHTSA No. C50506**

**FINAL REPORT**

| 4. Title and Subtitle<br>Final Report of FMVSS 201U Compliance Testing of a<br>2005 Hyundai Tucson 4-Door MPV, NHTSA No. C50506 | | 5. Report Date<br>May 27, 2006 | |

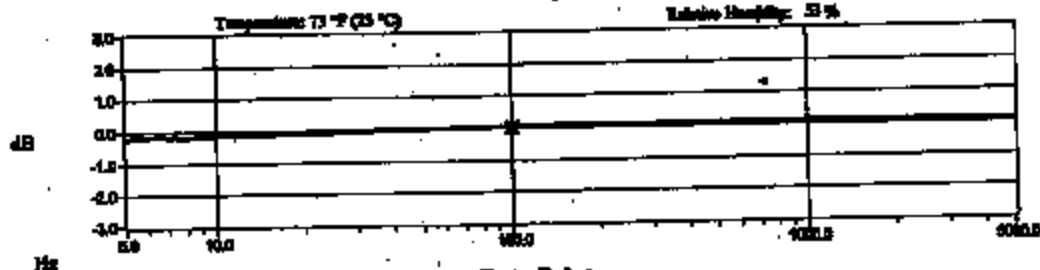
## Sensitivity

Sensitivity @ 100.0 Hz: 31.17 mV/g Output Bias: 0.6 VDC  
(3.179 mV/ms<sup>2</sup>) Transverse Sensitivity: 3.0 %
