**REPORT NUMBER: 214-CAL-07-03**

**SAFETY COMPLIANCE TESTING FOR FMVSS 214  
SIDE IMPACT PROTECTION  
INDICANT**

**GENERAL MOTORS CORPORATION  
2007 PONTIAC SOLSTICE  
2-DOOR CONVERTIBLE**

**NHTSA NUMBER: C70101**

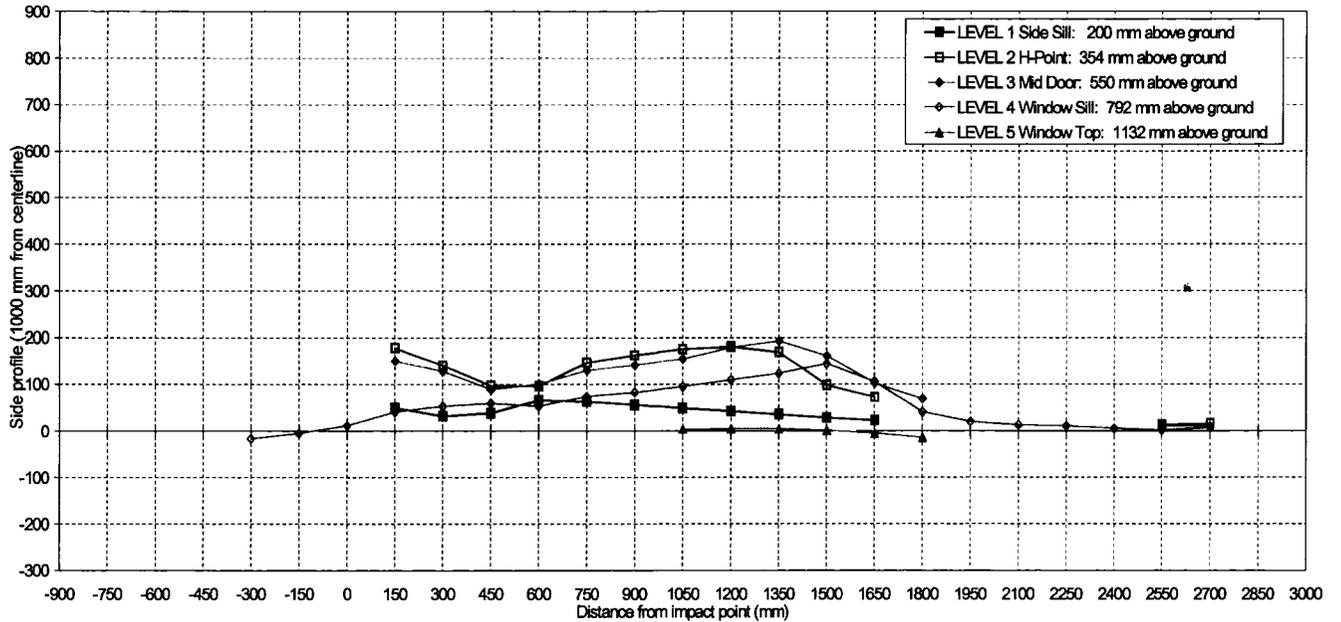
## VEHICLE EXTERIOR CRUSH PROFILES

NOTE: All dimensions are in millimeters with a tolerance of ±3 mm

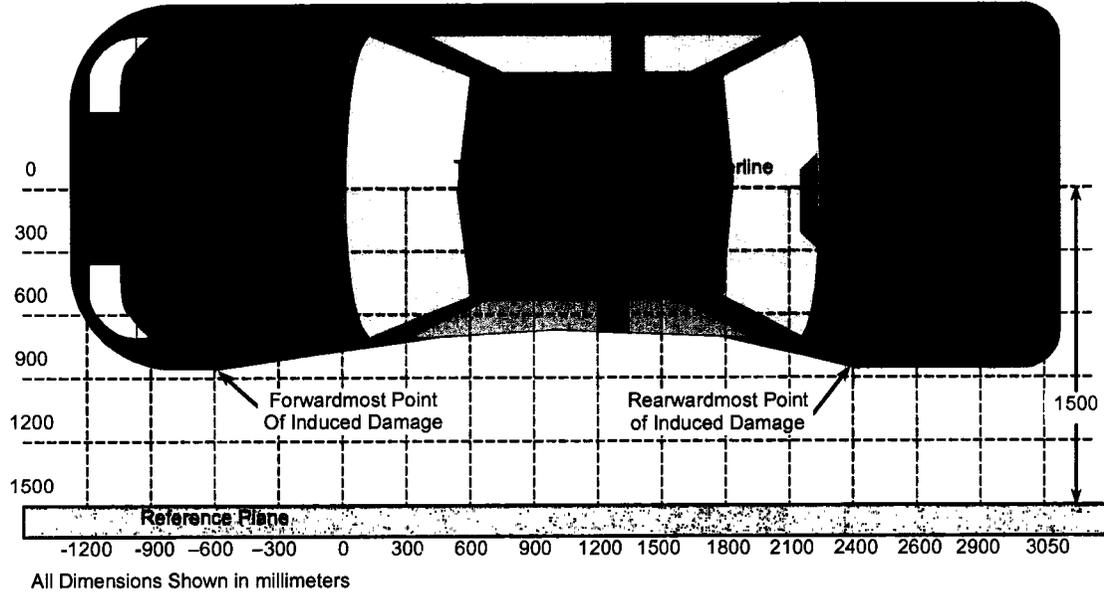
**VEHICLE DAMAGE PROFILE DISTANCES**

**TOP VIEW**

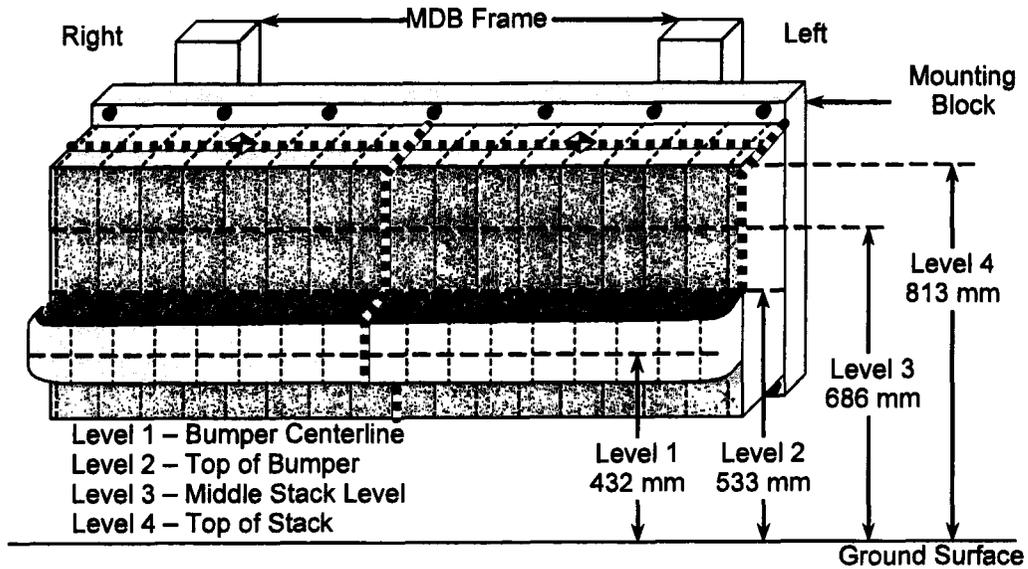
**DEFORMABLE BARRIER HONEYCOMB FACE STATIC CRUSH**

NOTE: All dimensions are in millimeters with a tolerance of  $\pm 3$  mm

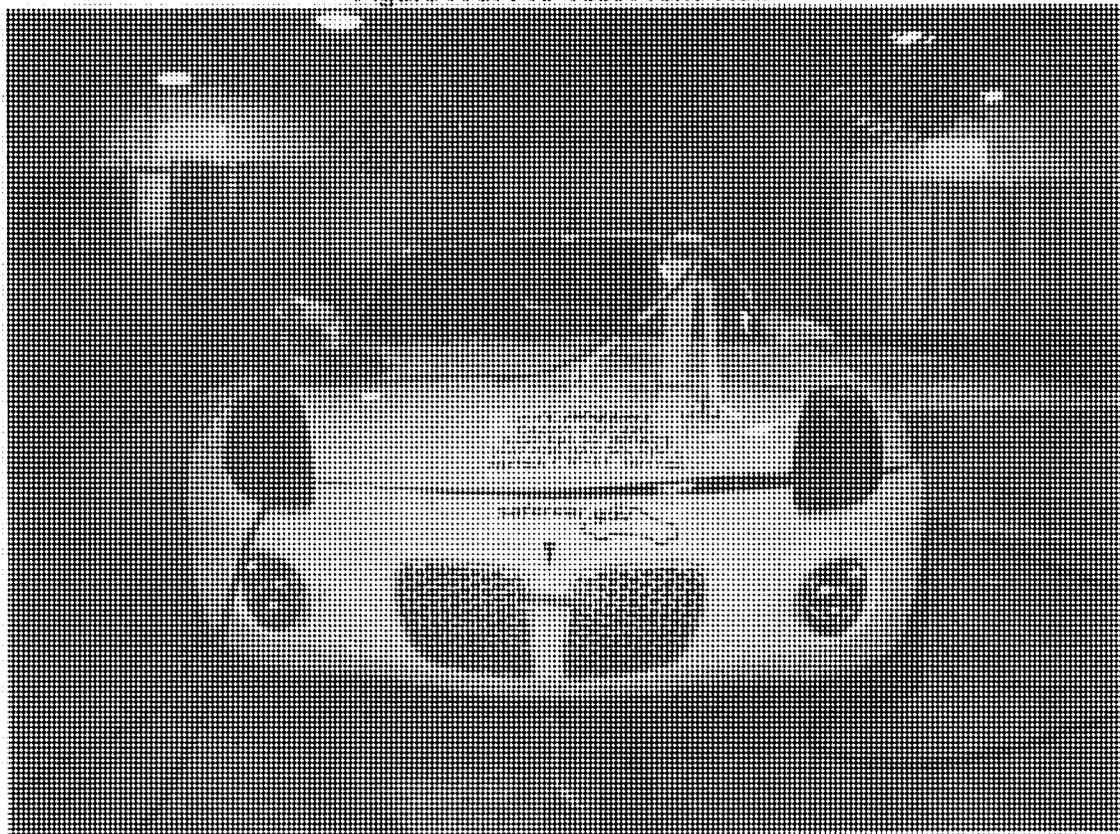
Figure A-6: Post-Test Front View

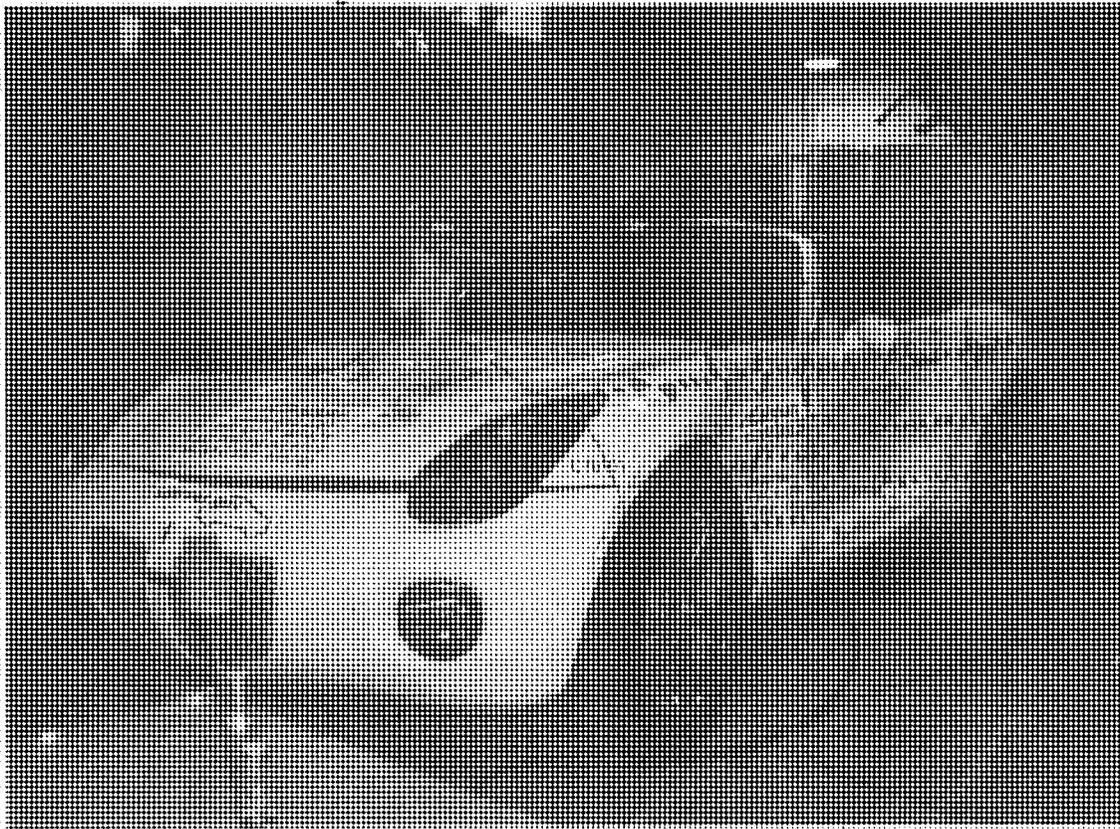
Figure A-8: Post-Test Left Front 1/4 View

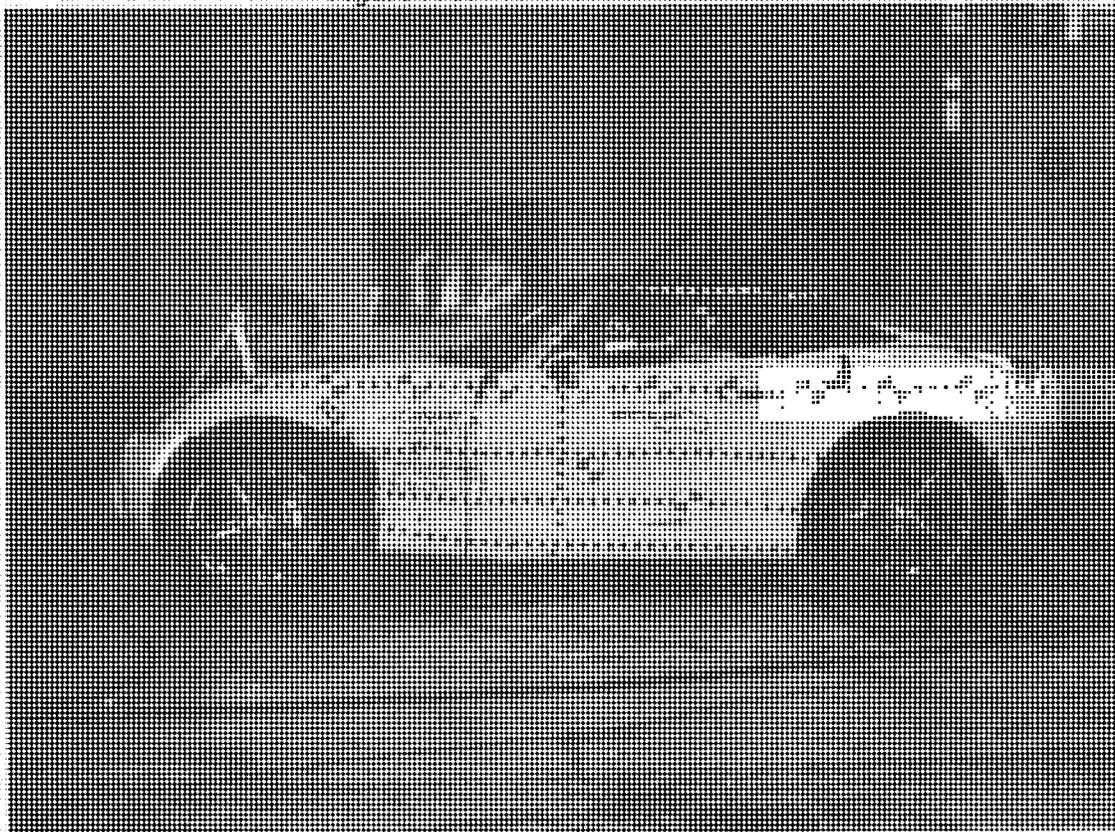
Figure A-10: Post-Test Left Side View

The test vehicle sustained a maximum static crush of 194 mm at level 3, 1350 mm rearward of the left vertical impact point. The driver SID/HIII, Serial No. 906, was calibrated just prior to this test.

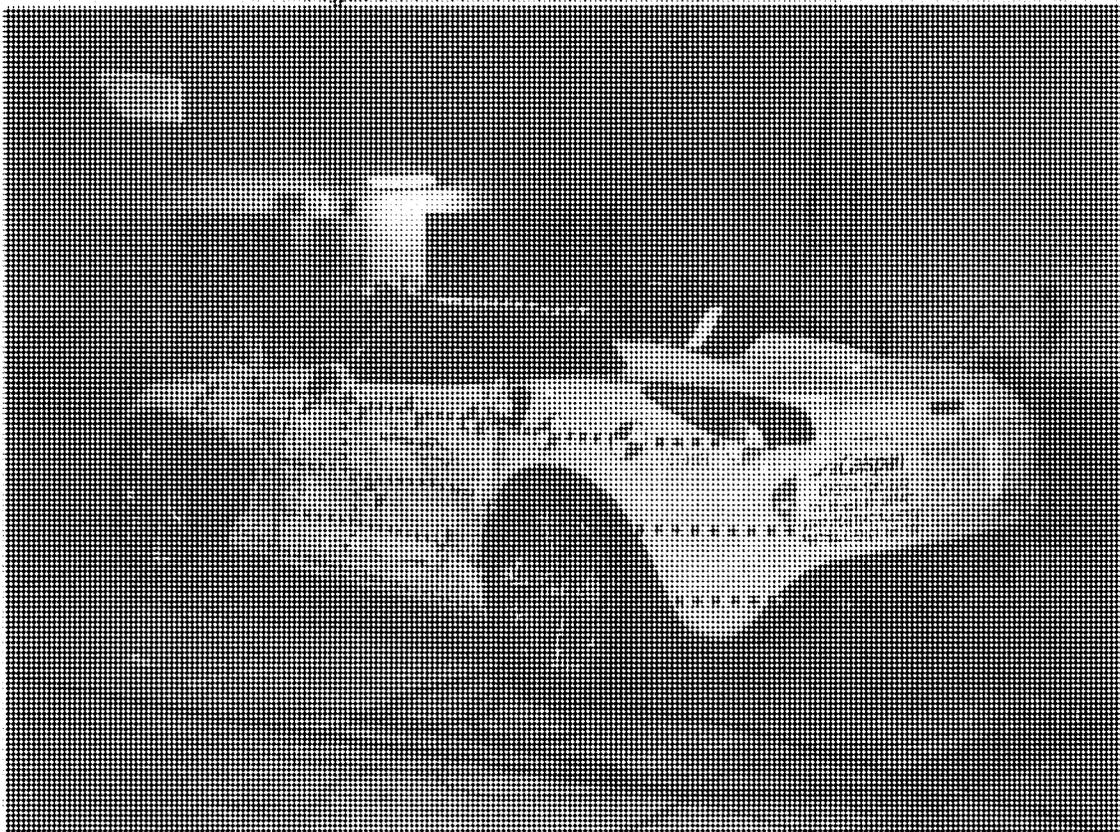
Figure A-12: Post-Test Left Rear 3/4 View

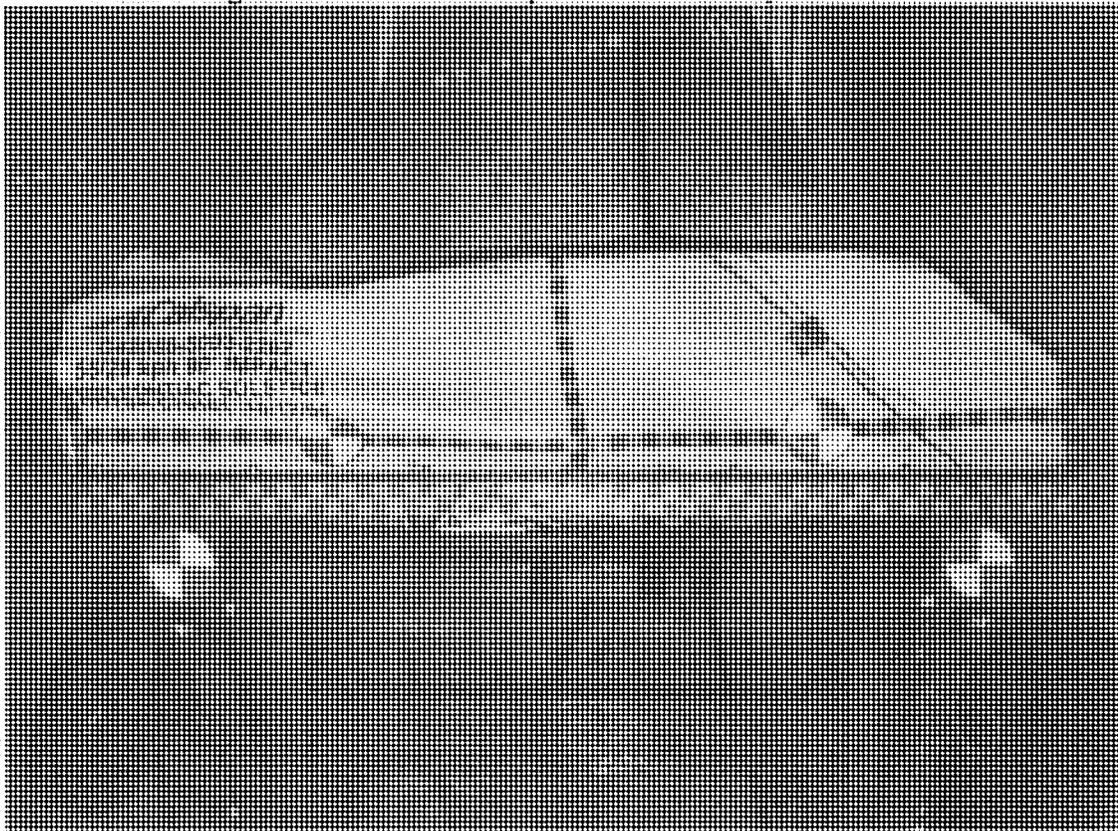
Figure A-28: Post-Test Top View of MDB Impactor Face

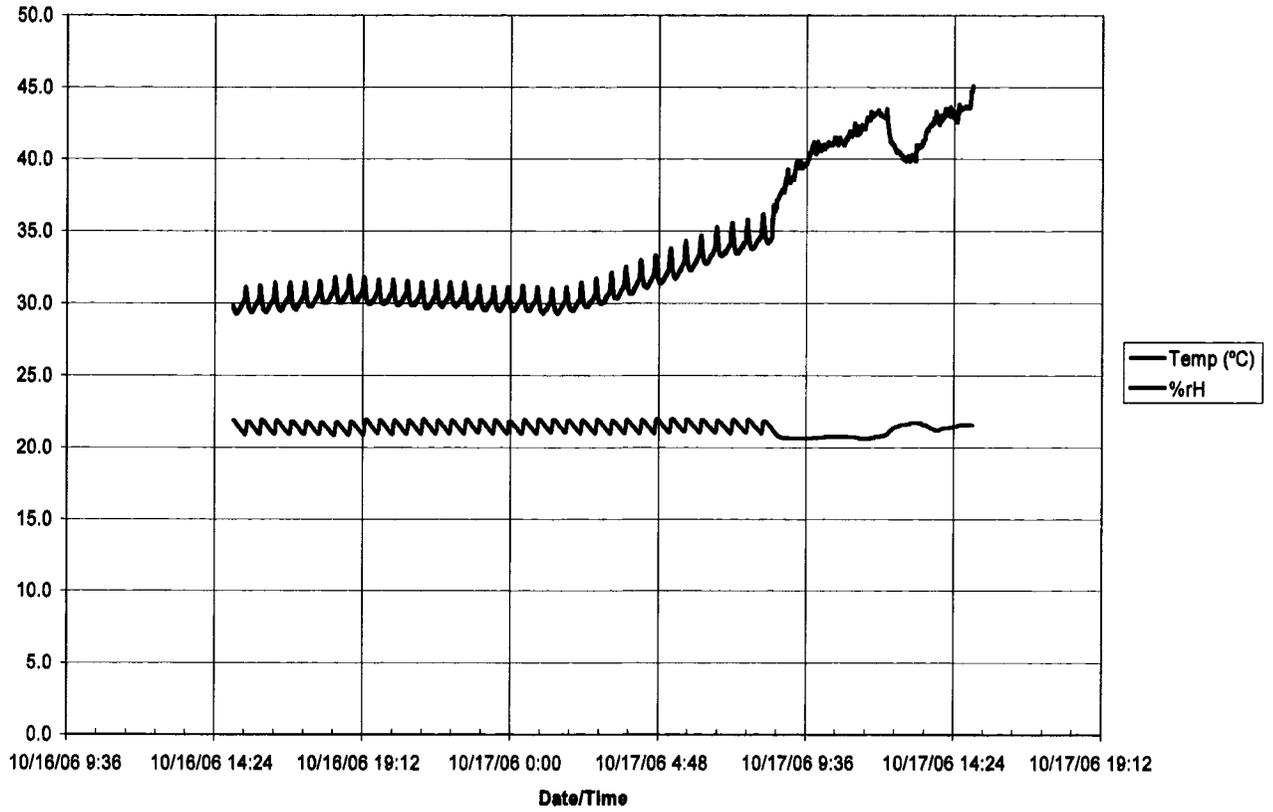
# TEMPERATURE TRACE

## 2007 Pontiac Soletice C70101 Environmental Conditions
