**REPORT NUMBER: 214-CAL-07-04**

**SAFETY COMPLIANCE TESTING FOR FMVSS 214  
SIDE IMPACT PROTECTION  
INDICANT**

**DAIMLERCHRYSLER  
2007 DODGE NITRO  
MPV**

**NHTSA NUMBER: C70304**

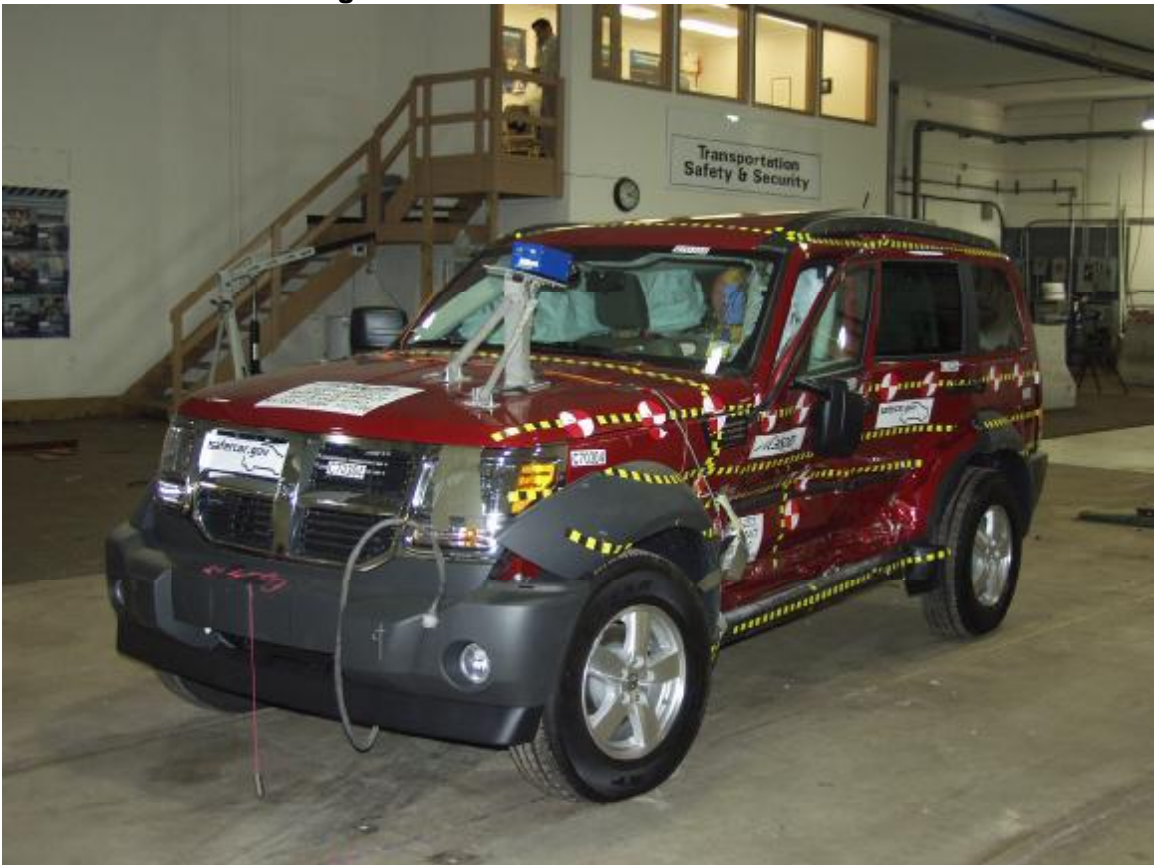
**Figure A-8: Post-Test Left Front  $\frac{3}{4}$  View**

Critical Areas of Performance	Observations and Conclusions
Pillar Performance	No Separation
Sill Separation	None
Windshield Damage	Left edge of the windshield cracked during the impact
Window Damage	None
Other Notable Effects	None

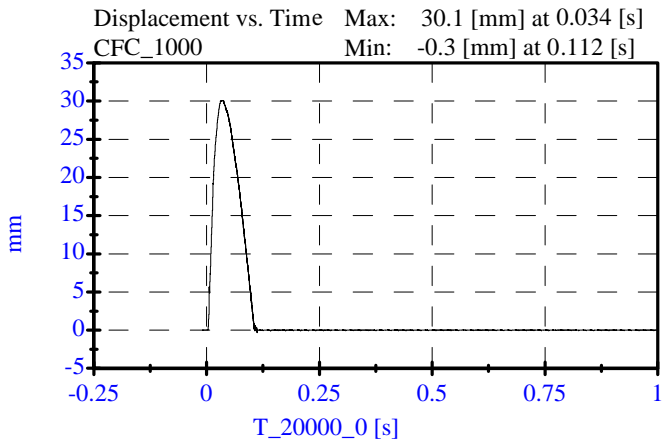
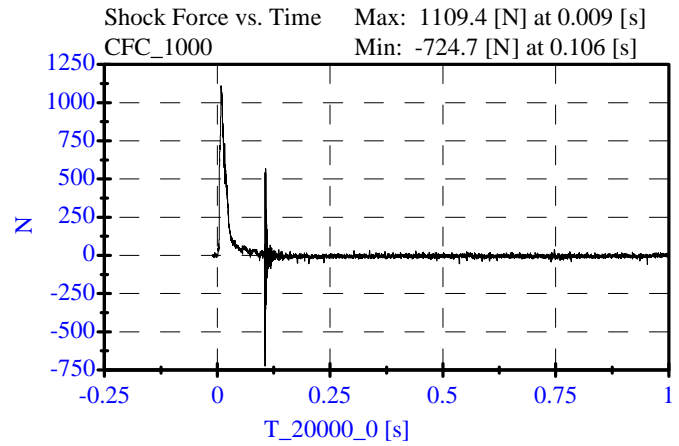
**SID Mid Speed Shock Test S/N:906 ( 4.27 m/s )**

<u>TEST PARAMETER</u>	<u>SPECIFICATION</u>	<u>TEST RESULTS</u>	<u>STATUS</u>
Lab Temperature:	18.9-25.5 C	21.1 C	Passed
Lab Humidity:	10-70 %	50.00 %	Passed
Displacement:	30.00-35.00 mm	30.05 mm	Passed
Maximum Force:	836.00-1125.00 N	1109.43 N	Passed
Impact Test Velocity:	3.05 m/s		
Damper Identification:	906		
Damper Setting:	5

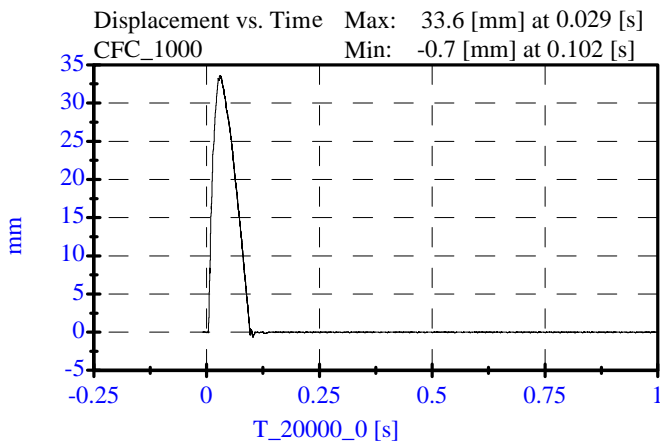
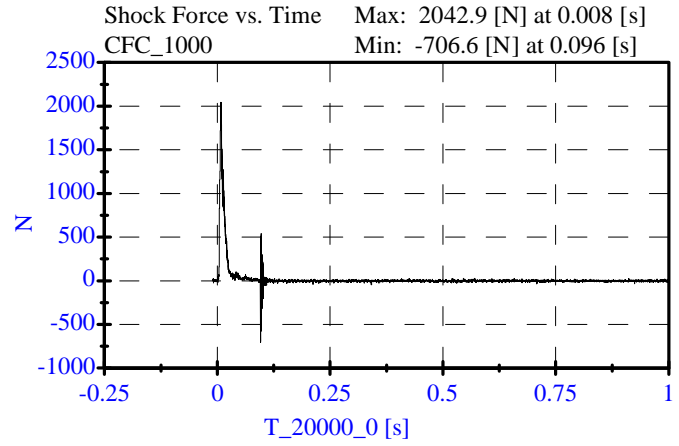
**SID High Speed Shock Test S/N:906 ( 6.10 m/s )**

<u>TEST PARAMETER</u>	<u>SPECIFICATION</u>	<u>TEST RESULTS</u>	<u>STATUS</u>
Lab Temperature:	18.9-25.5 C	21.1 C	Passed
Lab Humidity:	10-70 %	50.00 %	Passed
Displacement:	32.00-37.00 mm	33.58 mm	Passed
Maximum Force:	1730.00-2099.00 N	2042.90 N	Passed

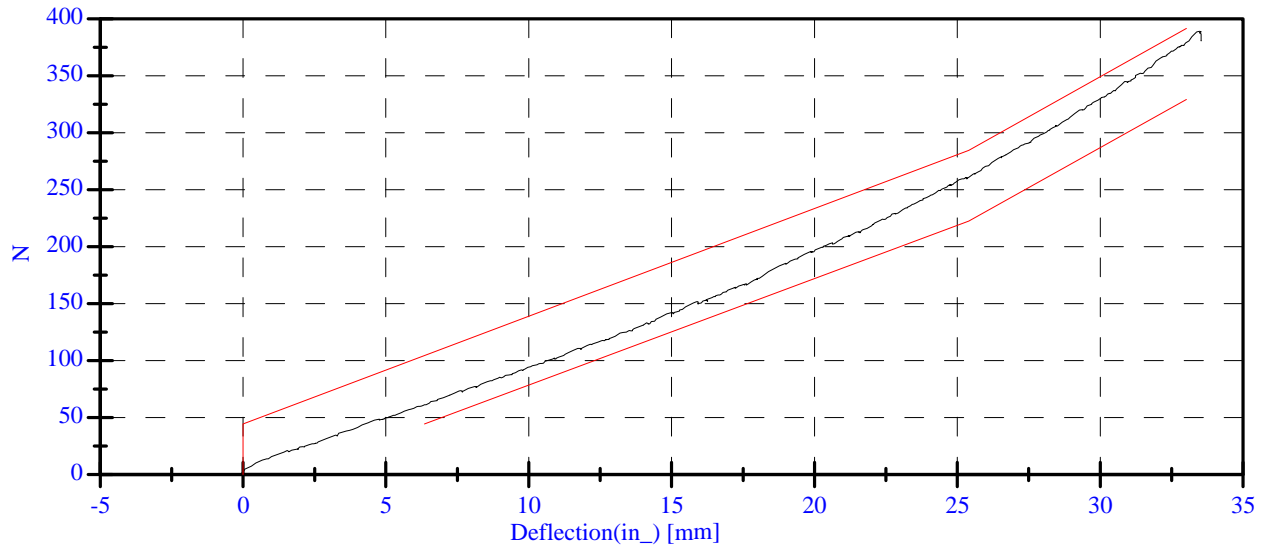
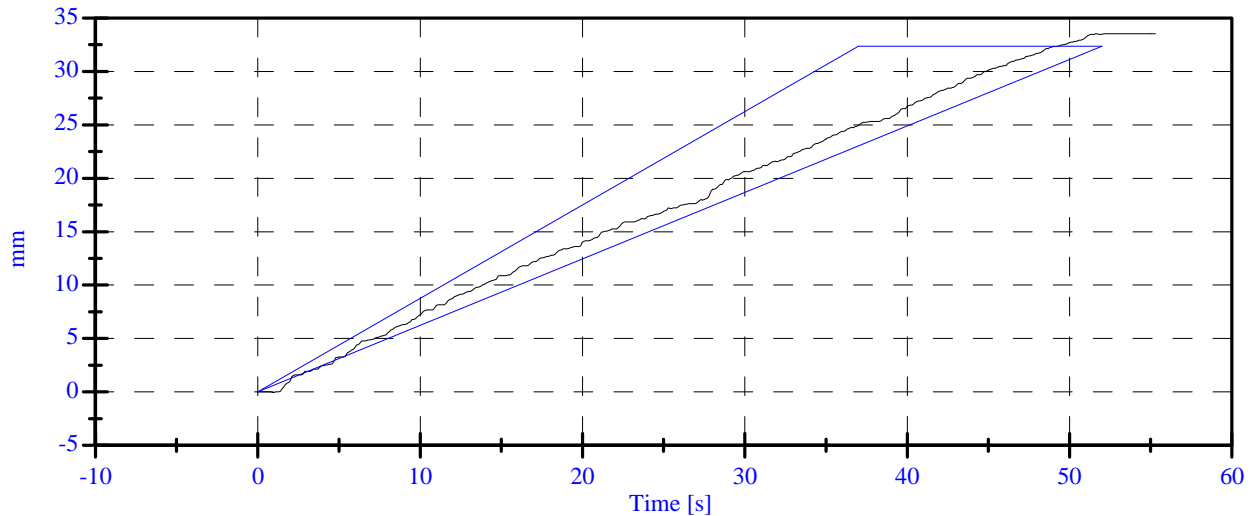
### ABDOMINAL COMPRESSION TEST

<u>TEST PARAMETER</u>	<u>SPECIFICATION</u>	<u>TEST RESULTS</u>	<u>STATUS</u>
Lab Temperature:	18.9-25.5 C	21.1 C	Passed
Lab Humidity:	10-70 %	41.00 %	Passed
Force at 12.95 mm :	104.00-162.00 N	121.50 N	Passed
Force at 19.05 mm :	162.98-220.99 N	185.30 N	Passed
Force at 25.40 mm :	221.97-280.02 N	260.70 N	Passed
Force at 33.02 mm :	324.99-391.00 N	378.87 N	Passed

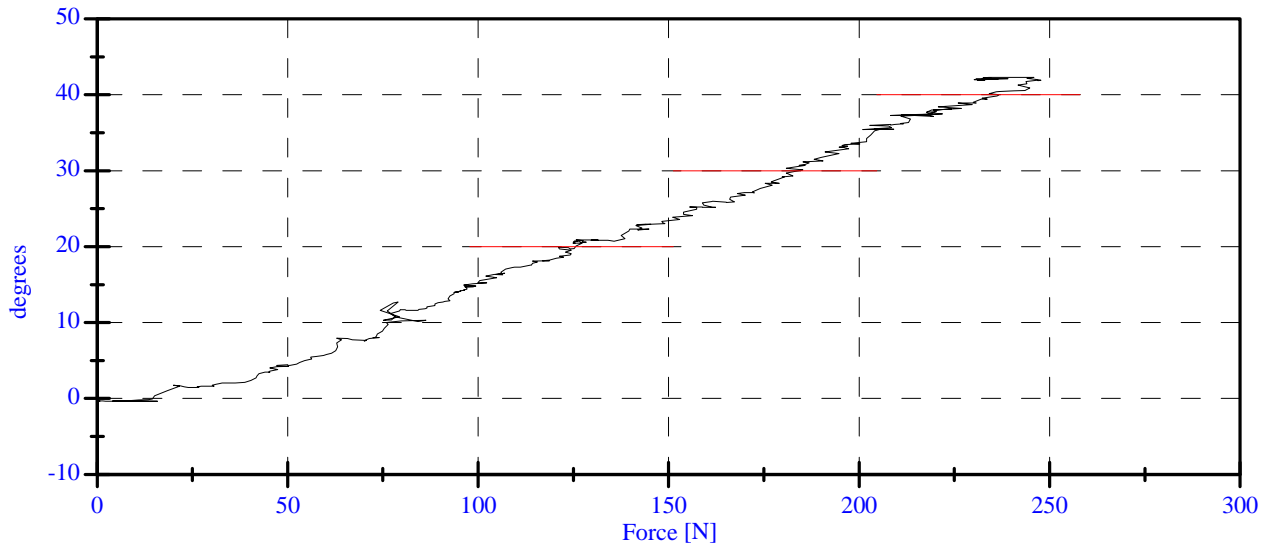
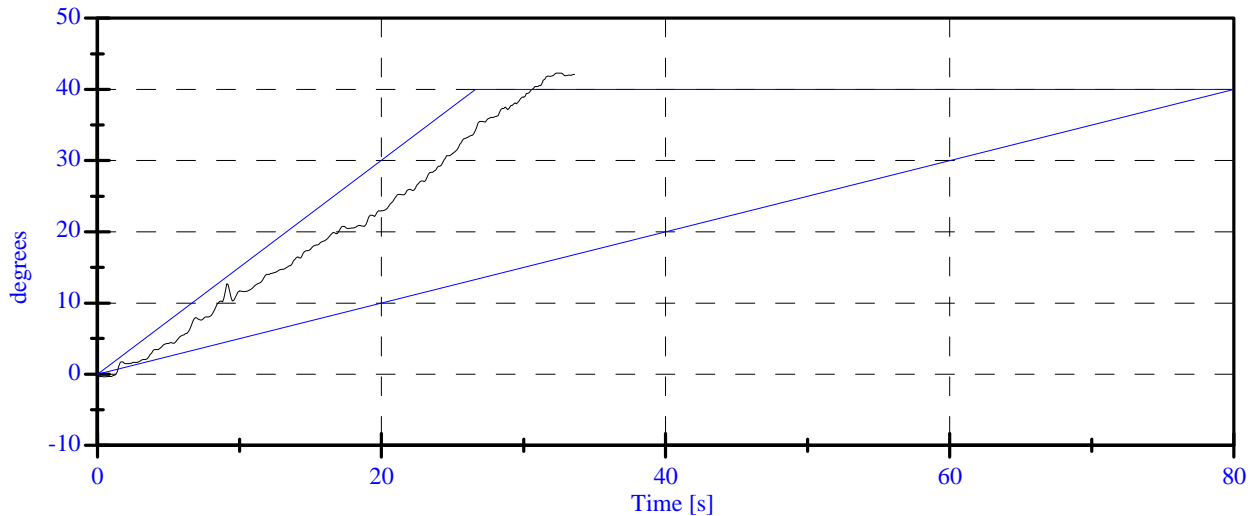
### LUMBAR SPINE FLEXION TEST

<u>TEST PARAMETER</u>	<u>SPECIFICATION</u>	<u>TEST RESULTS</u>	<u>STATUS</u>
Lab Temperature:	18.9-25.5 C	21.1 C	Passed
Lab Humidity:	10-70 %	31.00 %	Passed
Force at 0 Deg:	0.00-26.69 N	14.50 N	Passed
Force at 20 Deg:	97.86-151.24 N	125.75 N	Passed
Force at 30 Deg:	151.24-204.62 N	185.29 N	Passed
Force at 40 Deg:	204.62-258.00 N	236.74 N	Passed
Return Angle	12 Deg Max	1.91 deg	Passed

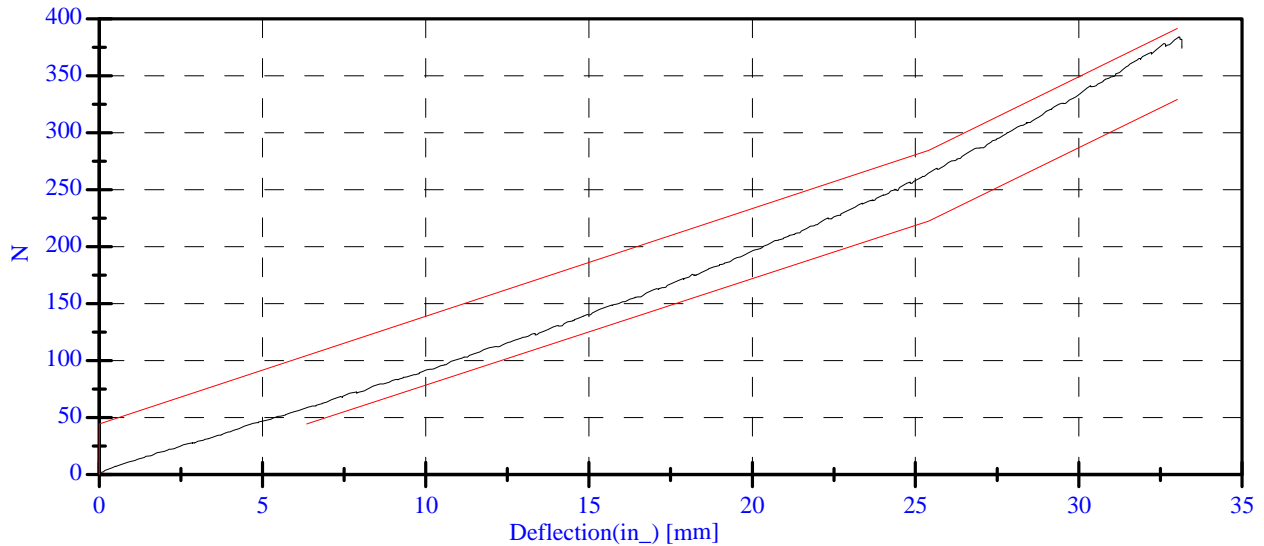
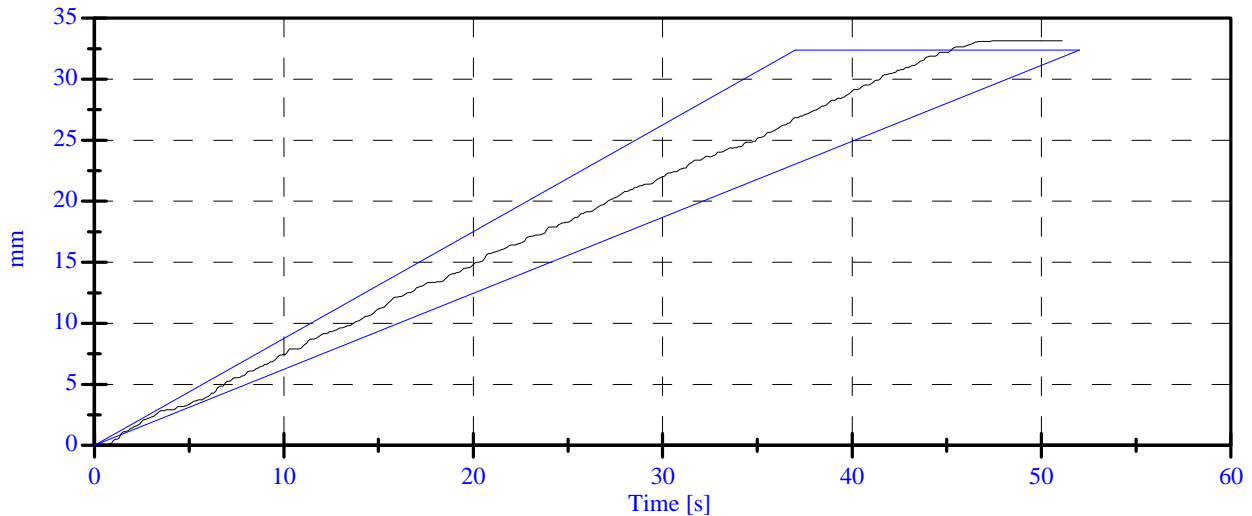
### ABDOMINAL COMPRESSION TEST

<u>TEST PARAMETER</u>	<u>SPECIFICATION</u>	<u>TEST RESULTS</u>	<u>STATUS</u>
Lab Temperature:	18.9-25.5 C	21.1 C	Passed
Lab Humidity:	10-70 %	41.00 %	Passed
Force at 12.95 mm :	104.00-162.00 N	120.42 N	Passed
Force at 19.05 mm :	162.98-220.99 N	184.58 N	Passed
Force at 25.40 mm :	221.97-280.02 N	264.32 N	Passed
Force at 33.02 mm :	324.99-391.00 N	383.58 N	Passed

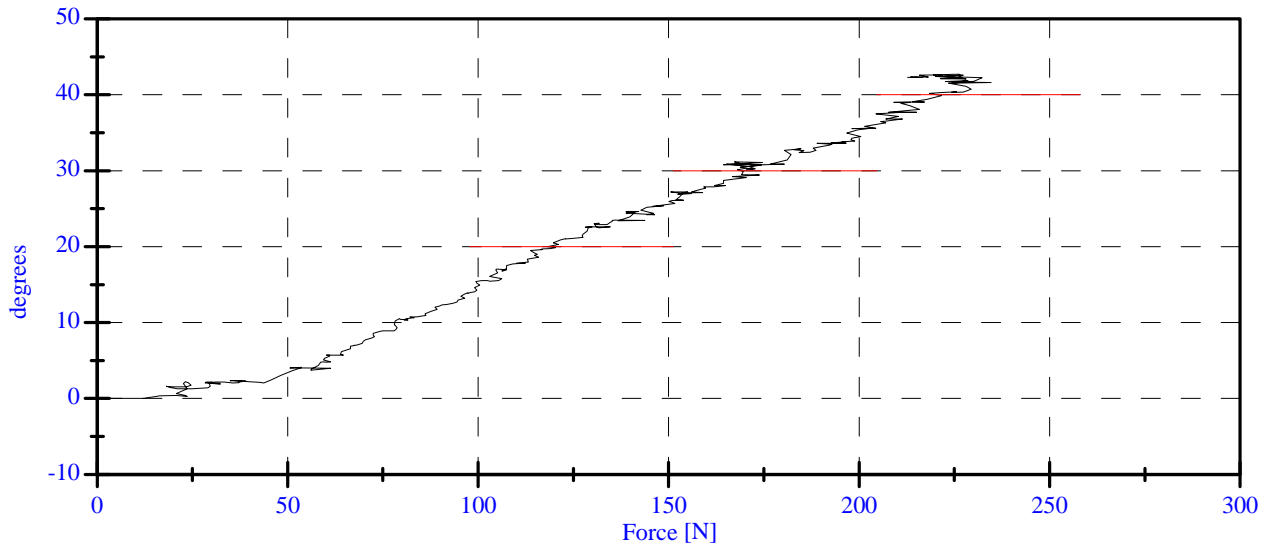
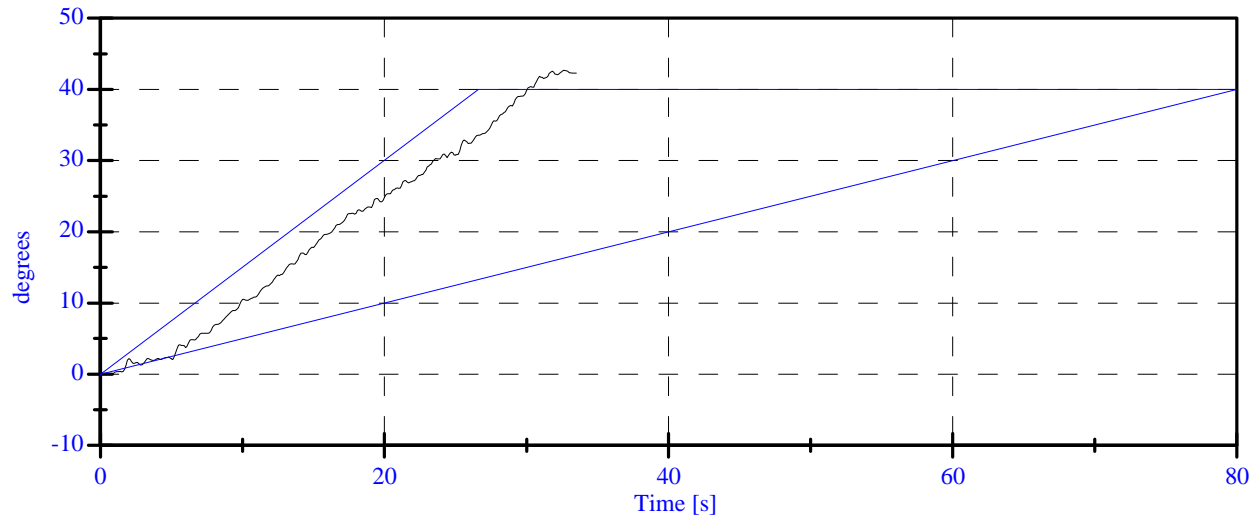
### LUMBAR SPINE FLEXION TEST

<u>TEST PARAMETER</u>	<u>SPECIFICATION</u>	<u>TEST RESULTS</u>	<u>STATUS</u>
Lab Temperature:	18.9-25.5 C	21.1 C	Passed
Lab Humidity:	10-70 %	31.00 %	Passed
Force at 0 Deg:	0.00-26.69 N	3.53 N	Passed
Force at 20 Deg:	97.86-151.24 N	118.18 N	Passed
Force at 30 Deg:	151.24-204.62 N	169.62 N	Passed
Force at 40 Deg:	204.62-258.00 N	221.59 N	Passed
Return Angle	12 Deg Max	3.69 deg	Passed

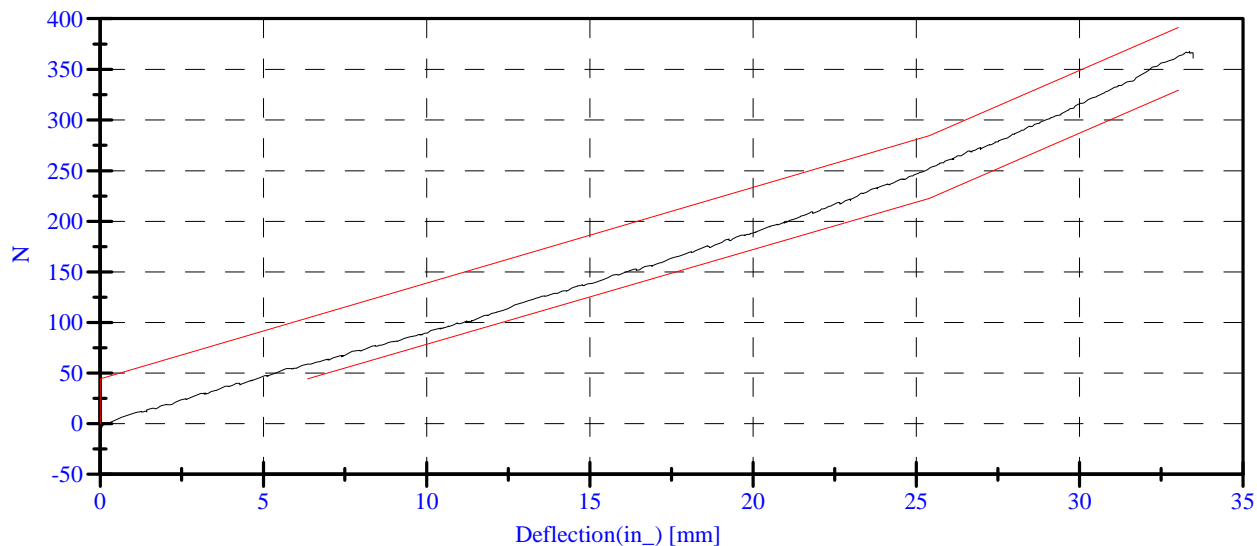
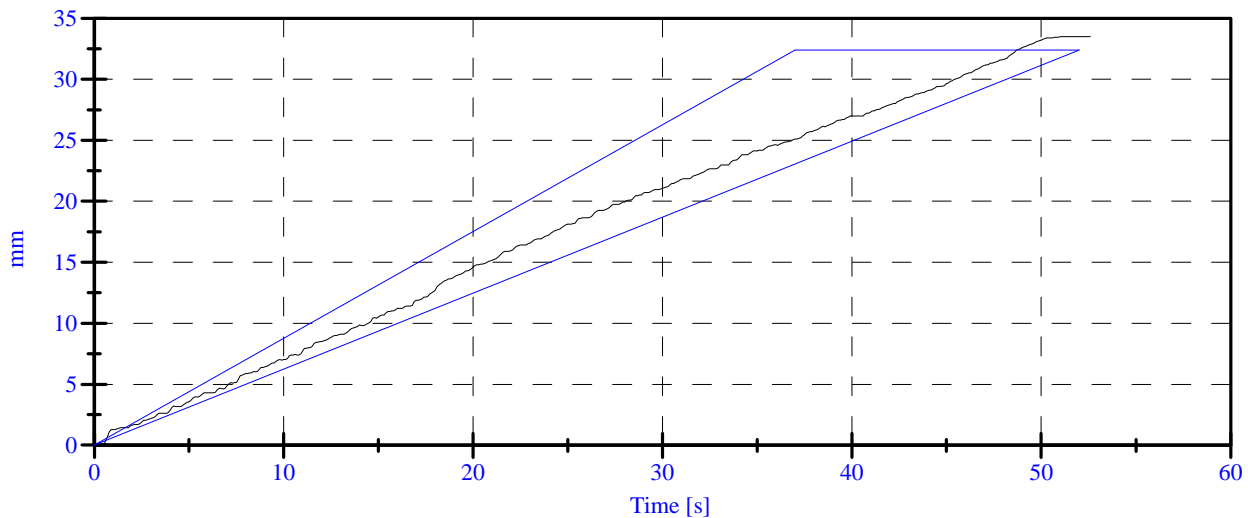
### ABDOMINAL COMPRESSION TEST

<u>TEST PARAMETER</u>	<u>SPECIFICATION</u>	<u>TEST RESULTS</u>	<u>STATUS</u>
Lab Temperature:	18.9-25.5 C	21.1 C	Passed
Lab Humidity:	10-70 %	40.00 %	Passed
Force at 12.95 mm :	104.00-162.00 N	120.05 N	Passed
Force at 19.05 mm :	162.98-220.99 N	179.14 N	Passed
Force at 25.40 mm :	221.97-280.02 N	253.45 N	Passed
Force at 33.02 mm :	324.99-391.00 N	363.28 N	Passed

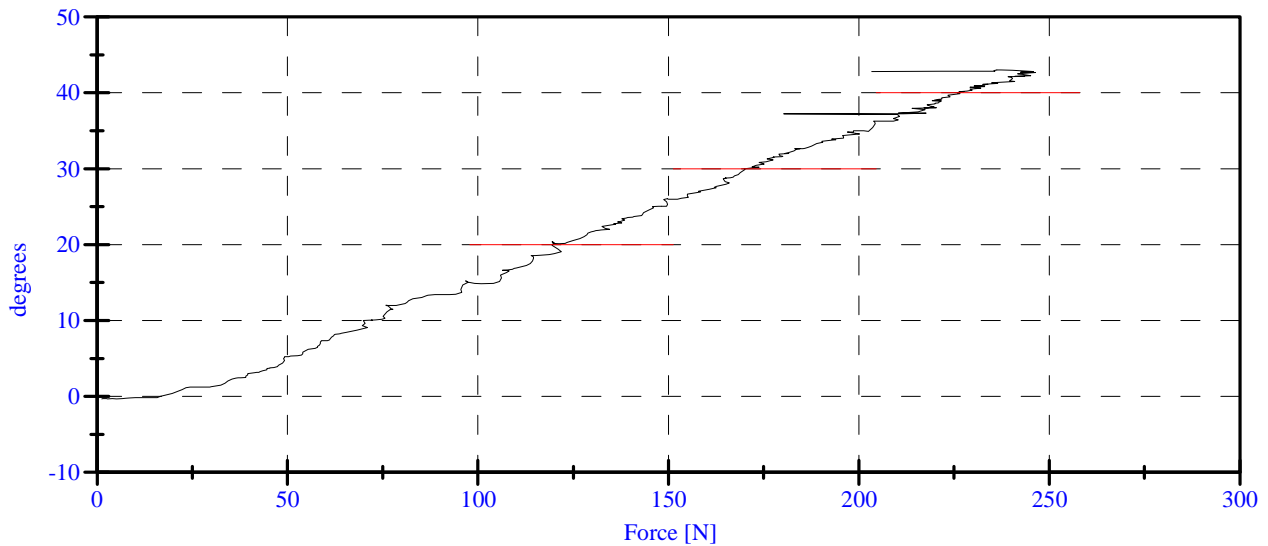
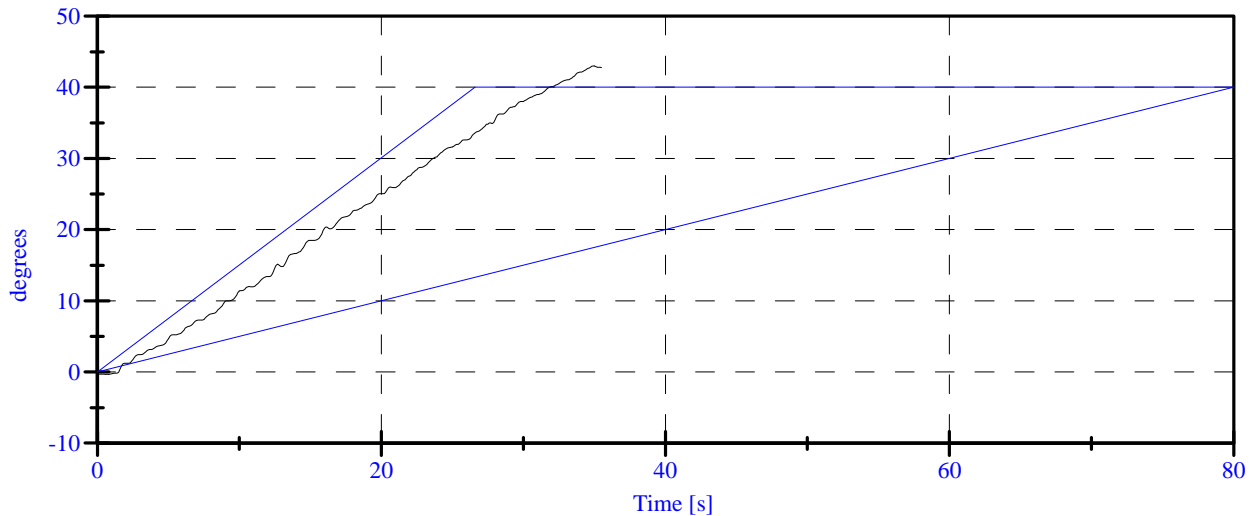
### LUMBAR SPINE FLEXION TEST

<u>TEST PARAMETER</u>	<u>SPECIFICATION</u>	<u>TEST RESULTS</u>	<u>STATUS</u>
Lab Temperature:	18.9-25.5 C	21.1 C	Passed
Lab Humidity:	10-70 %	40.00 %	Passed
Force at 0 Deg:	0.00-26.69 N	16.59 N	Passed
Force at 20 Deg:	97.86-151.24 N	119.48 N	Passed
Force at 30 Deg:	151.24-204.62 N	169.89 N	Passed
Force at 40 Deg:	204.62-258.00 N	225.77 N	Passed
Return Angle	12 Deg Max	1.60 deg	Passed

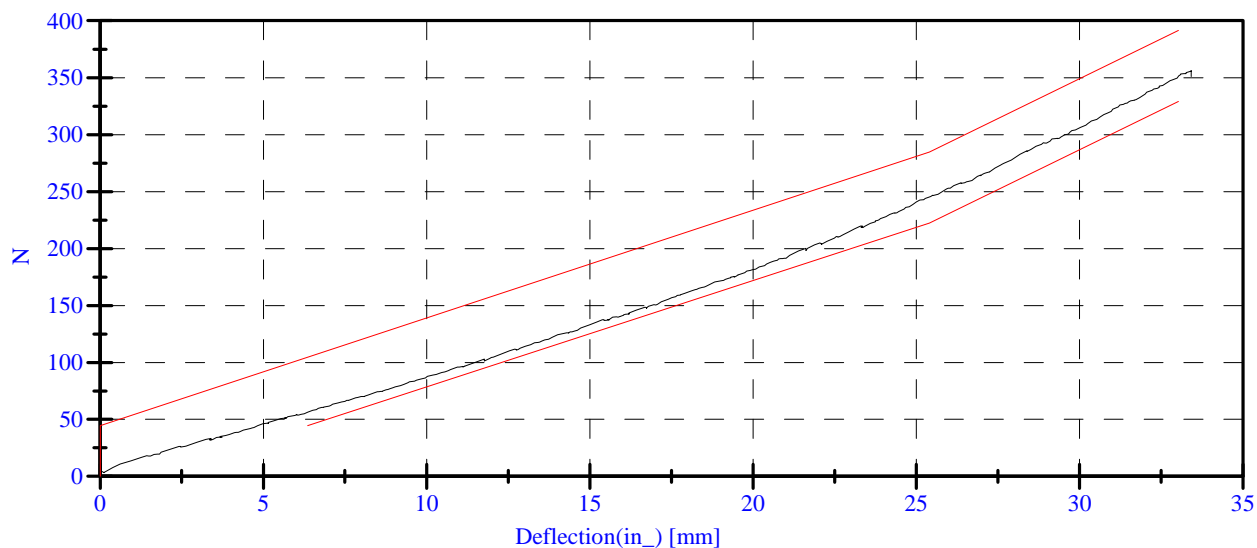
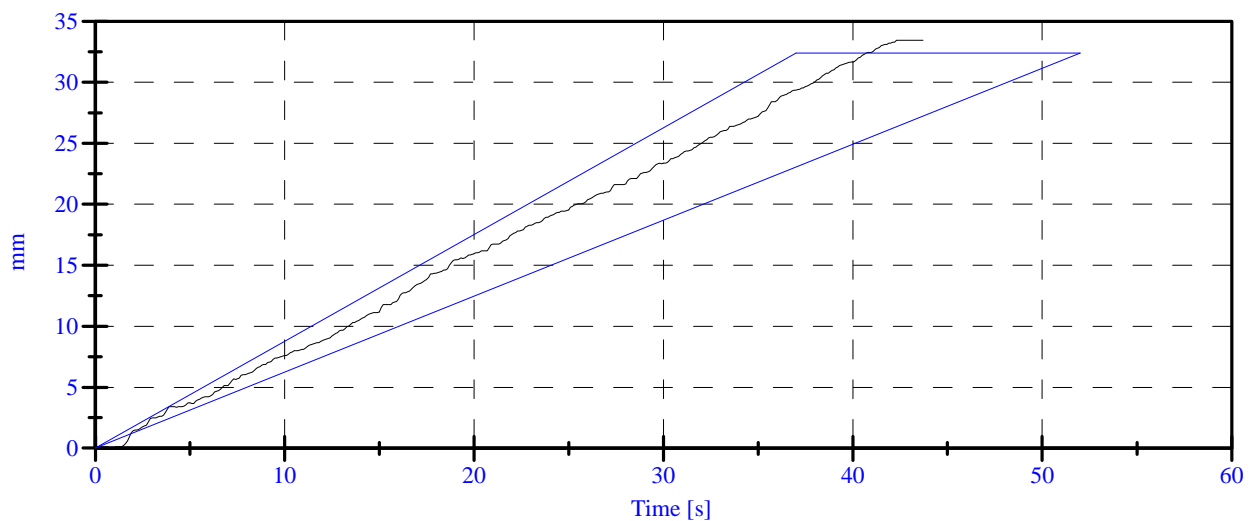
### ABDOMINAL COMPRESSION TEST

<u>TEST PARAMETER</u>	<u>SPECIFICATION</u>	<u>TEST RESULTS</u>	<u>STATUS</u>
Lab Temperature:	18.9-25.5 C	21.1 C	Passed
Lab Humidity:	10-70 %	40.00 %	Passed
Force at 12.95 mm :	104.00-162.00 N	114.25 N	Passed
Force at 19.05 mm :	162.98-220.99 N	171.89 N	Passed
Force at 25.40 mm :	221.97-280.02 N	245.84 N	Passed
Force at 33.02 mm :	324.99-391.00 N	351.68 N	Passed

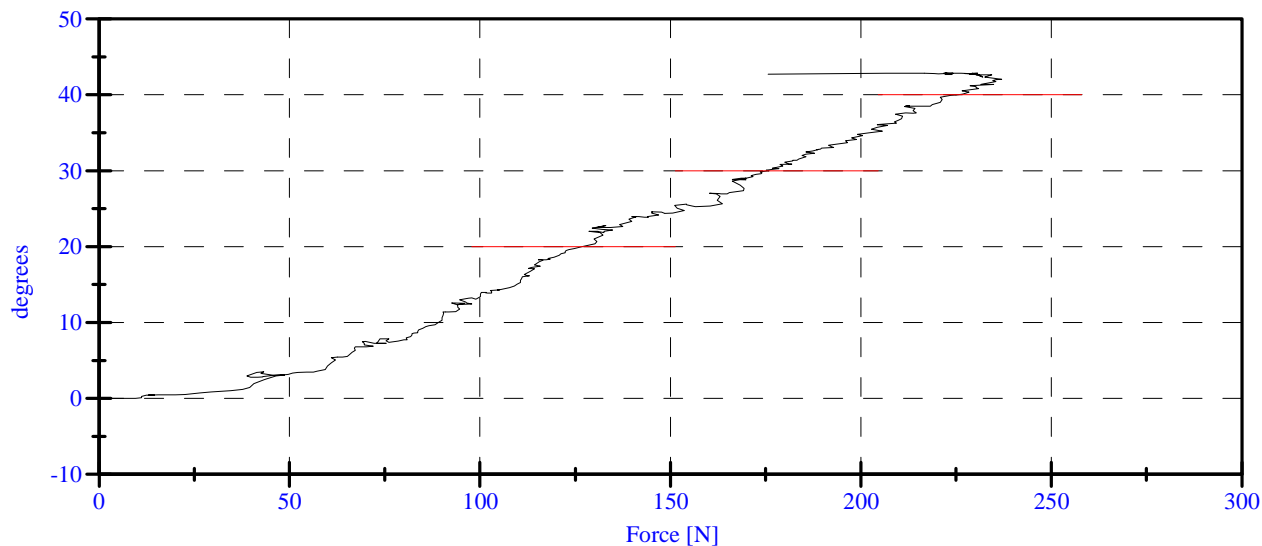
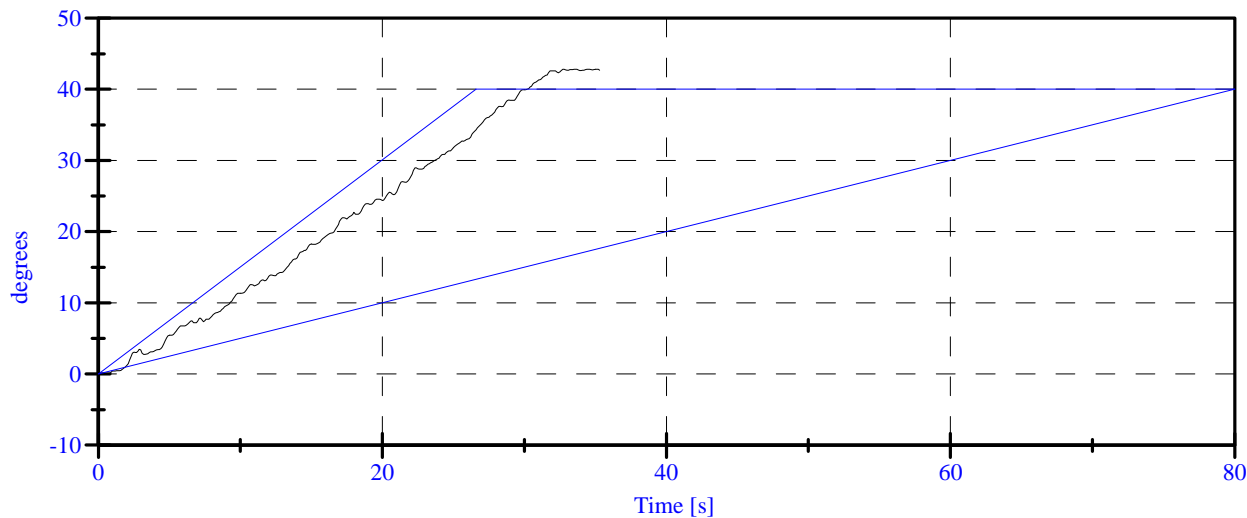
**LUMBAR SPINE FLEXION TEST**

<u>TEST PARAMETER</u>	<u>SPECIFICATION</u>	<u>TEST RESULTS</u>	<u>STATUS</u>
Lab Temperature:	18.9-25.5 C	21.1 C	Passed
Lab Humidity:	10-70 %	40.00 %	Passed
Force at 0 Deg:	0.00-26.69 N	2.22 N	Passed
Force at 20 Deg:	97.86-151.24 N	126.79 N	Passed
Force at 30 Deg:	151.24-204.62 N	175.89 N	Passed
Force at 40 Deg:	204.62-258.00 N	226.29 N	Passed
Return Angle	12 Deg Max	3.55 deg	Passed

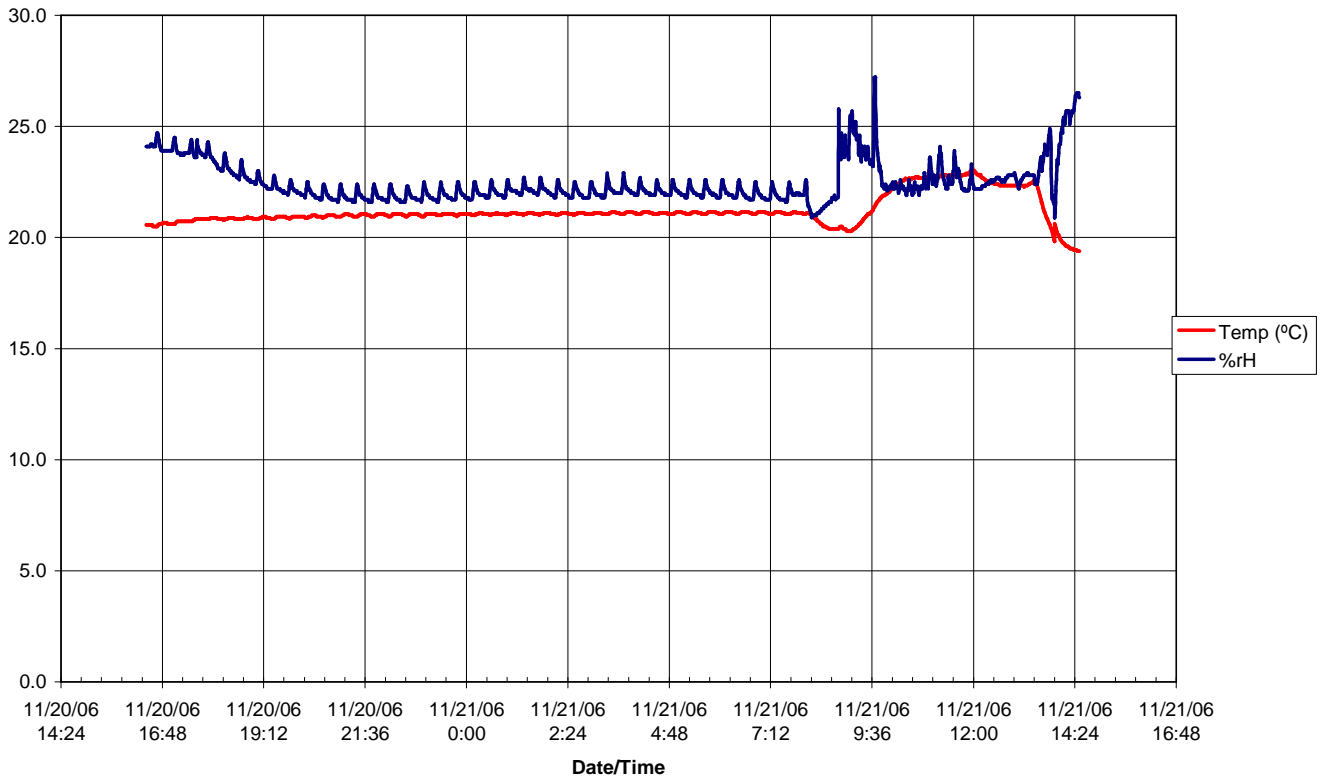
# TEMPERATURE TRACE

## 2007 Dodge Nitro C70304 Environmental Conditions
