SAFETY COMPLIANCE TESTING FOR FMVSS NO. 138 TIRE PRESSURE MONITORING SYSTEMS

FORD MOTOR COMPANY
2006 EXPEDITION
FOUR-DOOR MPV
NHTSA NO. C60206

FINAL REPORT

1. Report No. 138-STF-06-005	2. Government Accession No.	3. Recipient's Catalog No.
4. Title and Subtitle Final Report of FMVSS 138 Compliance Testing of 2006 Ford Expedition Four-door MPV, NHTSA No. C60206		5. Report Date April 12, 2007

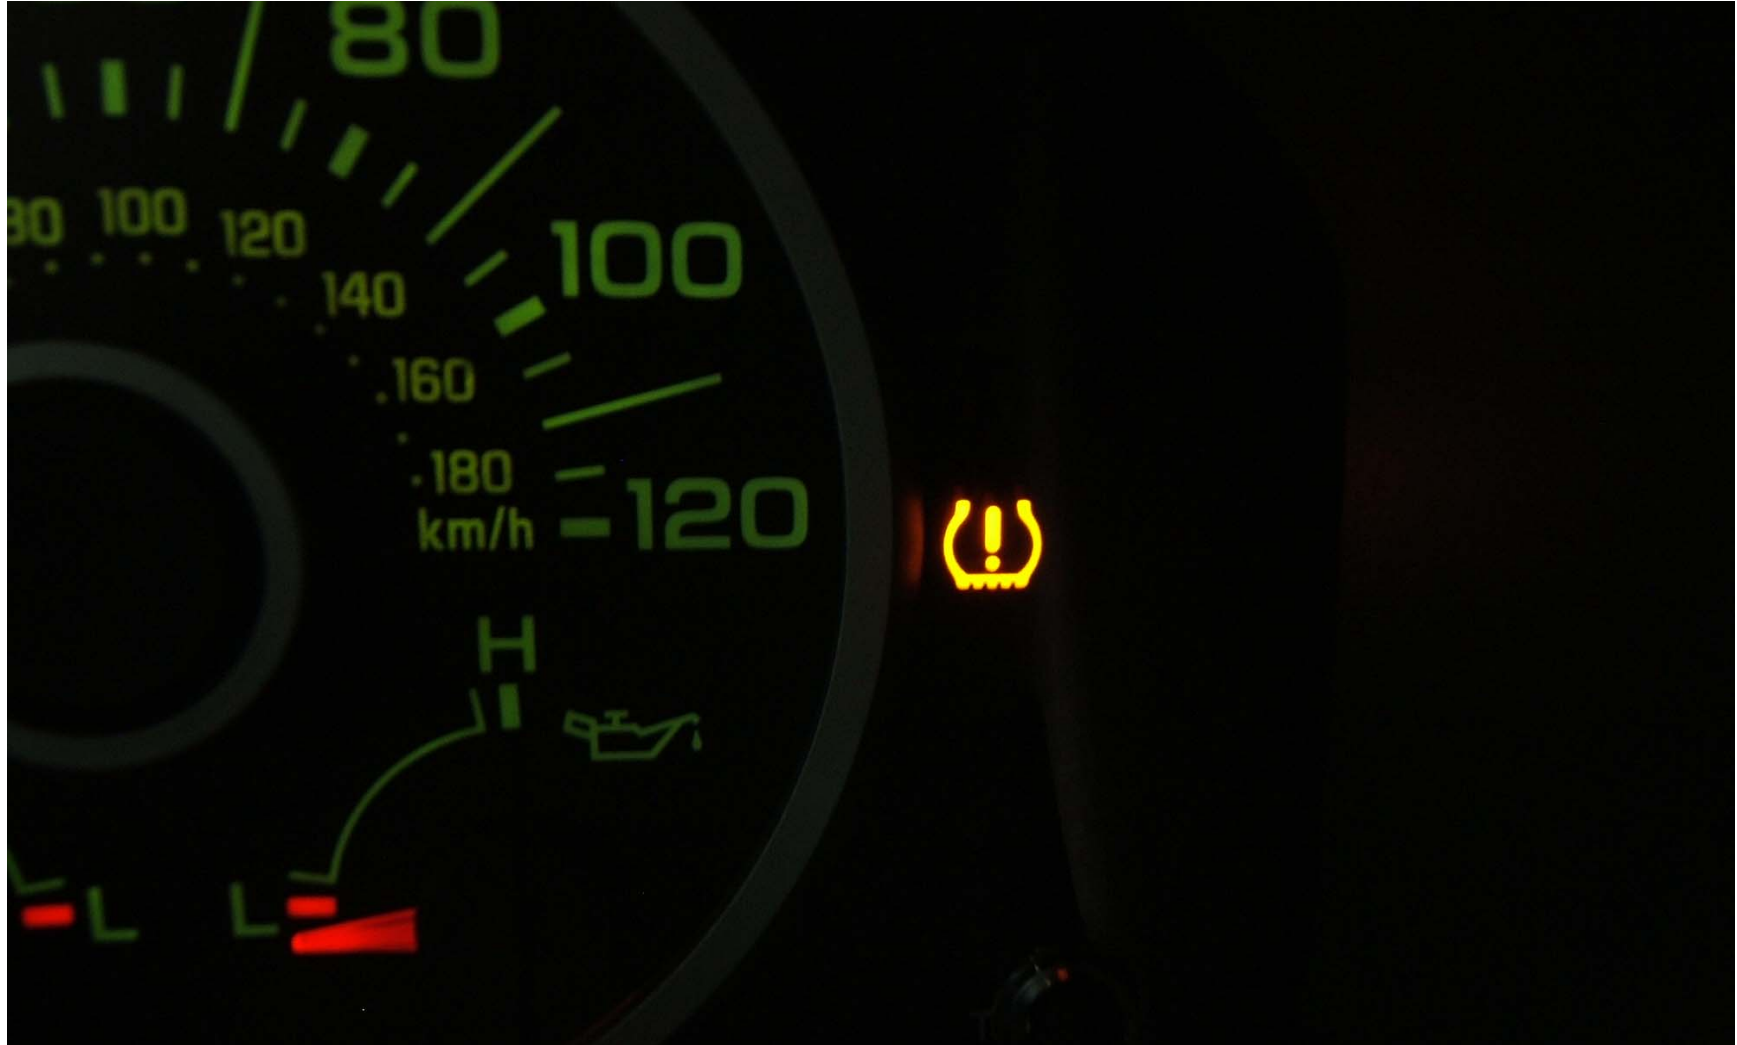
FIGURE 5.11
INSTRUMENT PANEL SHOWING COMBINATION LOW TIRE
PRESSURE WARNING AND MALFUNCTION TELLTALE

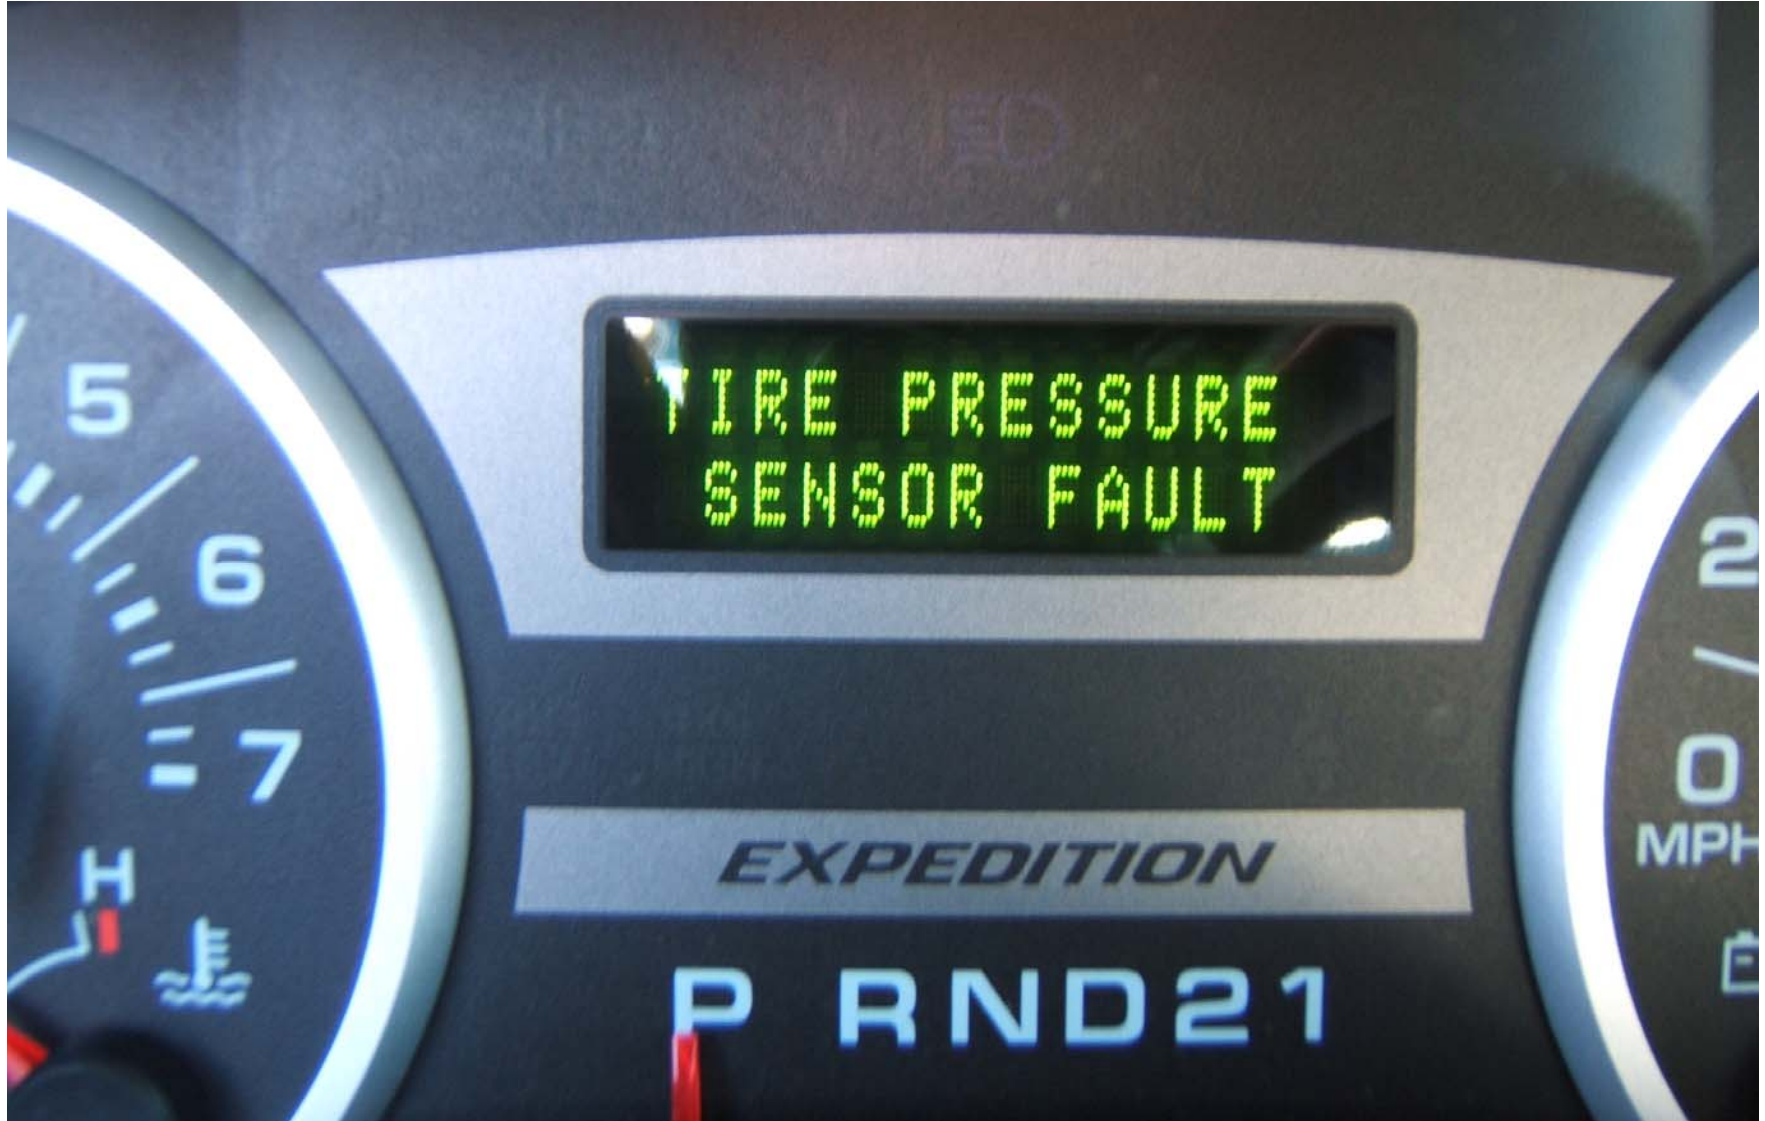
One indicant malfunction detection scenario was performed on the test vehicle at GVWR. The vehicle's combination low tire pressure warning and malfunction telltale indicated a malfunction, but did not flash and illuminate per the standard's requirements effective September 1, 2007.

FIGURE 5.12
RECONFIGURABLE DISPLAY SHOWING
TPMS MALFUNCTION WARNING

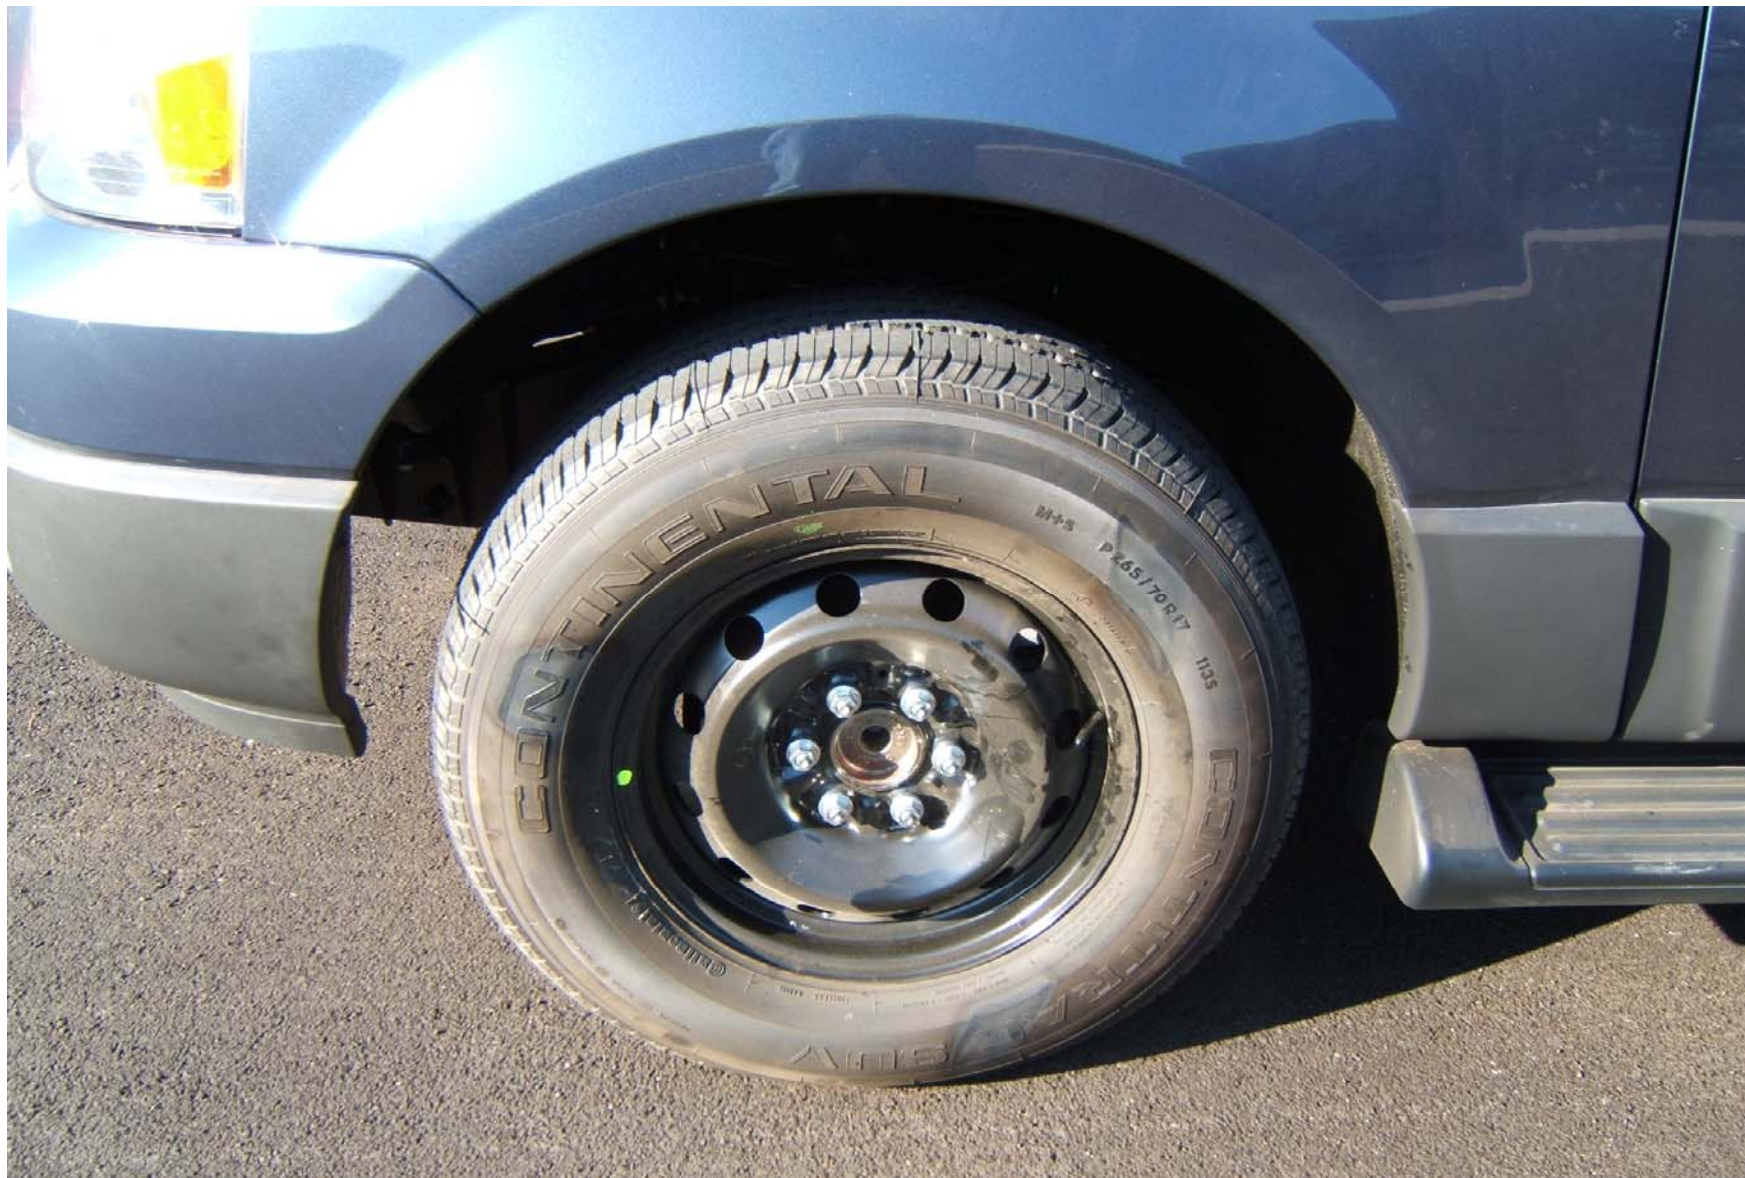
An indicant malfunction detection scenario was performed with the vehicle loaded to its GVWR. A malfunction was simulated by placing the full size spare tire (with no TPMS sensor) on the left front wheel position. The vehicle was driven until telltale illumination or until a minimum of 20 minutes of cumulative driving time between 50 and 100 km/h was attained.

FIGURE 5.16
SPARE ON LEFT FRONT POSITION
FOR MALFUNCTION DETECTION TEST

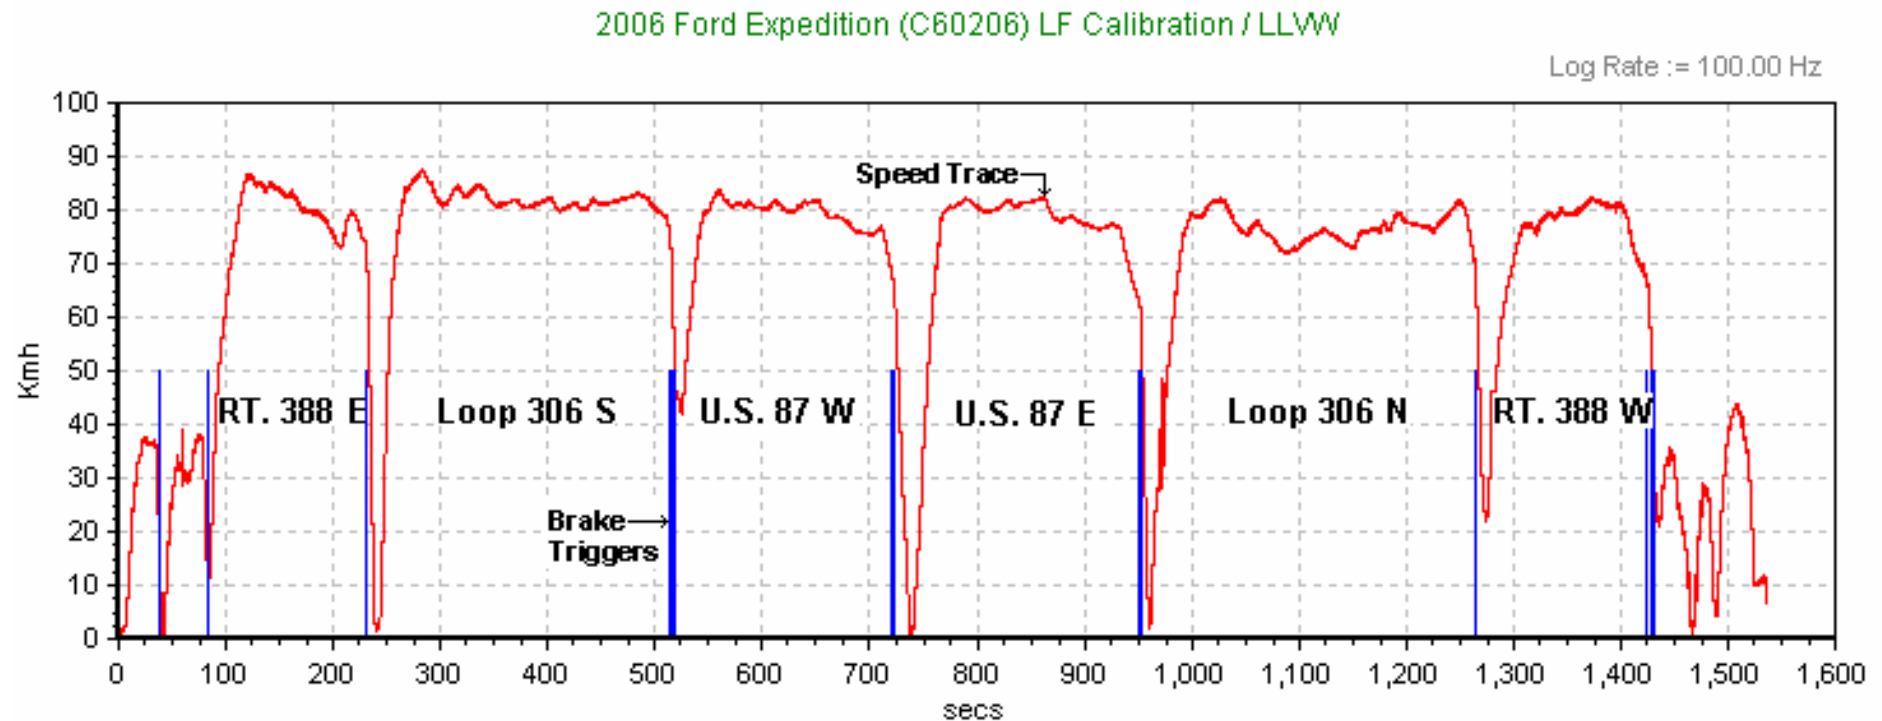
Calibration Phase

Scenario A: Left Front Tire
Test Date: 9/19/06
Data File Time: 25:36 minutes
Cumulative Driving Time: 20:20 minutes
Start Point: SATF shop

LF Detection Phase: Telltale illuminated upon ignition activation. Driving was not required.

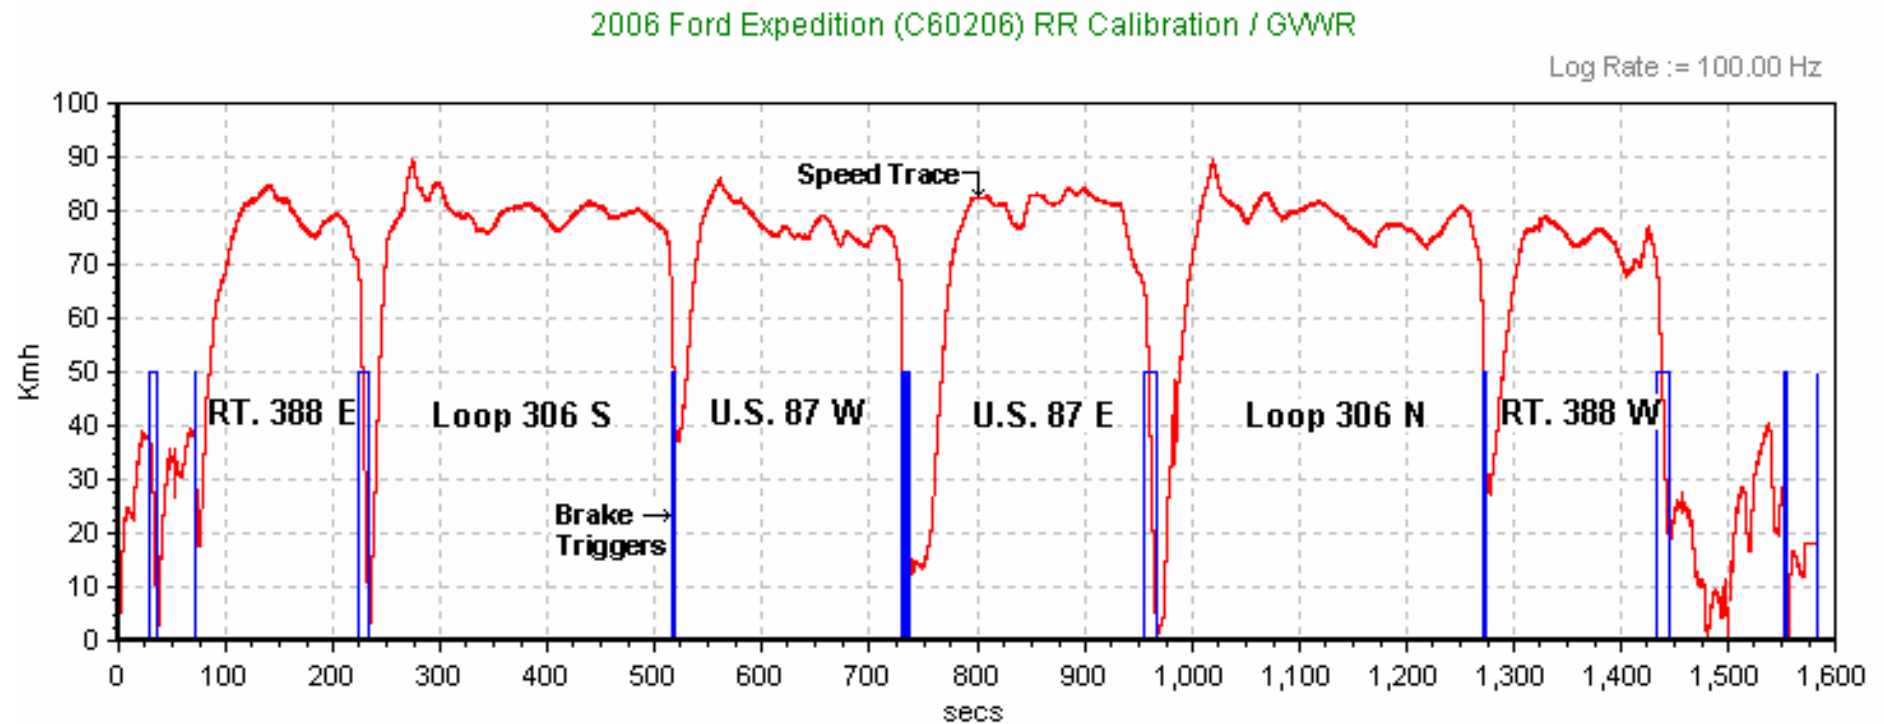
Calibration Phase

Scenario B: Right Rear Tire
Test Date: 9/20/06
Data File Time: 26:22 minutes
Cumulative Driving Time: 20:25 minutes
Start Point: SATF shop

RR Detection Phase: Illumination under 10 seconds. Driving was not required.

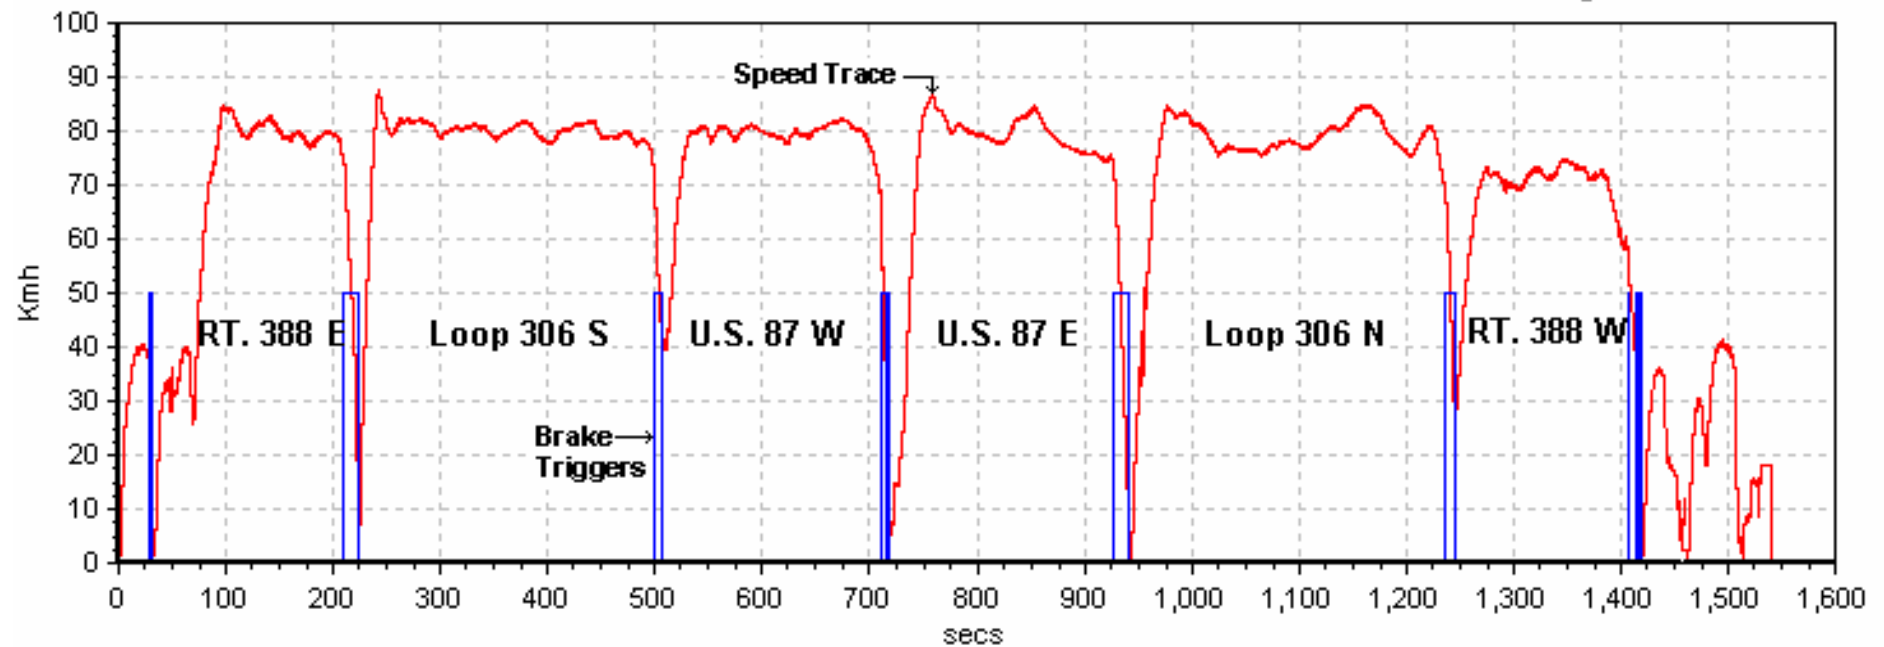
2006 Ford Expedition (C60206) LF, LR, RR, RF Calibration / GWR

Scenario C: Left Front, Left Rear, Right Rear, Right Front Tires
Test Date: 9/20/06
Data File Time: 25:40 minutes
Cumulative Driving Time: 20:19 minutes
Start Point: SATF shop

LF, LR, RR, RF Detection Phase: Illumination under 10 seconds. Driving was not required.

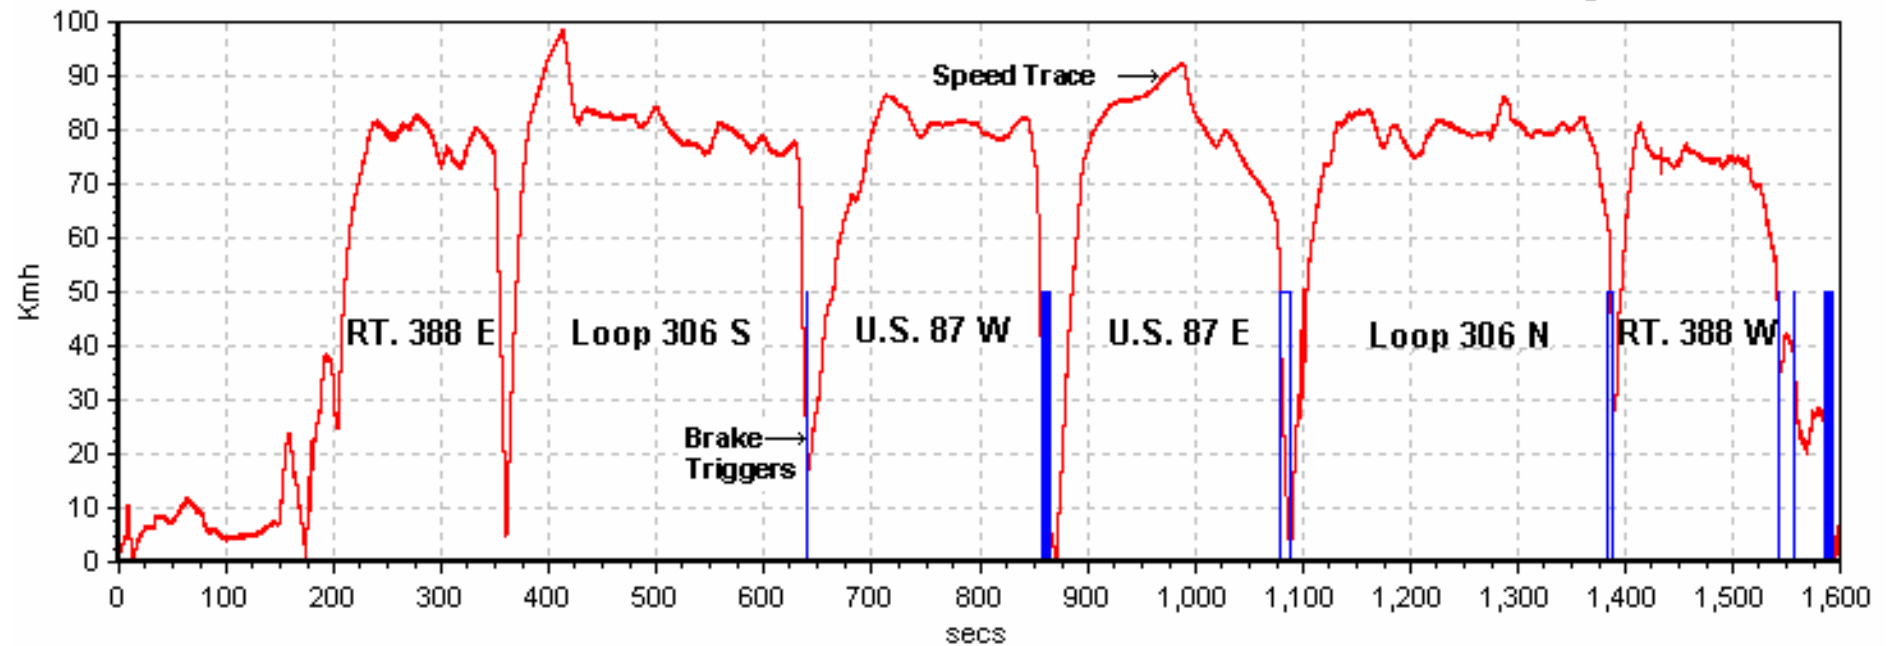
2006 Ford Expedition (C60206) LR Calibration / LLWW

Scenario D: Left Rear Tire
Test Date: 9/22/06
Data File Time: 27:59 minutes
Cumulative Driving Time: 20:21 minutes
Start Point: SATF shop

LR Detection Phase: Illumination under 10 seconds. Driving was not required.

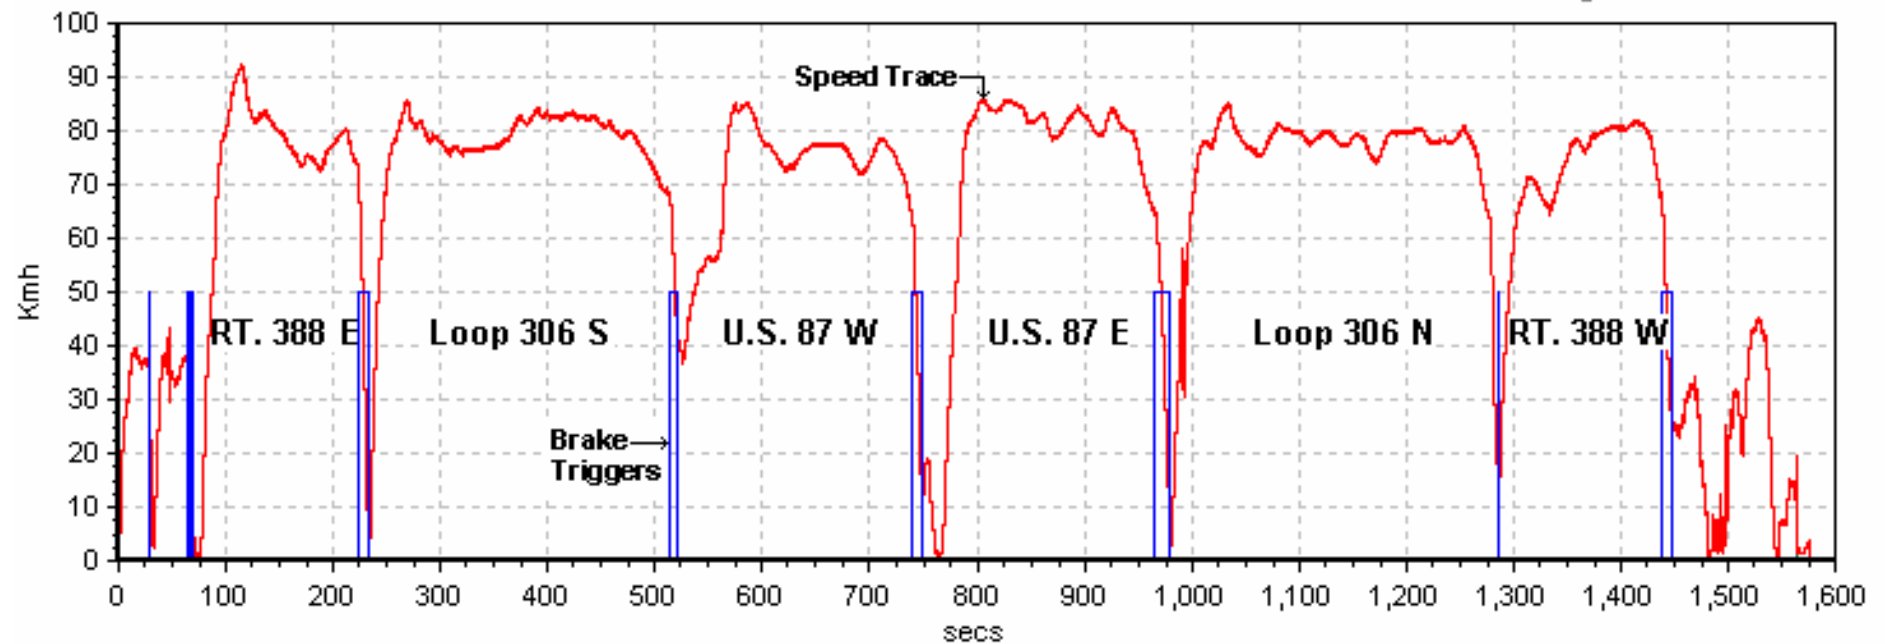
2006 Ford Expedition (C60206) RF Calibration / LLVW

Scenario E: Right Front Tire
Test Date: 9/22/06
Data File Time: 26:16 minutes
Cumulative Driving Time: 20:27 minutes
Start Point: SATF shop

RF Detection Phase: Illumination with ignition switch activation. Driving was not required.

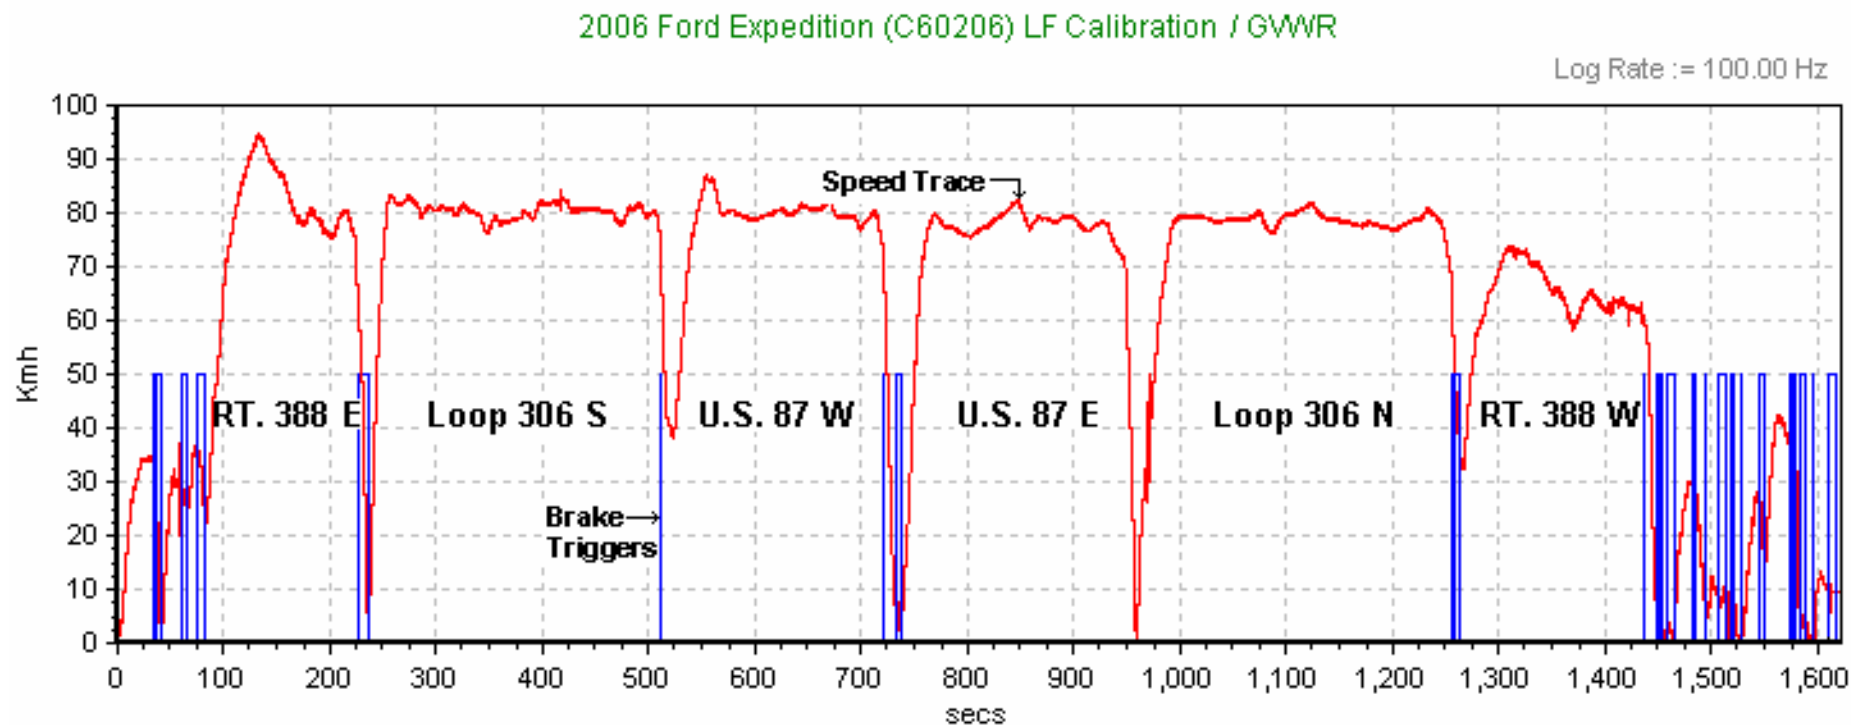
Calibration Phase

LF Detection Phase: Illumination with ignition switch activation. Driving was not required.

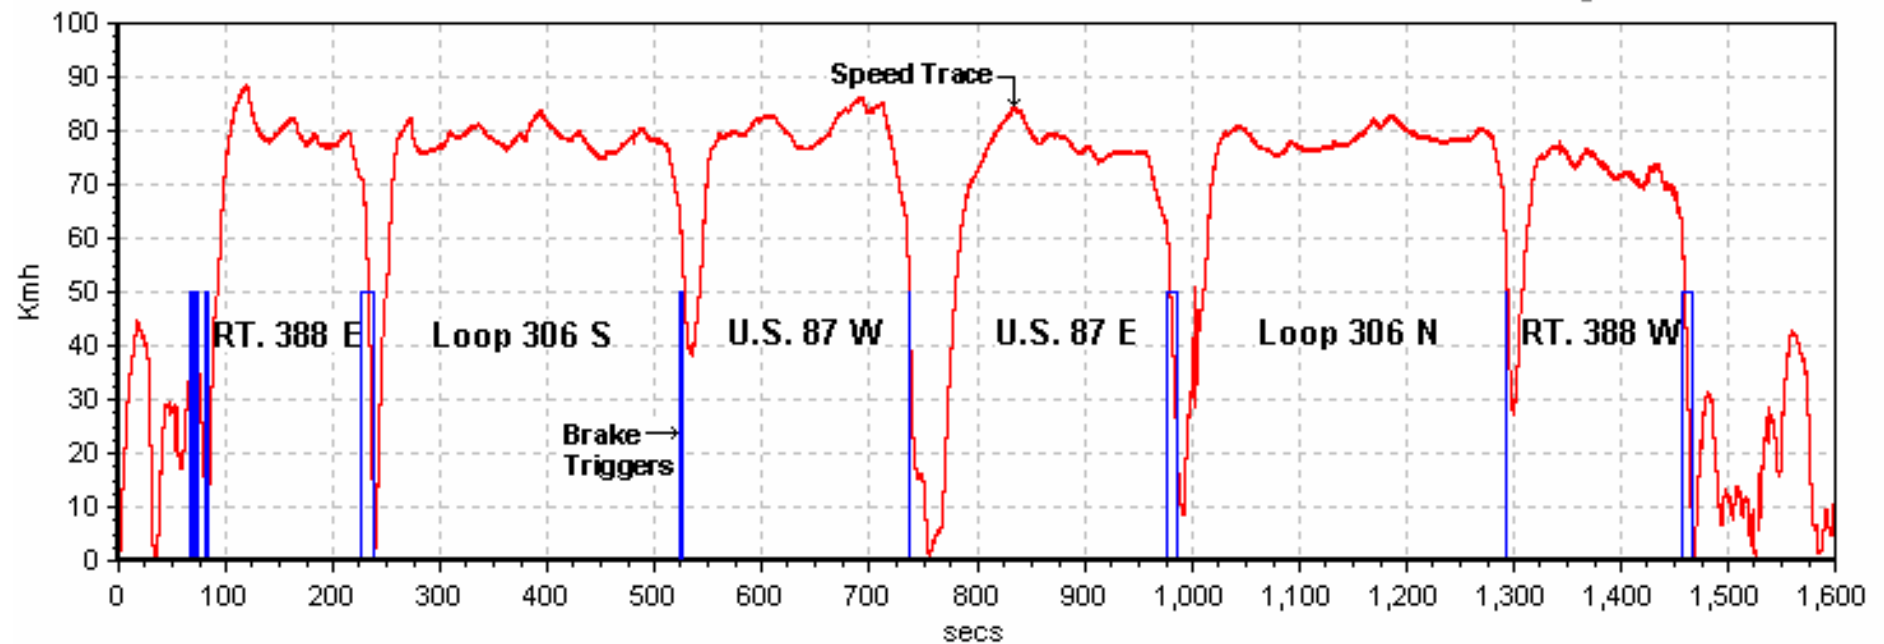
2006 Ford Expedition (C60206) LF, RF Calibration / GVWR

Scenario G: Left Front, Right Front Tires
Test Date: 10/2/06
Data File Time: 26:58 minutes
Cumulative Driving Time: 20:29 minutes
Start Point: SATF shop

LF, RF Detection Phase: Illumination with ignition switch activation. Driving was not required.

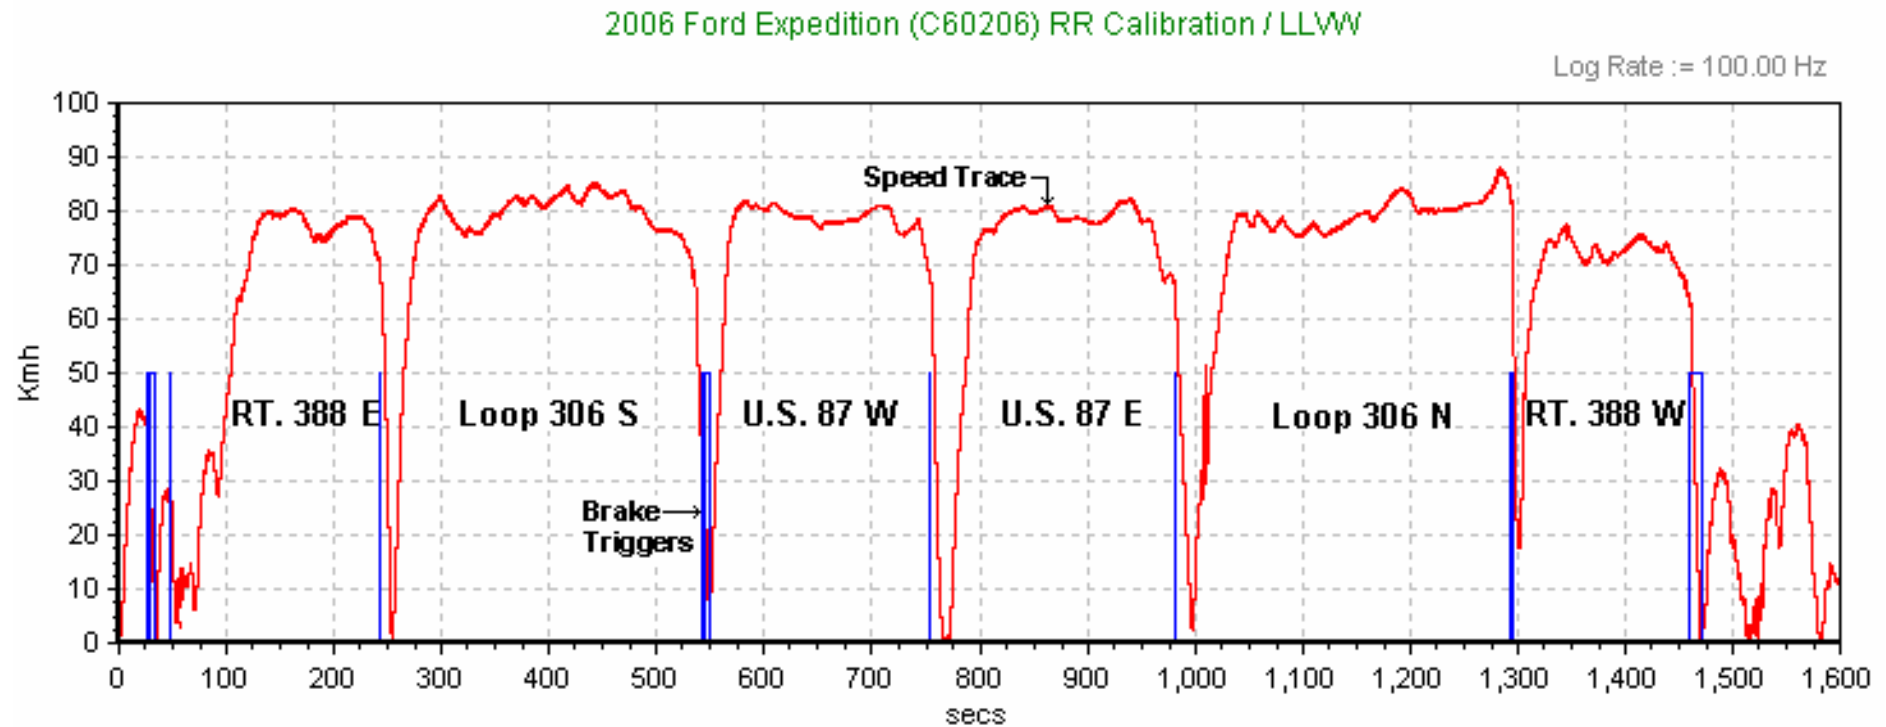
Calibration Phase

Scenario H: Right Rear Tire
Test Date: 10/4/06
Data File Time: 26:37 minutes
Cumulative Driving Time: 20:41 minutes
Start Point: SATF shop

RR Detection Phase: Illumination with ignition switch activation. Driving was not required.

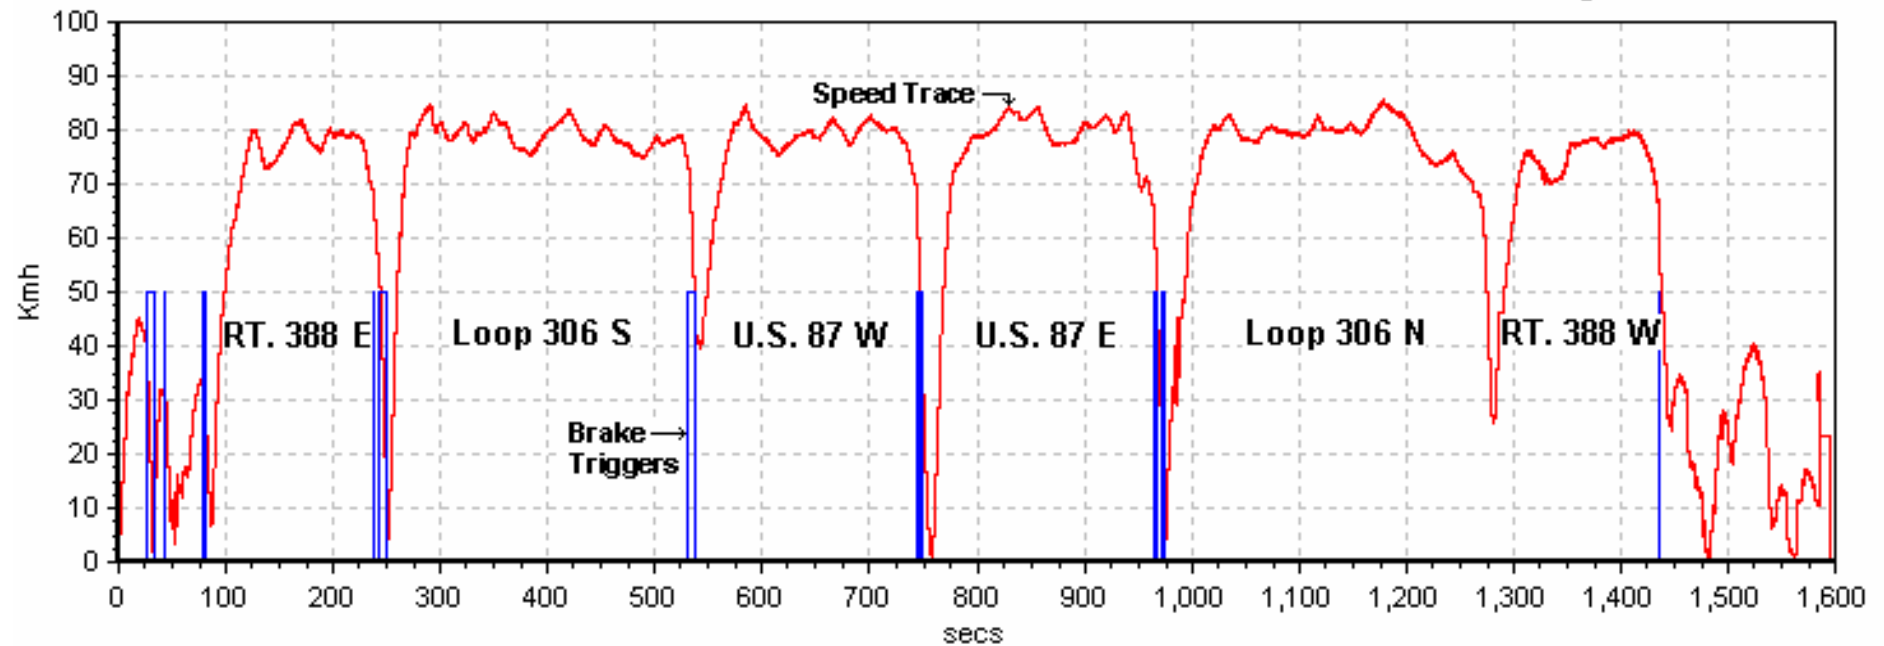
2006 Ford Expedition (C60206) LF, LR Calibration / LLWW

Scenario I: Left Front, Left Rear Tires
Test Date: 10/5/06
Data File Time: 26:35 minutes
Cumulative Driving Time: 20:34 minutes
Start Point: SATF shop

LF, LR Detection Phase: Illumination with ignition switch activation. Driving was not required.

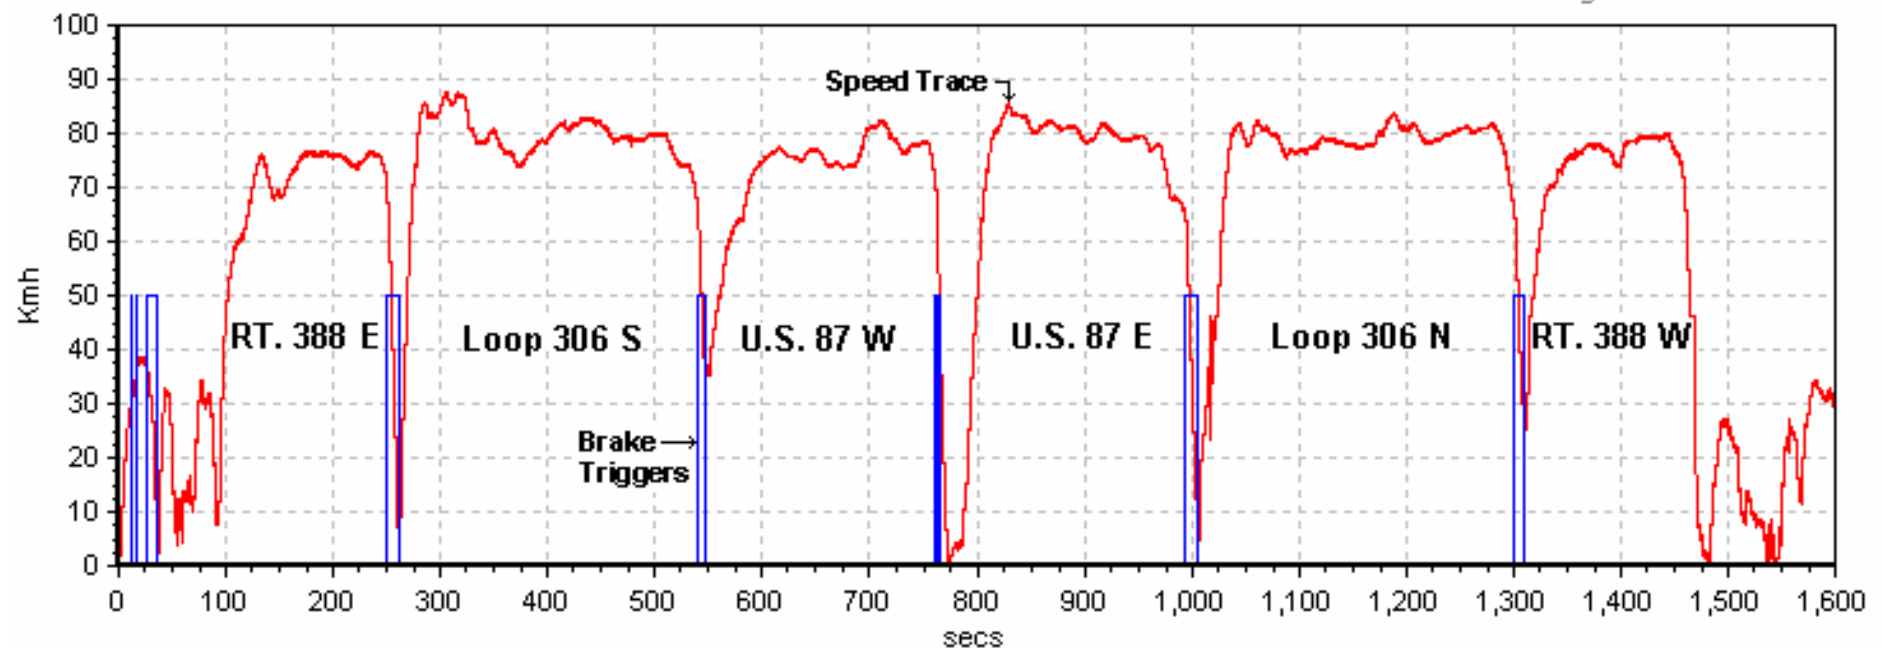
2006 Ford Expedition (C60206) LF, LR, RR, RF Calibration / LLWW

Scenario J: Left Front, Left Rear, Right Rear, Right Front Tires
Test Date: 10/6/06
Data File Time: 27:08 minutes
Cumulative Driving Time: 20:34 minutes
Start Point: SATF shop

LF, LR, RR, RF Detection Phase: Illumination with ignition switch activation. Driving was not required.

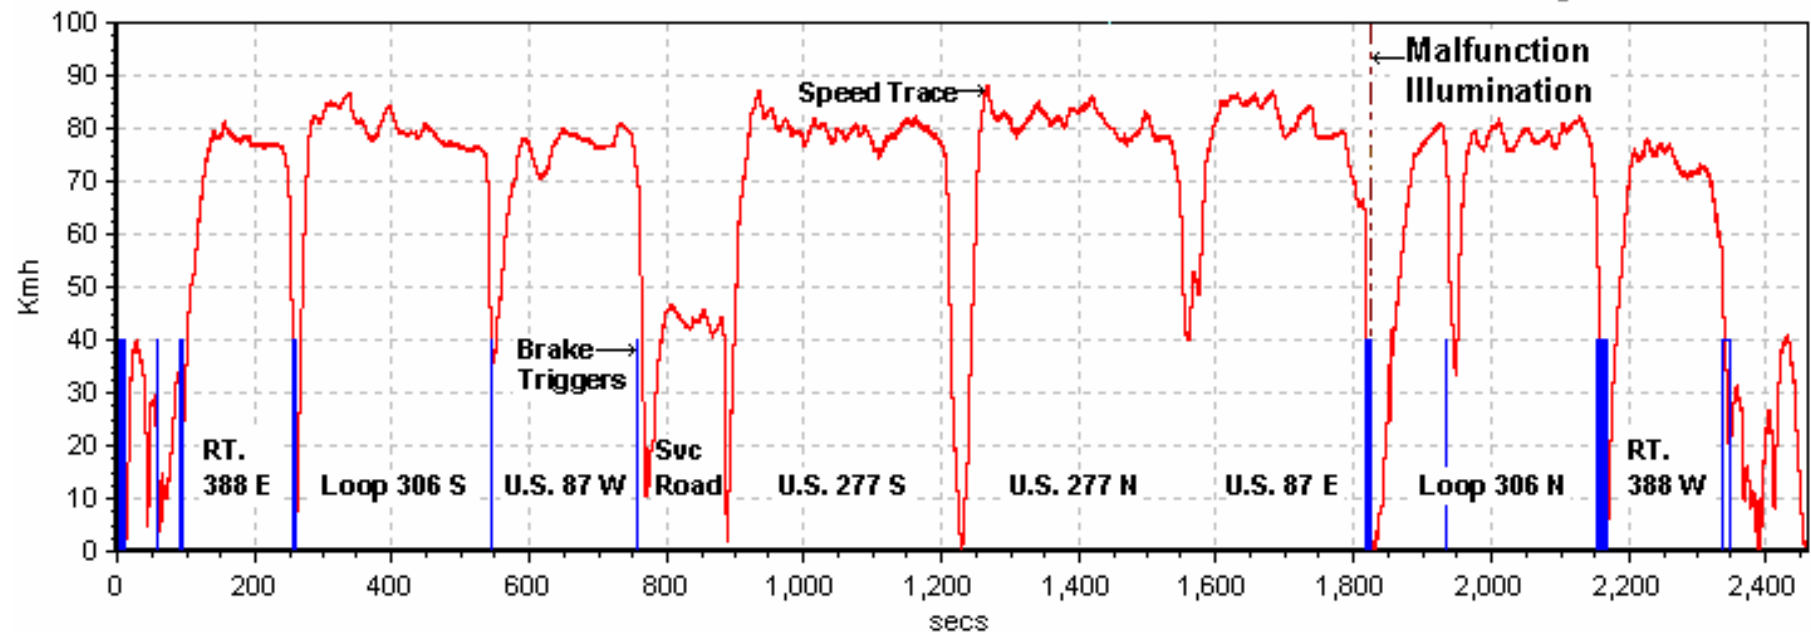
2006 Ford Expedition (C60206) LF Combination Low Tire / Malfunction Telltale Illumination / GVWR

Scenario K: Spare without Sensor Installed on Left Front Position
Test Date: 10/4/06
Data File Time: 41:01 minutes
Illumination: 24:06 minutes
Start Point: SATF shop

LF Malfunction Telltale: Indicant test only
